Your Inspection Report

16 First Avenue
Toronto, ON

Tuesday, November 15, 2016

RE: Report No. 2019, v.2
16 First Avenue
Toronto, ON

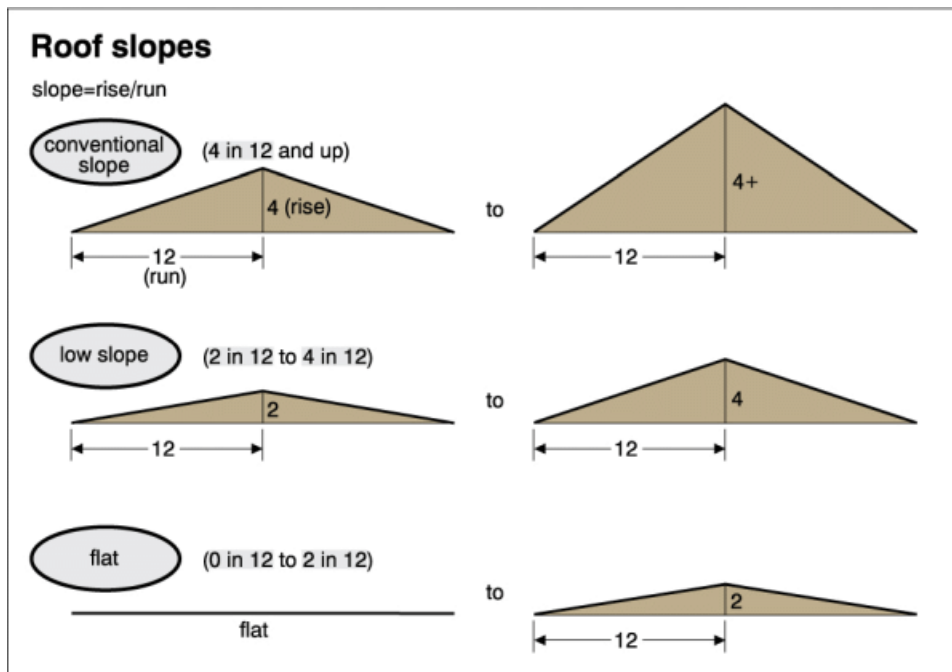
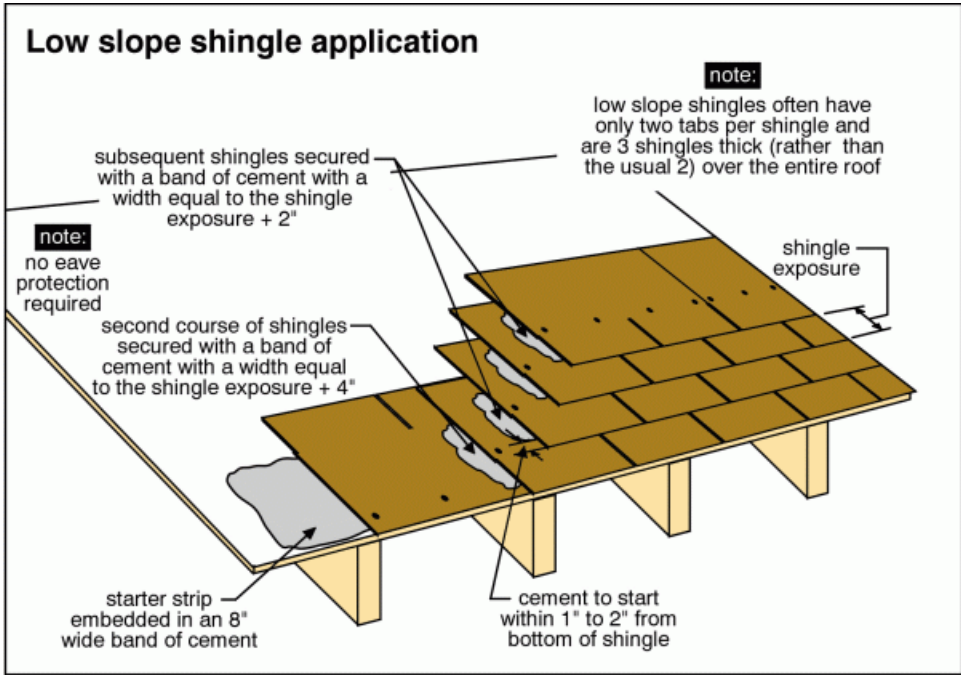
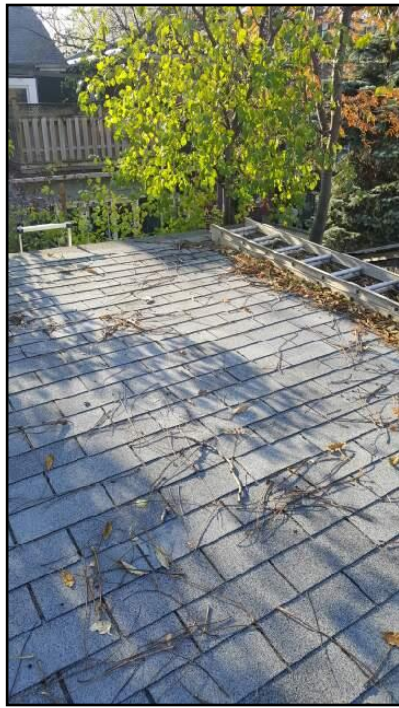
1. Condition: • [Slope too low](#)

Garage slope is too low for traditional shingles. Seal exposed fasteners at upper course and monitor. Treat as flat when resurfacing.

Implication(s): Chance of water damage to contents, finishes and/or structure

Location: Garage

4. Slope too low

Task: Resurface as flat

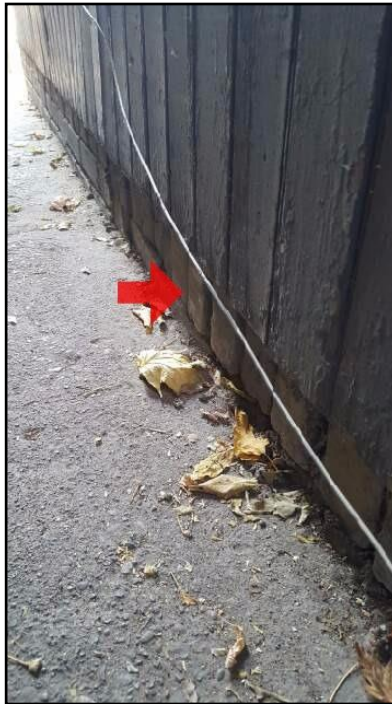
2. Condition: • [Parging damaged or missing](#)

Portion of foundation above grade is covered by wood skirt. Mortar is missing at visible areas. This area is protected by overhang of both houses so repair is not urgent but will eventually be necessary. Remove boards and parge exposed area.

Implication(s): Shortened life expectancy of material | Chance of damage to structure

Location: East Foundation

5. Parging damaged or missing

Task: Improve

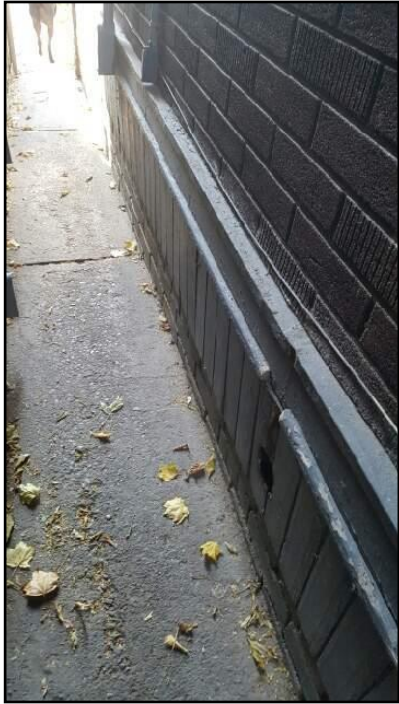
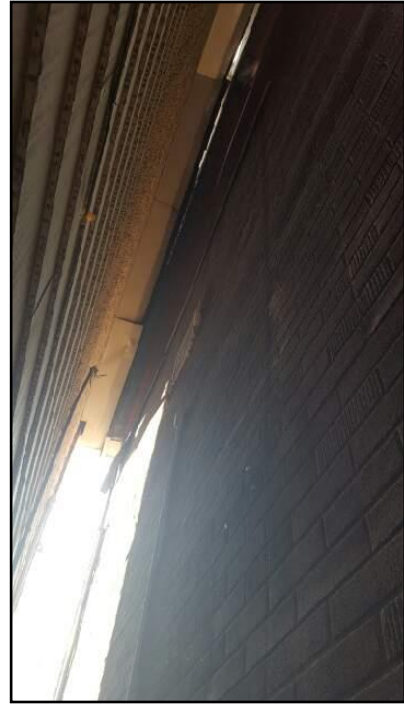
3. Condition: • Original insulbrick is protected by overhang of both houses but eventual replacement will be necessary due to loose siding, poorly sealed abandoned window and loose flashings.

Implication(s): Water damage/rot.

Location: Southeast Exterior Wall

Task: Replace

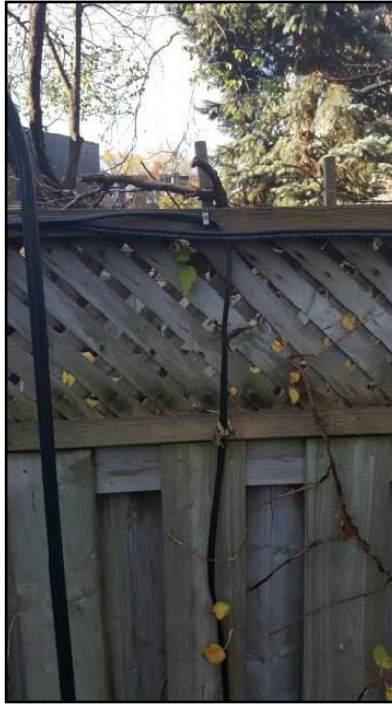
7. Condition: • Exterior wiring exposed to damage and contact by people.

Location: Northwest Exterior

8. Exterior wiring exposed to damage and...

Protect exposed wiring at fence with conduit.

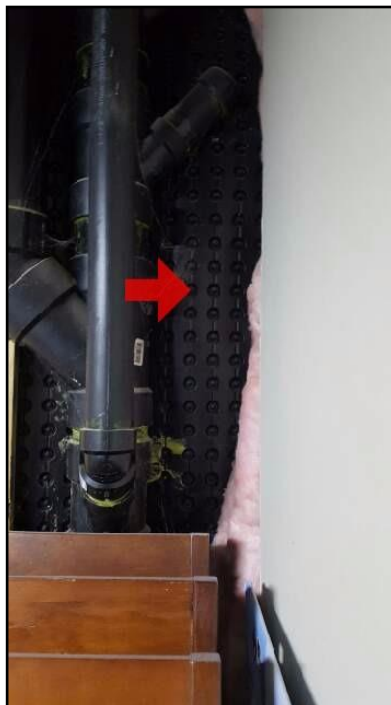
Note: Very low potential for basement leakage due to presence of interior membrane linked to sump system.

9. Interior membrane

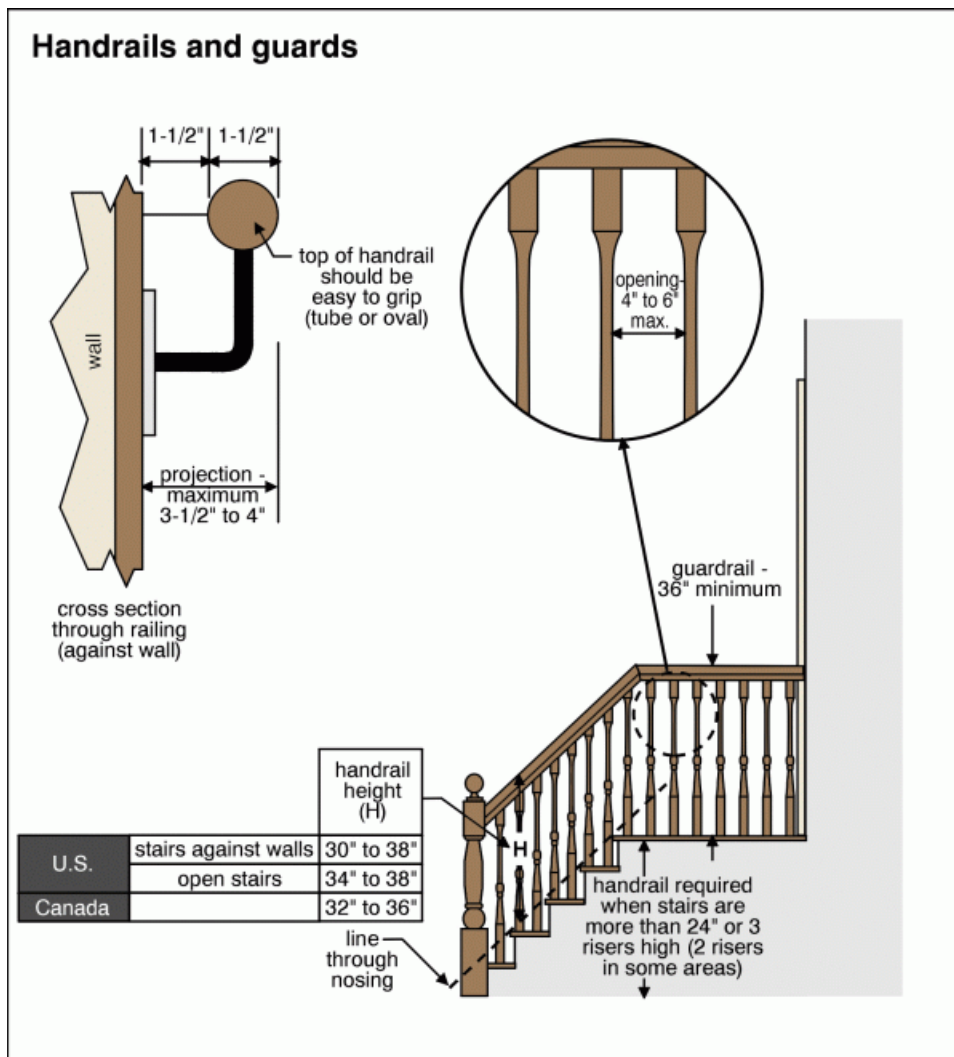
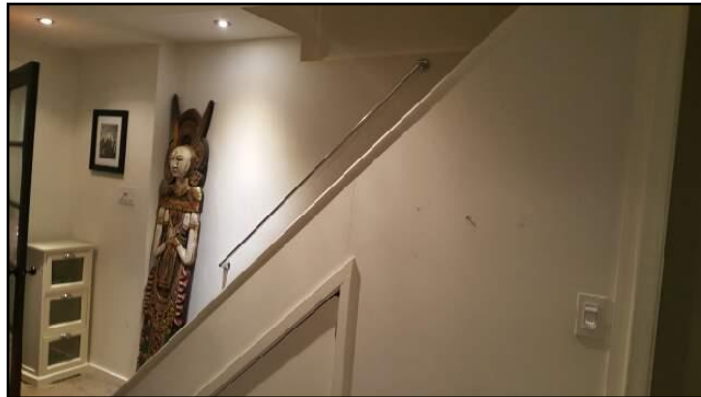
12. Condition: • [Missing](#)

Implication(s): Fall hazard

Location: Basement Staircase

10. *Missing guardrail.*

Task: Provide
