Your Inspection Report

14 Golden Avenue
Toronto, ON

Tuesday, January 20, 2015

Report No. 1326

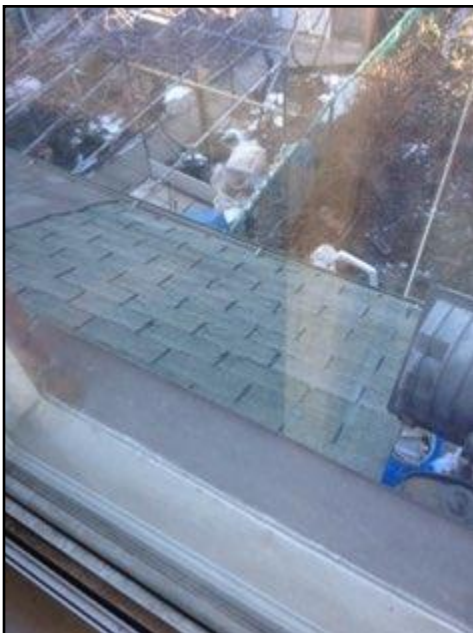
1. Condition: • [Old, worn out](#)

Strip and reshingle both lower sloped roof areas.

1. Old, worn out

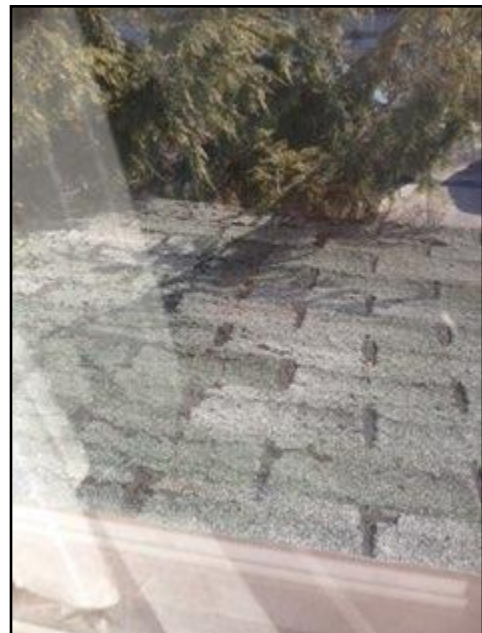
2. Old, worn out

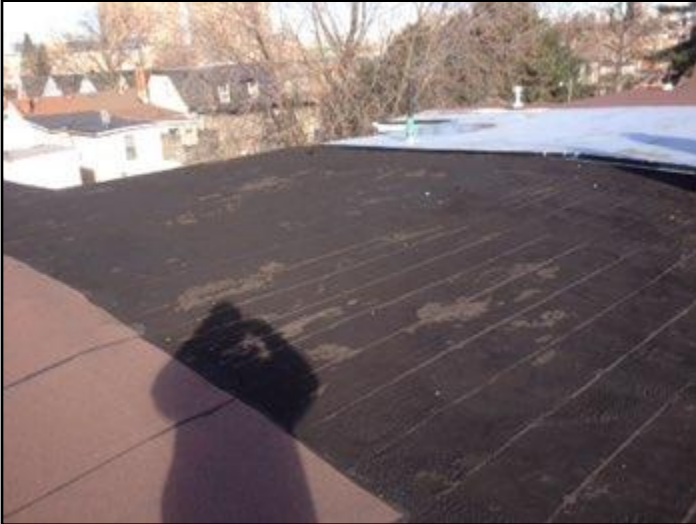
2. Condition: • [Old, worn out](#)

Strip and resurface flat roof, leakage evident.

3. Old, worn out

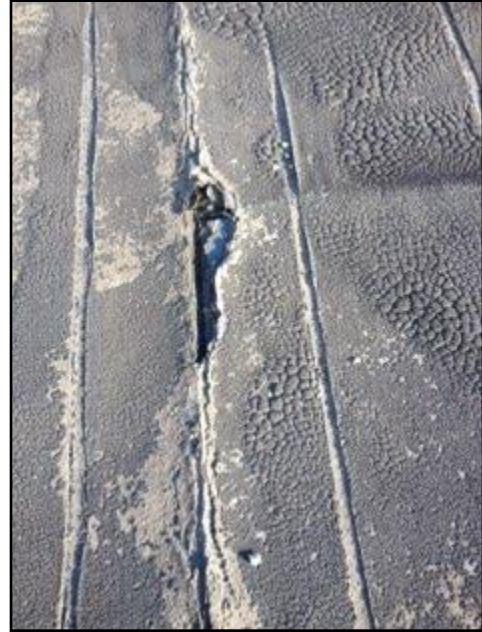
4. Old, worn out

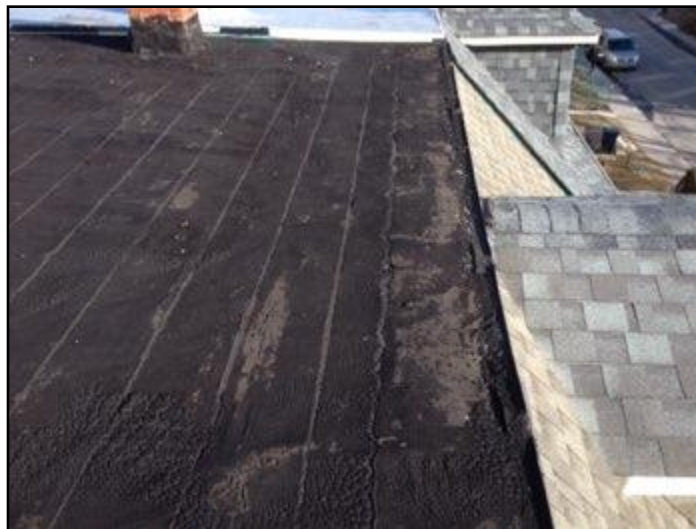
5. Old, worn out

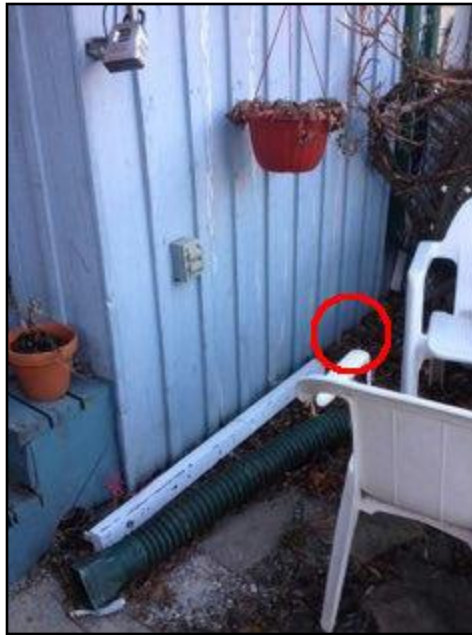
3. Condition: • [Too close to grade](#)

Implication(s): Chance of water damage to contents, finishes and/or structure | Material deterioration | Rot | Insect damage

6. Too close to grade

Eliminate wood/soil contact when renovating.

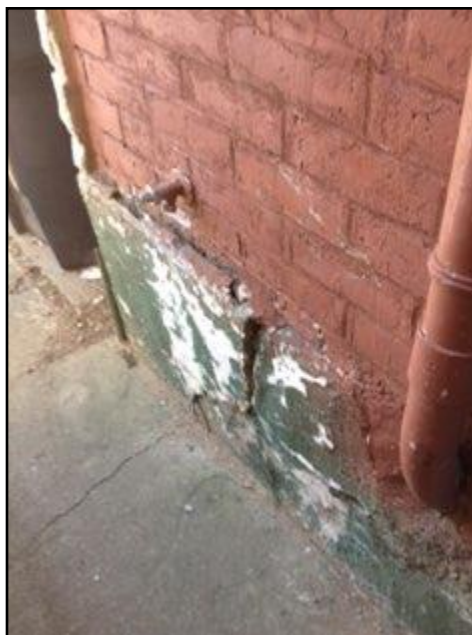
4. Condition: • [Parging damaged or missing](#)

Implication(s): Chance of damage to structure | Shortened life expectancy of material

7. Parging damaged or missing

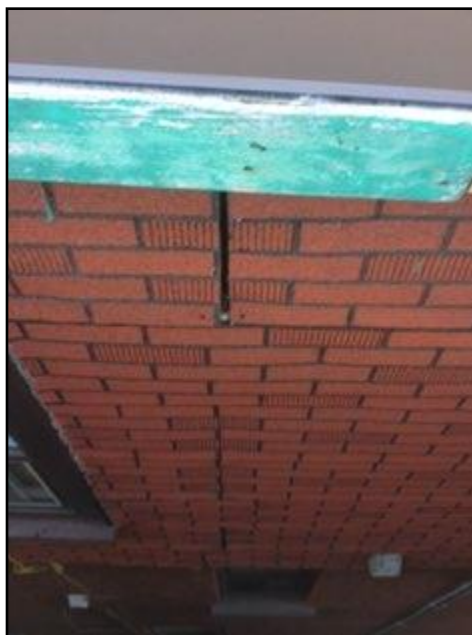
5. Condition: • [Aging](#)

Maintenance or residing needed.

8. Aging

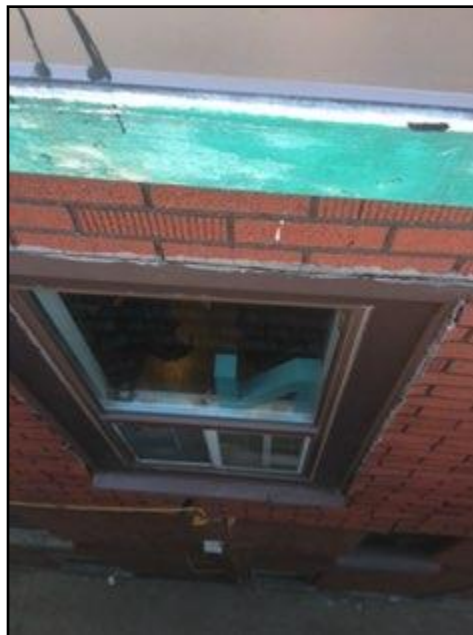
6. Condition: • [Flashing loose, missing or deteriorated](#)

Caulking maintenance needed.

9. *Flashing loose, missing or deteriorated*

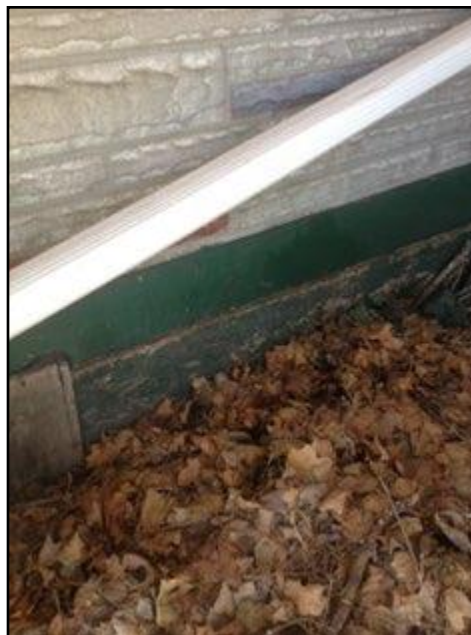
7. Condition: • [Wood/soil contact](#)

10. Wood/soil contact

Eliminate wood/soil contact with all future exterior improvements.

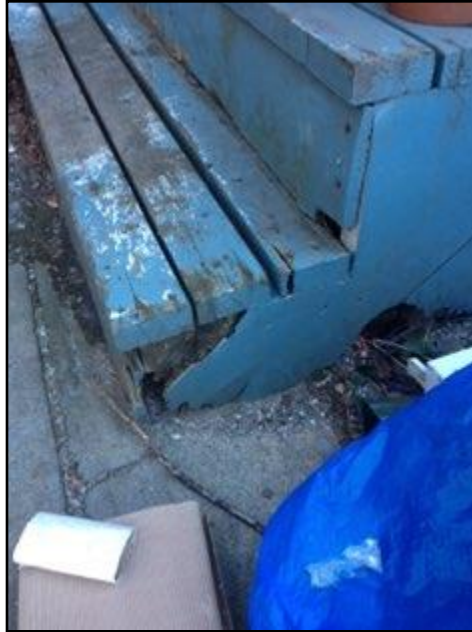
PORCHES, DECKS, STEPS, PATIOS AND BALCONIES \ Steps and landings**8. Condition:** • [Rot](#)**Implication(s):** Weakened structure | Material deterioration**Location:** West Exterior Steps**Task:** Replace**Time:** Immediate**Cost:** Minor

**11. Rot****LANDSCAPING \ Walkway****9. Condition:** • [Improper slope or drainage](#)**Implication(s):** Chance of water damage to contents, finishes and/or structure**Location:** East Exterior**Task:** Improve**Time:** Discretionary**Cost:** Minor

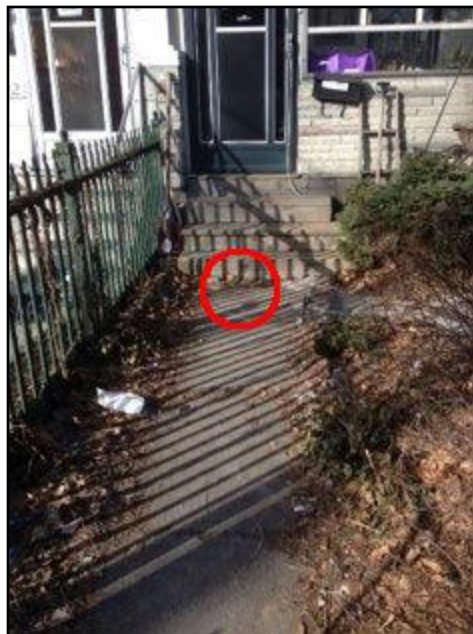
12. Improper slope or drainage

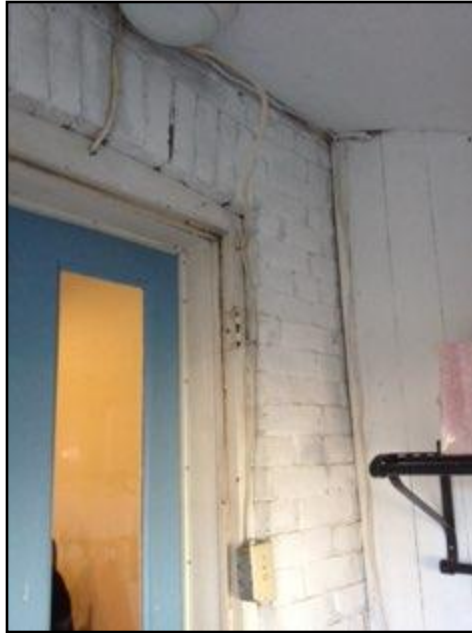
13. Condition: • [Exposed on walls or ceilings](#)

Implication(s): Electric shock

13. Exposed on walls or ceilings

Cover exposed wiring with conduit.

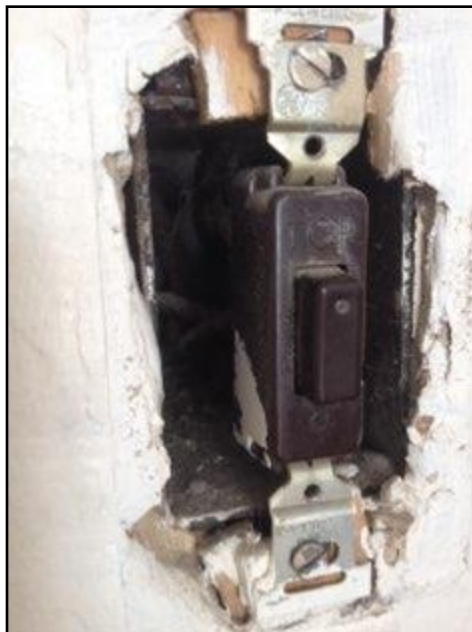
14. Condition: • [Outdated](#)

Knob and tube wiring visible at east entrance, east second floor bedroom and third floor lights and switches.

14. Outdated

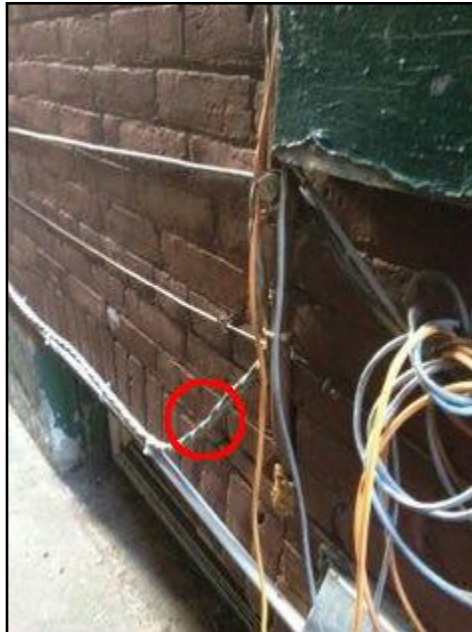
15. Condition: • Exterior wiring exposed to damage and contact by people.

15. Exterior wiring exposed to damage and...

Protect exposed wire with conduit.

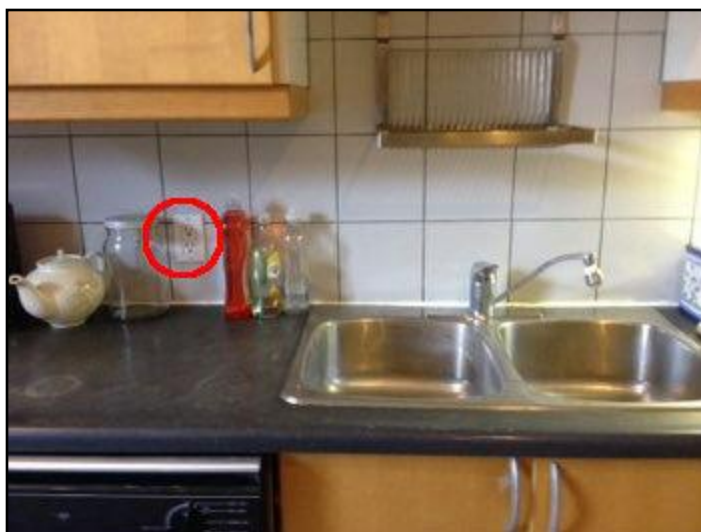
16. Condition: • [No GFI \(Ground Fault Interrupter\)](#)

16. No GFI (Ground Fault Interrupter)

Add gfi receptacles to wet areas and secure loose receptacles.

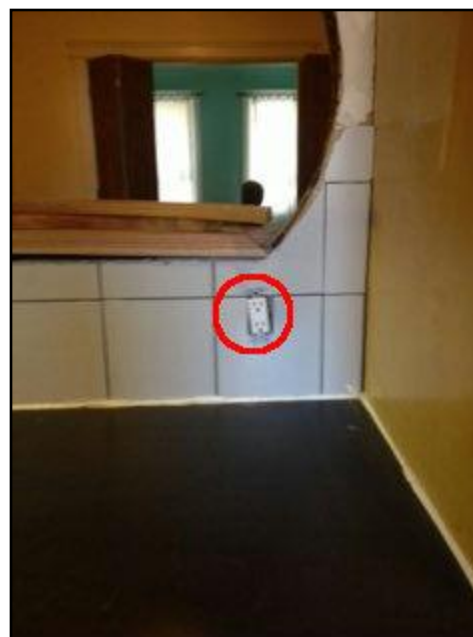
17. Loose

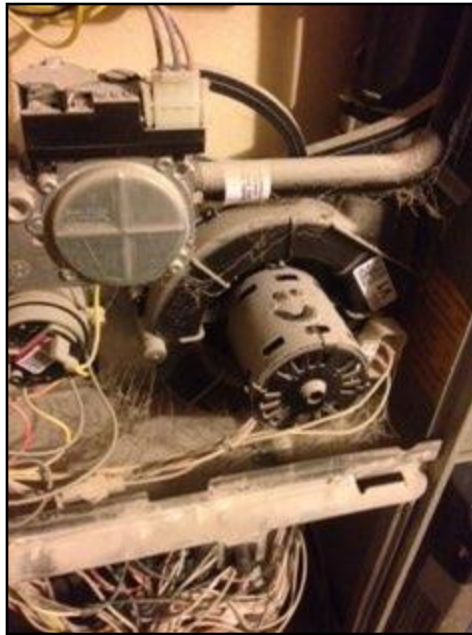
17. Condition: • Suggest cleaning furnace to eliminate construction dust.

18. Suggest cleaning furnace to eliminate...

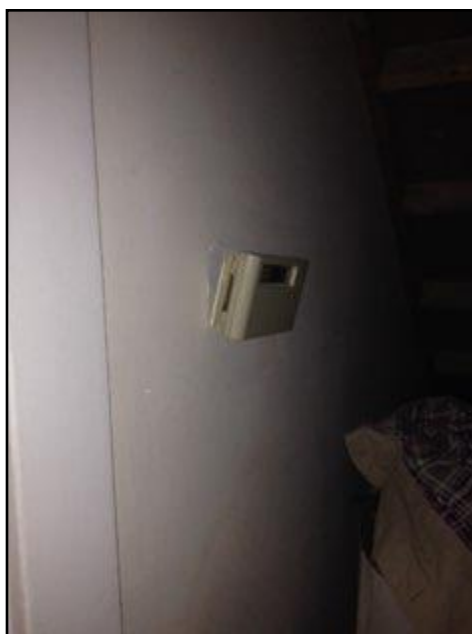
18. Condition: • [Poor location](#)

19. Poor location

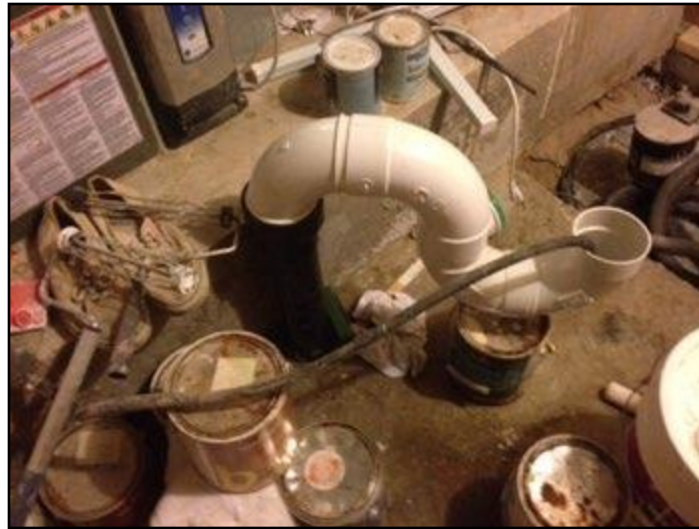
Above floor trap does not allow discharge from condensate to enter drain. Suggest adding 1 1/2 inch Y adapter and trap, and capping 3 inch pipe.

23. Condition: • [No trap](#)

20. Poor trap configuration.

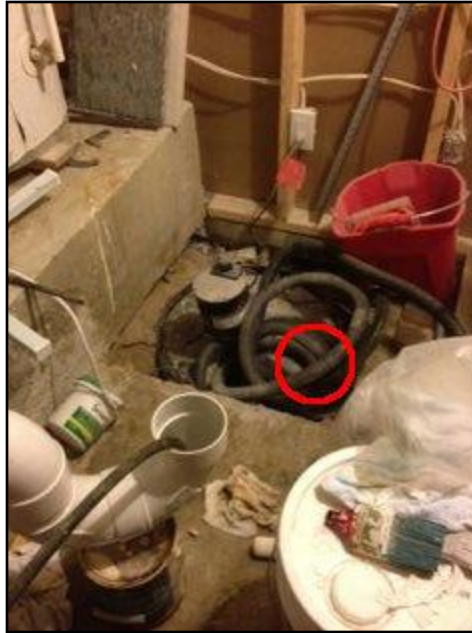
24. Condition: • [Discharge pipe problems](#)

Implication(s): Chance of water damage to contents, finishes and/or structure

21. Discharge pipe problems

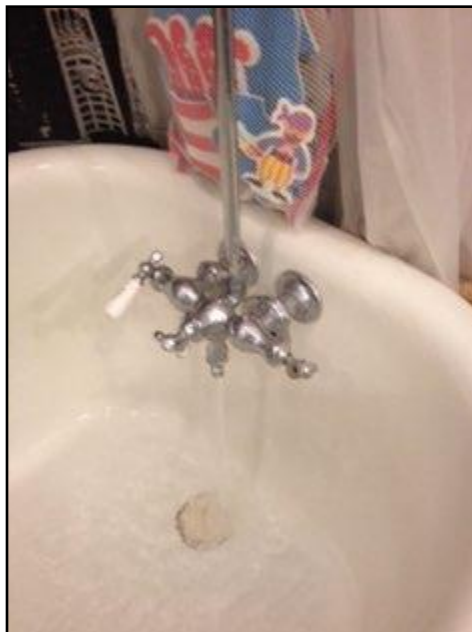
25. Condition: • [Drip, leak](#)

22. Drip, leak

Replace missing handles and leaking washers.

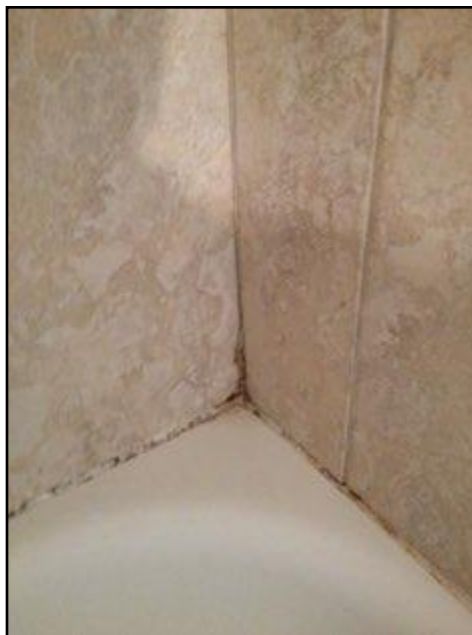
26. Condition: • [Caulking loose, missing or deteriorated](#)

23. Caulking loose, missing or deteriorated

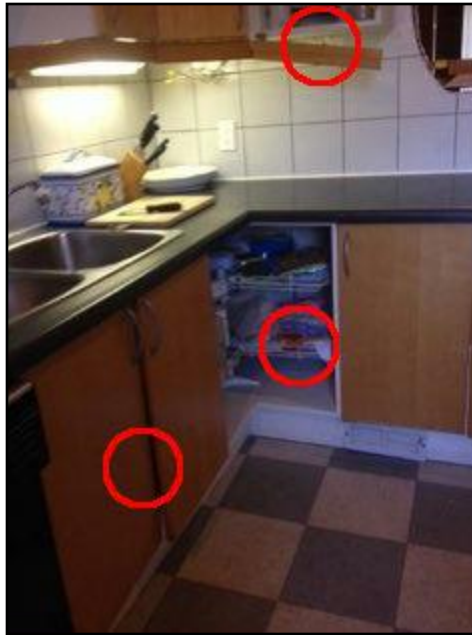
29. Condition: • [Doors or drawers missing or loose](#)

First floor kitchen cabinetry in poor condition.

24. *Doors or drawers missing or loose*
