Your Inspection Report

119 Cowan Ave
Toronto, ON

Friday, February 27, 2015

Report No. 1361

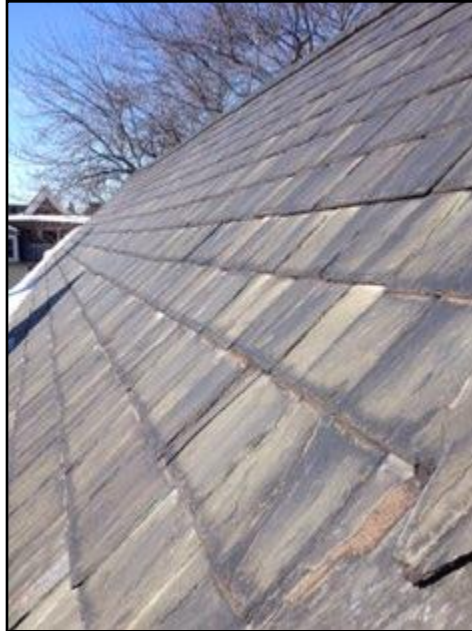
1. *Slate shingles*

1. • Roof primarily snow covered, visible areas in good condition. Suggest lifting several deck boards to inspect flat roof when free of snow. Slate is original and will require periodic inspection and maintenance.

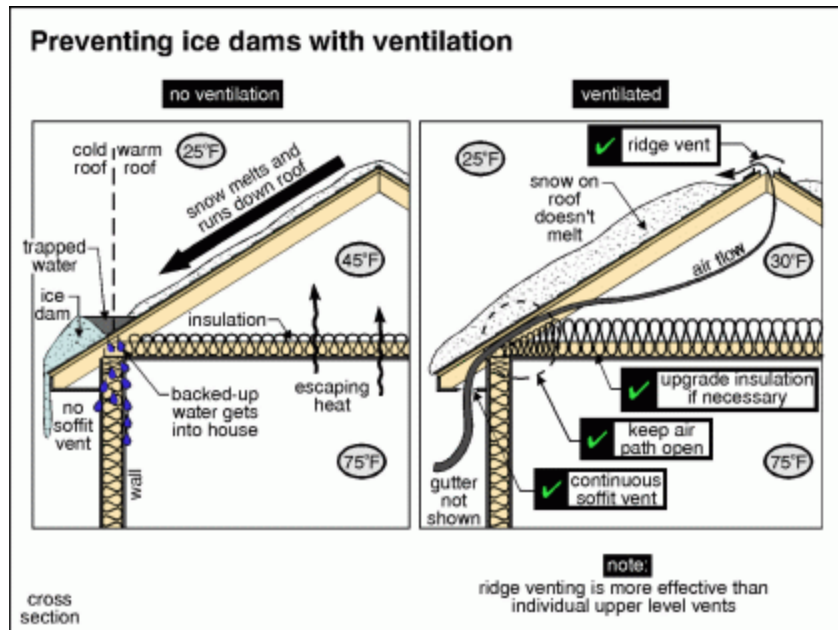
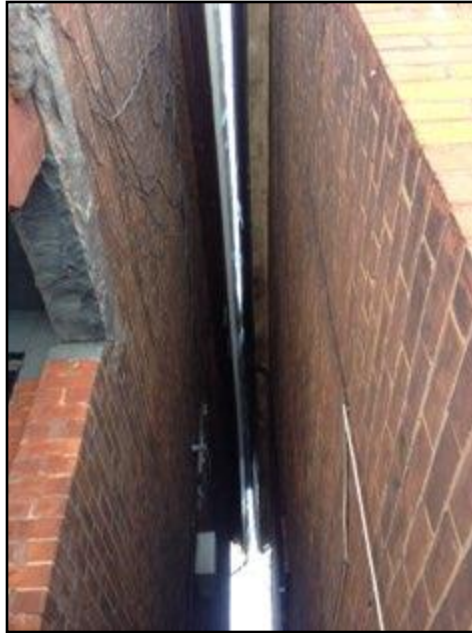
2. Condition: • [Vulnerable to ice damming](#)

Significant ice damming present, suggest installation of deicing cables as interior finishes would make insulation and ventilation improvements difficult.

2. *Vulnerable to ice damming*

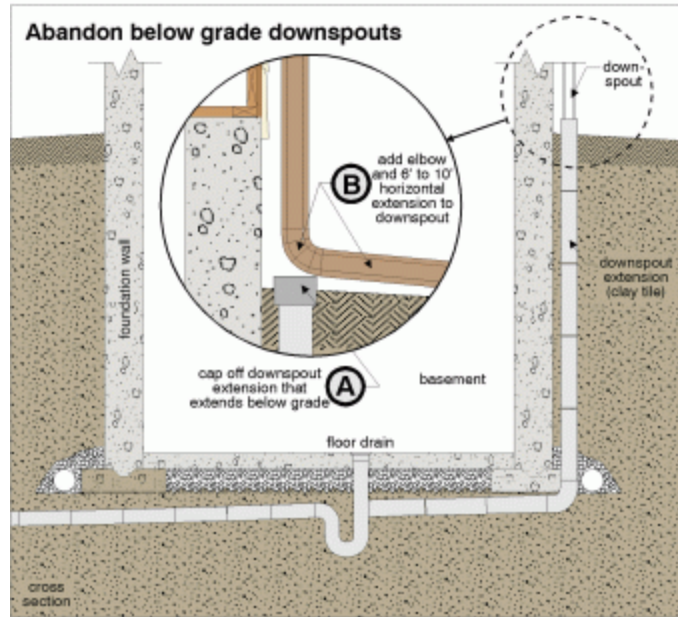
3. Condition: • [Downspouts discharging below grade](#)

Implication(s): Chance of water damage to contents, finishes and/or structure

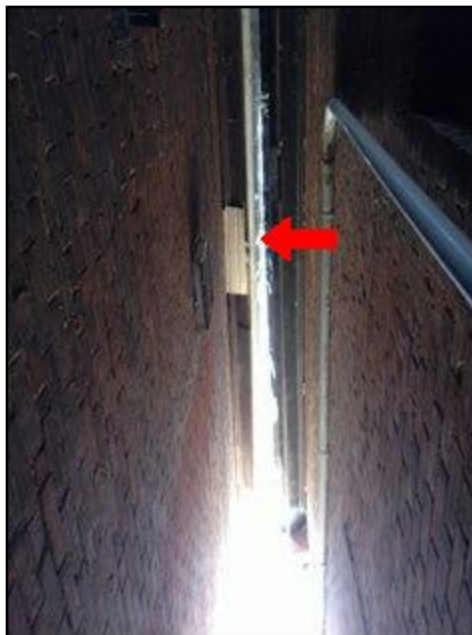
4. Condition: • Pest entry

Previous repair to prevent pest entry has come loose, resecure to prevent new pest entry.

3. Pest entry

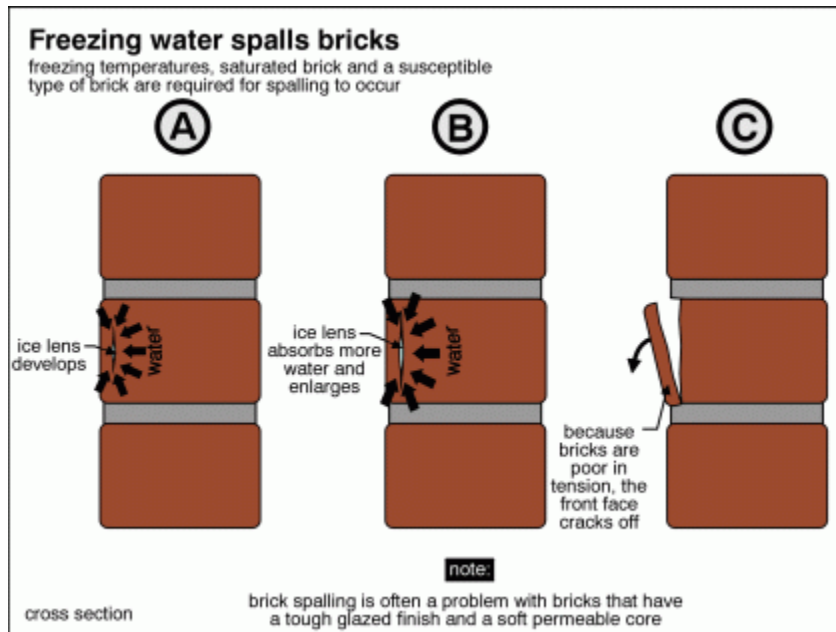
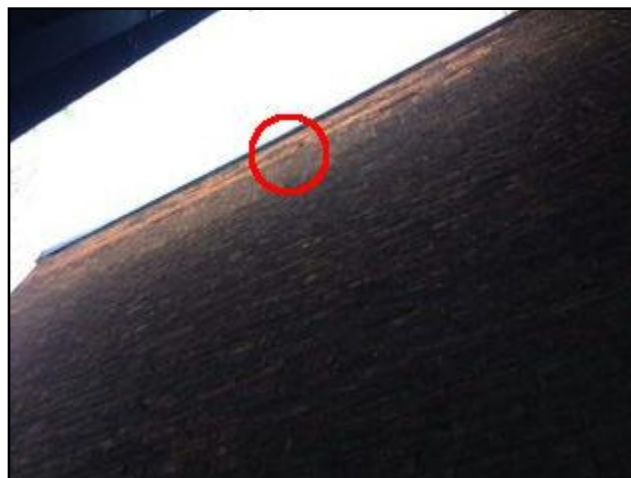
5. Condition: • [Spalling](#)

Some brick replacement or parging needed, especially at upper northeast wall

4. Spalling

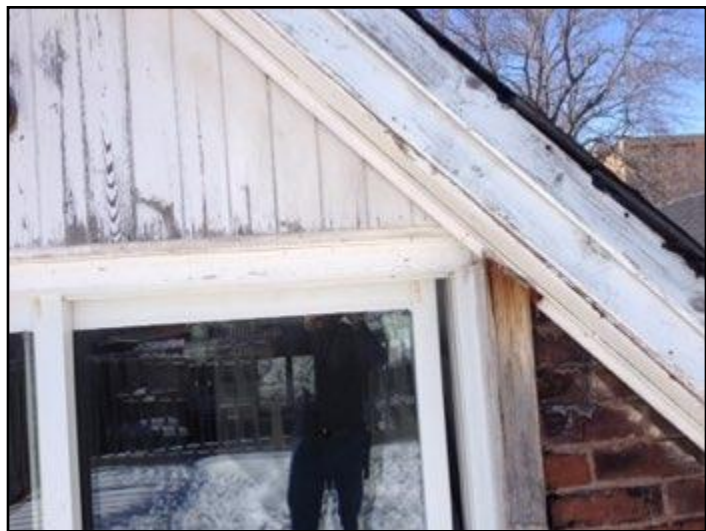
6. Condition: • [Paint or stain needed](#)

Typical paint and caulking maintenance needed at wood trim.

5. *Paint or stain needed*

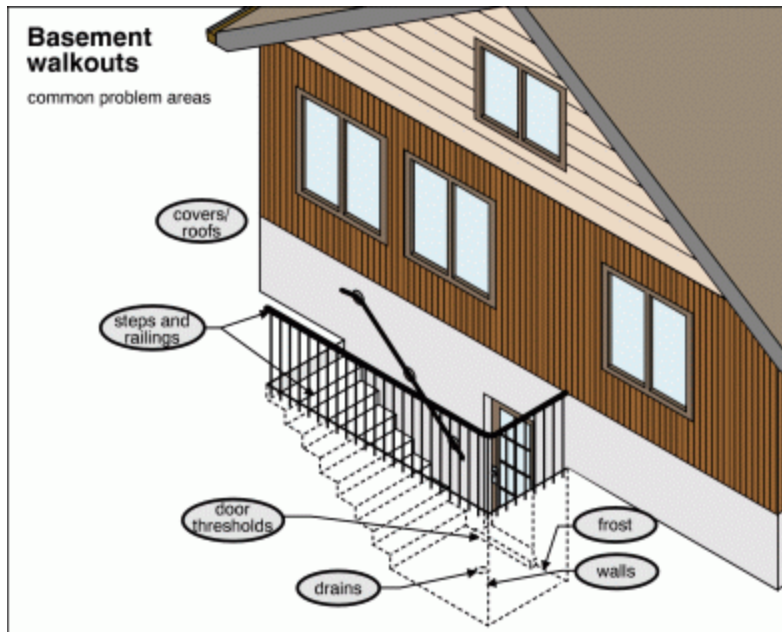
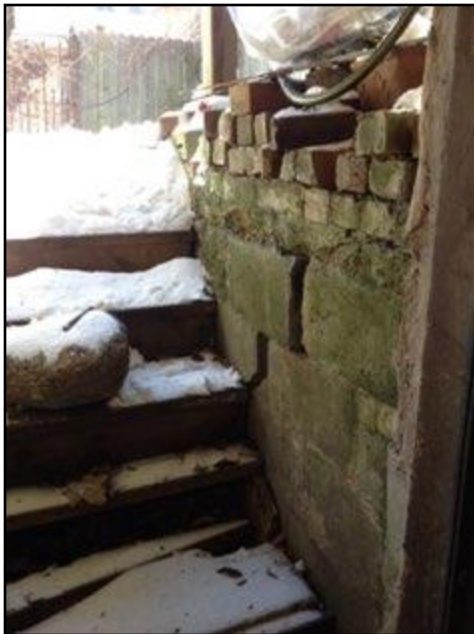
7. Condition: • [Walls cracking, leaning, bowing or spalling](#)

Exterior basement staircase and retaining wall will require eventual rebuild. New construction should create landing lower than interior floor and include an exterior drain.

6. Walls cracking, leaning, bowing or spalling

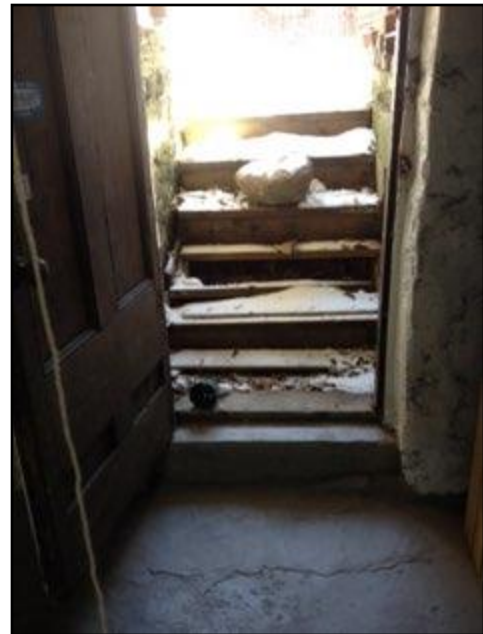
7. No drain

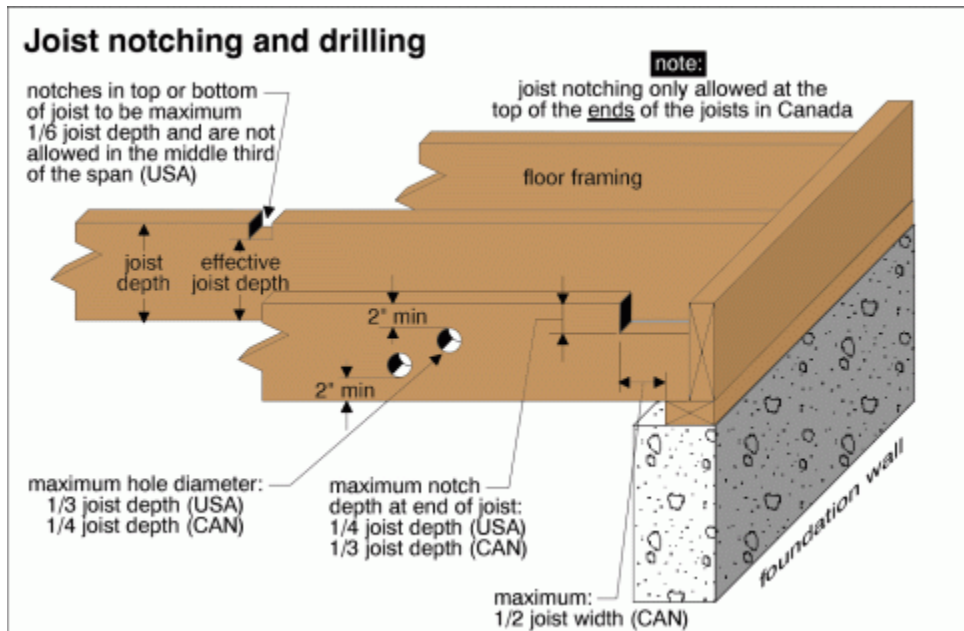
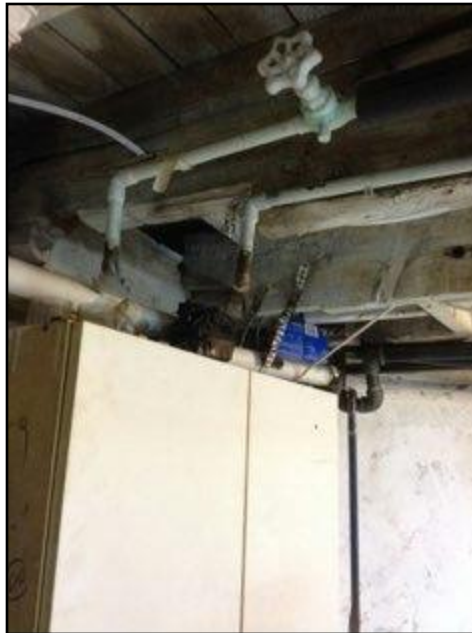
8. Condition: • [Notches or holes](#)

Sister or replace several notched joists near plumbing stack at basement if renovating basement or floor above.

8. Notches or holes

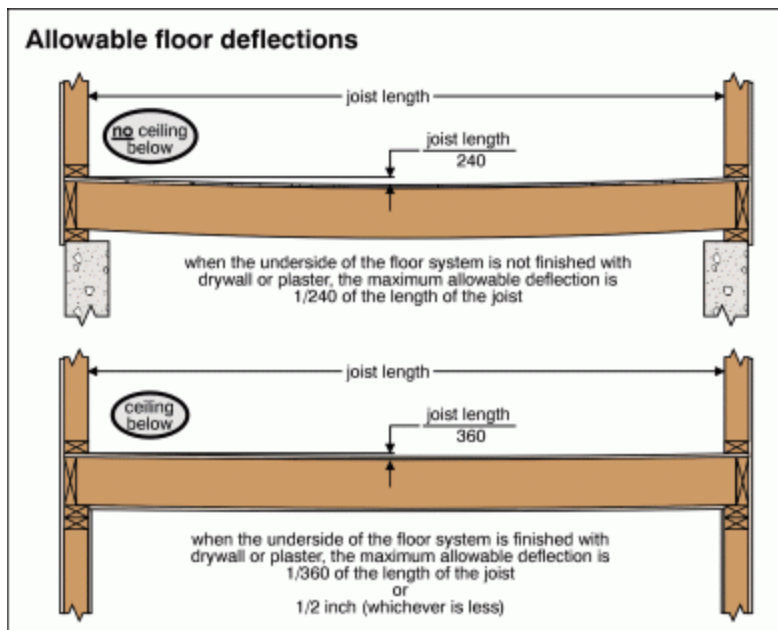
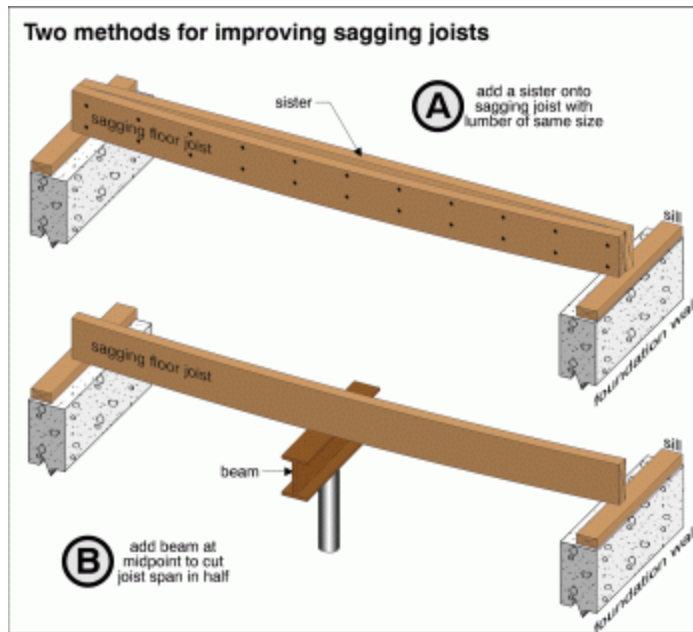
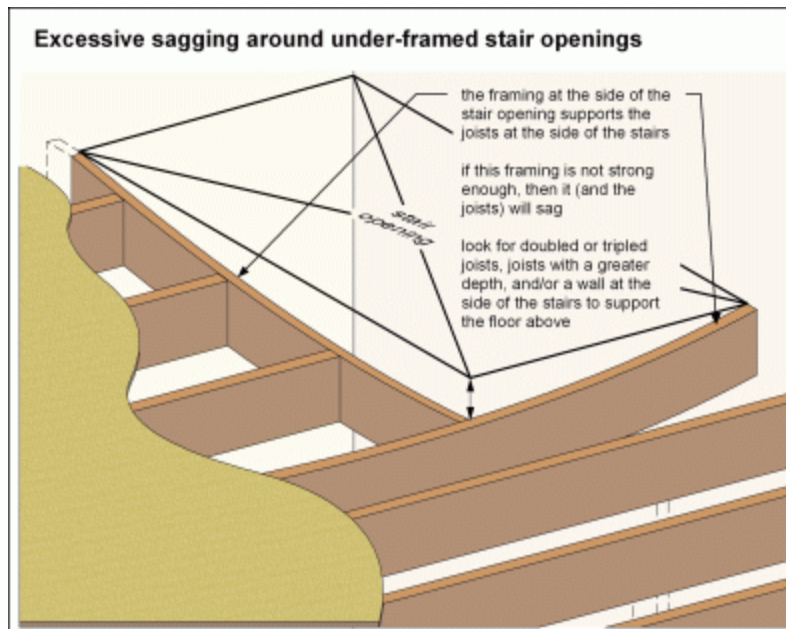
9. Condition: • [Sag or springy](#)

Significant slope evident at north second floor towards middle of house. Previous renovations appear to have arrested further settlement with introduction of beam at dining room. The support to this beam should be continued at basement before further renovations.

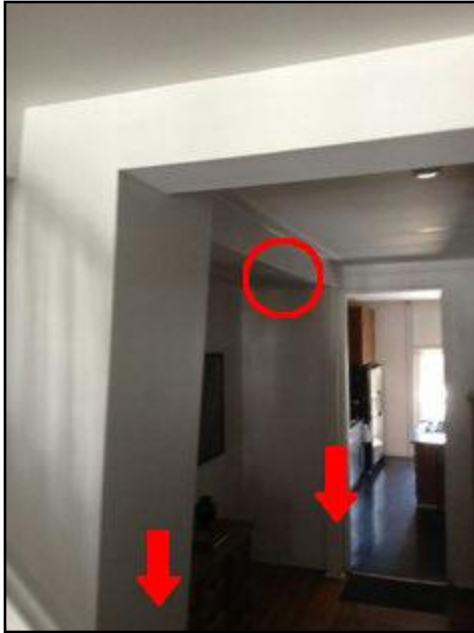
9. Support at first floor

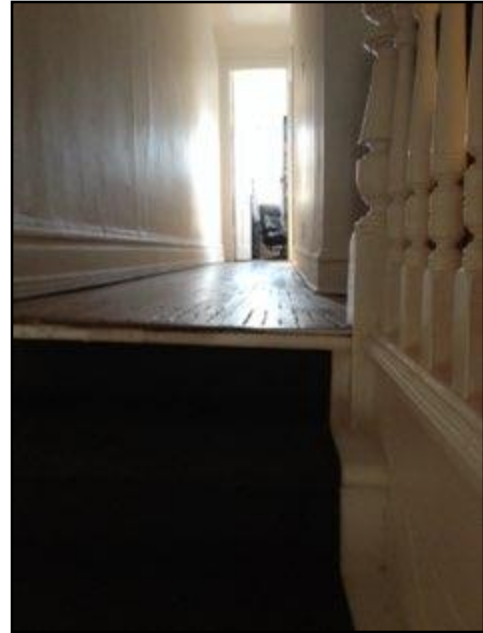
10. Slope evident

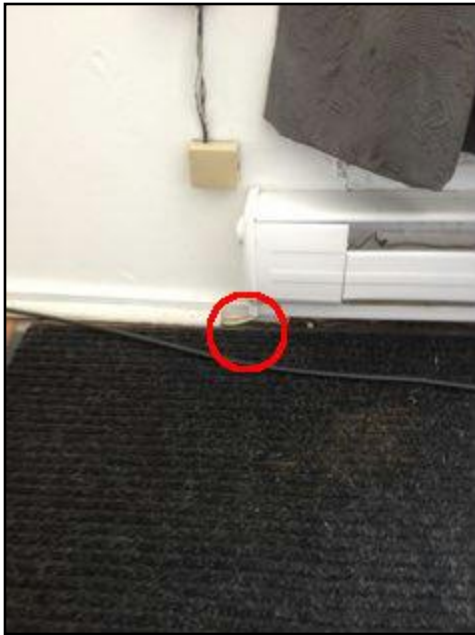
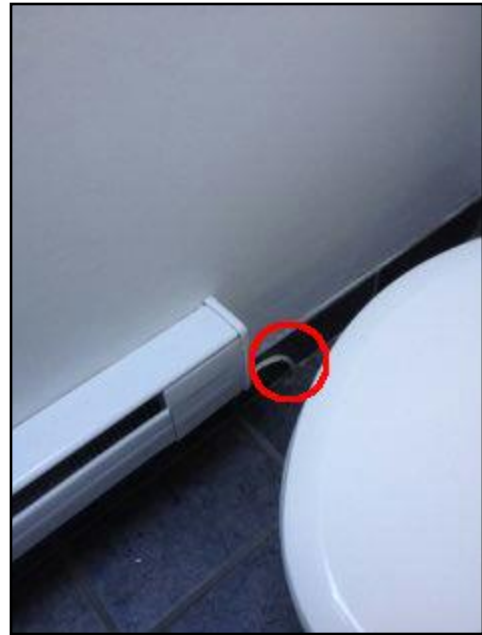
10. Condition: • [Exposed on walls or ceilings](#)

Cover exposed wiring with conduit at baseboard electric heaters.

11. Exposed on walls or ceilings

12. Exposed on walls or ceilings

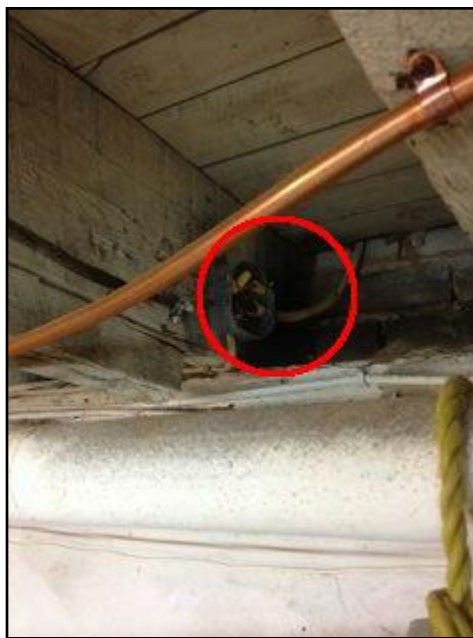
11. Condition: • [Cover loose or missing](#)

13. Cover loose or missing

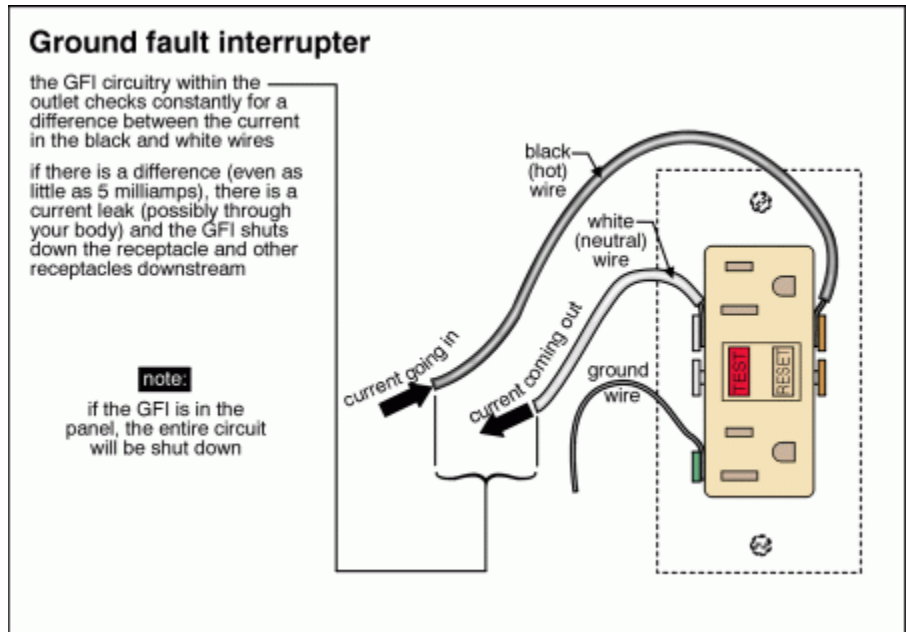
12. Condition: • [No GFI \(Ground Fault Interrupter\)](#)

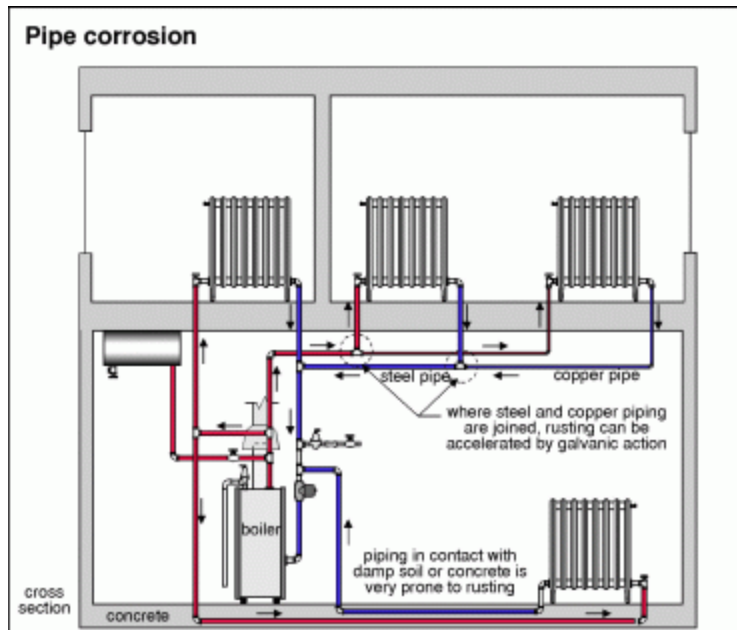
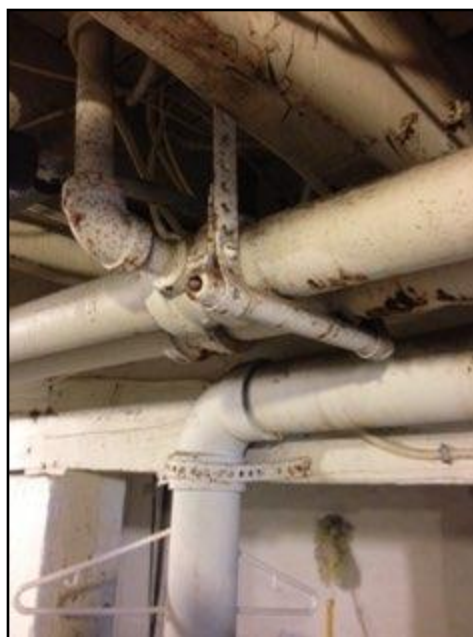
13. Condition: • [Rust](#)

Original rad supply piping in use, consider replacement if renovating.

14. Typical rust

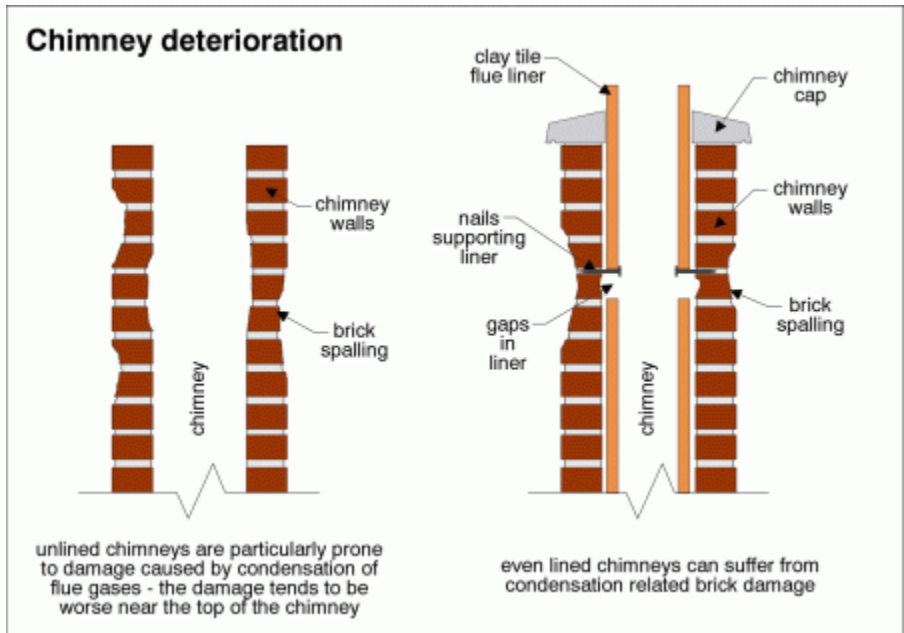
15. Condition: • [Unlined chimney flue](#)

Living room fireplace is operable but flue is unlined, insurance company may request retrofit at approx. \$2000. Fireplace was built for coal and is not intended for wood fires, use artificial logs only.

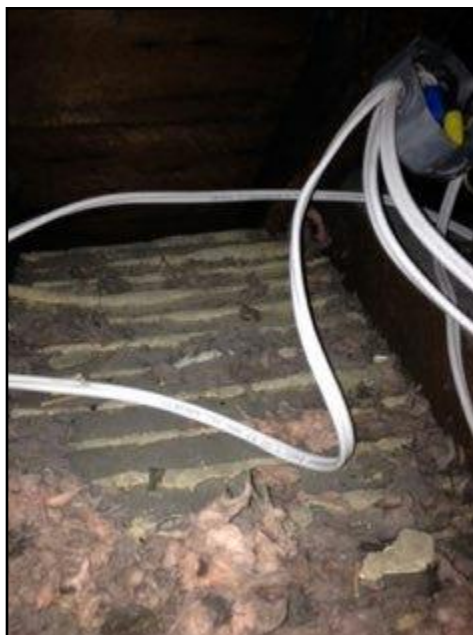
- 16. Condition:** • [Amount inadequate](#)
Add cover to junction box shown before adding insulation.
- Implication(s):** Increased heating and cooling costs
- Location:** Attic
- Task:** Provide
- Time:** Discretionary
- Cost:** \$1,000

15. Amount inadequate

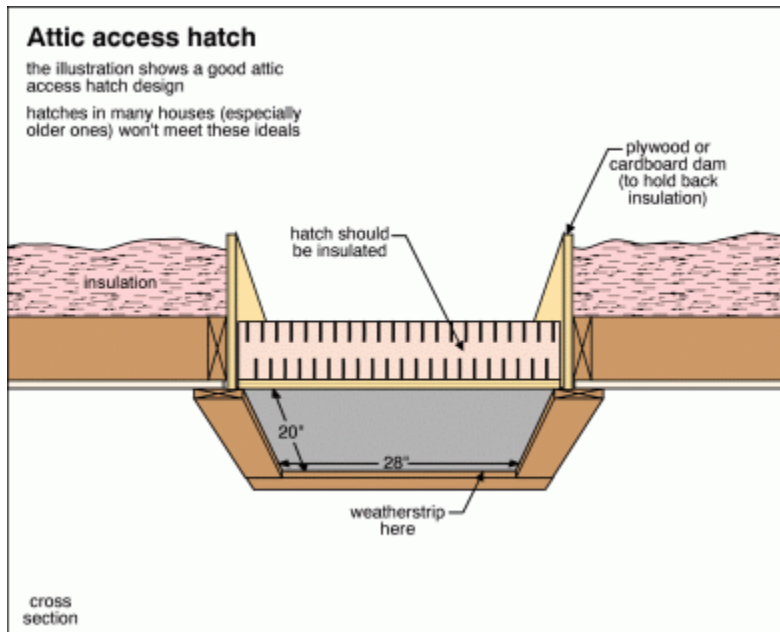
17. Condition: • [Not insulated and not weatherstripped](#)

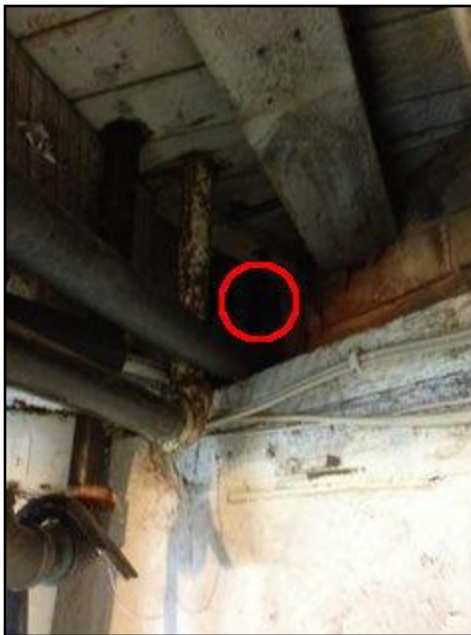
18. Condition: • Potential for pipes against exterior wall to freeze.

16. Potential for pipes against exterior wall t...

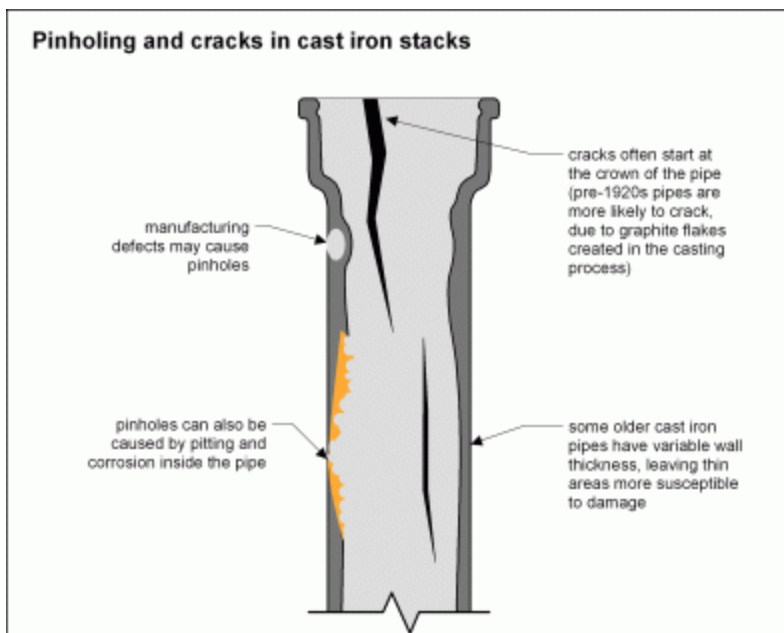
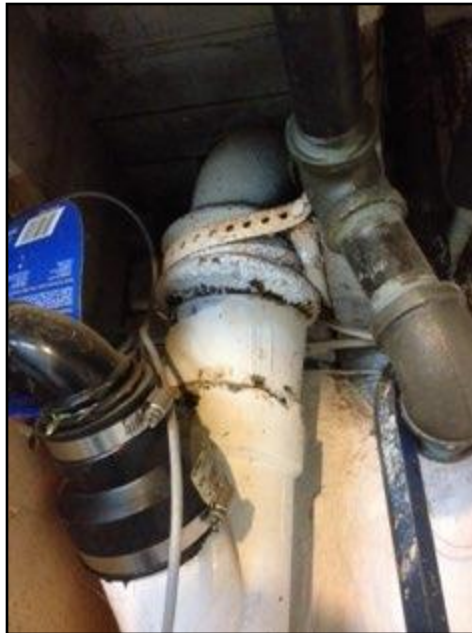
19. Condition: • [Rust](#)

Replace cast iron waste piping if renovating.

17. Typical rust

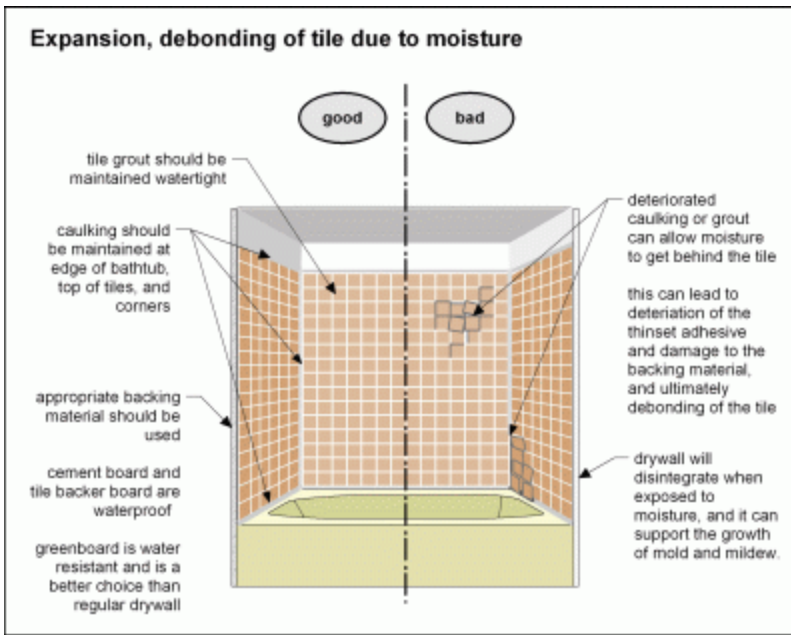
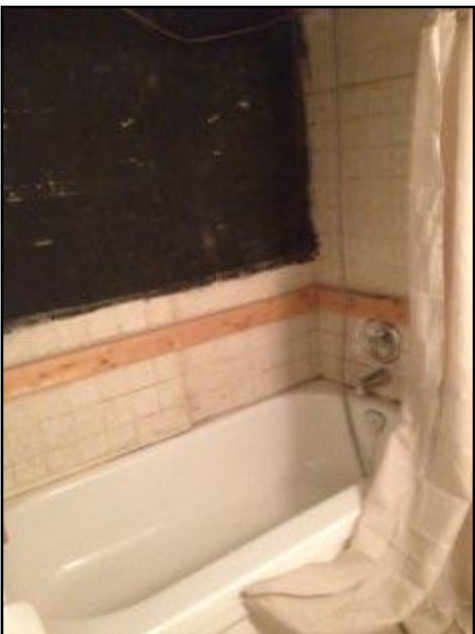
21. Condition: • [Leak](#)

18. Leak

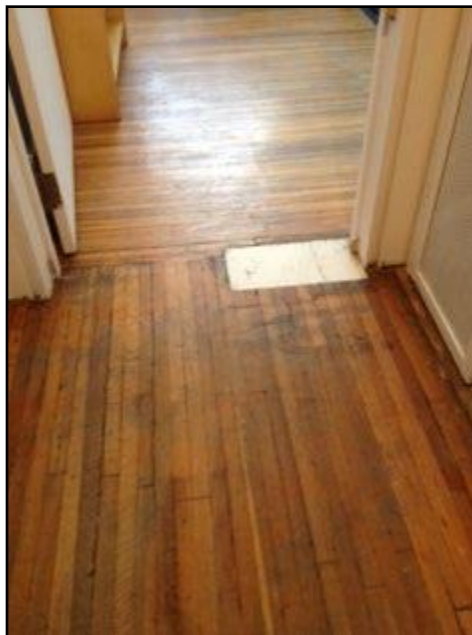
23. Condition: • Floors are sloped on second floor and worn or patched throughout. See STRUCTURE before renovating.

19. Patched

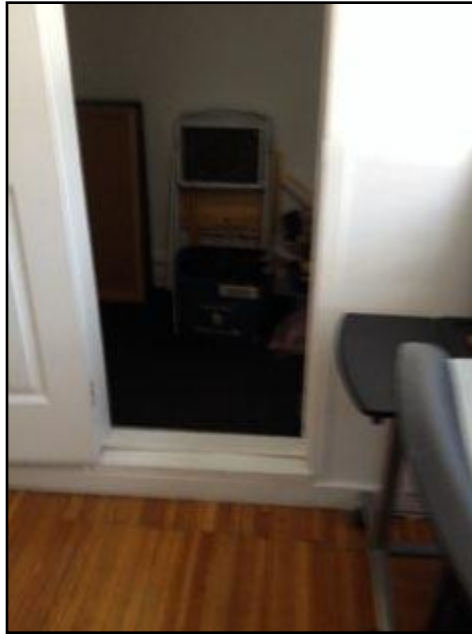
24. Condition: • [Springy](#)
Implication(s): Cosmetic defects | Physical injury
Location: Southwest Second Floor Closer
Task: Replace

20. Springy floor
