# Your Inspection Report

1351 Ogden Avenue.  
Miss, ON

Thursday, March 19, 2015

Report No. 1387

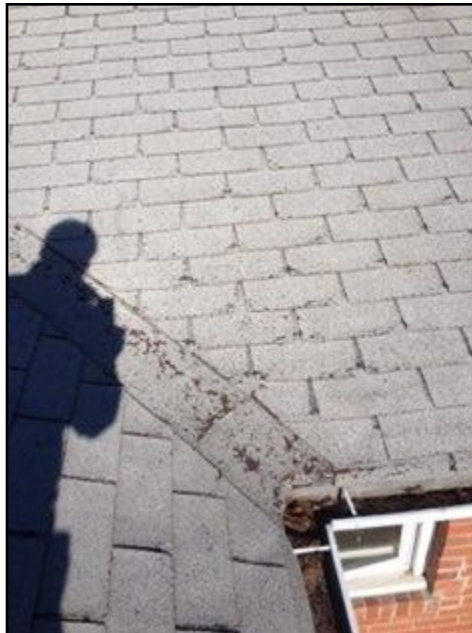
1. *Near end of life expectancy*

**1. Condition:** • [Near end of life expectancy](#)

Roof will require reshingling in near future.

**Implication(s):** Chance of water damage to contents, finishes and/or structure

**Task:** Reshingle

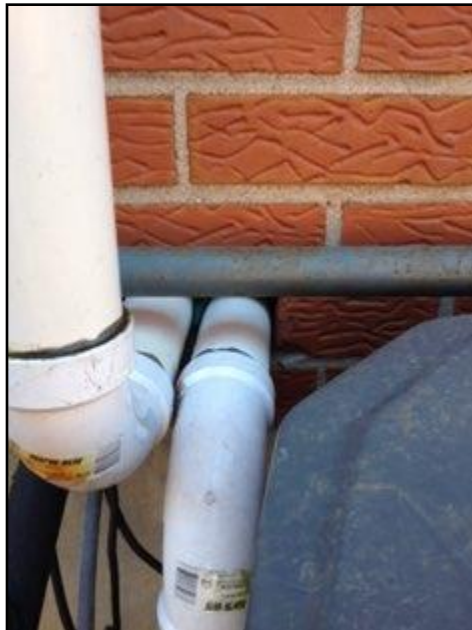
- ROOF DRAINAGE \ Downspouts**
- 2. Condition:** • [Downspouts discharging below grade](#)
- Disconnect downspouts and route well away from foundation.
- Implication(s):** Chance of water damage to contents, finishes and/or structure
- Location:** Throughout Exterior
- Task:** Improve
- Time:** Discretionary
- Cost:** Minor

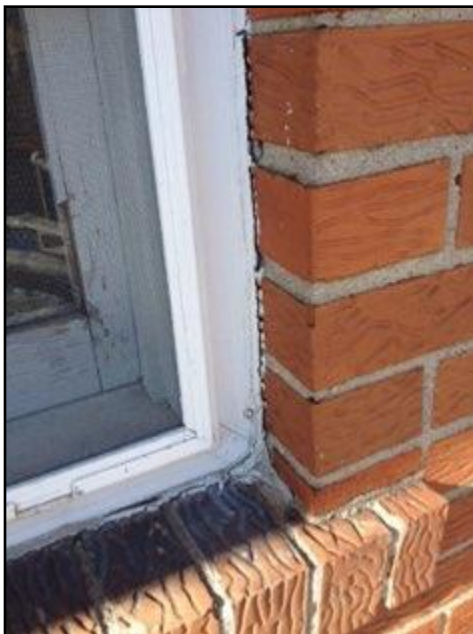
*3. Caulking loose, missing or deteriorated*

### **4. Condition:** • [Caulking loose, missing or deteriorated](#)

Typical caulking maintenance needed.

**Implication(s):** Chance of water damage to contents, finishes and/or structure | Increased heating and cooling costs

**Task:** Improve

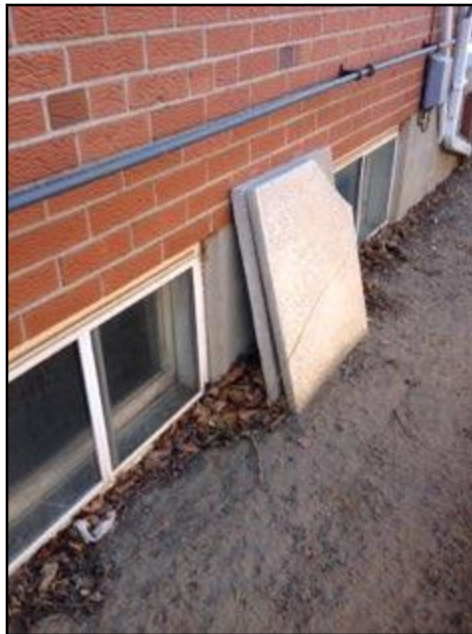
4. Missing

### **5. Condition:** • [Missing](#)

**Implication(s):** Chance of water damage to contents, finishes and/or structure | Material deterioration

**Task:** Provide

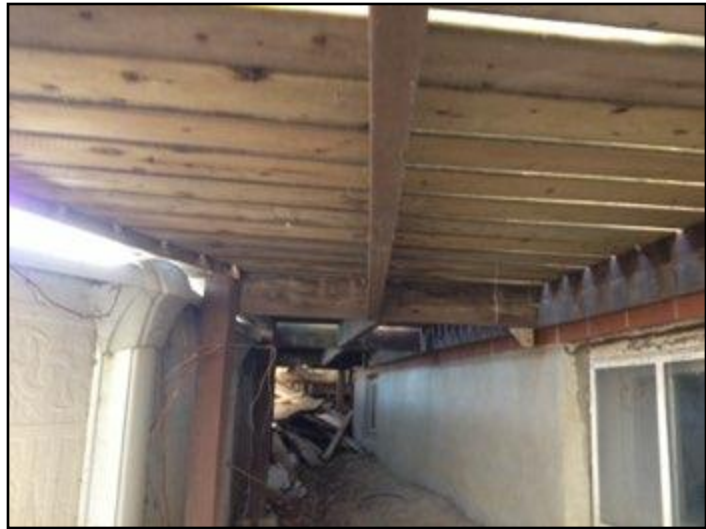
5.

**6. Condition:** • Too weak for structure. Improve spacing and/or end bearing.

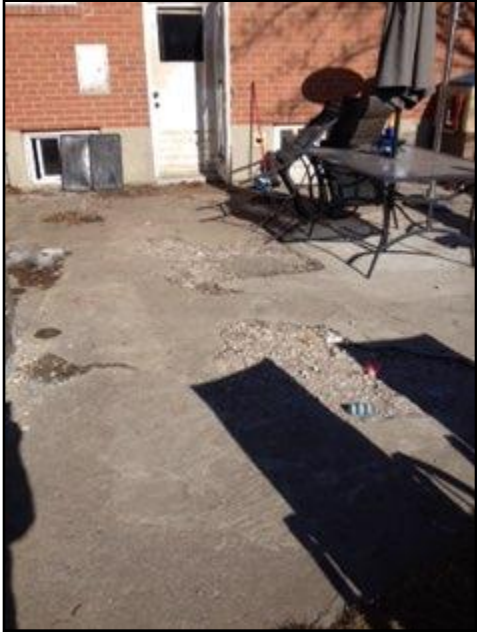
6. Concrete spalled

7. Condition: • [Concrete spalled](#)

Damage to patio is mainly cosmetic.

Implication(s): Cosmetic defects | Material deterioration

Task: Repair or replace

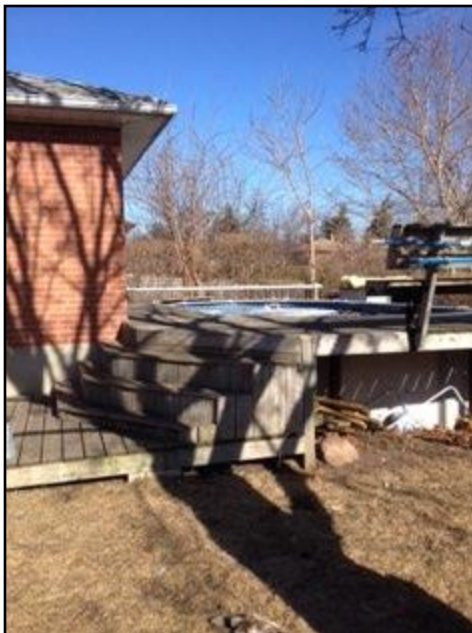
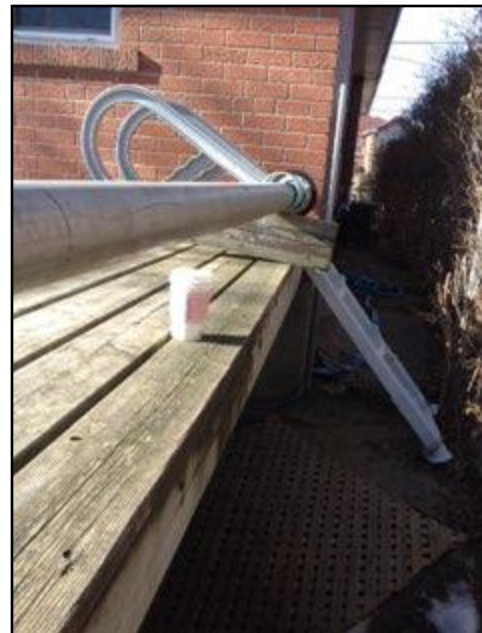
8. Condition: • [Missing](#)

**Implication(s):** Fall hazard

Add railing to deck and stairs

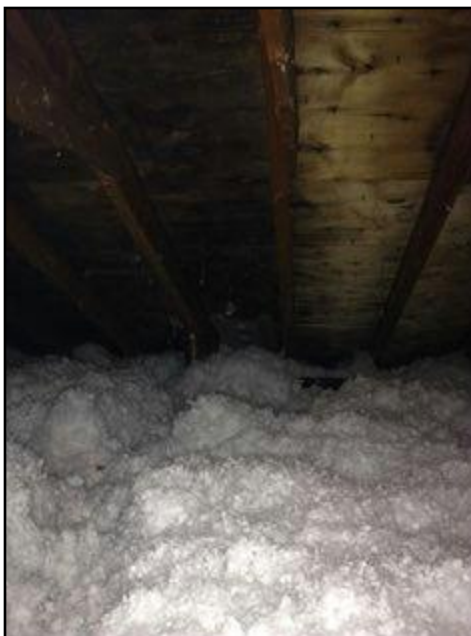
9. Mould on plywood

Plywood sheathing is sagging and has mould growth on underside. Recent attempt at improved ventilation incomplete (see INSULATION). Options after improved ventilation include: maintaining existing, replacing at reroofing, mould encapsulation or removal. Cost \$2000 for treatment, \$3000 for replacement.

**10. Condition:** • [Mold](#)

**Implication(s):** Weakened structure | Chance of structural movement

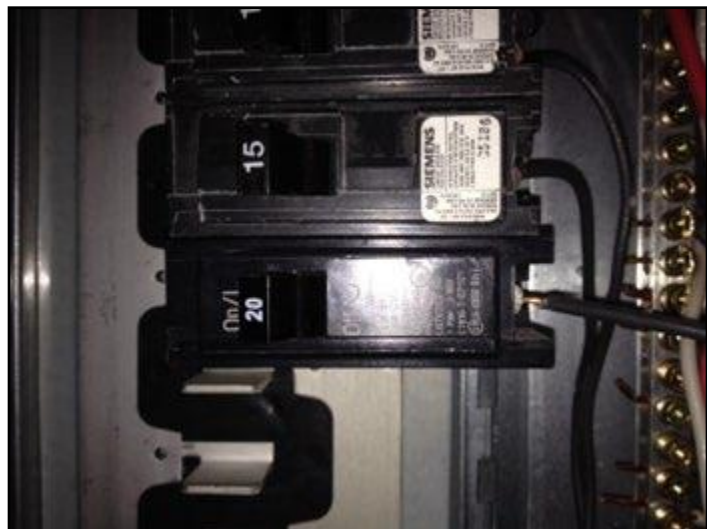
10. Fuses or breakers too big

**11. Condition:** • [Fuses or breakers too big](#)  
Replace 20 amp breaker with 15 amp.  
**Implication(s):** Equipment overheating | Fire hazard  
**Location:** Basement sub panel  
**Task:** Replace  
**Time:** Immediate  
**Cost:** Minor

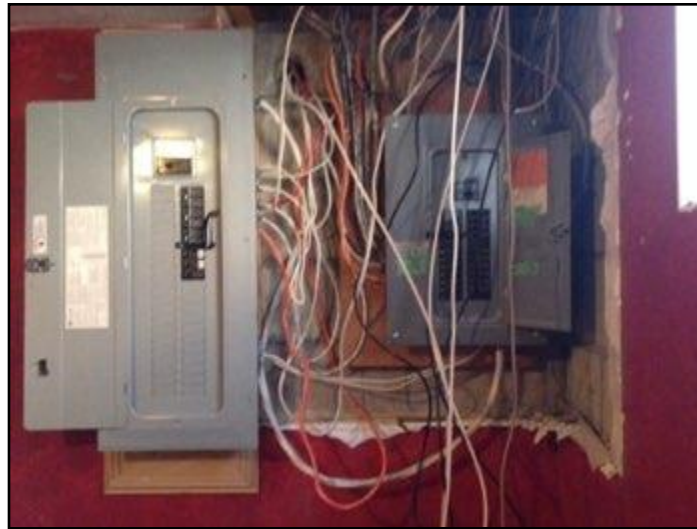
11.

### 12. Condition: • [Not well secured](#)

Unprofessional installation of sub panel and wiring needs clean up. (Second panel will accept 200 amps but is fed by a 60 amp breaker. Entire house is fed by 100 amps which is typical for a single family home. No panel changes are needed.)

**Implication(s):** Electric shock | Fire hazard

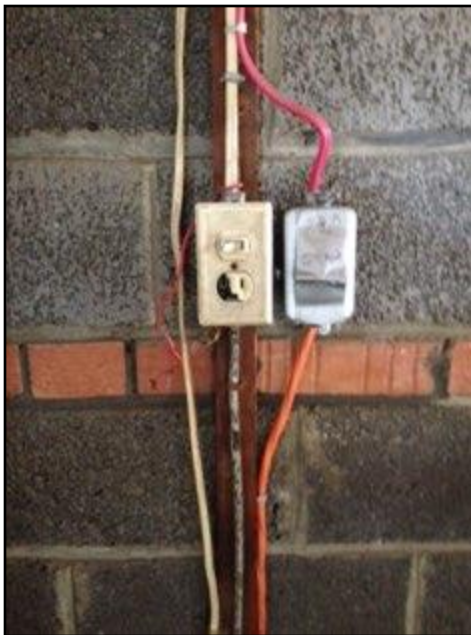
12. Damage

### 13. Condition: • [Damage](#)

**Implication(s):** Electric shock | Fire hazard

**Task:** Replace

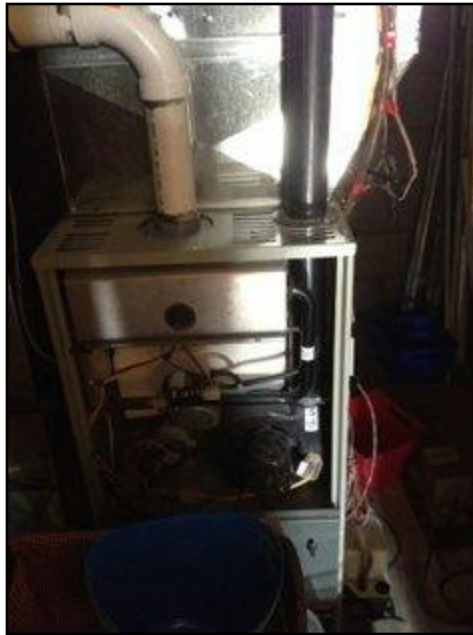
13. Missing cover

**15. Condition:** • [Missing components](#)

**Implication(s):** Reduced operability | Equipment not operating properly

Replace missing furnace cover.

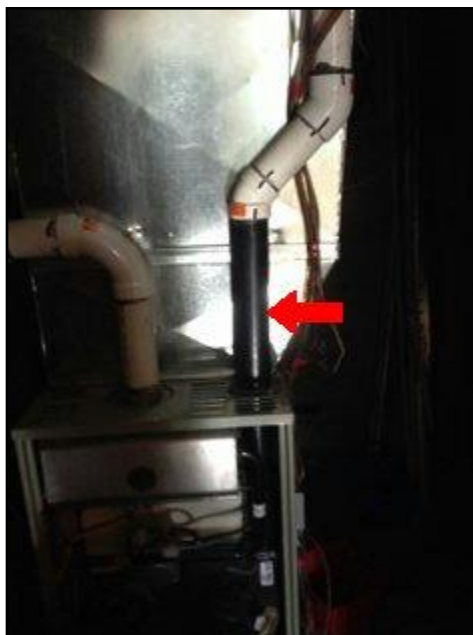
14. Improper material

16. Condition: • [Improper material](#)

**Implication(s):** Equipment not operating properly | Hazardous combustion products entering home

**Task:** Replace

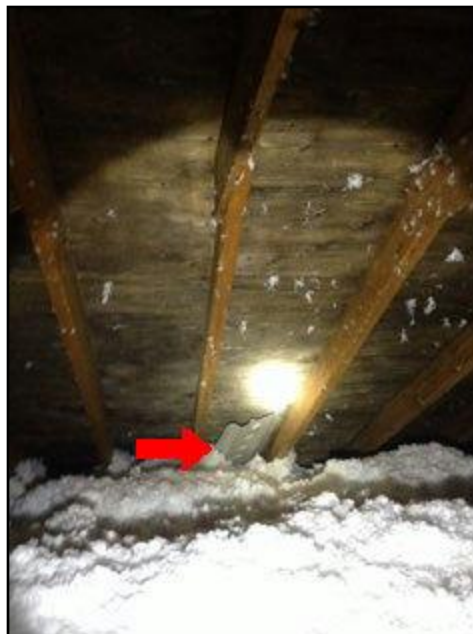
15. *Obstructed*

**18. Condition:** • [Obstructed](#)

Styrofoam baffles recently installed do not allow enough air entry into attic due to being obstructed by masonry at roof overhang. Remove one or two bricks at top of wall (from attic) where each baffle is present. Increased air flow will prevent further mould growth.

**Implication(s):** Chance of condensation damage to finishes and/or structure

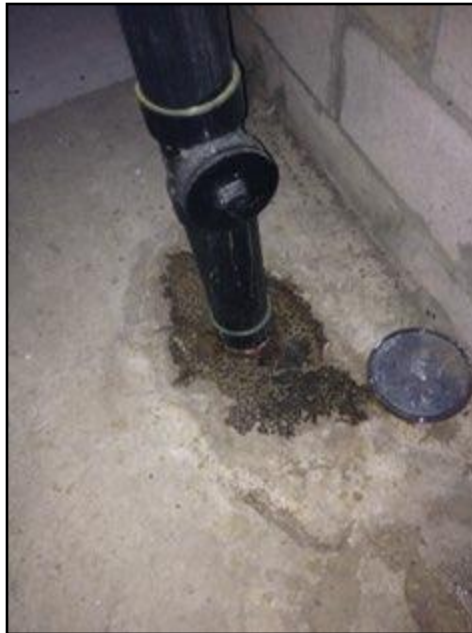
16. Leak

**19. Condition:** • [Leak](#)

**Task:** Repair

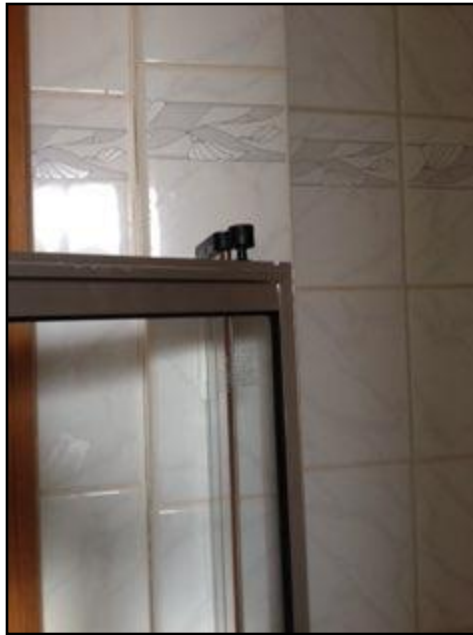
**17. Entrance problems**

**22. Condition:** • [Entrance problems](#)

Door loose at shower stall

**Task:** Repair

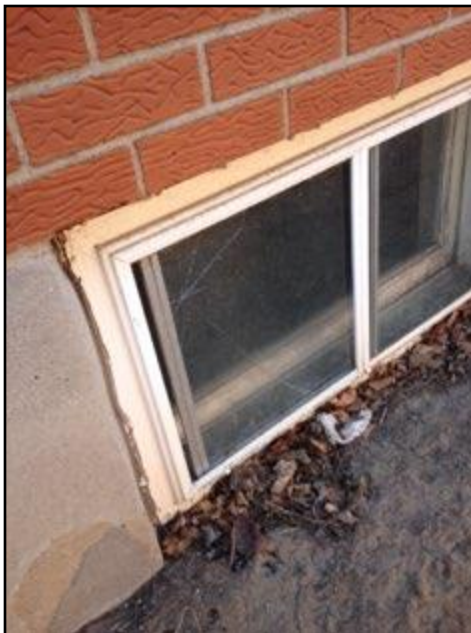
18. Cracked

**23. Condition:** • [Cracked](#)

**Implication(s):** Cosmetic defects | Physical injury

**Task:** Repair

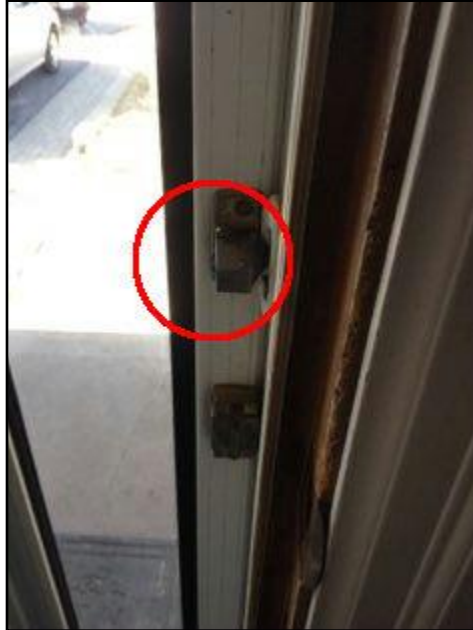
19. *Missing*

**24. Condition:** • [Missing](#)

**Task:** Replace Handle
