Your Inspection Report

20 Garden Avenue
Toronto, ON

Thursday, February 18, 2016

RE: Report No. 1716
20 Garden Avenue
Toronto, ON

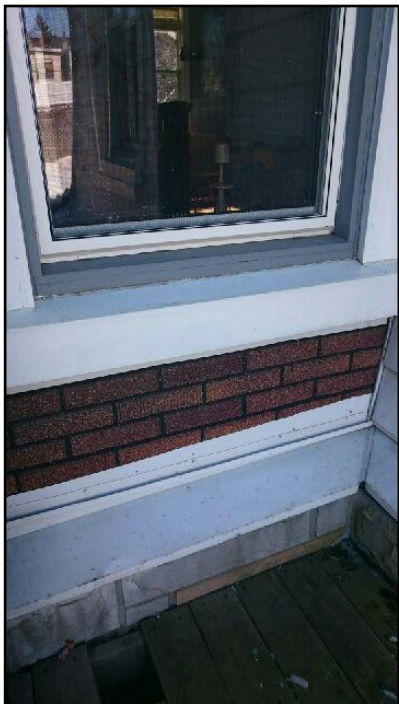
1. Flashing and caulking defects

3. Condition: • [Flashing and caulking defects](#)

Some areas of siding need repair or replacement.

Implication(s): Chance of water damage to contents, finishes and/or structure | Material deterioration

Task: Repair

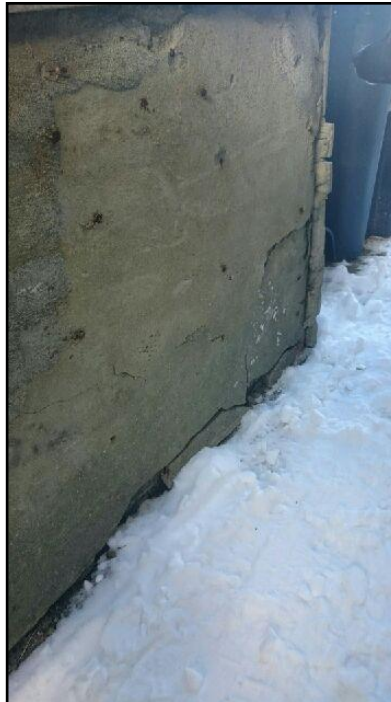
3. *Parging damaged or missing*

4. Condition: • [Parging damaged or missing](#)

Implication(s): Chance of damage to structure | Shortened life expectancy of material

Task: Repair

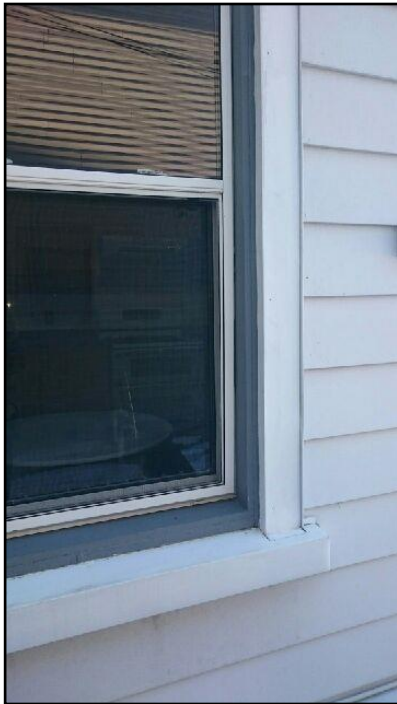
4. Flashings incomplete.

5. Condition: • Flashings incomplete.

Finish window flashings or caulk and paint exposed wood trim.

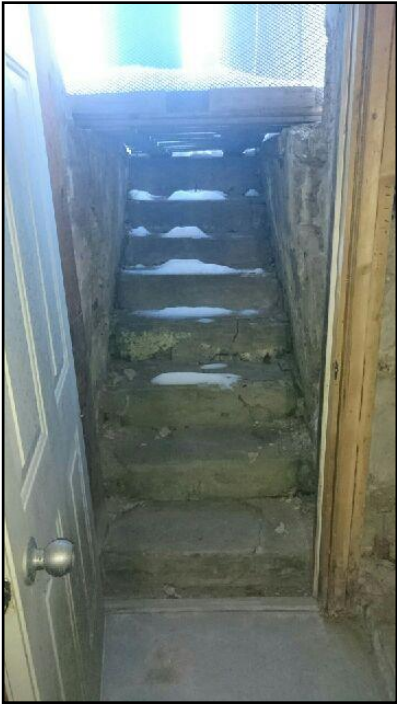
6. Walls cracking, leaning, bowing or spalling

6. Condition: • [Walls cracking, leaning, bowing or spalling](#)

Exterior basement staircase and retaining wall will require eventual rebuild. New construction should create landing lower than interior floor and include an exterior drain.

Implication(s): Weakened structure | Chance of movement

Task: Replace or Remove

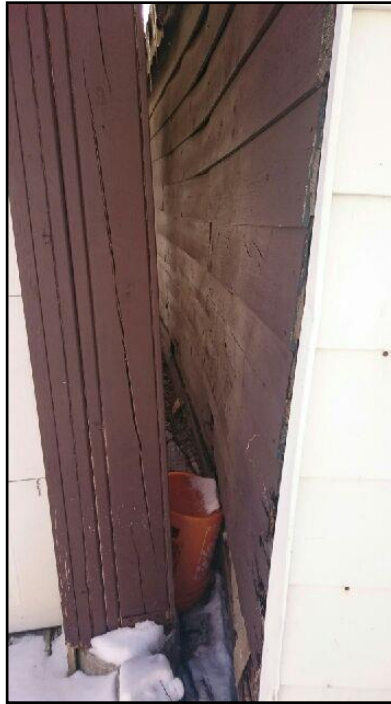
7. Typical low quality structure

7. Condition: • Typical low quality structure
Wood soil contact creating rot at garage walls.

Implication(s): Chance of water entering building | Chance of structural movement | Chance of pests entering building | Physical injury

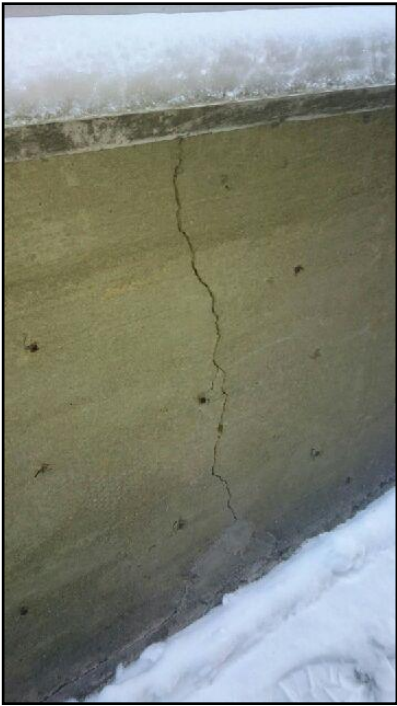
8. Cracked

9. Condition: • [Cracked](#)

Typical minor cracks are not structurally significant but indicate areas of basement most vulnerable to leakage. See INTERIOR re waterproofing.

Implication(s): Chance of water damage to contents, finishes and/or structure | Weakened structure

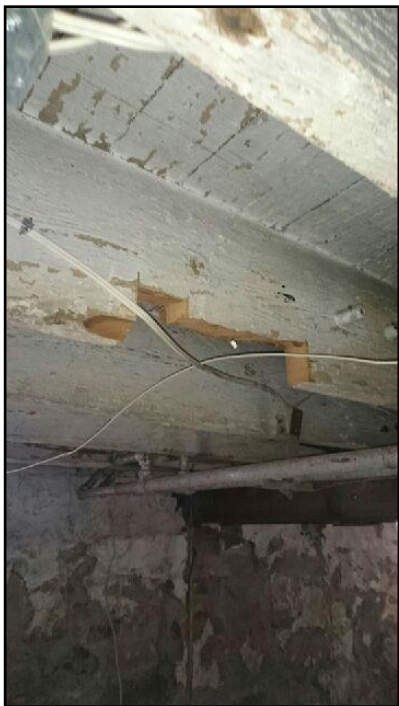
9. Notches or holes

10. Condition: • [Notches or holes](#)

Implication(s): Weakened structure

Strengthen joists at basement, before renovating.

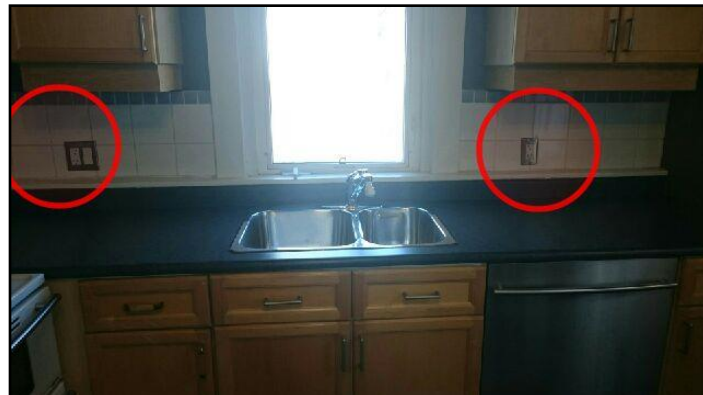
11. No GFCI (Ground Fault Circuit Interrupter)

12. Condition: • [No GFCI \(Ground Fault Circuit Interrupter\)](#)

Implication(s): Electric shock

Replace outlets near sink with gfc type.

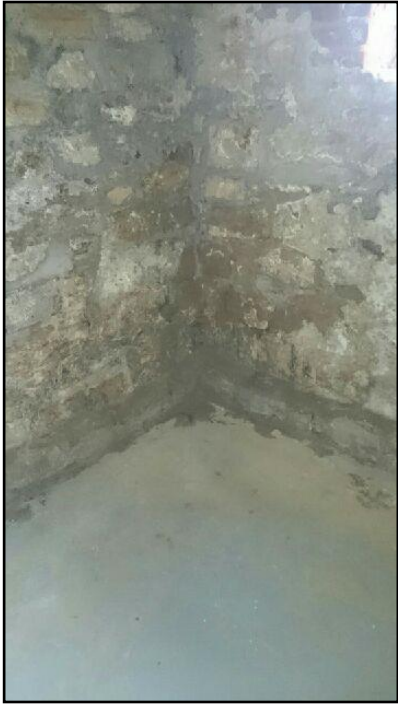
14. Dampness on floor or walls

21. Condition: • [Dampness on floor or walls](#)

Dampness at basement indicates need for interior or exterior damp proofing prior to finishing, use dehumidifier in interim.

Implication(s): Cosmetic defects | Chance of water damage to contents, finishes and/or structure | Material deterioration
