# Your Inspection Report

22 Mansfield  
Toronto, ON

RE: Report No. 1707, v.2  
22 Mansfield  
Toronto, ON

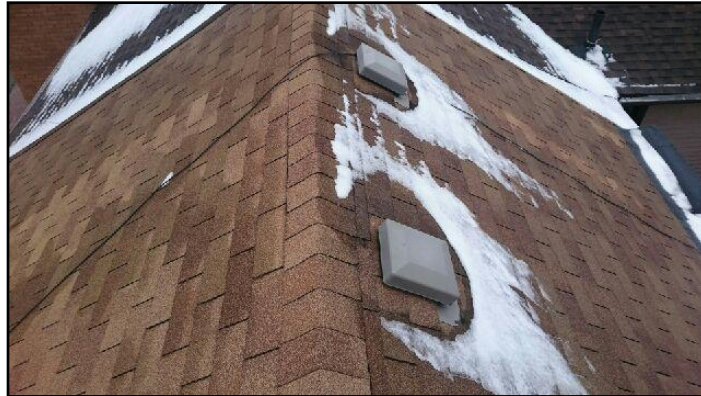
Reshingled 2009

1. *Asphalt shingles*

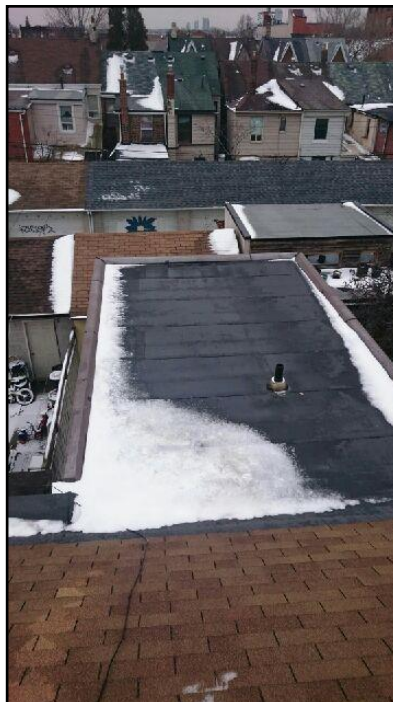
Resurfaced 2016

2. *Modified bitumen*

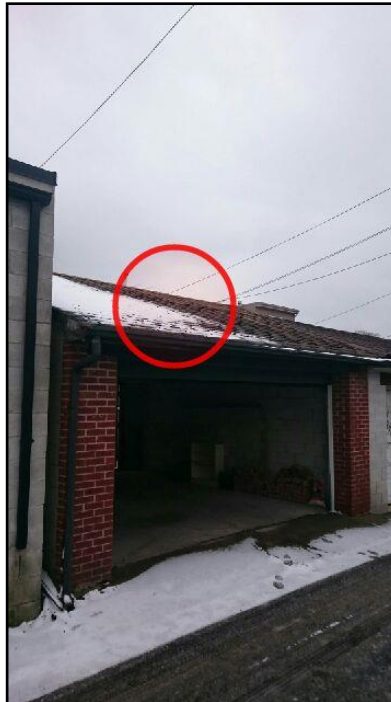
**1. Condition:** • [Old, worn out](#)

North side of garage requires reshingling.

**Implication(s):** Chance of water damage to contents, finishes and/or structure

3. Old, worn out

**Task:** Replace

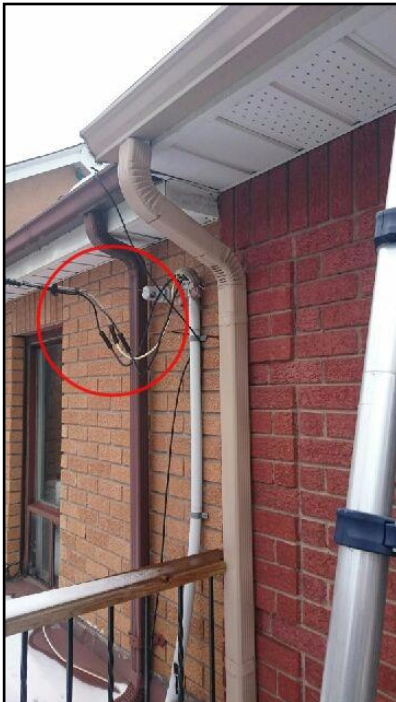
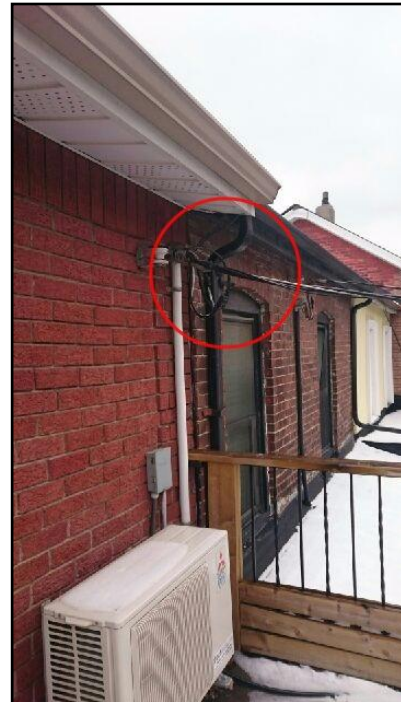
4.

**4. Condition:** • Increase railing height to prevent contact of electrical wires by occupants of balcony.

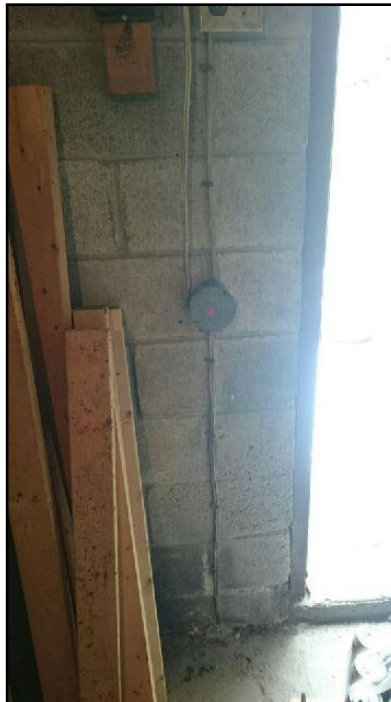
### 5. Condition: • [Exposed on walls or ceilings](#)

**Implication(s):** Electric shock

6. Exposed on walls or ceilings

Protect wiring with conduit.

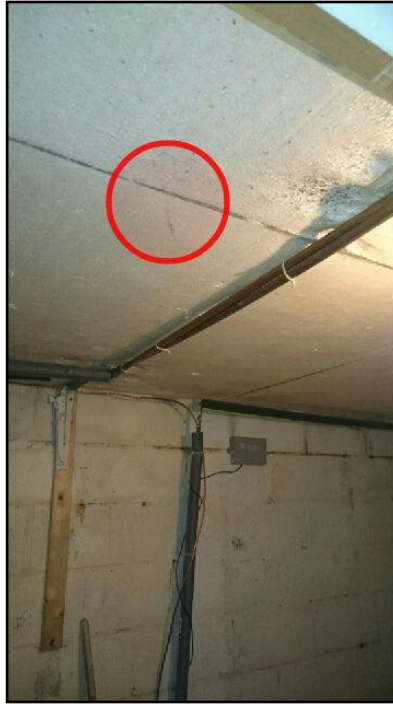
**FOUNDATION \ Interior insulation**  
**10. Condition:** • [Exposed combustible insulation](#)  
Cover or remove exposed styrofoam at laundry room ceiling.  
**Implication(s):** Fire hazard  
**Location:** Basement Laundry Area  
**Task:** Protect  
**Time:** Immediate  
**Cost:** Minor

7. Exposed combustible insulation

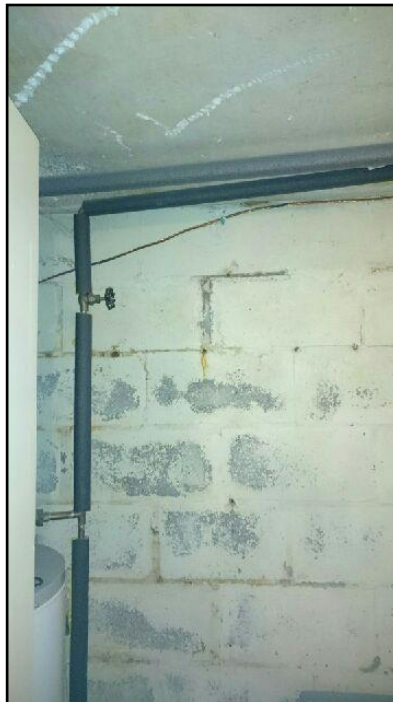
- WALLS \ Masonry or concrete**
12. Condition: • [Efflorescence](#)
- Implication(s): Cosmetic defects
- Location: South Basement

8. Efflorescence

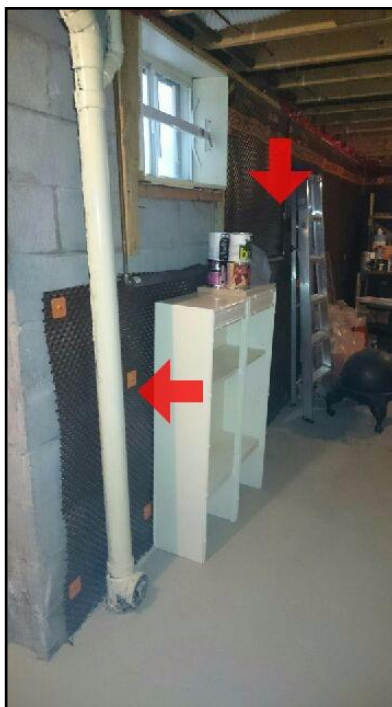
14. Condition: • Interior drainage membrane.

Very low potential for leakage at north basement.

9. Interior drainage membrane.
