Your Inspection Report

15 Algonquin
Toronto, ON

Tuesday, April 5, 2016

RE: Report No. 1768
15 Algonquin
Toronto, ON

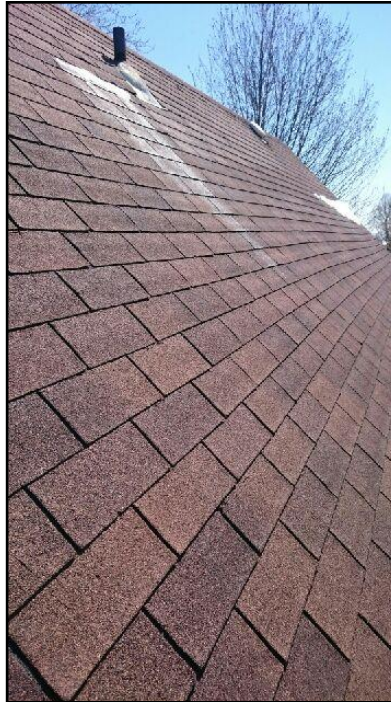
1. *Asphalt shingles*

Probability of leakage: • Medium

1. **Condition:** • [Granule loss](#)

Shingles aprox. 13-14 years old, reinspect in 2-3 years.

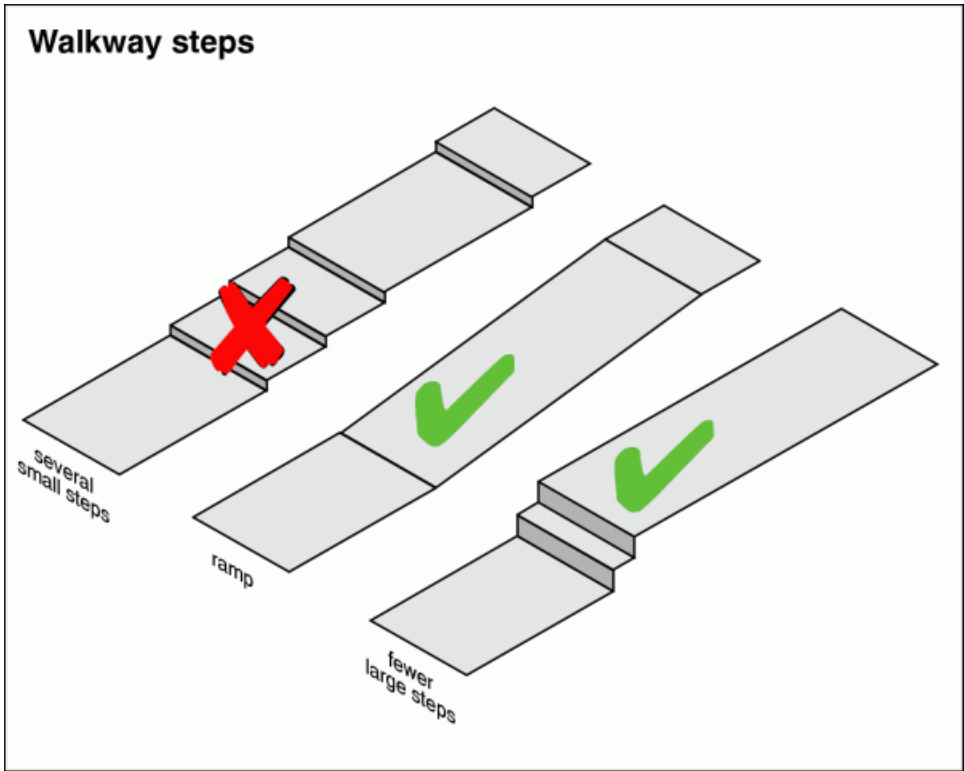
LANDSCAPING \ Walkway

3. Condition: • [Uneven \(trip hazard\)](#)

Implication(s): Physical injury

Location: North Exterior

Fill low spot on walkway with concrete.

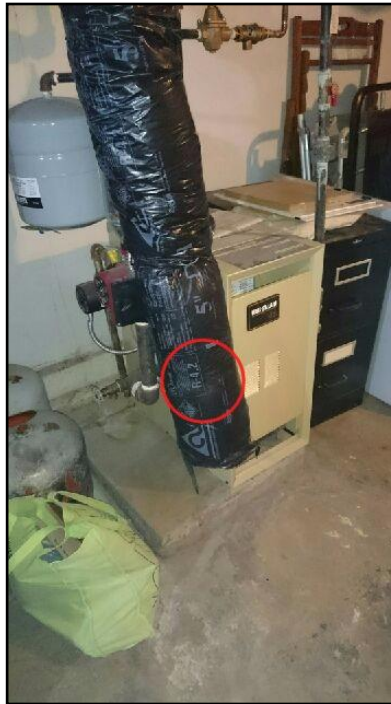
2. Combustible clearance

GAS HOT WATER BOILER \ Cabinet

7. Condition: • [Combustible clearance](#)

Implication(s): Increased fire hazard

Location: Northwest Basement

Isolate plastic wrapped combustion air supply from boiler cabinet and circulating pump.

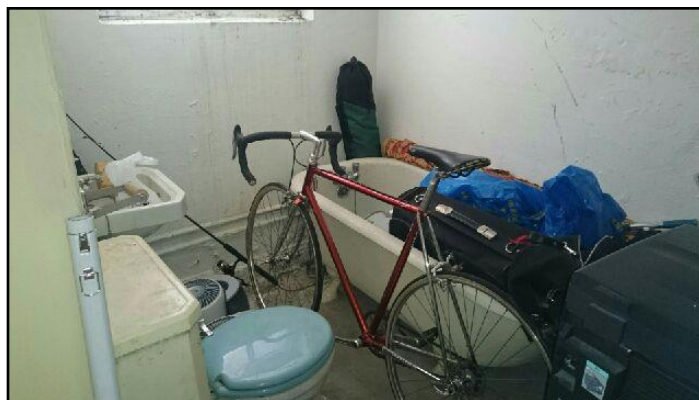
4. Dated fixtures

10. Condition: • Basement washroom due for renovation.

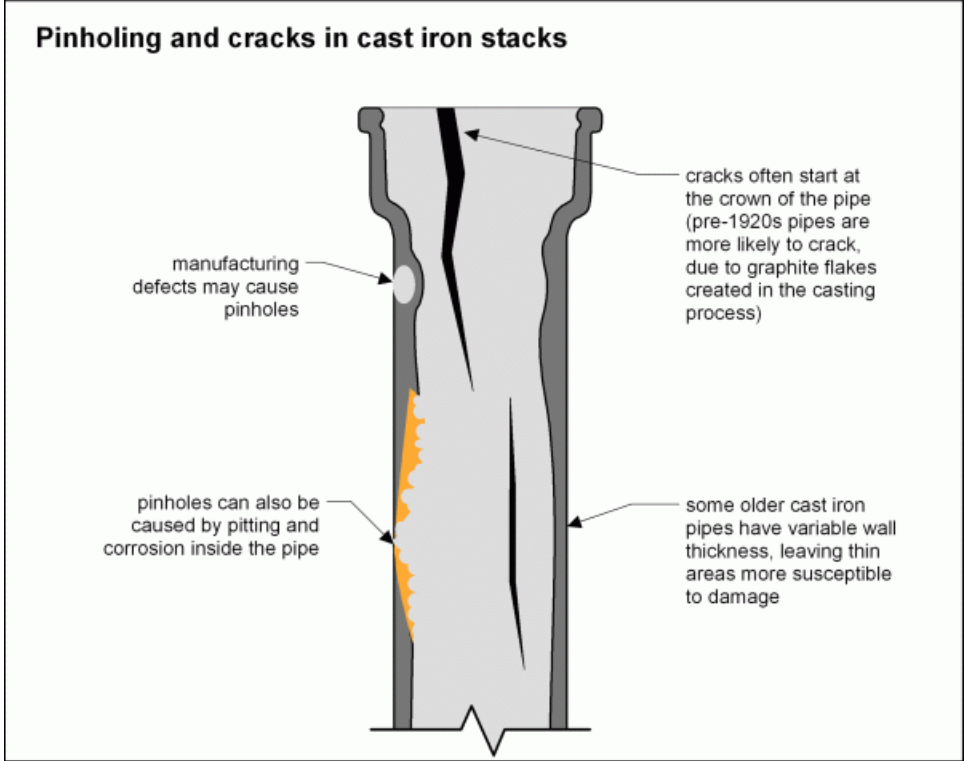
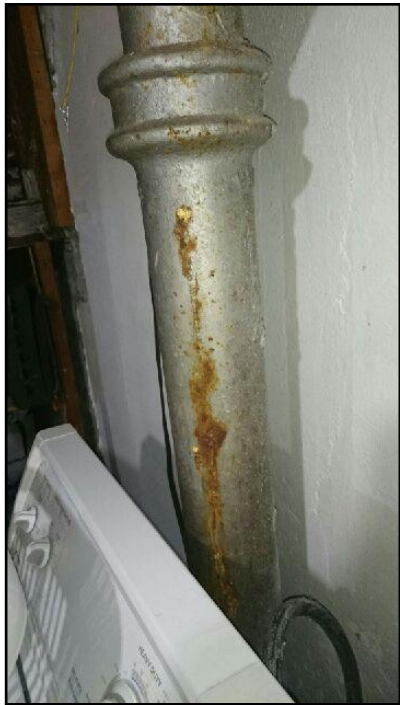
5. Rust

WASTE PLUMBING \ Drain piping - performance

11. Condition: • [Rust](#)

Implication(s): Sewage entering the building

Location: Throughout
Task: Replace
Time: When remodelling

Original cast iron waste piping remaining in use, replace if/when renovating.
