# Your Inspection Report

472 Lansdowne Avenue  
Toronto, ON

Tuesday, May 24, 2016

RE: Report No. 1839  
472 Lansdowne Avenue  
Toronto, ON

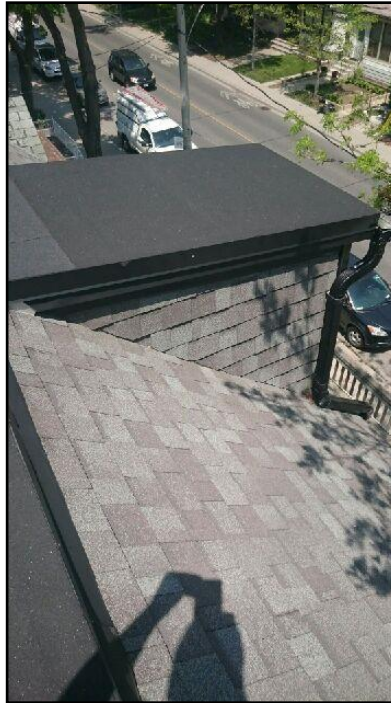
2010

1. *Asphalt shingles*

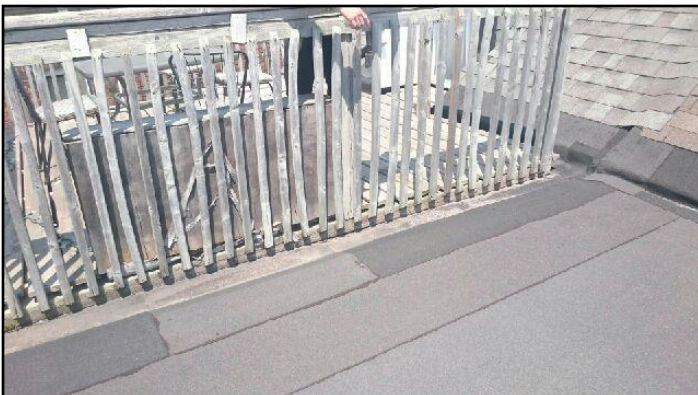
Aprox. 10 years old, tuned up 2010.

2. *Modified bitumen*

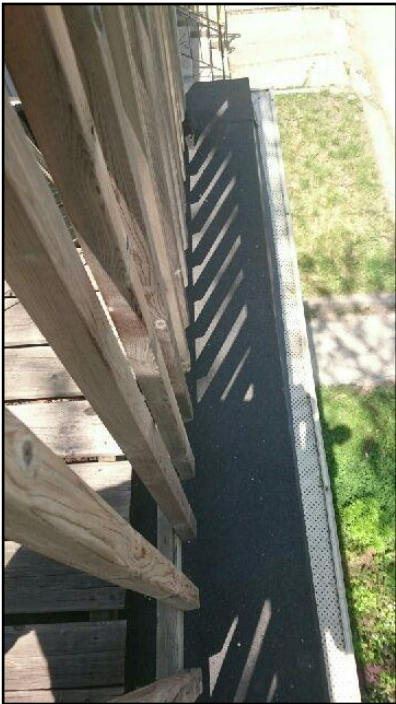
3. Modified bitumen

Probability of leakage: • Low

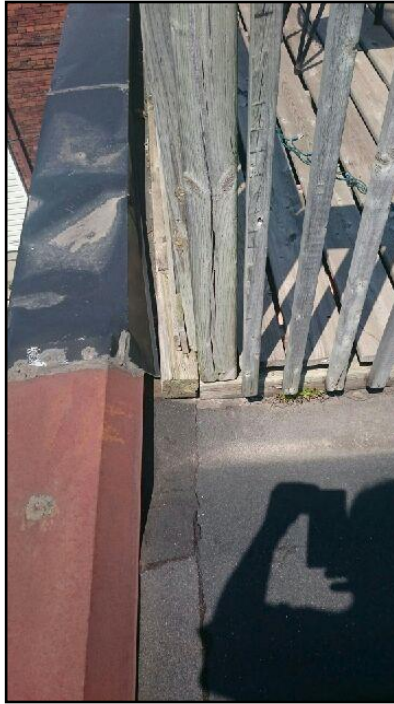
- 1. Condition:** • Vulnerable areas.  
Ideally deck would be isolated from roofing material with styrofoam (or similar) to protect roofing membrane.
- Implication(s):** Premature roof wear.
- Location:** Both roof decks
- Task:** Improve
- Time:** Unpredictable
- Cost:** Depends on work needed

4. *Vulnerable areas.*

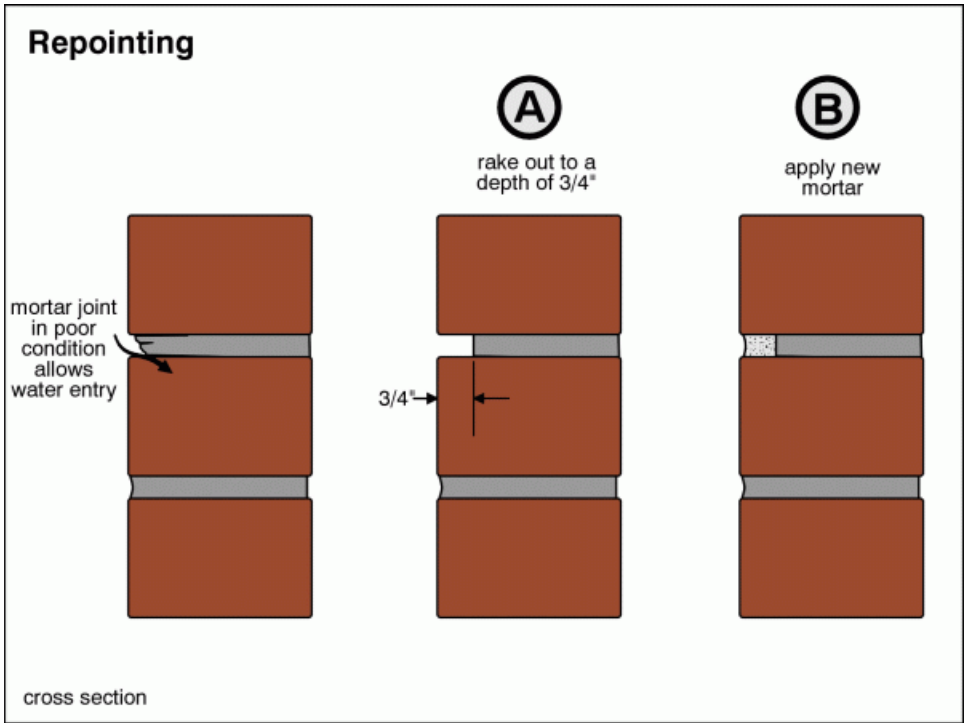
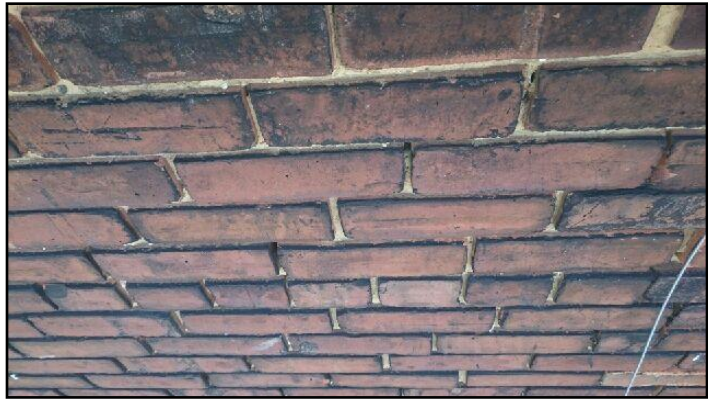
- WALLS \ Brick, stone and concrete**
- 2. Condition:** • [Mortar deterioration](#)  
Typical tuckpointing maintenance needed, not urgent.
- Implication(s):** Chance of water entering building | Weakened structure | Chance of structural movement
- Location:** Various Exterior Wall
- Task:** Repair
- Time:** Regular maintenance
- Cost:** \$2,000 - and up

5. Mortar deterioration

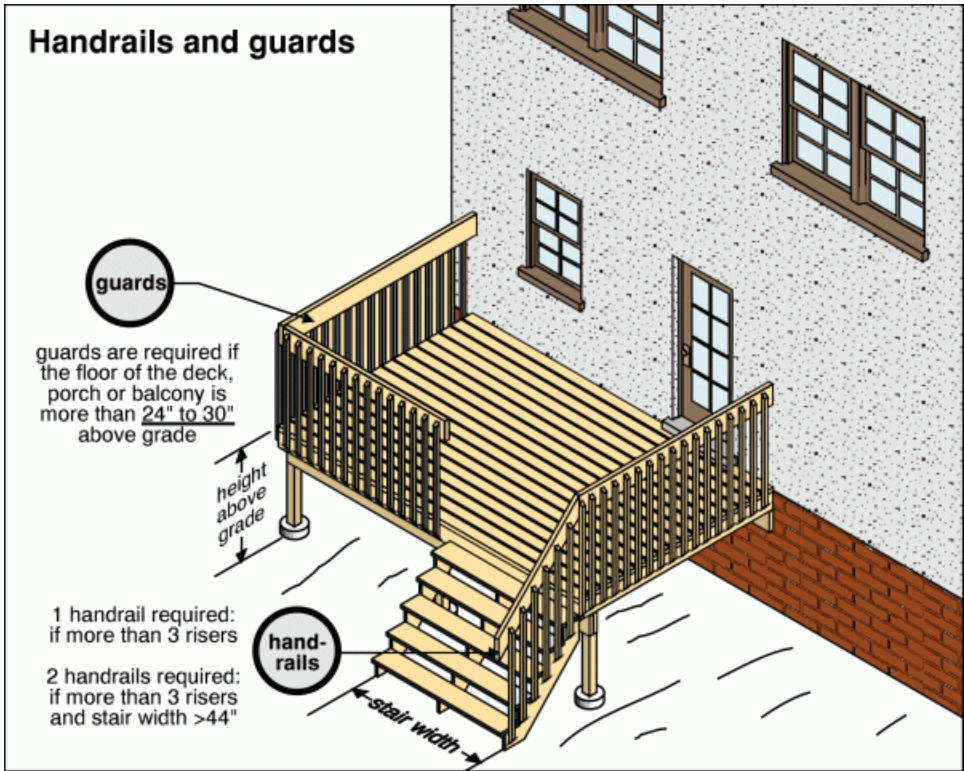
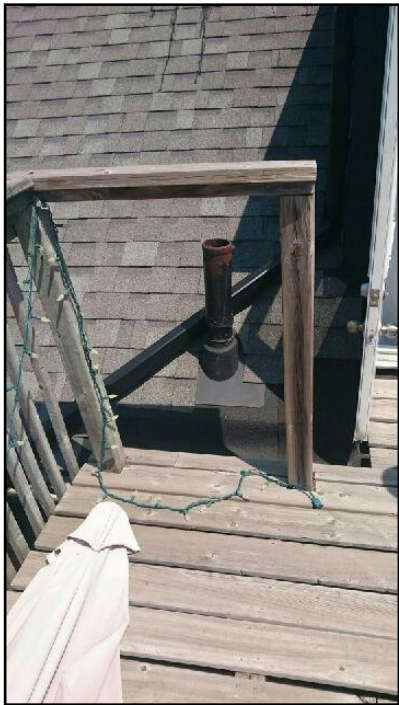
Upper and lower deck need guardrail improvements.

**Implication(s):** Fall hazard

6. Missing guardrail

**Task:** Provide

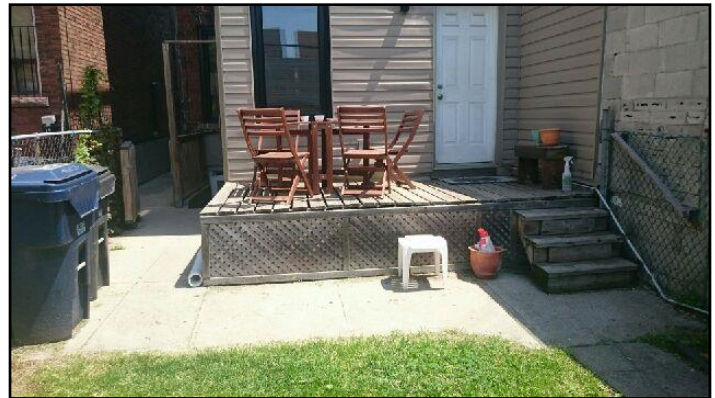
7. Missing guardrail

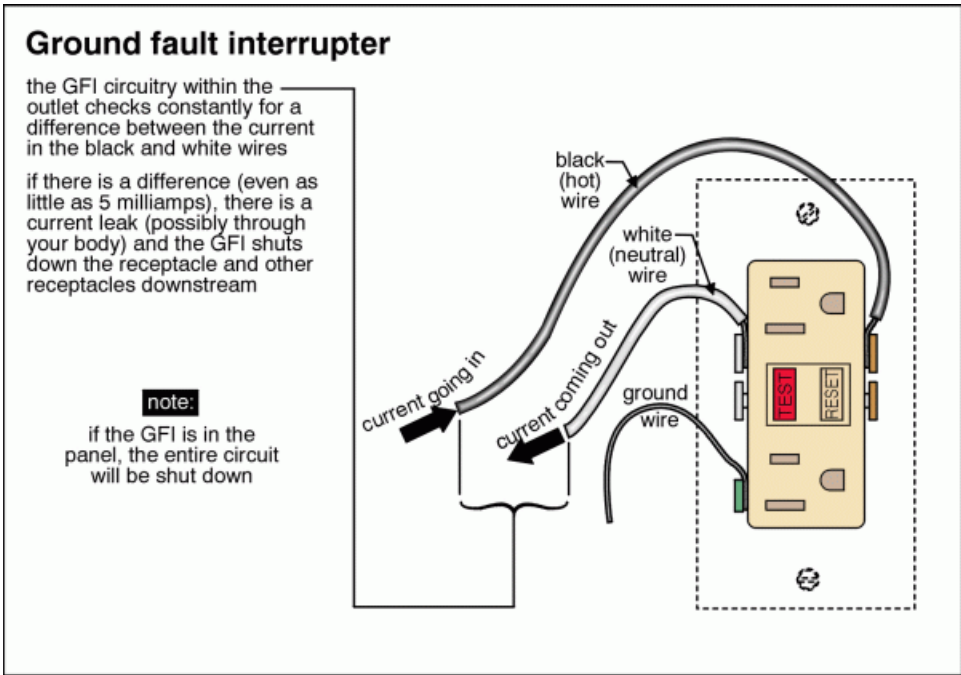
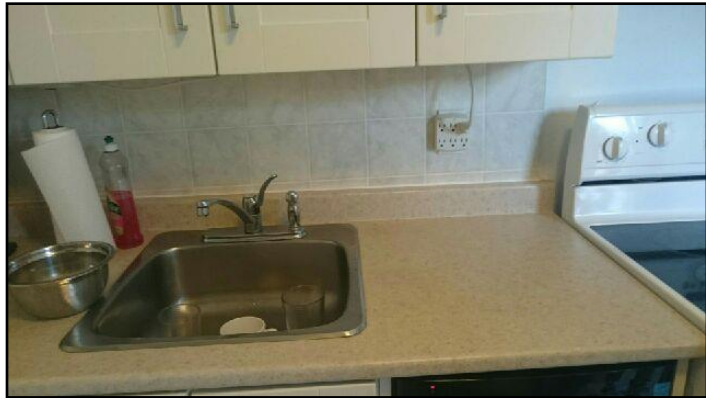
#### **8. Condition:** • [No GFCI \(Ground Fault Circuit Interrupter\)](#)

8. No GFCI (Ground Fault Circuit Interrupter)

Recommend installation of gfcı receptacles at all wet locations.

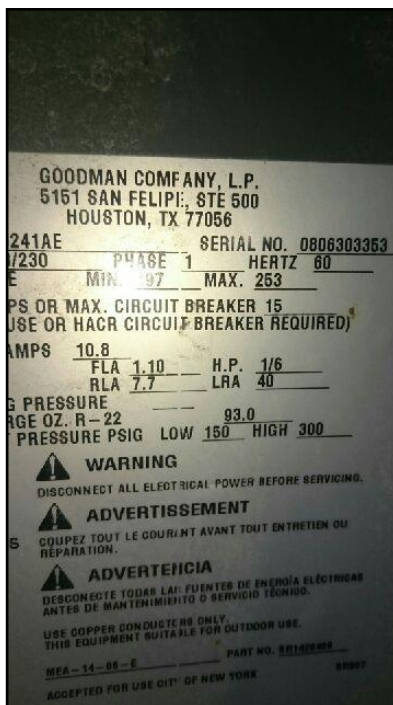
9. Air cooled

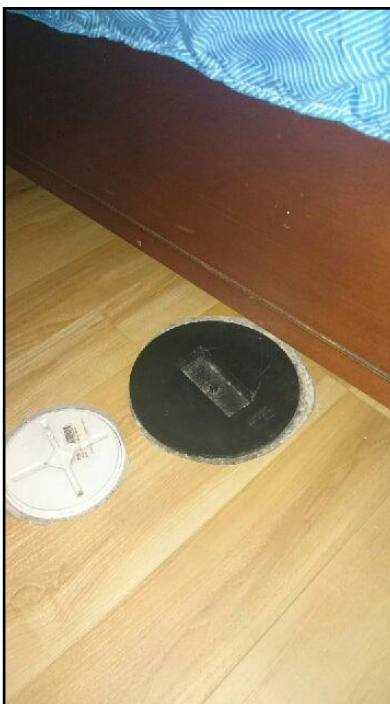
- Present. These valves help prevent sewer backup. Many insurance companies insist these be installed before they will offer a sewer backup endorsement, which we strongly recommend you obtain.

10. Present. These valves help prevent sewer...

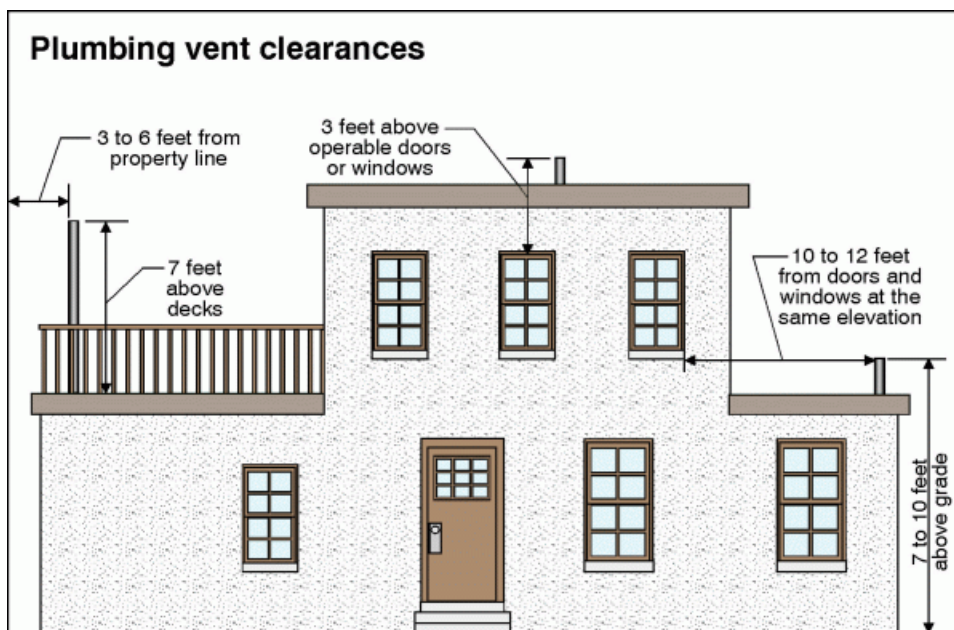
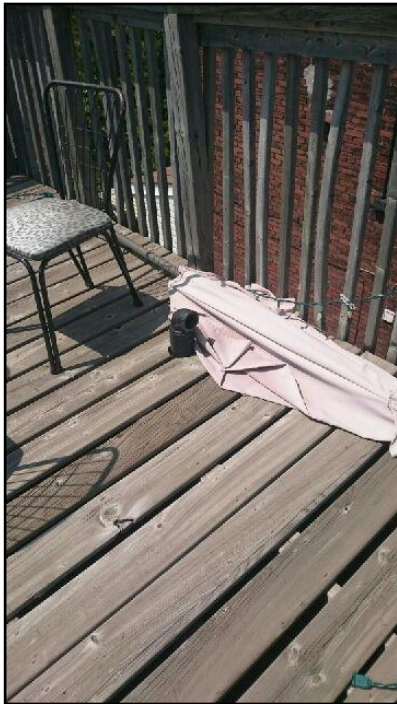
14. Condition: • [Vent termination problems](#)

11. Vent termination problems

Extend vent above and away from deck if odours are noticed.

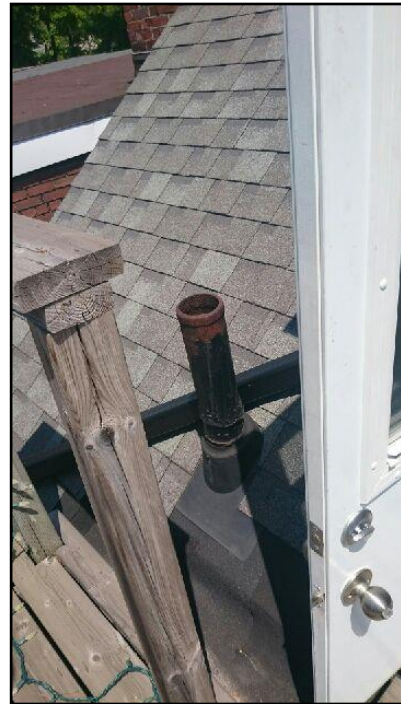
12. Vent termination problems

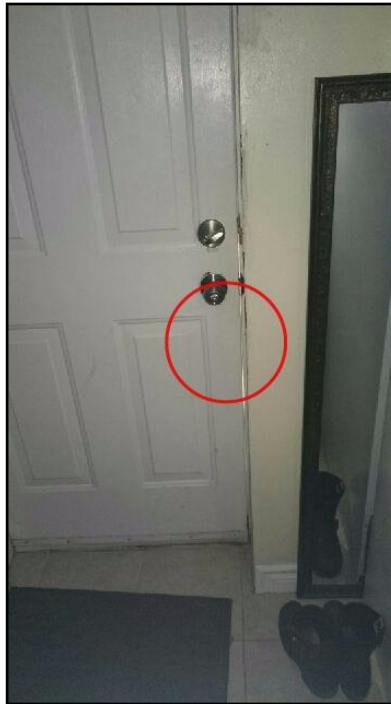
16. **Condition:** • [Weatherstripping missing or ineffective](#)

13. Weatherstripping missing or ineffective

**Task:** Improve

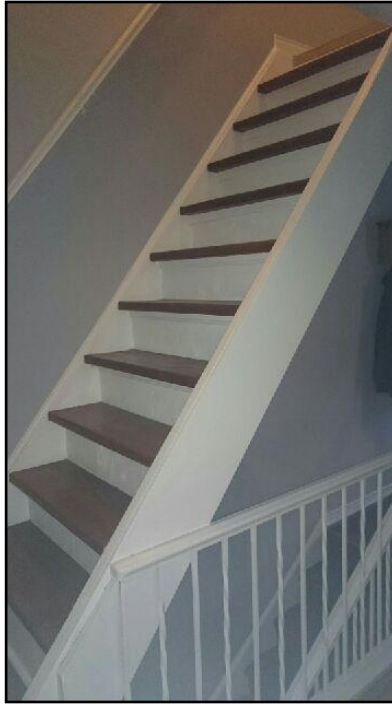
Stairs to third floor are steep and lack guardrail.

**Implication(s):** Fall hazard

14. *Missing guardrail*

**Task:** Provide guardrail

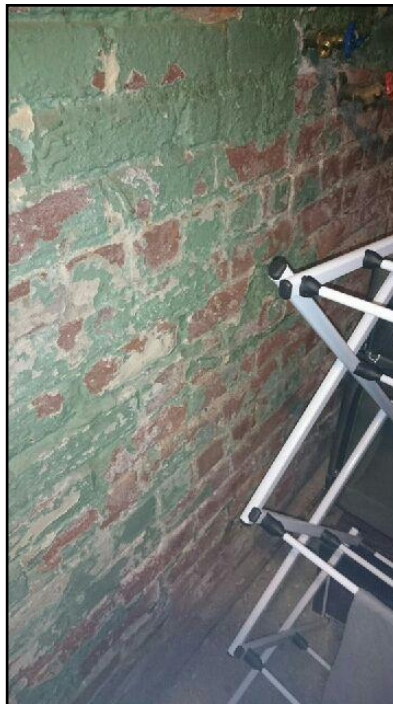
Typical efflorescence for this era and type of construction, no leakage noted. Introduce interior membrane of renovating basement.

15. Efflorescence

**Task:** Monitor
