Your Inspection Report

137 Spruce
Toronto, ON

Friday, April 29, 2016

RE: Report No. 1805
137 Spruce
Toronto, ON

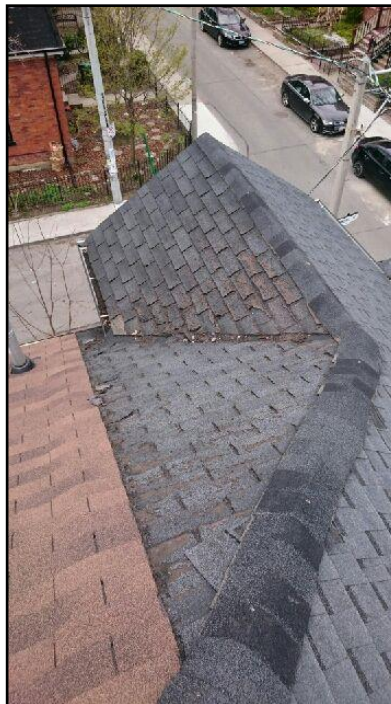
1. Condition: • [Old, worn out](#)

Strip and reshingle southwest section.

3. Old, worn out

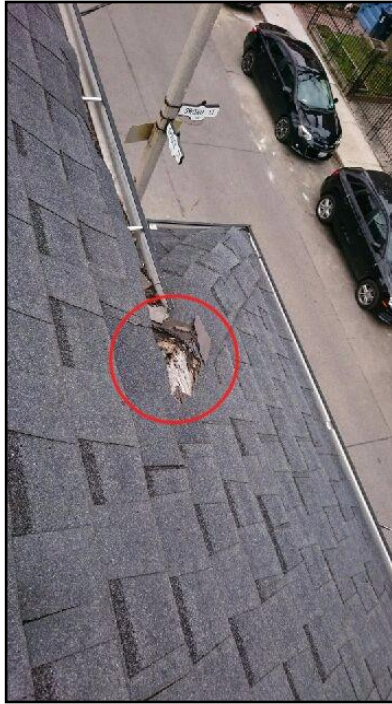
2. Condition: • [Damage](#)

Small area of newer roof needs repair, preferably with sheet metal to prevent further pest entry.

4. *Damage*

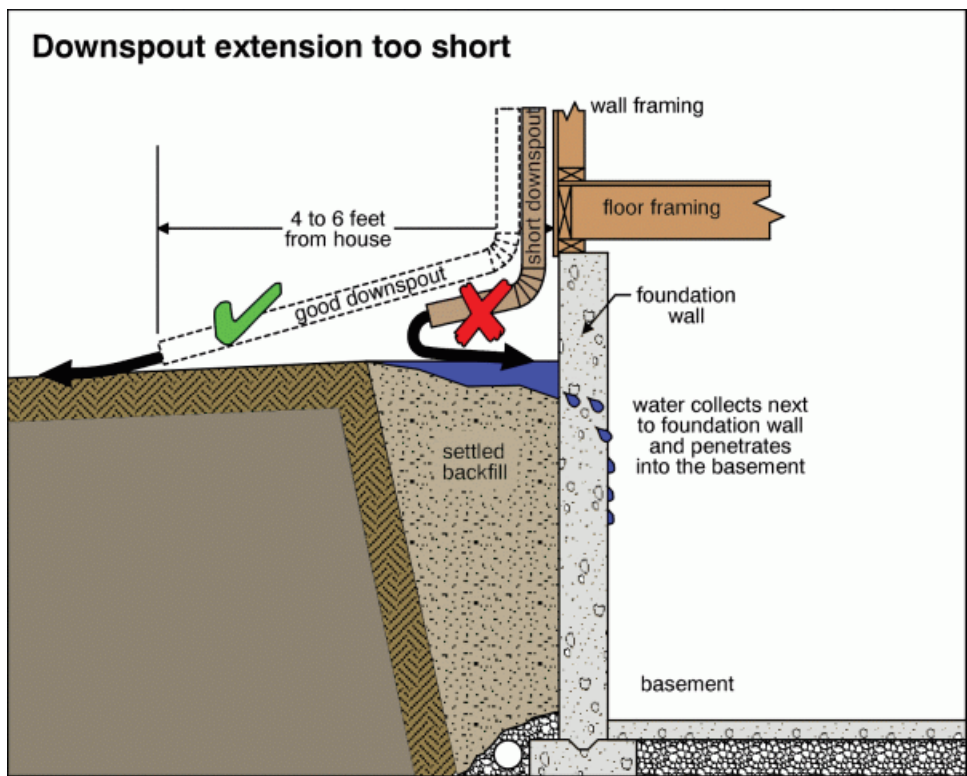
3. Condition: • [Downspouts end too close to building](#)

Evidence of dampness in basement where s/w downspouts discharges next to wall. Extend well away from foundation.

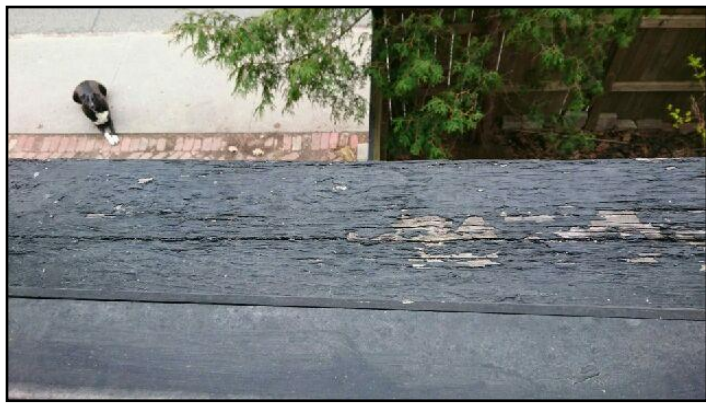
Wood trim needs prep and paint.

5. *Paint or stain needed*

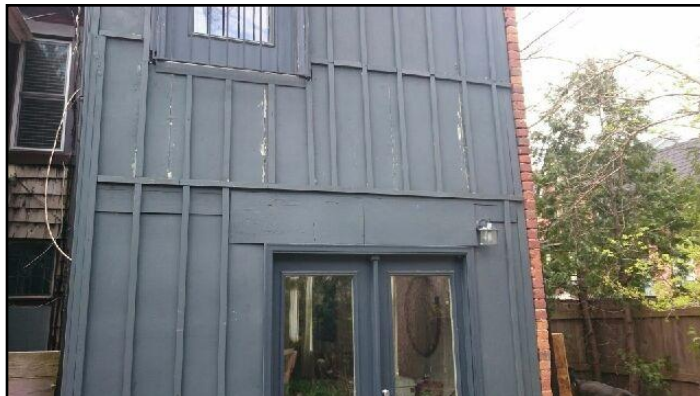
Some sections of wood siding in poor condition, consider replacing with more durable siding when asphalt shingles at south siding are replaced.

6. Cracked, split or broken

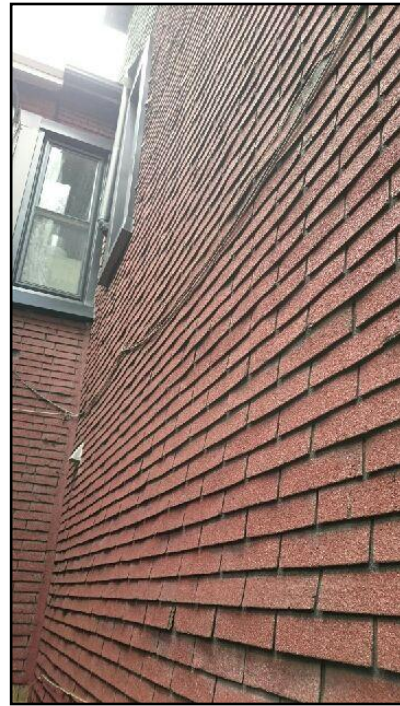
6. **Condition:** • [Aging](#)

8. Aging siding

Recommend residing at lower asphalt shingle.

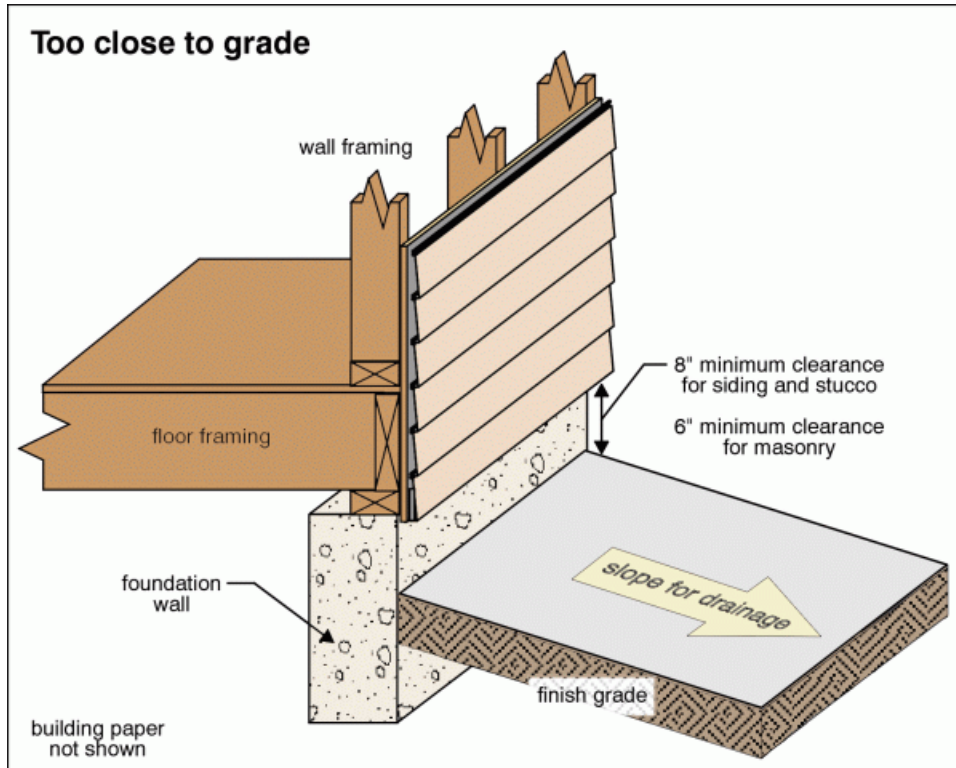
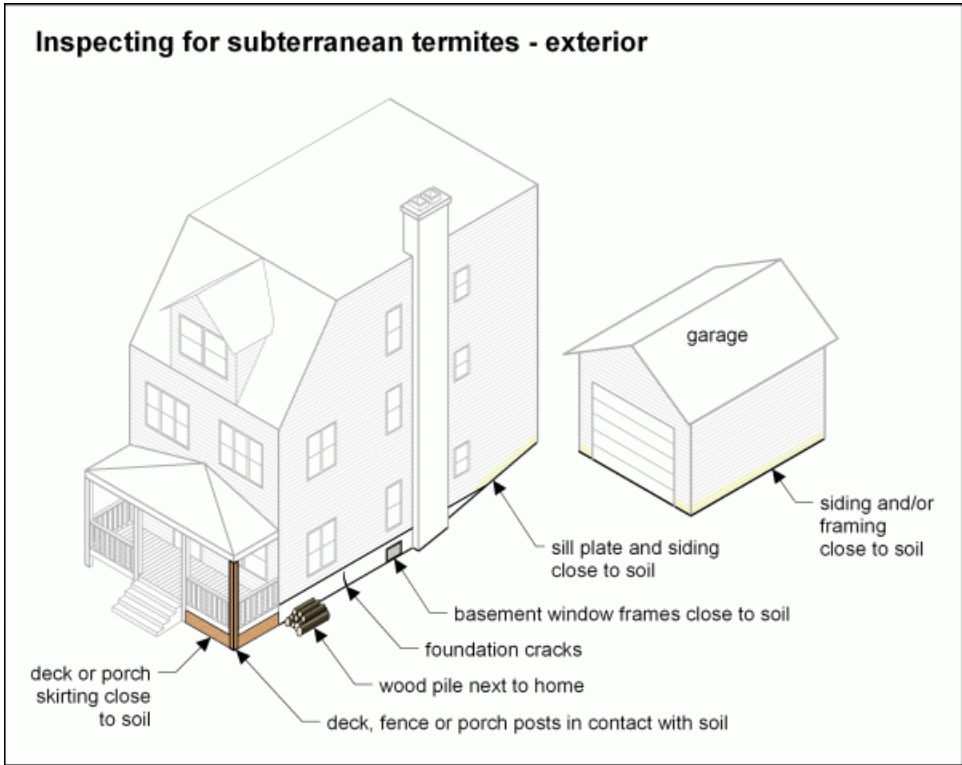
7. Condition: • [Too close to grade](#)

See STRUCTURE before replacing siding.

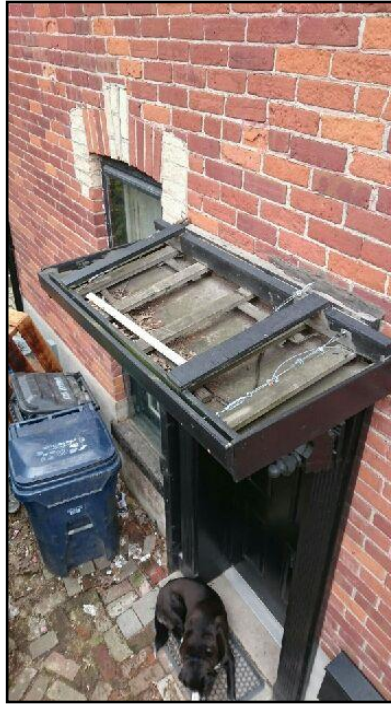
8. Condition: • Remove poor roof structure at north door.

9. Poor roof structure

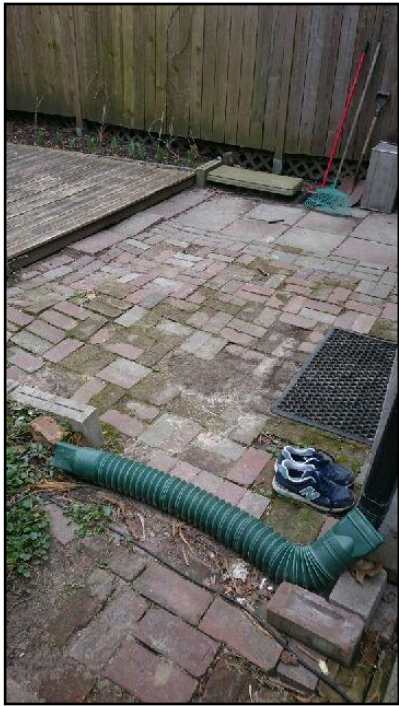
9. Condition: • [Slope toward building](#)

10. Poor drainage

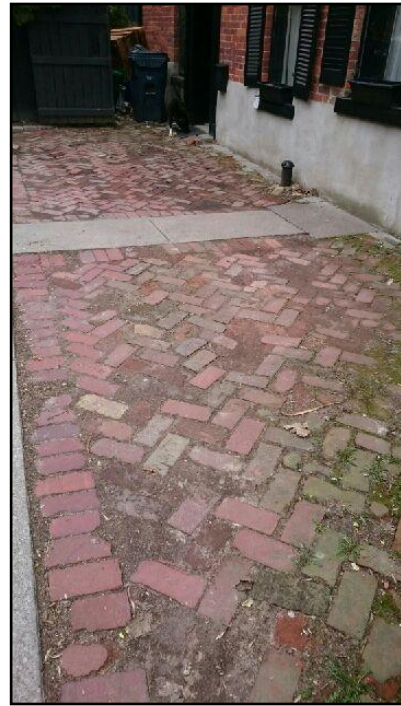
11. Poor drainage

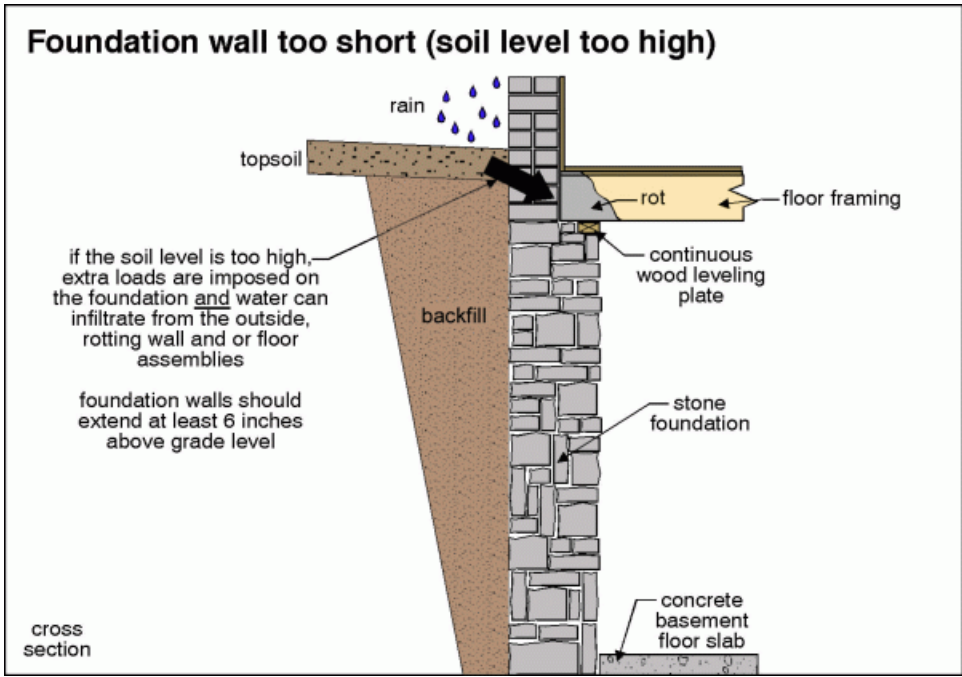
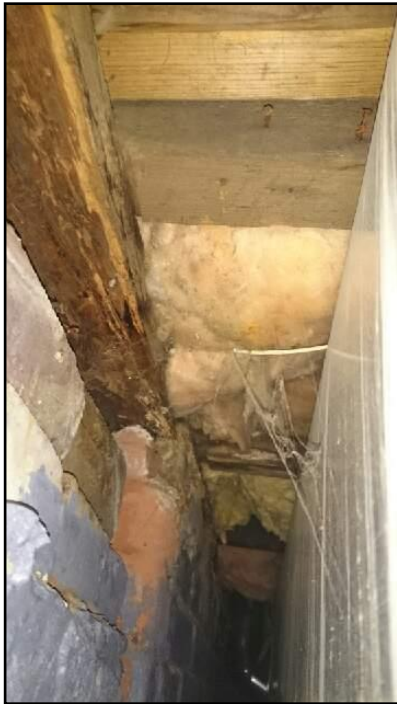
As is typical with this era and type of construction, wood frame walls and sill beams they sit on, are at or below grade level. This wood/soil contact has caused rot and the resulting settlement evident in slope of floors. Ideally wood sill beams are replaced with concrete. This eliminates wood to soil contact, gives joists solid end bearing and stops settlement. This can be done from the exterior, siding repairs would be done after structural repairs. Note interior photo show dryer ducting above wood structure while exterior photo shows soil above same wood.

12. Rotted sill

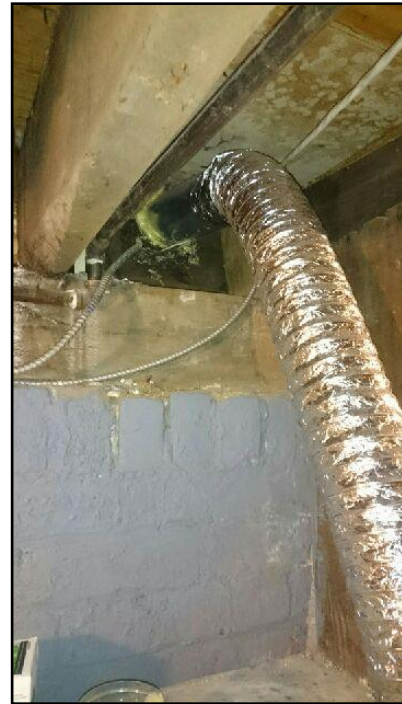
13. Interior view

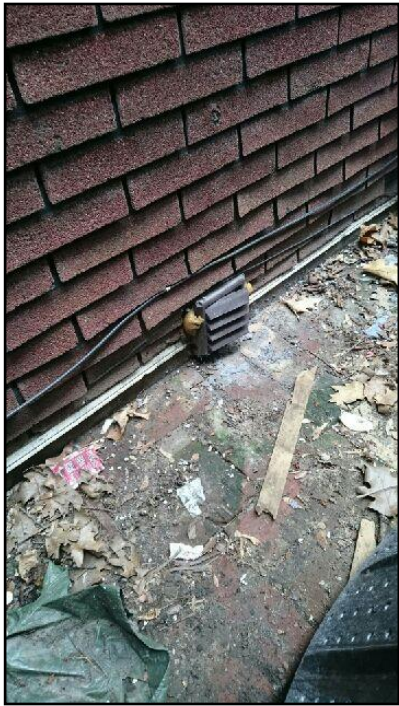
14. Exterior view

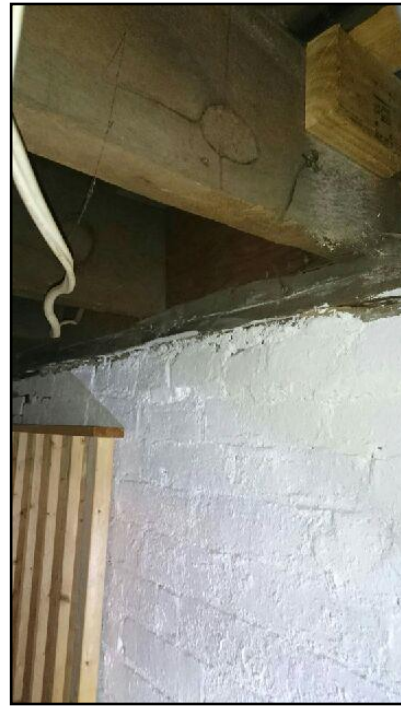
15. Rotted sill

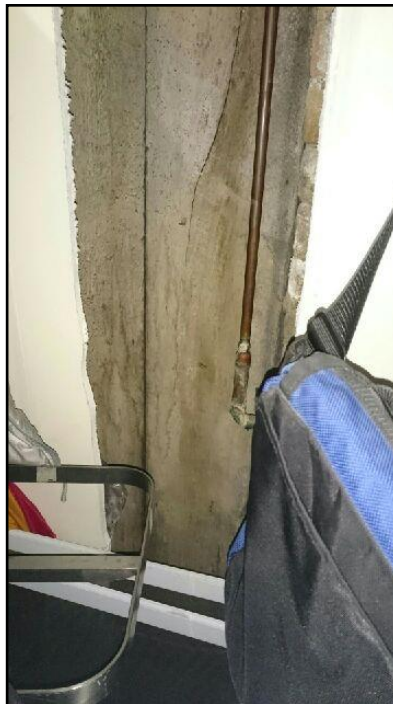
11. **Condition:** • FYI party walls at basement are wood not masonry.

16. Wood party wall

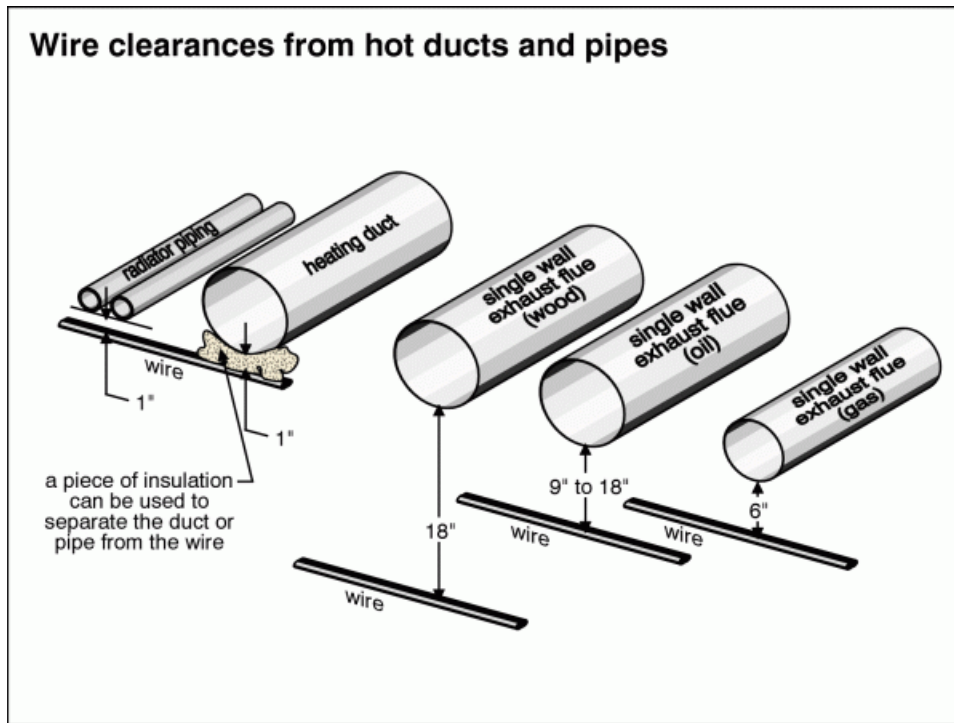
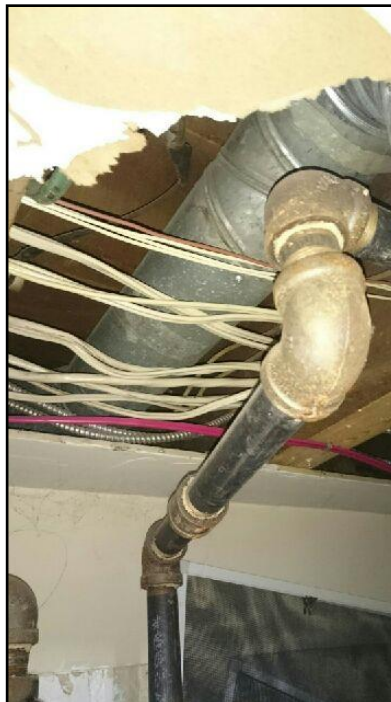
13. Condition: • [Too close to duct, pipe, vent or chimney](#)

17. Too close to duct

Isolate wiring from ducting with insulation.

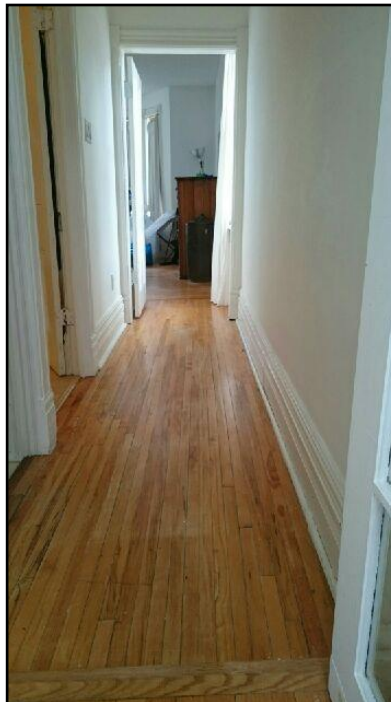
18. Condition: • Sloped
Slope to floors created by settlement at sill beams in basement. See STRUCTURE
Location: Throughout

18. Sloped

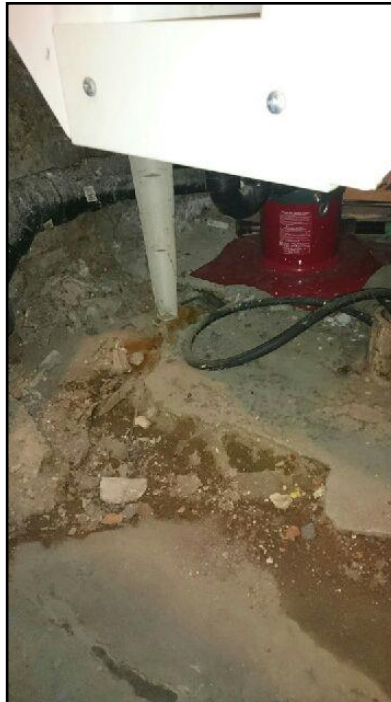
19. Condition: • [Hollow below](#)

19. *Hollow below*

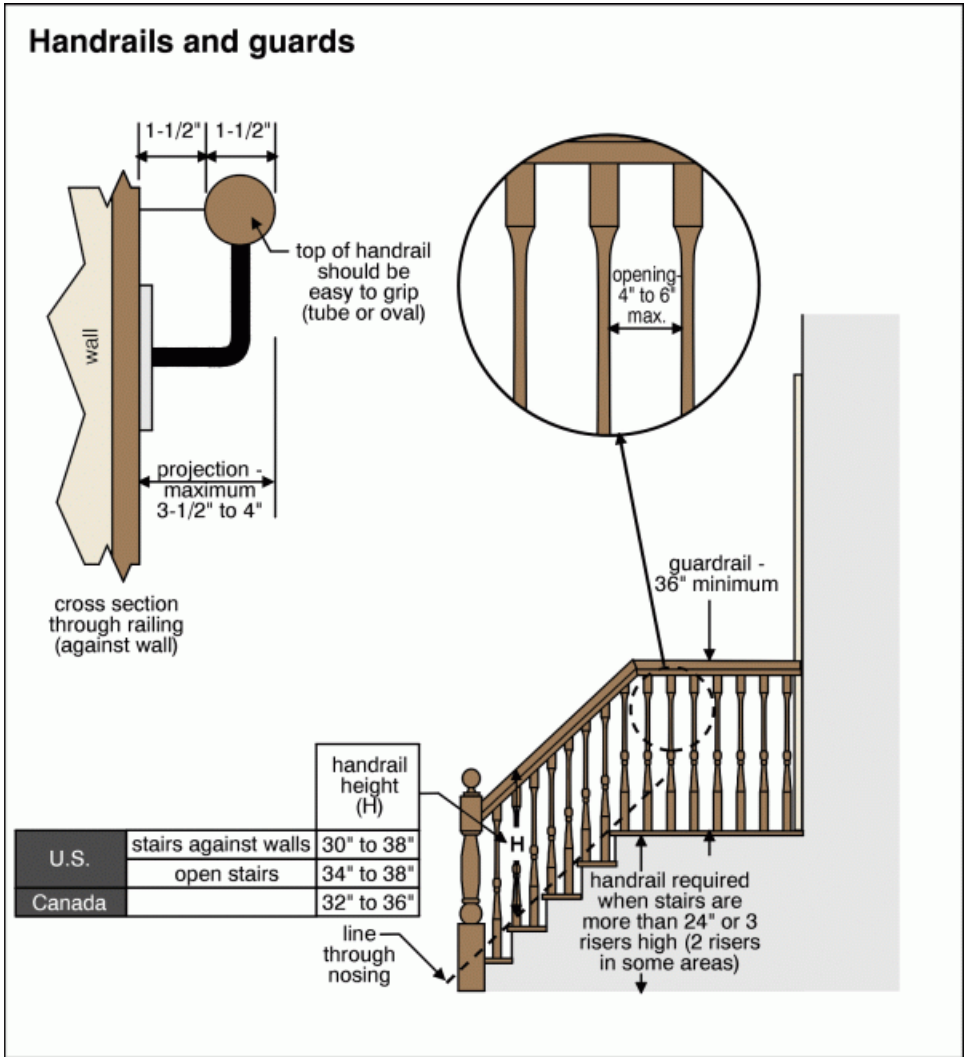
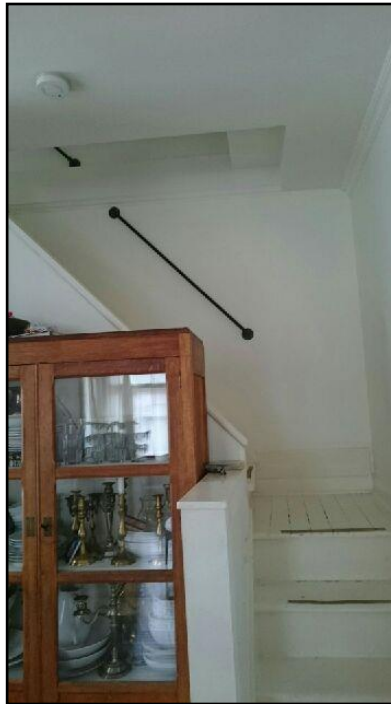
20. Condition: • [Missing](#)

20. Missing guardrail

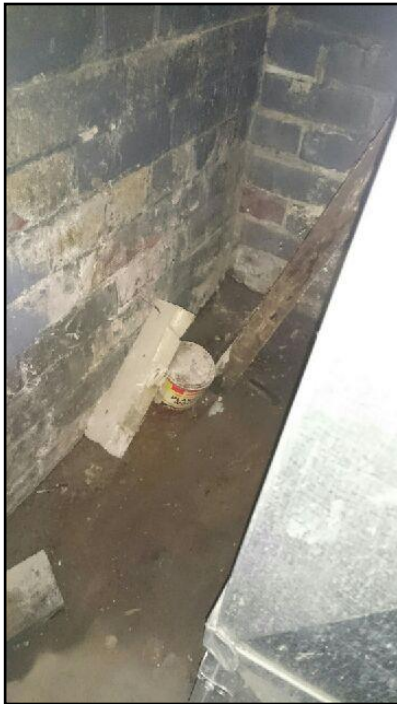
Leakage evident at s/w and east basement. Extend downspout and reslope patio and further evaluate for need for further action.

21. Dampness on floor or walls

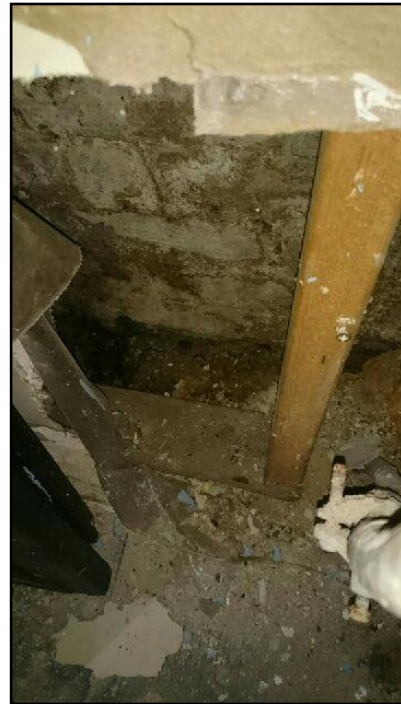
22. Dampness on floor or walls
