# Your Inspection Report

46 Cowan Avenue  
Toronto, ON

Friday, July 8, 2016

RE: Report No. 1896  
46 Cowan Avenue  
Toronto, ON

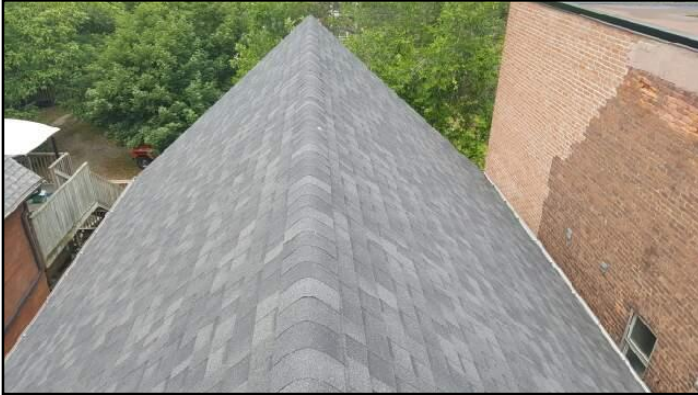
1. Asphalt shingles

1. **Condition:** • No roofing recommendations are offered as a result of this inspection. Roof recently stripped and resingled and in excellent condition.

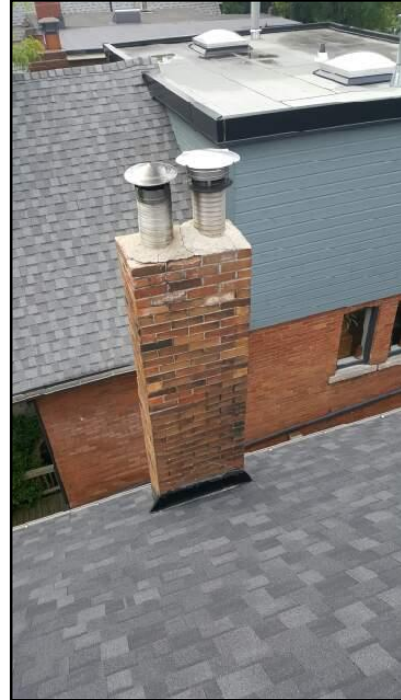
2. Asphalt shingles

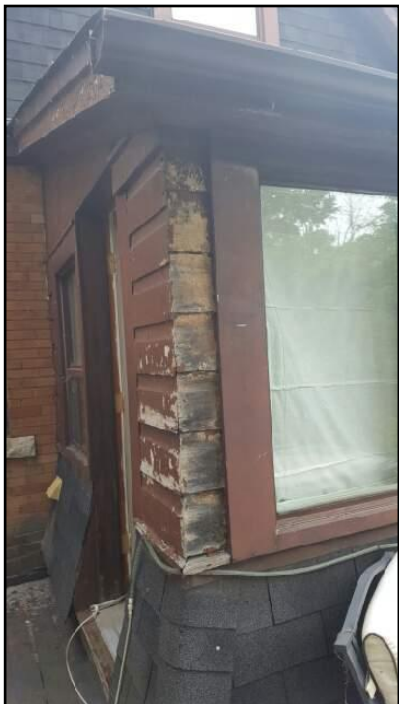
**WALLS \ Trim**  
**2. Condition:** • Paint or stain needed  
All wood areas need repair and maintenance. See STRUCTURE re n/w wall before working on lower wood siding at this area.  
**Implication(s):** Chance of water damage to contents, finishes and/or structure | Material deterioration  
**Location:** Exterior  
**Task:** Improve  
**Time:** Immediate  
**Cost:** \$3000 and up.

3. *Paint or stain needed*

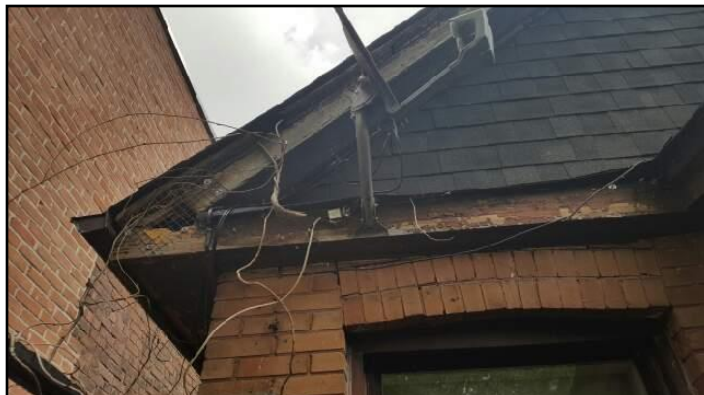
4. *Paint or stain needed*

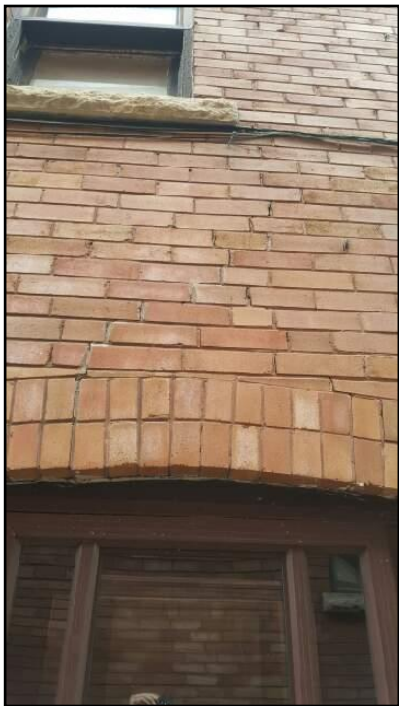
Typical minor cracks, not structurally significant, minor tuckpointing needed. These cracks indicate area where foundation is most vulnerable to water entry (where not already waterproofed).

5. Cracked

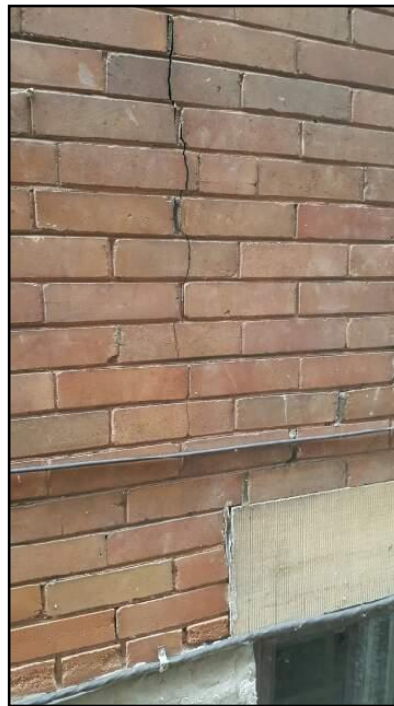
6. Cracked

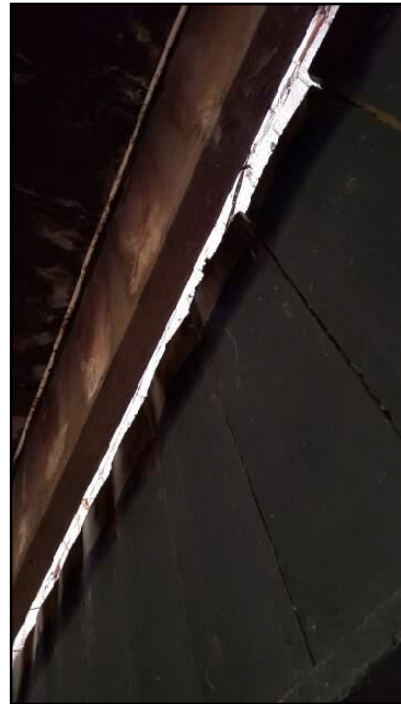
Installation of main floor walkout door may not have included necessary steel lintels to support brick above, wood siding serves as a water trap and prevents inspection for lintel. Remove wood and further evaluate. If lintel is present rebuild of brick above is needed at aprox. \$3000.

8. Poor finish

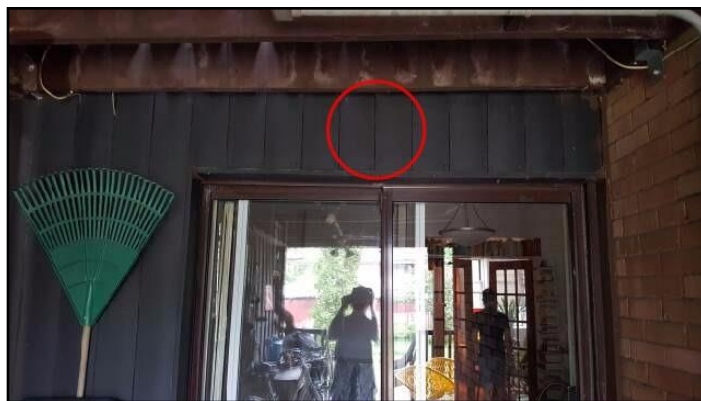
9. Missing lintel?

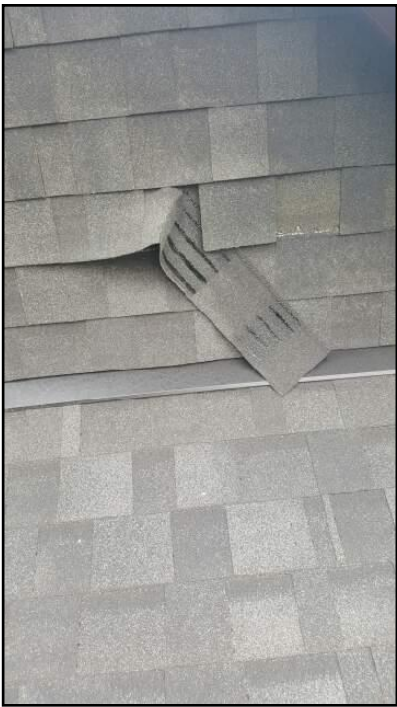
5. Condition: • [Loose, missing or torn tabs](#)

10. Loose, missing or torn tabs

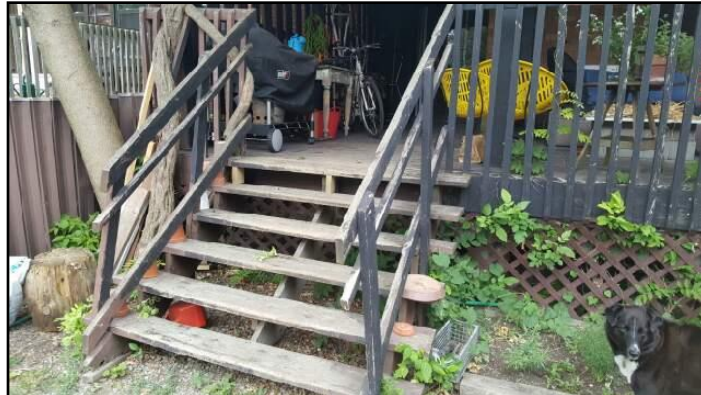
6. Condition: • Trip hazard  
Vine growth has damaged west stairs.

11. Trip hazard

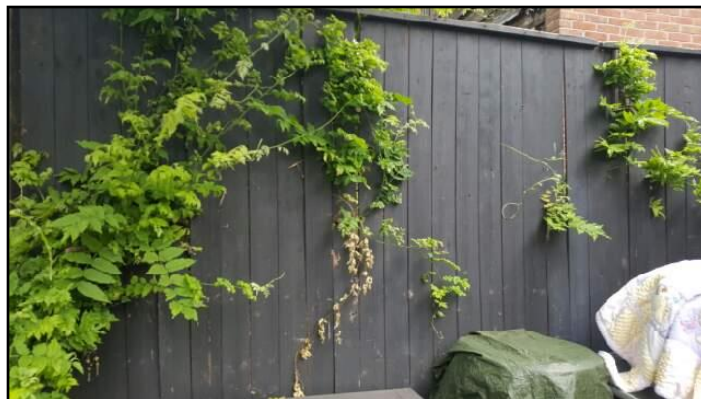
7. **Condition:** • [Loose](#)

12. Loose

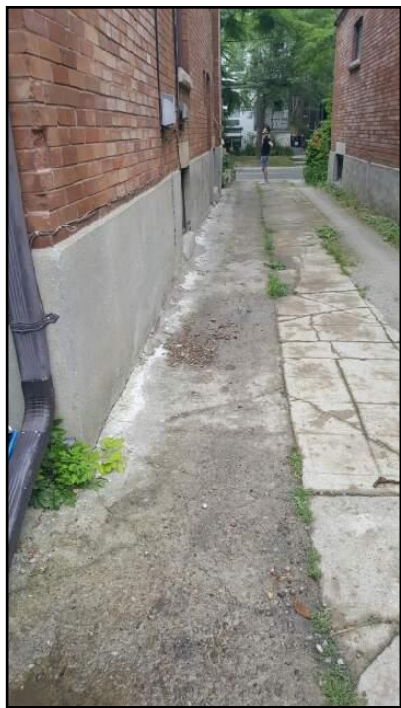
Driveway drains poorly, this side of building does not appear to have been waterproofed, consider excavation and waterproofing before replacing concrete.

8. **Condition:** • [Improper slope or drainage](#)

13. Improper slope or drainage

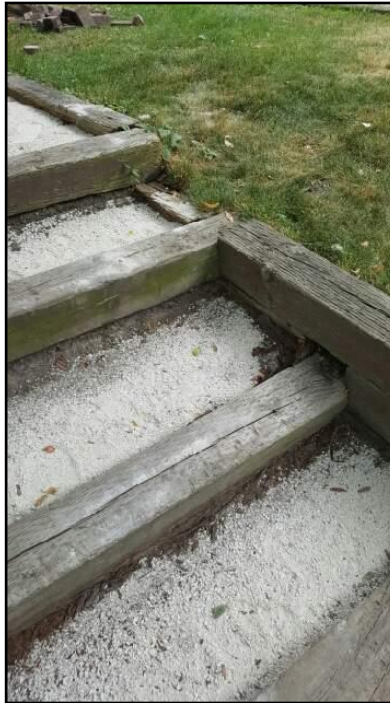
9. Condition: • [Rot or insect damage](#)

Retaining wall and step borders due for replacement. Recommend elimination of wood soil contact and use of masonry

14. *Rot or insect damage*

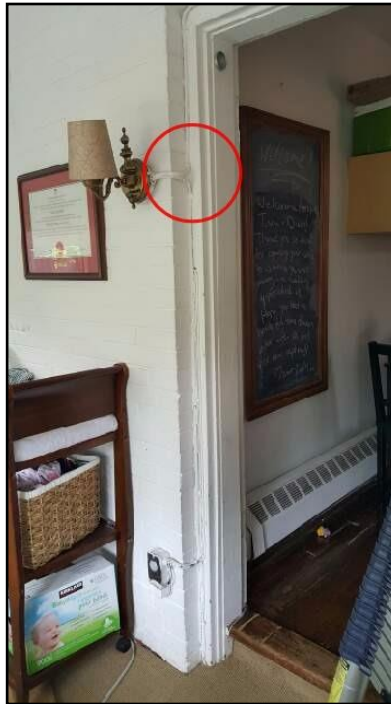
**11. Condition:** • [Exposed on walls or ceilings](#)

15. Exposed on walls or ceilings

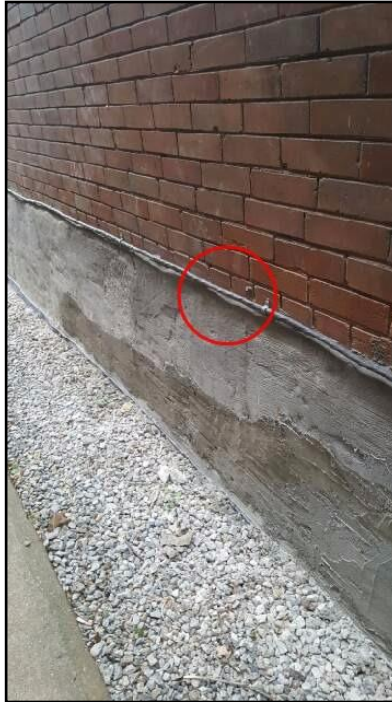
**12. Condition:** • Exterior wiring exposed to damage and contact by people.  
Cover exposed wiring with conduit.

16. Exterior wiring exposed to damage and...

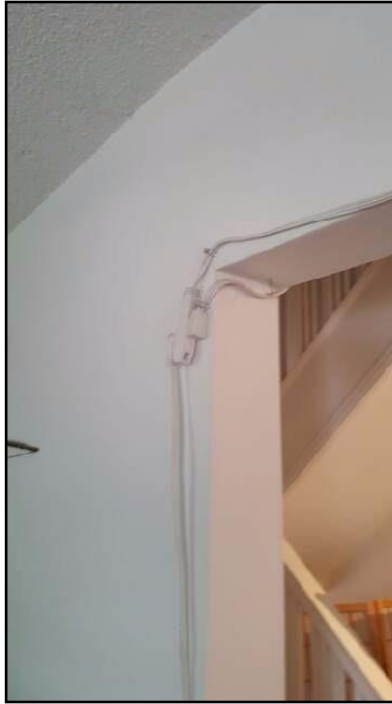
### 14. Condition: • [Too few outlets](#)

17. *Too few outlets*

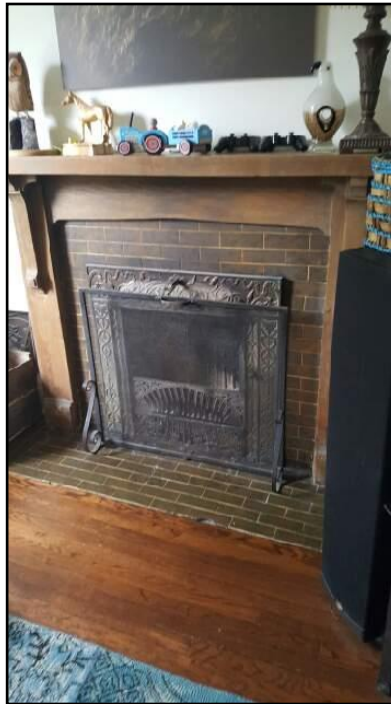
19. Coal-burning fireplace

- 15. Condition:** • [Designed for coal. Consult a specialist before using.](#)

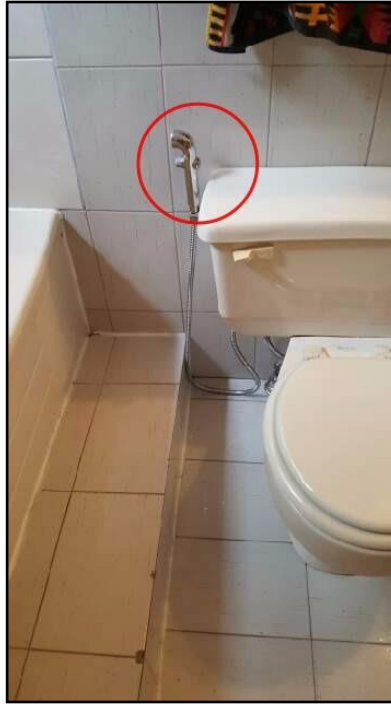
Leak from bidet handle is causing water damage at finishes in room below.

20. Leak

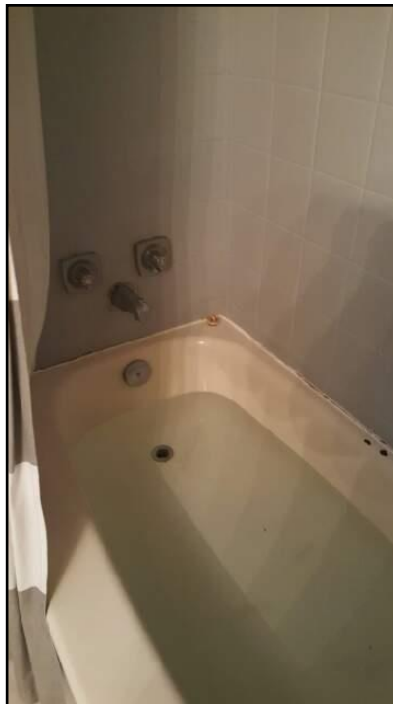
Tub surround leaking at basement bathroom. Consider renovation of entire bathroom due to previous leakage.

21. Leak

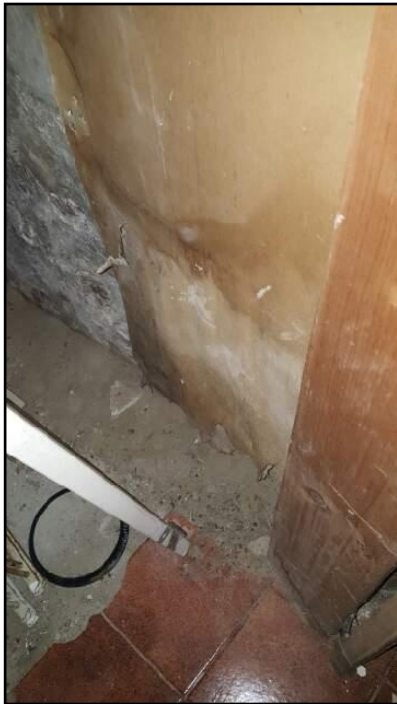
Indication of previous leakage throughout basement, waterproofing is evident at north side only. Recommend waterproofing of remaining portions of exterior and renovation of basement due to high probability of mould behind water damaged finishes.

22. Damaged

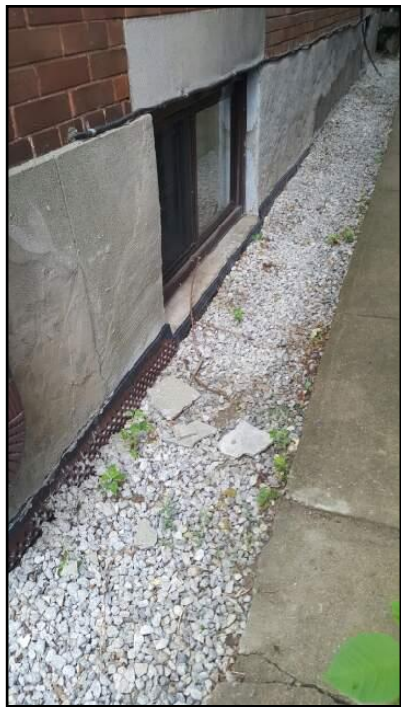
Exterior waterproofing visible at north exterior. It is possible that other areas have been done, consult vendor. Additional waterproofing recommended at \$200 per linear foot.

25. Recent exterior excavation
