Your Inspection Report

22 Lynd
Toronto, ON

Tuesday, November 1, 2016

RE: Report No. 1998
22 Lynd
Toronto, ON

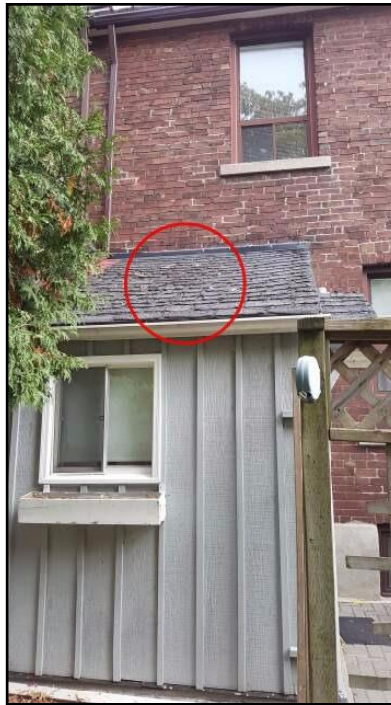
3. Old, worn out

1. **Condition:** • [Old, worn out](#)

Reshingle west mud room.

Implication(s): Chance of water damage to contents, finishes and/or structure

Location: West entrance

Task: Replace

Time: Immediate

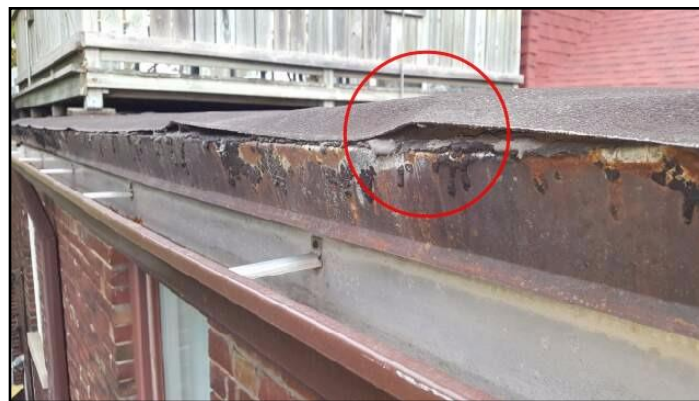
4. Openings at seams or flashings

2. Condition: • [Openings at seams or flashings](#)

Implication(s): Chance of water damage to contents, finishes and/or structure

Location: Flat roof

Reseal flat roof at drip edge with roofing cement. Reinspect annually.

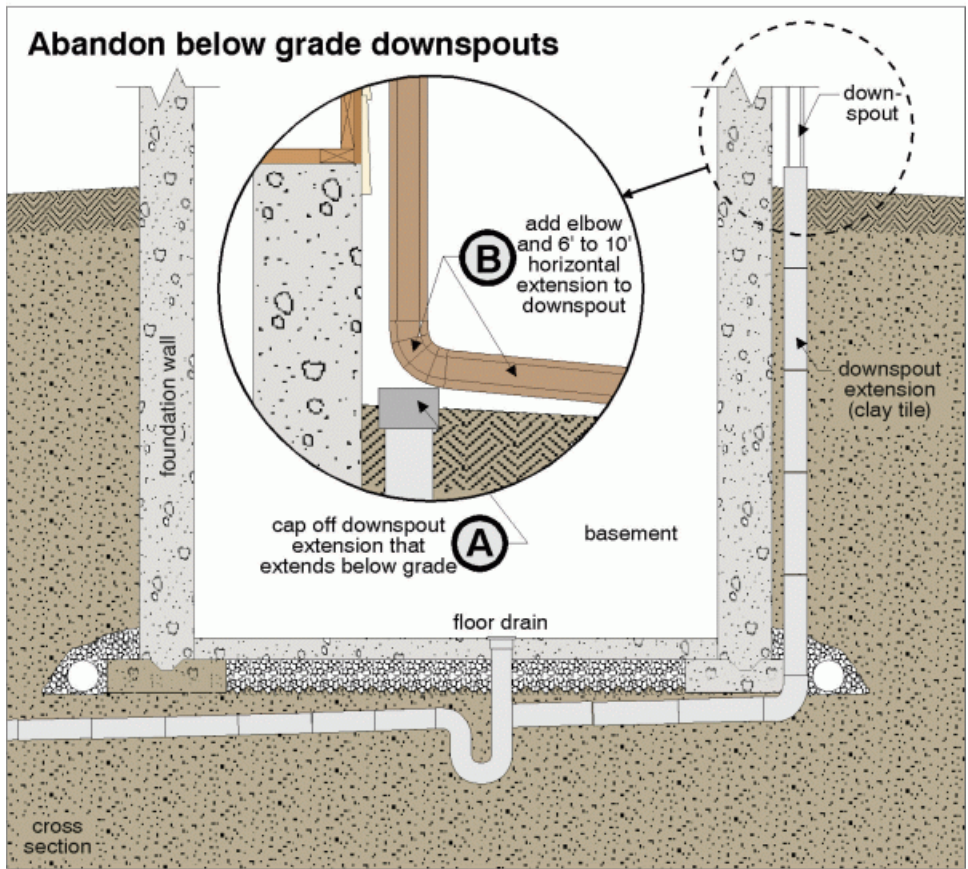
4. Condition: • [Downspouts discharging below grade](#)

Implication(s): Chance of water damage to contents, finishes and/or structure

Location: S/E exterior

Task: Improve

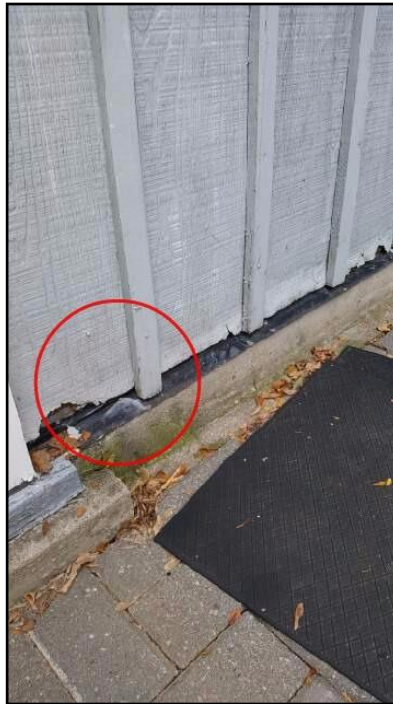
5. Rot

5. Condition: • Rot

Damage is cosmetic at present.

Implication(s): Chance of water damage to contents, finishes and/or structure | Material deterioration

Location: Exterior Wall

Task: Replace

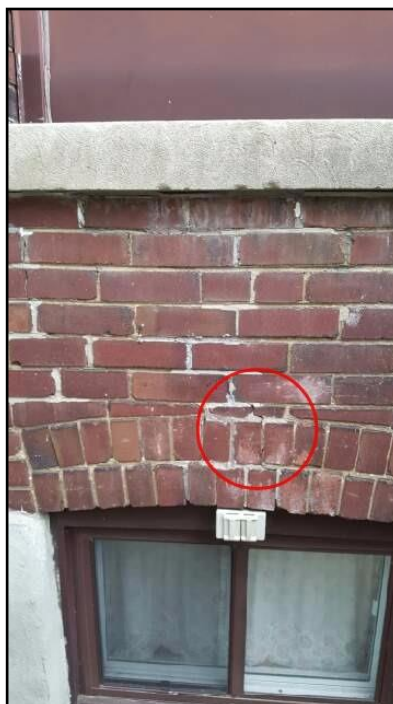
6. Condition: • Typical minor cracks are not structurally significant. Some tuckpointing needed, not urgent.

Location: Various Exterior Wall

Task: Repair

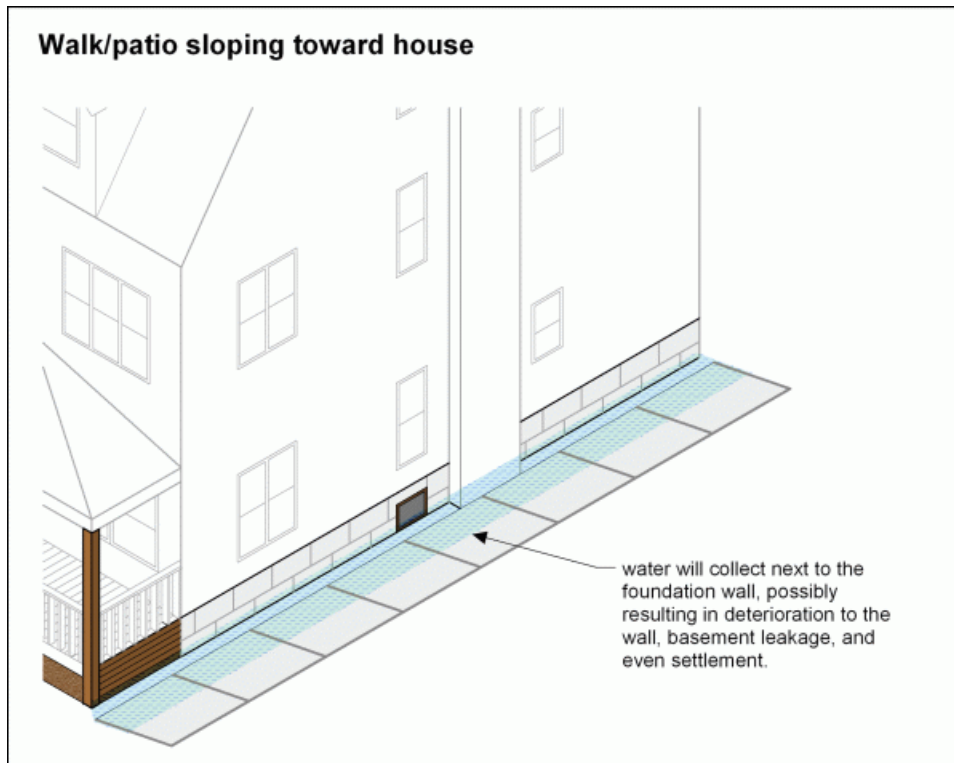
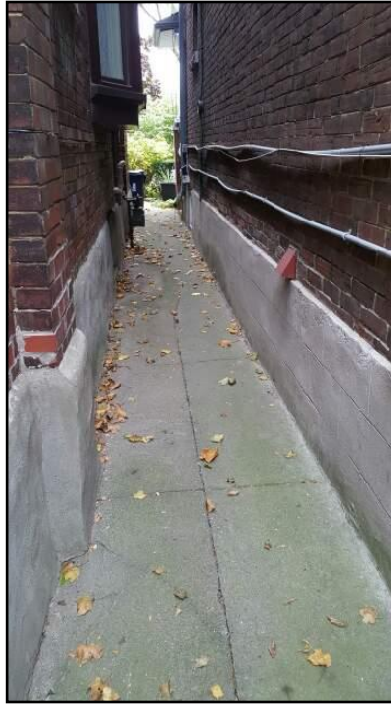
7. Improper slope or drainage

7. Condition: • [Improper slope or drainage](#)

Implication(s): Chance of water damage to contents, finishes and/or structure

Location: South Exterior

Reslope walkway and seal joint at wall.

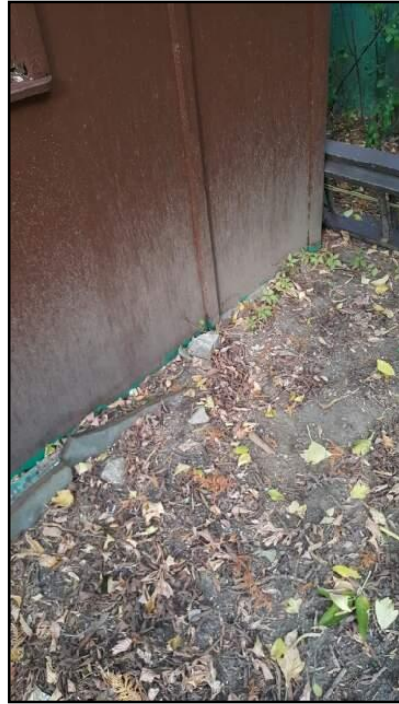
8. Condition: • Eliminate wood soil contact.

Location: Throughout Garage

9. *Eliminate wood soil contact.*

Ideally garage floor would be replaced and wood frame wall lifted onto concrete base.

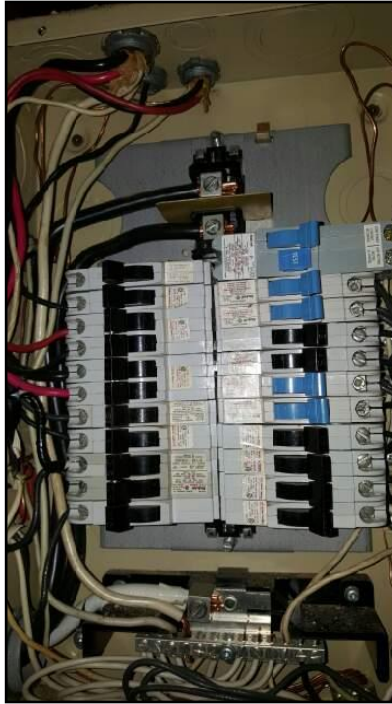
10. Breakers too big

11. Condition: • [Fuses or breakers too big](#)
Some double taps and oversized breakers at panel.

Implication(s): Fire hazard | Equipment overheating

Location: Basement Panel

Task: Improve

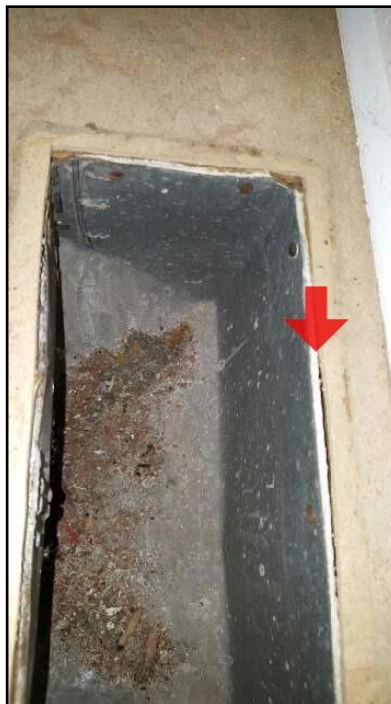
12. Asbestos

12. Condition: • Some asbestos insulation present on ducting. Remove or encapsulate if necessary to disturb. Typical for this era of construction.

Location: Throughout

Task: Remove

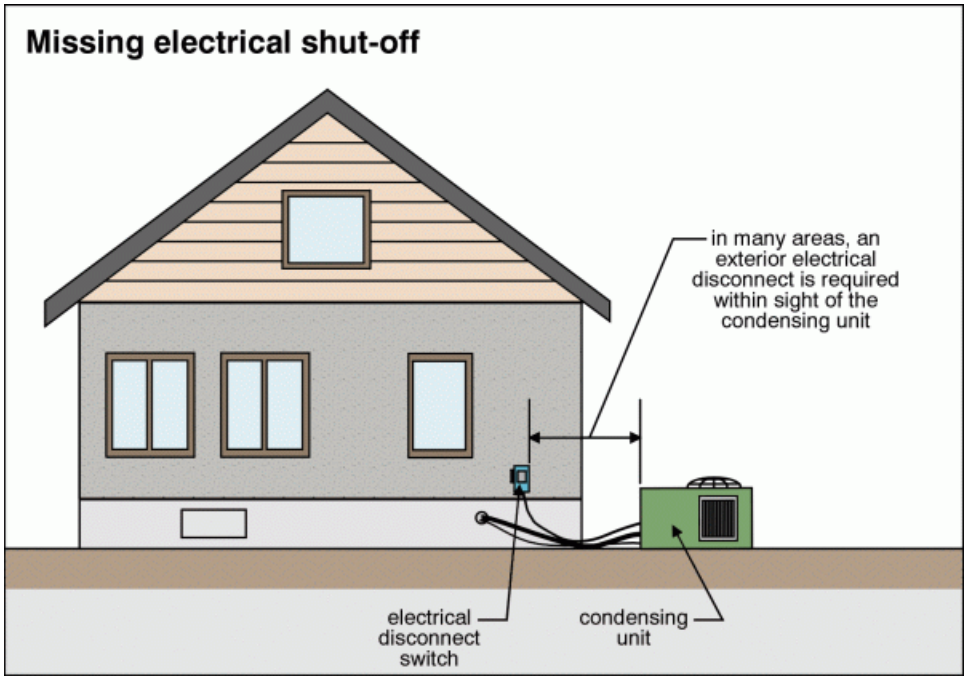
15. Condition: • [Missing electrical shutoff](#)
Implication(s): Difficult to service
Location: Exterior Wall
Task: Provide
Time: When replacing a/c

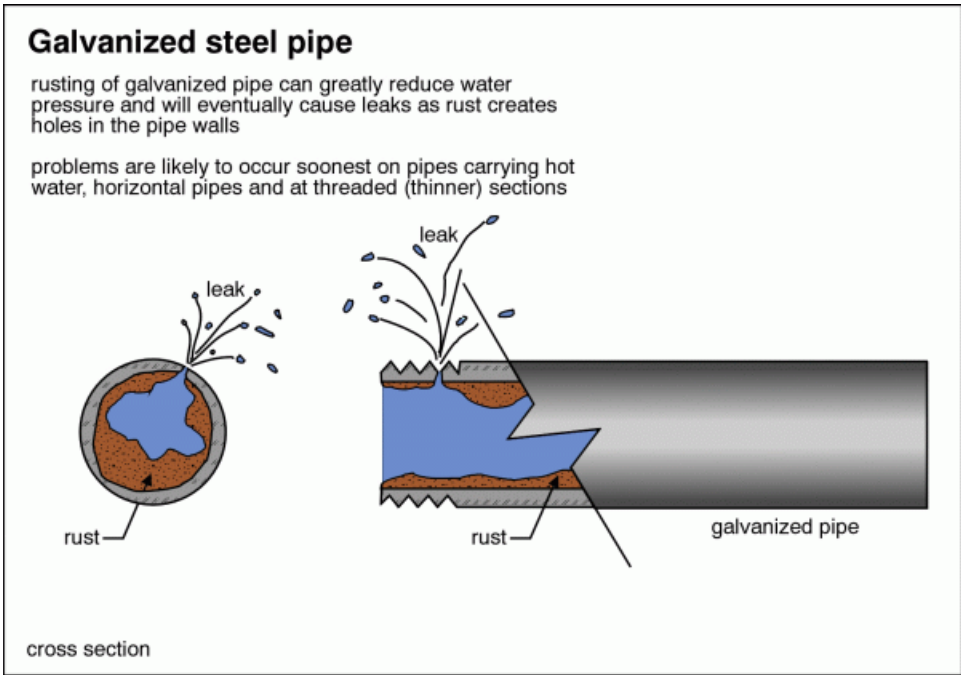
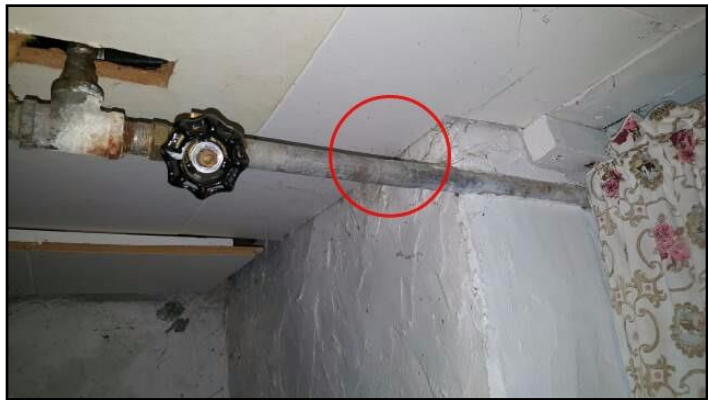
14. Galvanized steel

18. Condition: • [Galvanized steel](#)

Implication(s): Reduced water pressure and volume

Location: Basement

Replace short sections of galvanized steel serving exterior faucets.

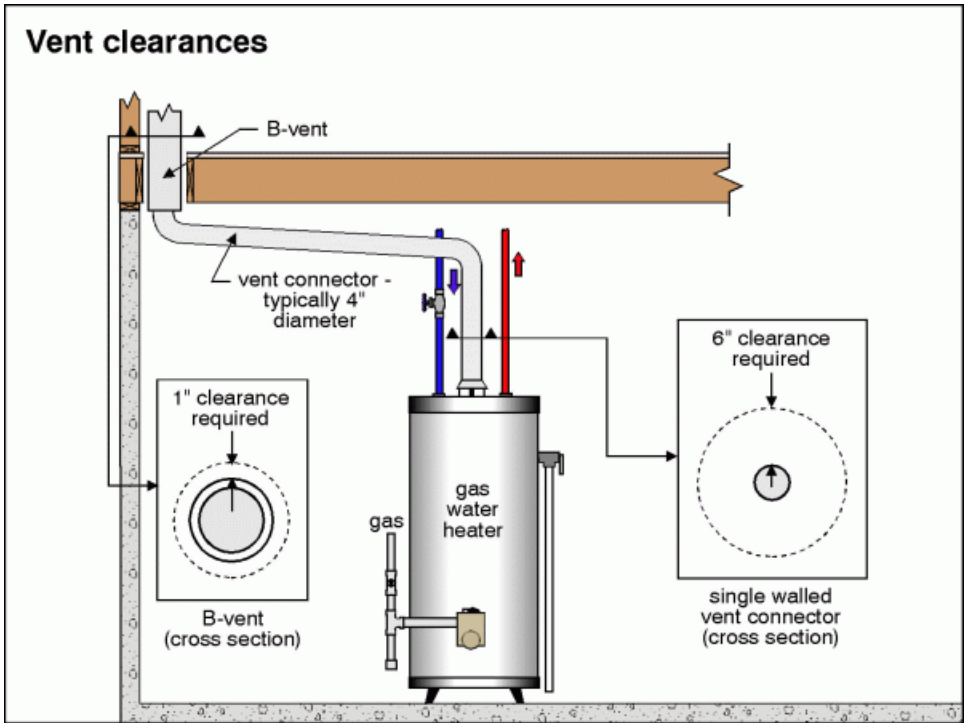
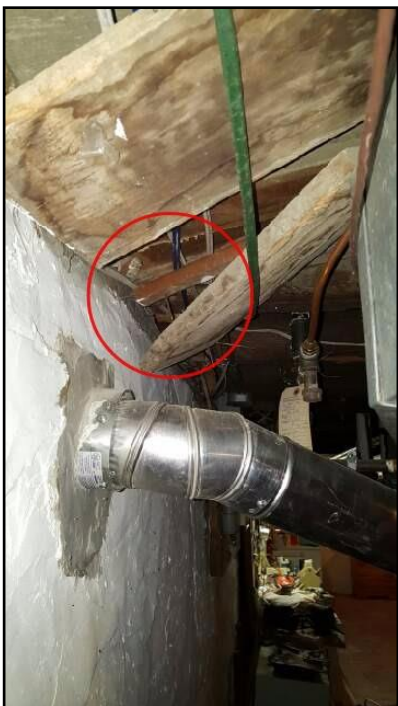
15. Combustible clearance

19. Condition: • [Combustible clearance](#)

Implication(s): Fire hazard

Location: Southeast Basement

Remove loose boards above water heater flue, and protect wiring with fiberglass insulation.

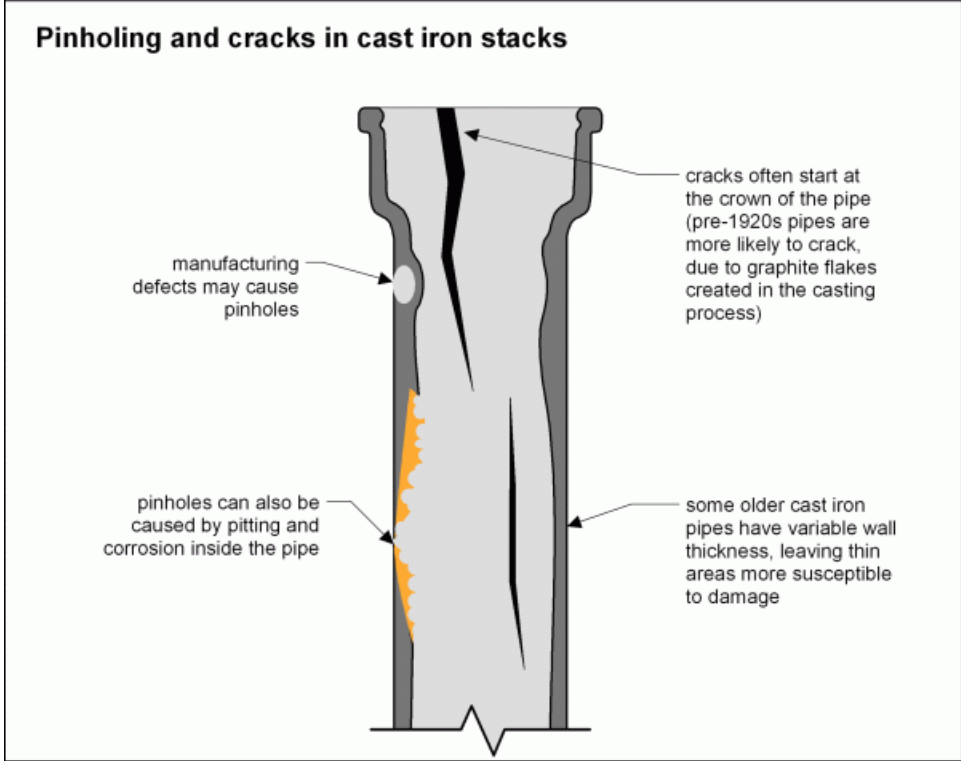
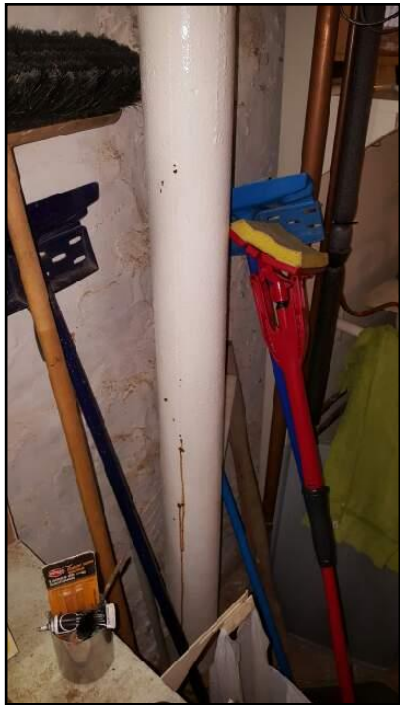
16. Rust

20. Condition: • [Rust](#)

Original cast iron waste piping remaining in use, replace if/when renovating. No leaks at time of inspection.

Implication(s): Sewage entering the building

Location: Throughout
Task: Replace
Time: When renovating
