# Your Inspection Report

132 Indian Road  
Toronto, ON

Wednesday, April 19, 2017

RE: Report No. 2149  
132 Indian Road  
Toronto, ON

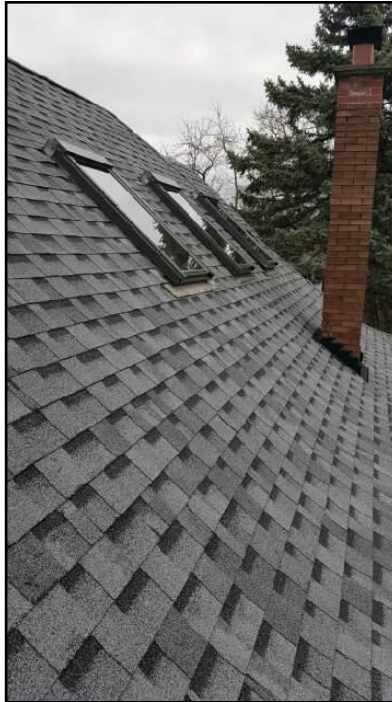
1. *Asphalt shingles*

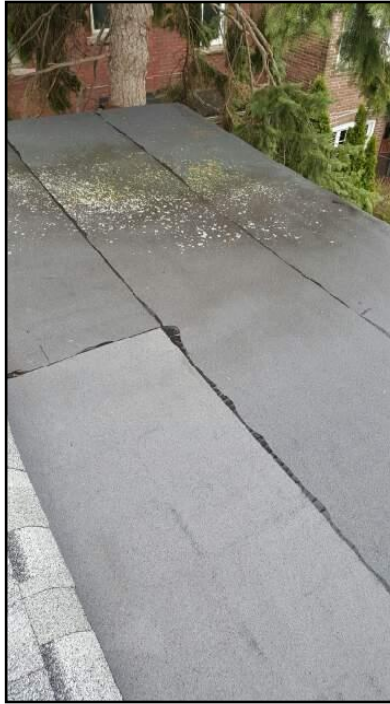
2. Modified bitumen

1. **Condition:** • No roofing recommendations are offered as a result of this inspection. Newer roof surfaces throughout, all in good condition.

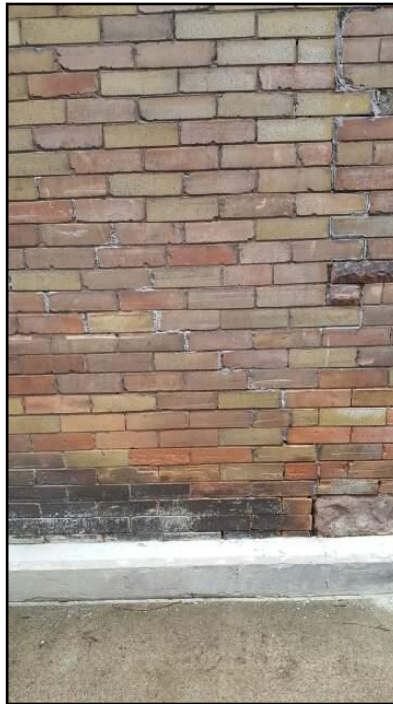
**3. Condition:** • Typical minor cracks, not structurally significant.

3. Cracked

Typical tuckpointing needed, not urgent.

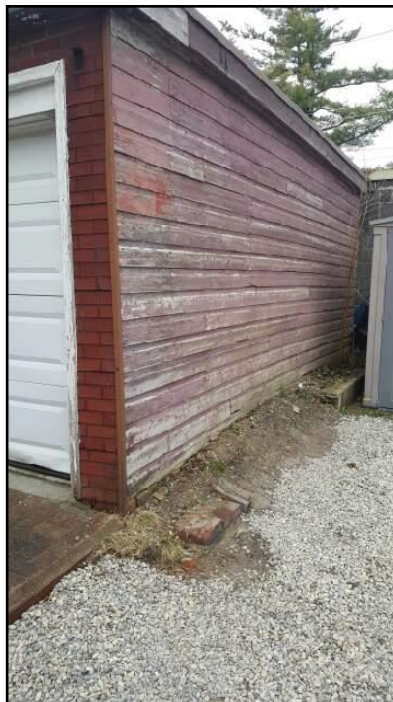
Implication(s): Chance of water entering building | Chance of structural movement | Chance of pests entering building | Physical injury

4. Typical low quality structure

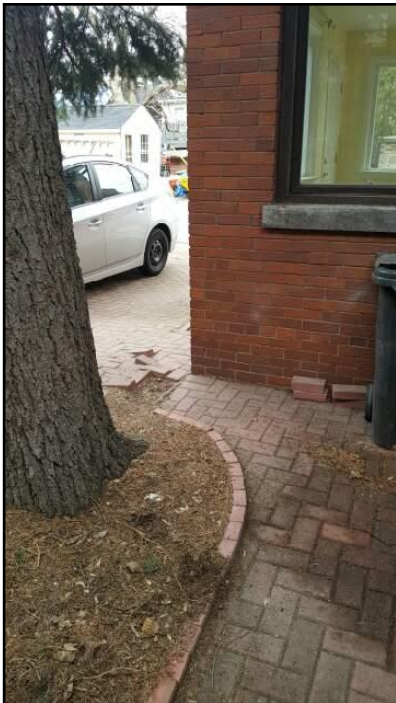
Large tree at s/w of property is creating movement of west structure, while not urgent, tree will likely need to be removed. Masonry repairs would be minor in cost. Contact arborist re cost of tree removal.

**Implication(s):** Weakened structure

5. Tree too close

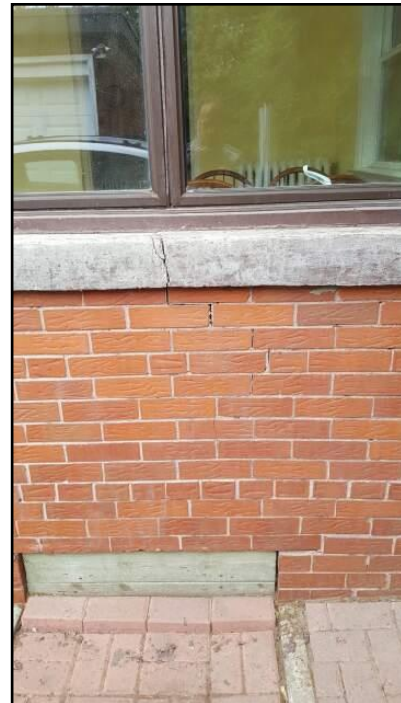
6. Cracked structure

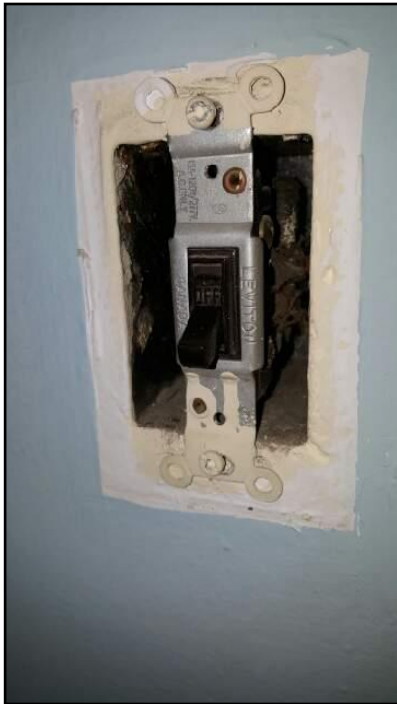
Knob and tube visible at dining room and switches at base of stairs only. Disconnect to determine if more is present.

**Implication(s):** Nuisance | Potential problem when obtaining home insurance

7. Outdated

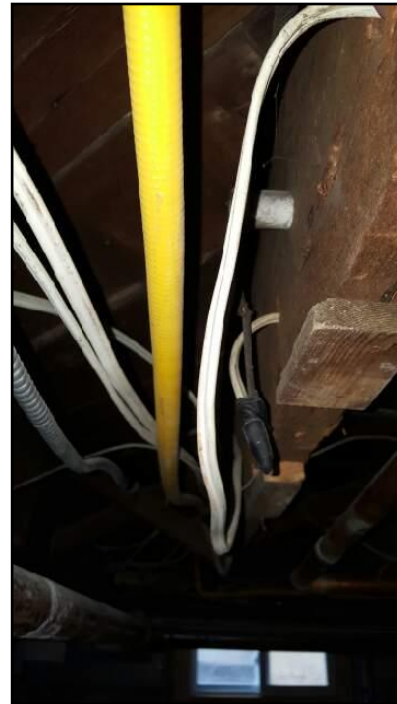
8. Outdated

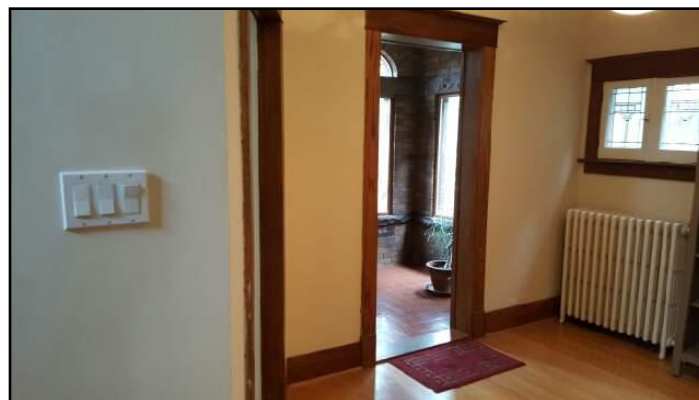
**7. Condition:** • Poor location of switches.  
Relocate entrance switches closer to front door.

9. Poor location of switches.

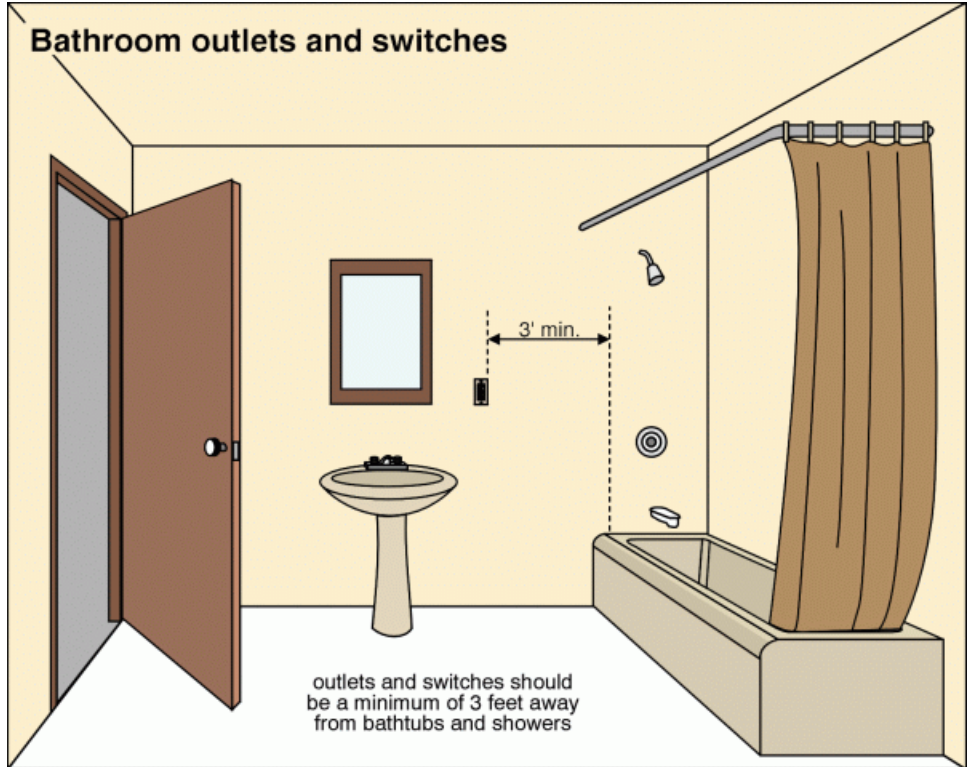
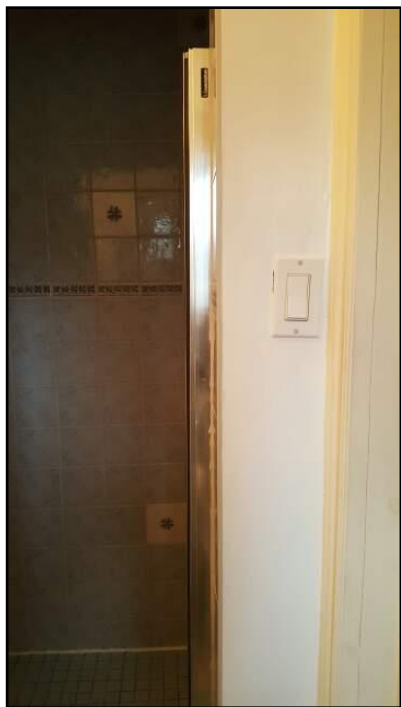
**Implication(s):** Electric shock

10. Location poor (near Bath Tub or Shower Stall)

Move electrical further from shower stall.

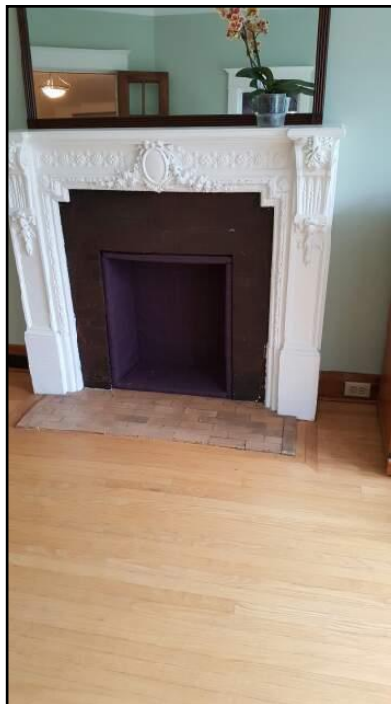
Chimney in good condition if restoration or conversion to gas/wood desired.

11. Coal-burning fireplace - not in service

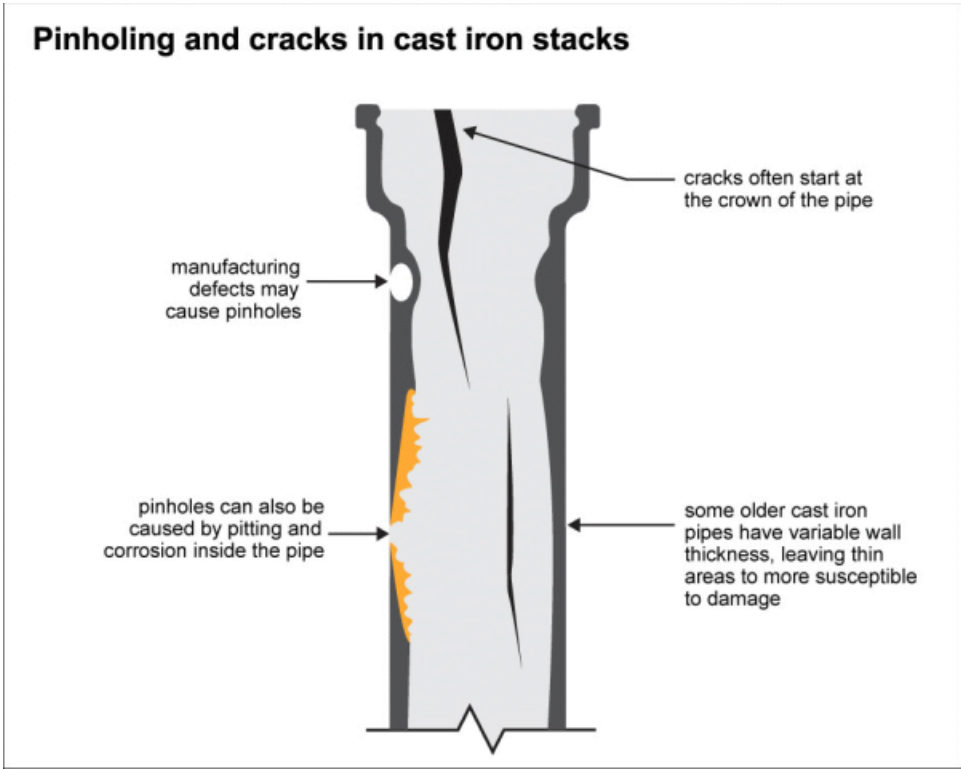
**12. Condition:** • [Rust](#)

**Implication(s):** Sewage entering the building

Replace original cast iron waste piping if renovating.

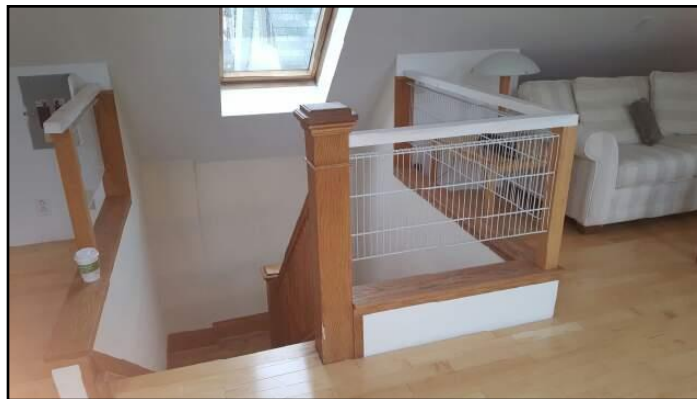
12.

14. **Condition:** • Railing not child safe.
