# Your Inspection Report

1306 Winding Trail  
Mississauga, ON

Tuesday, June 13, 2017

RE: Report No. 2224  
1306 Winding Trail  
Mississauga, ON

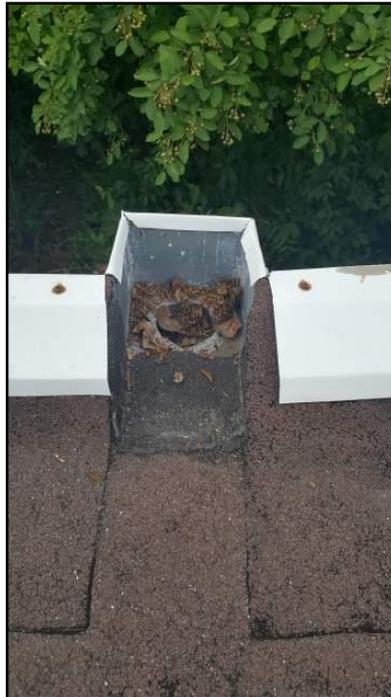
**1. Condition:** • Vulnerable areas.

**Location:** Garage roof

**3. Vulnerable areas.**

Remove loose nail, seal opening, and clear downspout.

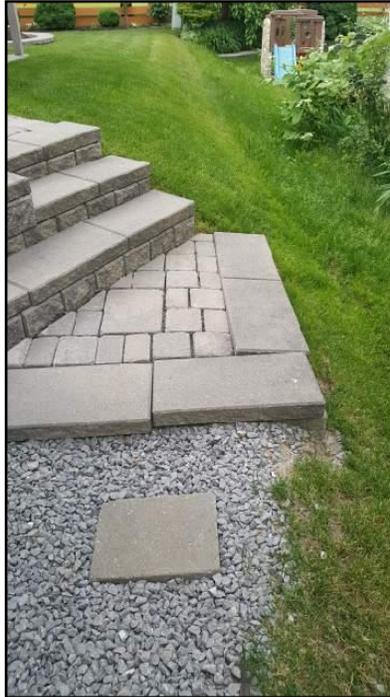
**PORCHES, DECKS, STEPS, PATIOS AND BALCONIES \ Patios**  
**2. Condition:** • [Trip hazards](#)  
Lift and relay bricks at east patio step to eliminate trip hazard.  
**Implication(s):** Physical injury  
**Location:** East Exterior  
**Task:** Improve  
**Time:** Immediate  
**Cost:** Minor

4. Trip hazards

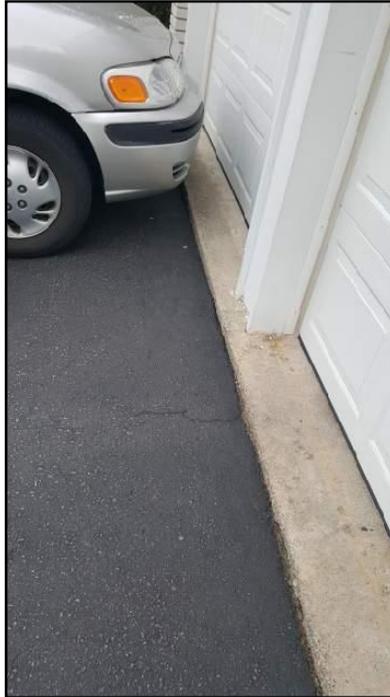
**3. Condition:** • [Unsealed gap at building](#)

**Implication(s):** Chance of water damage to contents, finishes and/or structure

5. Unsealed gap at building

Fill void at joint between driveway and garage.

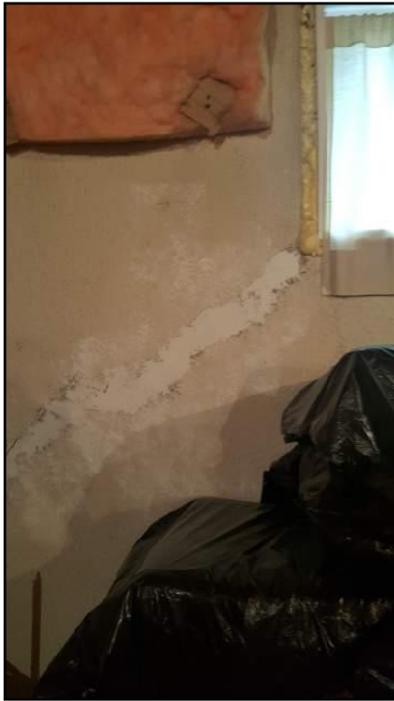
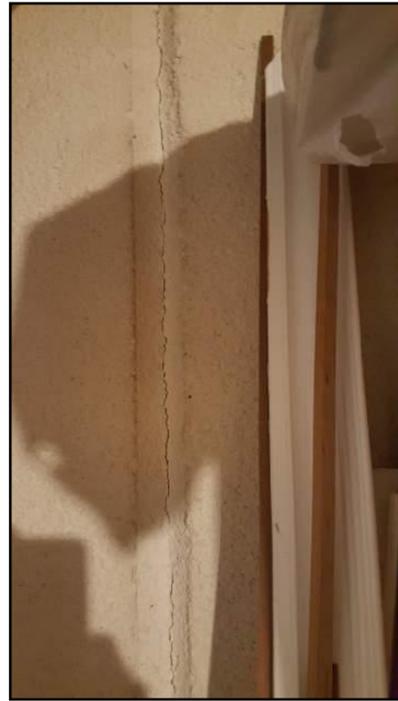
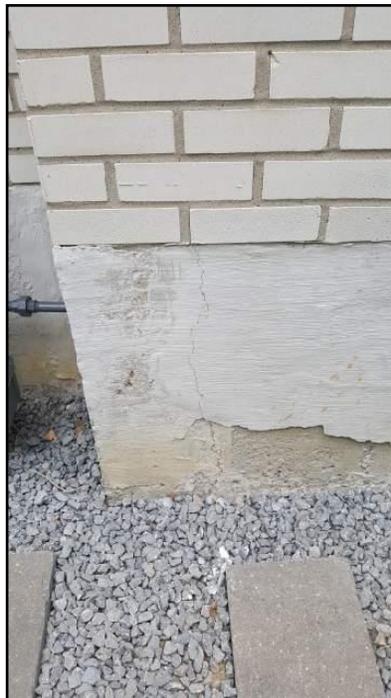
**6. Condition:** • Typical minor cracks

Typical hairline cracks are not structurally significant, but indicate areas of foundation most vulnerable to water entry. These cracks can be epoxy repaired at aprox. \$500 each if leakage develops. No evidence of leakage at time of inspection.

**Implication(s):** Chance of water entering building

6. Typical minor cracks

7. Typical minor cracks

8. Typical minor cracks

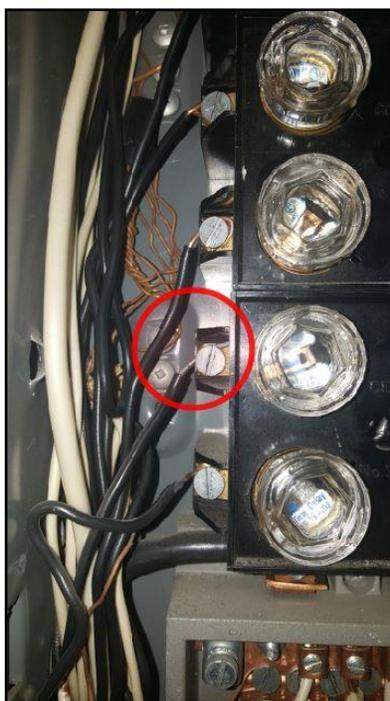
**7. Condition:** • At least one circuit of aluminum wiring present, could not determine if anti oxidant or appropriate connectors are present on load end.

9. Aluminum

**Task:** Further evaluation

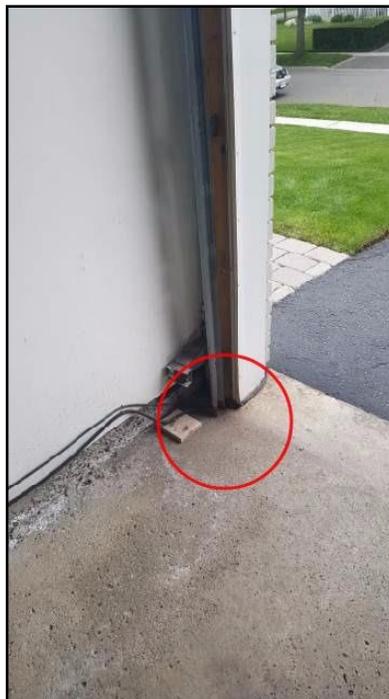
#### **8. Condition:** • [Extension cords for exterior outlets](#)

**Implication(s):** Electric shock | Fire hazard

10. Extension cords for exterior outlets

Replace unprotected wiring at garage/exterior.

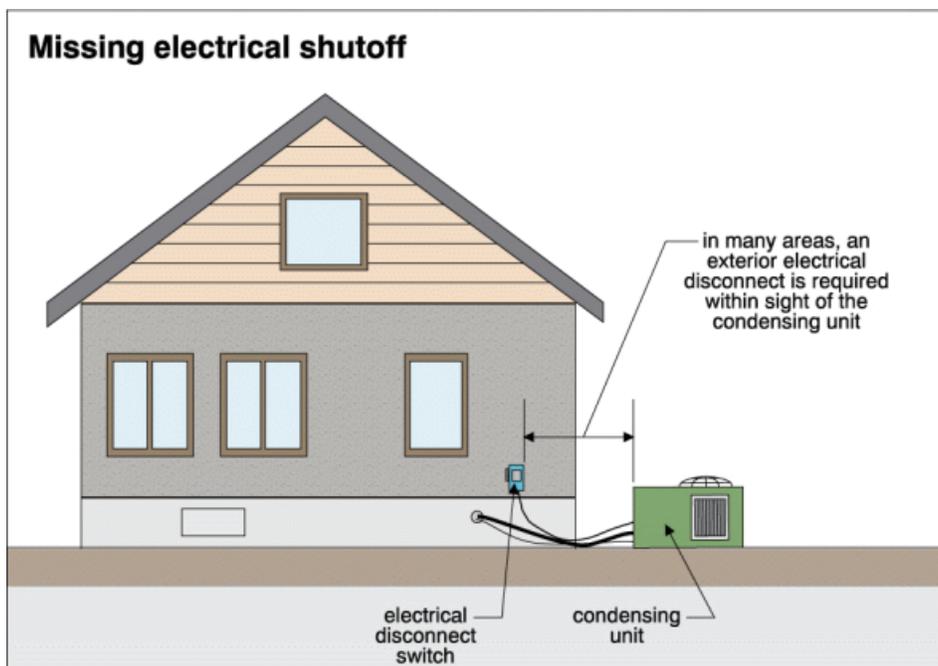
11. Condition: • [Missing electrical shutoff](#)

Implication(s): Difficult to service

Task: Provide
