# Your Inspection Report

491 Salem Avenue North  
Toronto, ON

RE: Report No. 2216, v.2  
491 Salem Avenue North  
Toronto, ON

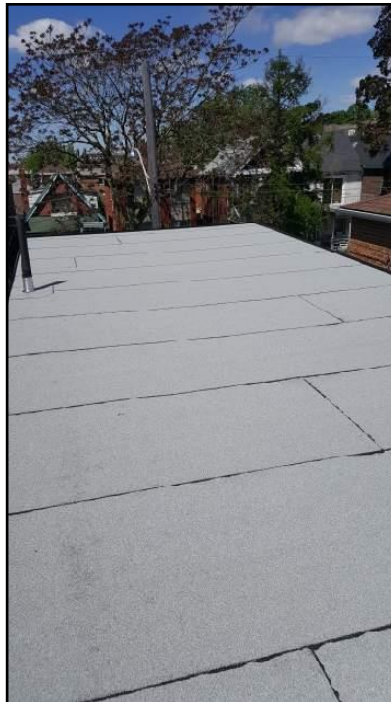
1. Modified bitumen

Probability of leakage: • Low

1. **Condition:** • No roofing recommendations are offered as a result of this inspection.  
Roof in excellent condition.

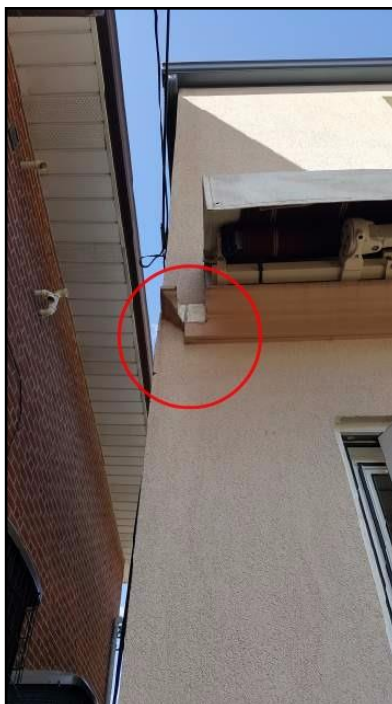
**2. Condition:** • Voids in EIFS.

Some patching/caulking needed at window and wall trim.

**Location:** Various Exterior Wall

2. Voids in EIFS.

**Task:** Repair

**Time:** Immediate
