# Your Inspection Report

10 Lascelles Boulevard  
Toronto, ON M4V 2X4

Wednesday, September 13, 2017

RE: Report No. 2296  
10 Lascelles Boulevard  
Toronto, ON  
M4V 2X4

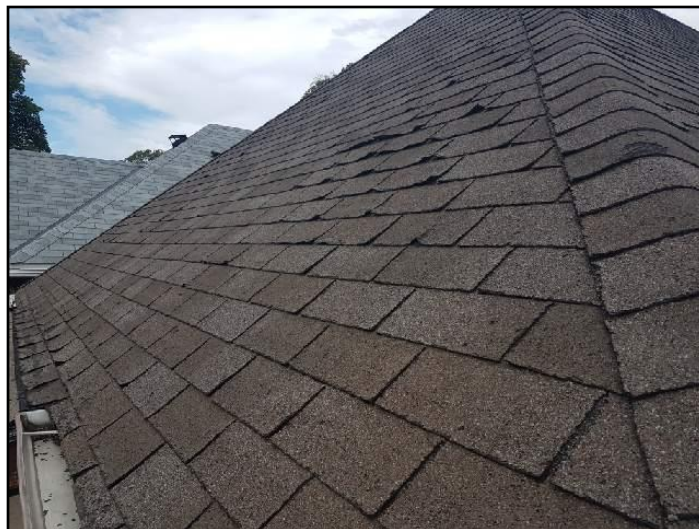
Shingles due for replacement.

**Implication(s):** Chance of water damage to contents, finishes and/or structure

4. *Near end of life expectancy*

**Task:** Replace

**Time:** 1-2 years max.

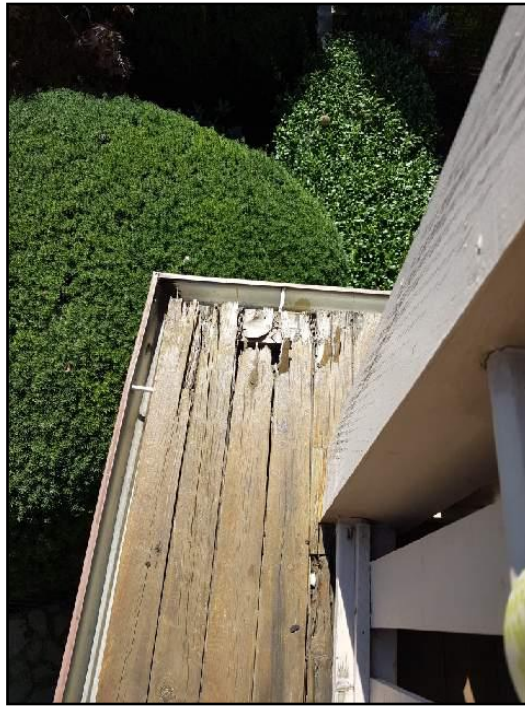
**3. Condition:** • [Rot](#)

**Implication(s):** Weakened structure | Chance of movement | Material deterioration

5. Rot

Inspect condition of flat roofing when boards are removed.

**Task:** Replace

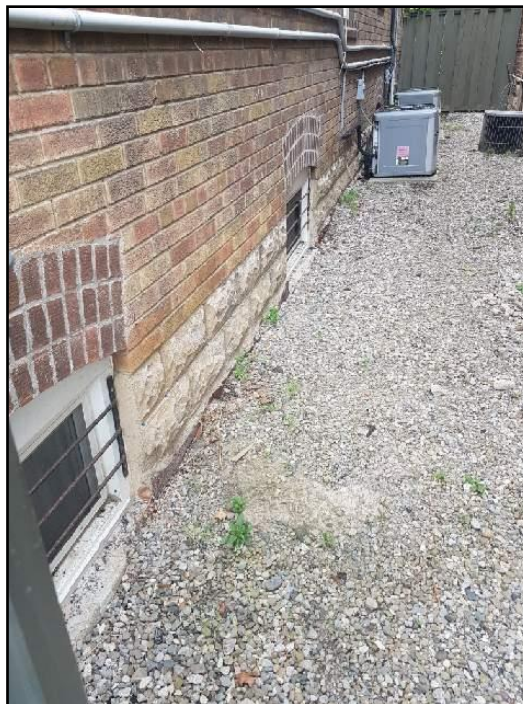
Excavation for waterproofing has left slope towards foundation and window wells are required.

**Implication(s):** Chance of water damage to contents, finishes and/or structure

6. Improper slope or drainage

**Task:** Improve

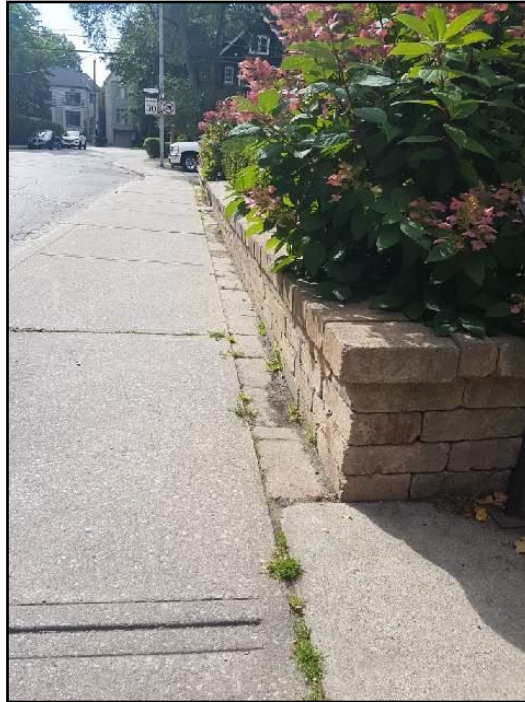
5. Condition: • [Leaning](#)

Some sections of retaining wall will require eventual rebuild.

**Implication(s):** Weakened structure | Chance of movement

7. Leaning

**Task:** Repair

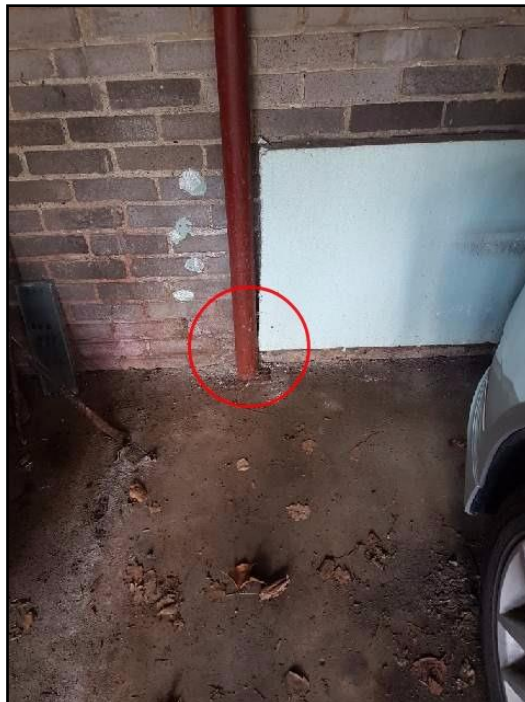
6. Condition: • Garage columns lack footings but are sound, no action recommended.

8. No footing

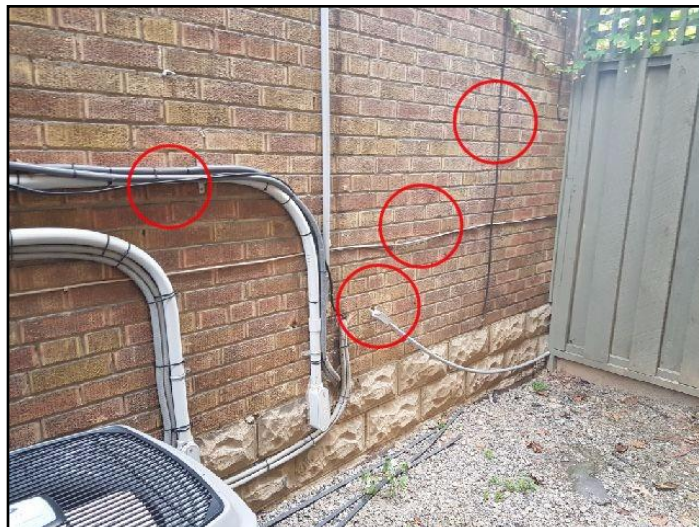
**9. Condition:** • Exterior wiring exposed to damage and contact by people.

**9. Exterior wiring exposed to damage and...**

Protect exposed wiring with conduit.

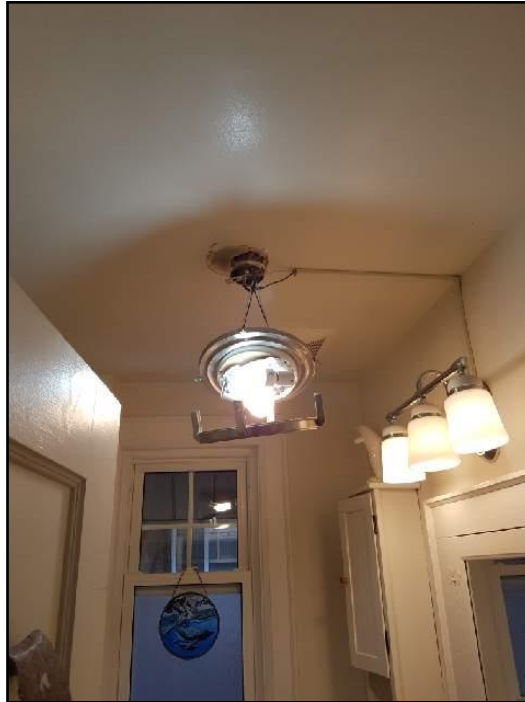
### 11. Condition: • Exposed wires.

10. Exposed wires.

**Task:** Repair

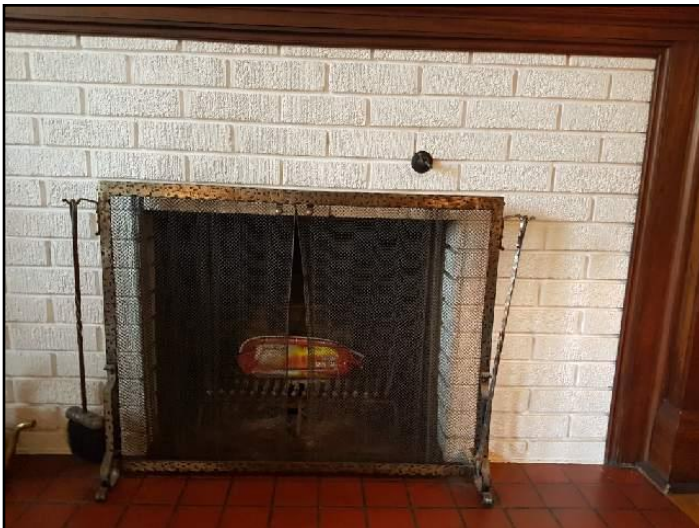
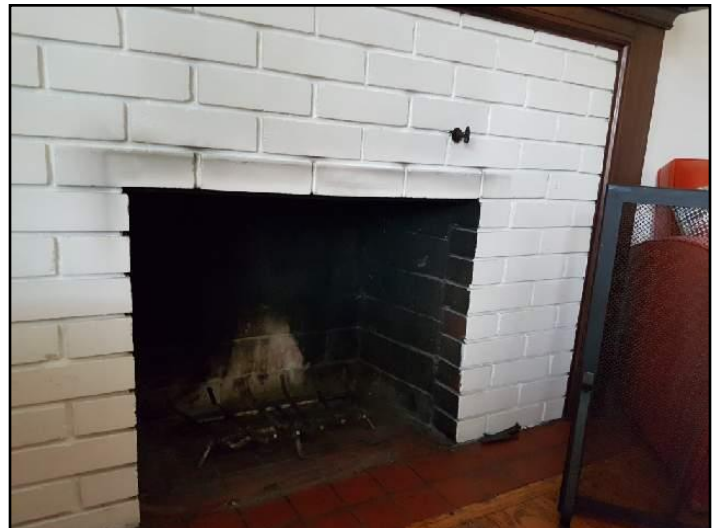
11. Wood-burning fireplace

12. Wood-burning fireplace

**14. Condition:** • Both fireplaces are operable and have separate flues, but lack flue liners and hearth depth is too shallow by today's standards. Insurance company will likely request upgrades.

**Task:** Improve

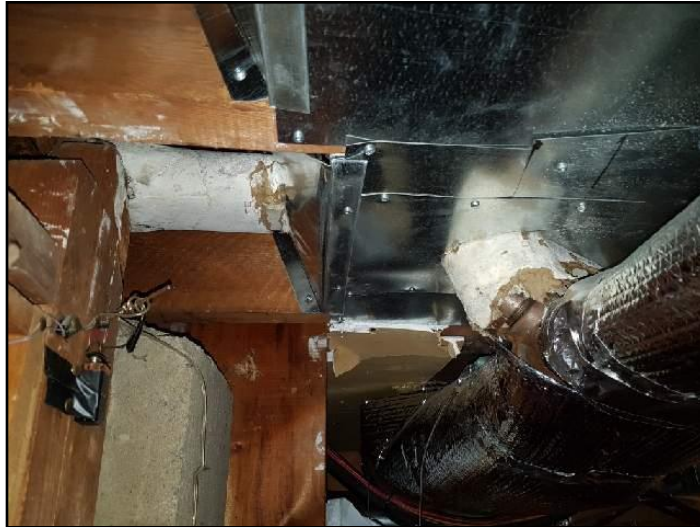
**13. Condition:** • Some asbestos pipe insulation present within ceiling, have professionally removed if necessary to disturb.

13. Some asbestos pipe insulation present withi...

**Task:** Remove

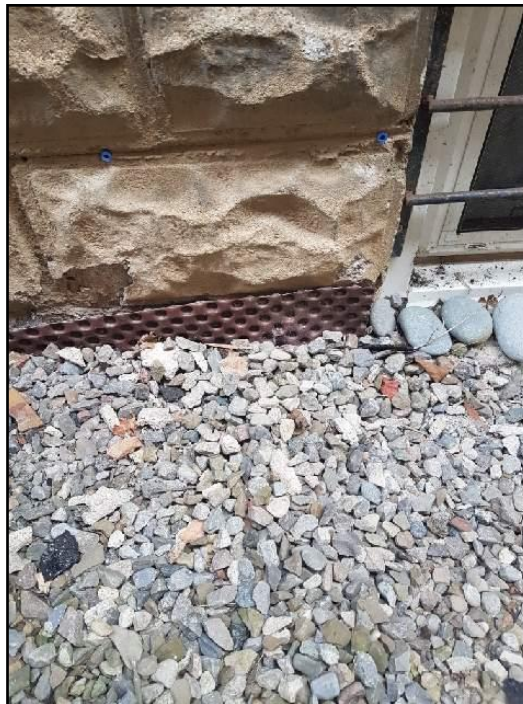
Very low potential for basement leakage at west wall, due to presence of exterior drainage membrane.

14. Drainage membrane
