Your Inspection Report

27 Grafton Avenue
Toronto, ON M6R 1C3

Monday, September 11, 2017

RE: Report No. 2292
27 Grafton Avenue
Toronto, ON
M6R 1C3

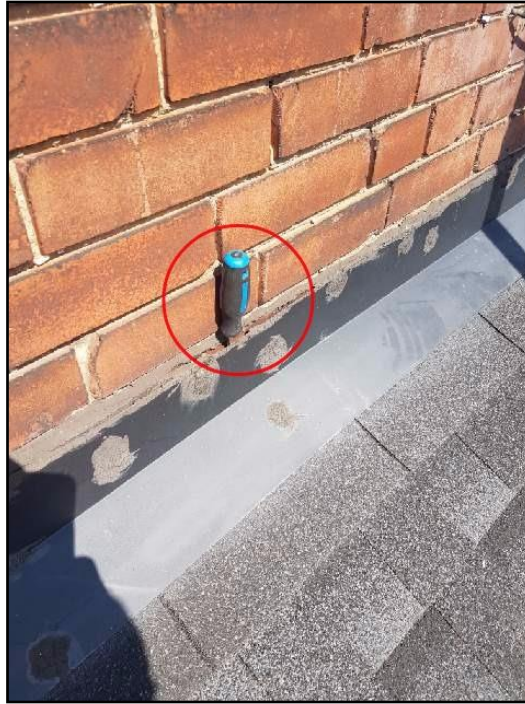
3. Loose flashing

2. **Condition:** • Loose

Reseal roof/wall flashing at south addition.

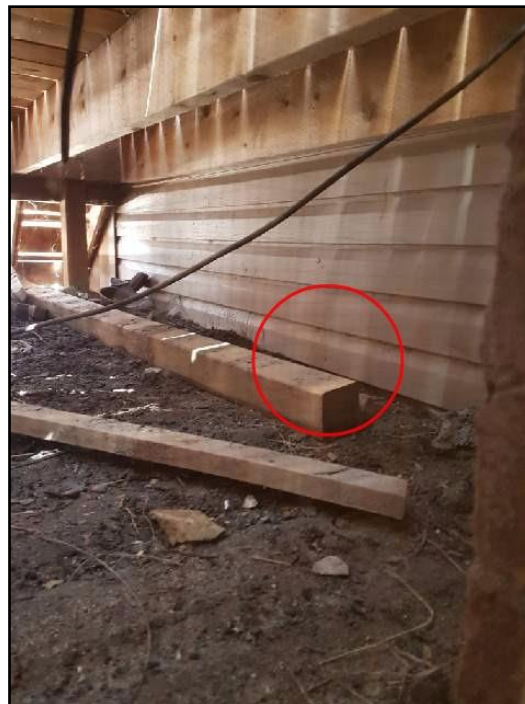
4. Too close to grade

4. Condition: • [Too close to grade](#)

Ideally siding and wood structure would terminate above grade, to prevent moisture from contacting wood wall behind siding.

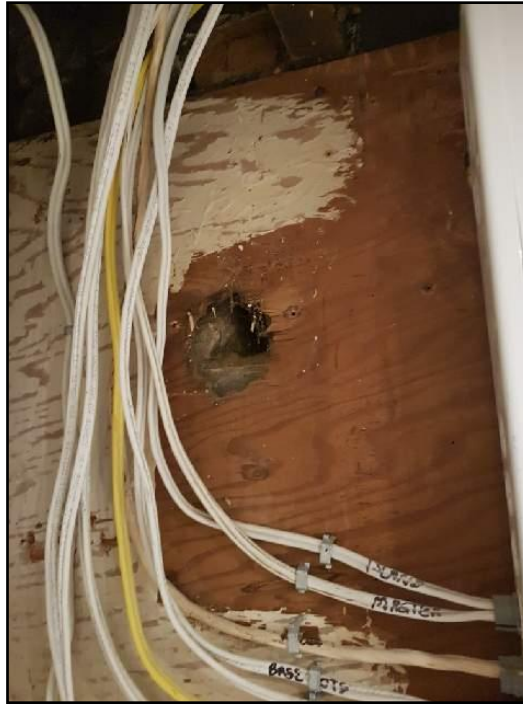
5. Seal utility entrance at wall.

5. Condition: • Seal utility entrance at wall.

Seal wall against pest entry and heat loss.

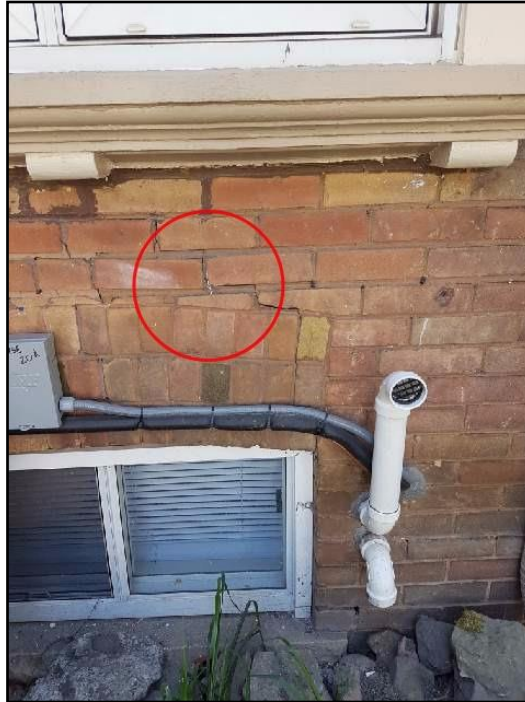
6. Cracked

6. Condition: • [Cracked](#)

Typical minor cracks, not structurally significant, include with tuckpointing.

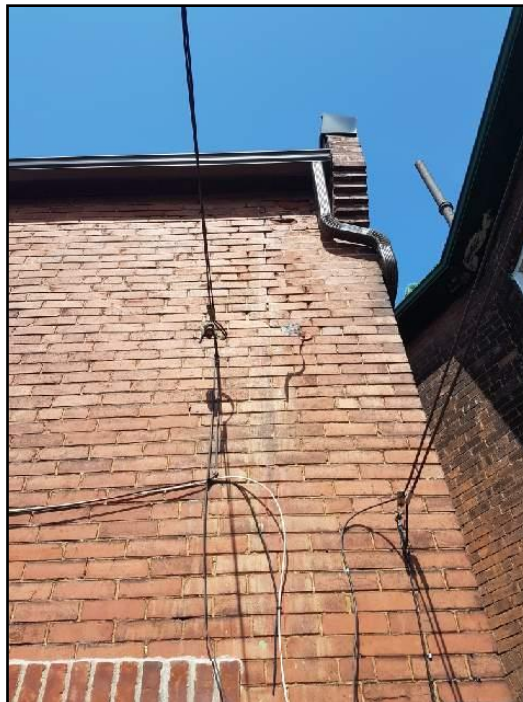
7. Mortar deterioration

7. Condition: • [Mortar deterioration](#)

Typical tuckpointing needed.

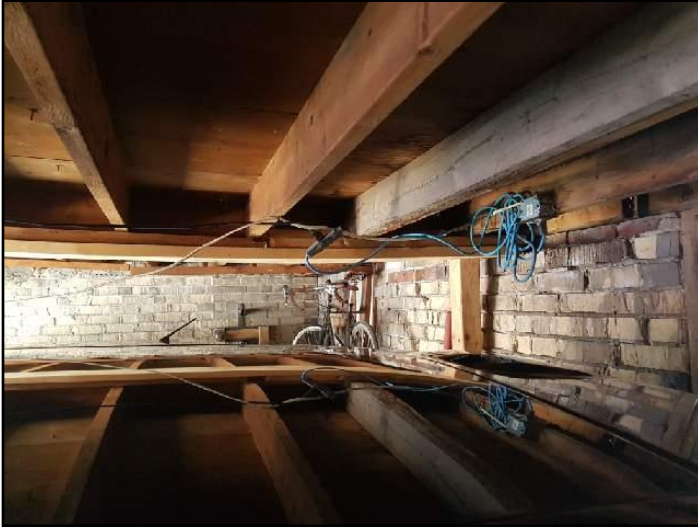
8. Disrepair

8. Condition: • Disrepair

Garage masonry and roof support structure in very poor condition.

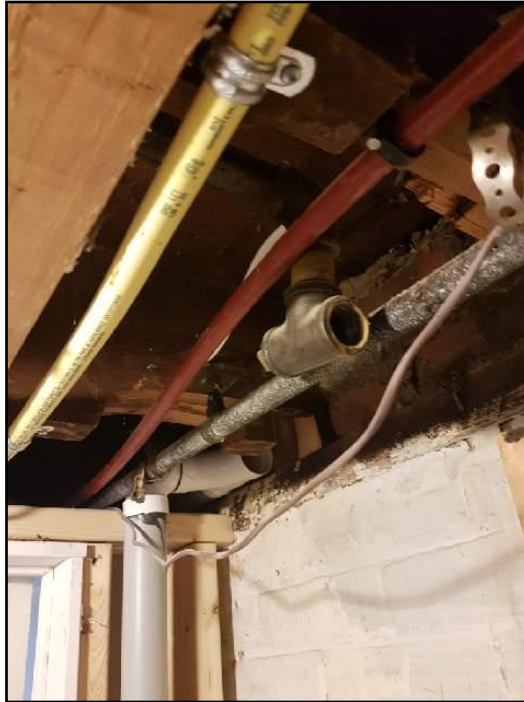
10. Notches or holes

9. Condition: • [Notches or holes](#)

Implication(s): Weakened structure

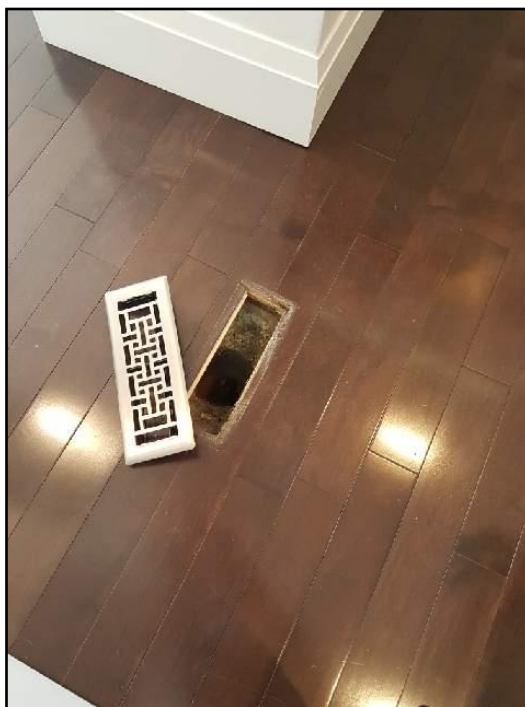
11. *Disconnected ducts*

11. Condition: • [Disconnected ducts](#)

Implication(s): Increased heating costs | Reduced comfort

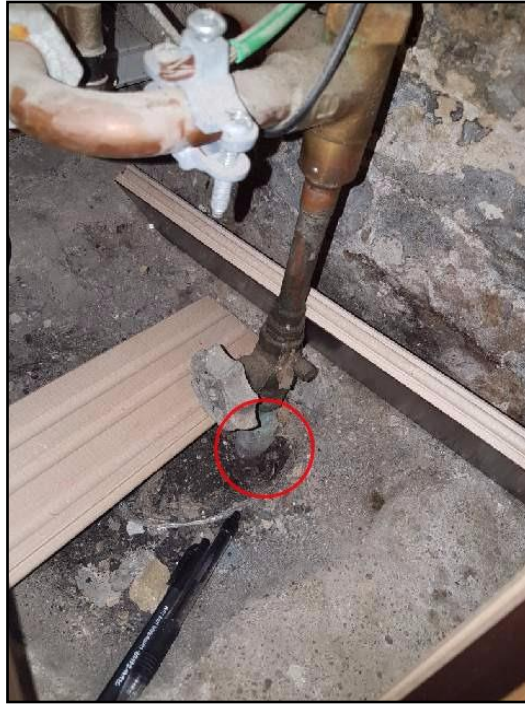
12. Old

14. Condition: • [Old](#)

Main supply from street appears to be lead or gavanized steel. Contact city re potential for subsidized replacement.

Implication(s): Chance of water damage to contents, finishes and/or structure | Reduced water pressure and volume

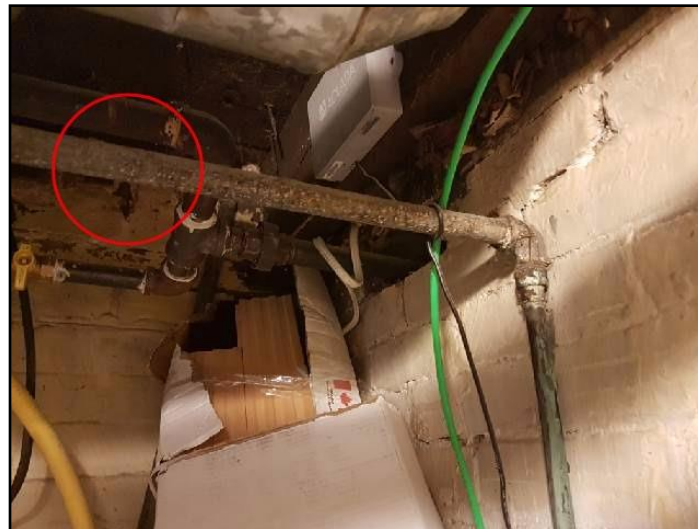
13. Galvanized steel

15. Condition: • [Galvanized steel](#)

rusting of galvanized pipe can greatly reduce water pressure and will eventually cause leaks as rust creates holes in the pipe walls

problems are likely to occur soonest on pipes carrying hot water, horizontal pipes and at threaded (thinner) sections

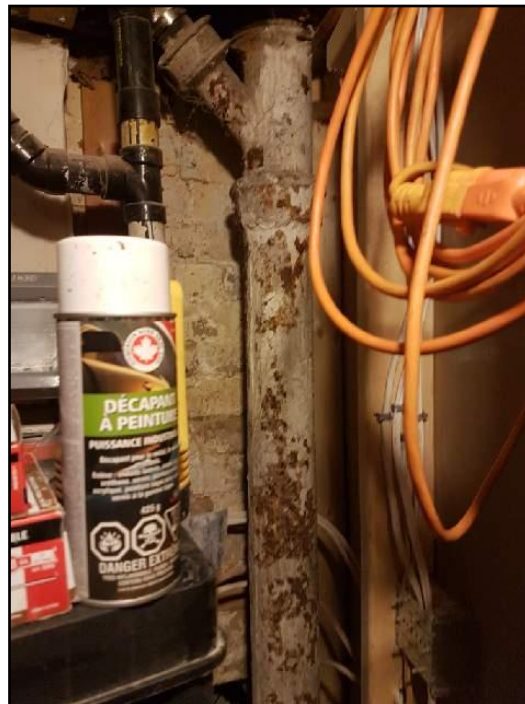
14. Rust

16. Condition: • [Rust](#)

Pinholing and cracks in cast iron stacks

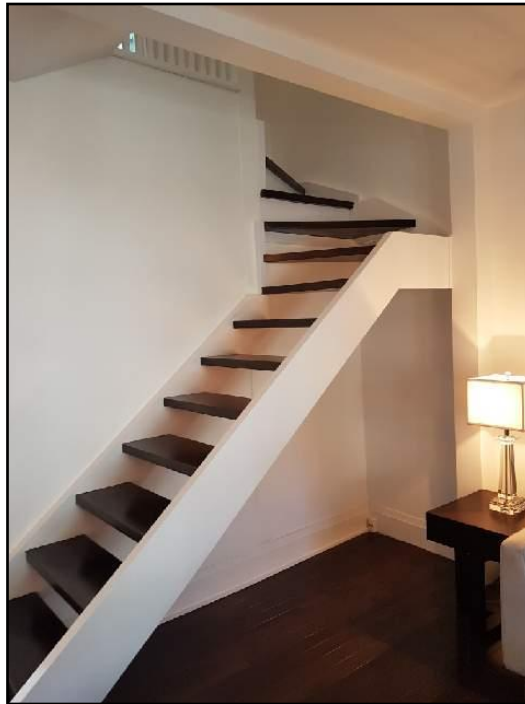
15. Missing guardrail

18. Condition: • [Missing](#)

Implication(s): Fall hazard

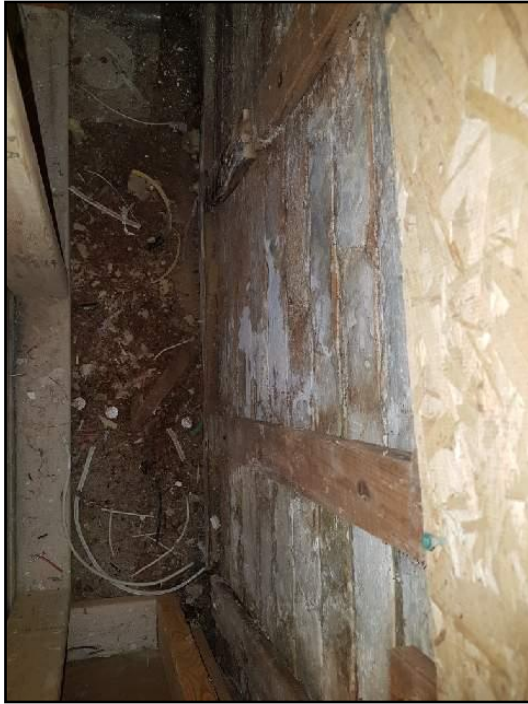
16. Dampness on floor or walls

Typical dampness at basement for this area and era of construction. Monitor for need to install exterior membrane.

19. Condition: • [Dampness on floor or walls](#)
