Your Inspection Report

21 Caroline Avenue
Toronto, ON M4M 2X6

Tuesday, October 17, 2017

RE: Report No. 2331
21 Caroline Avenue
Toronto, ON
M4M 2X6

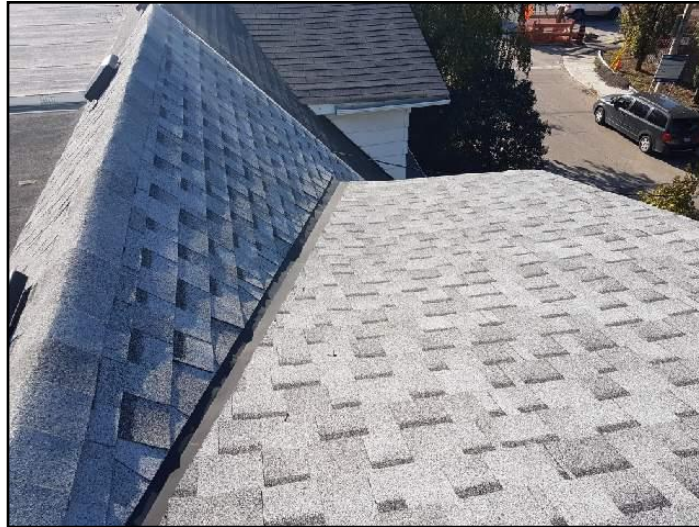
1. *Asphalt shingles*

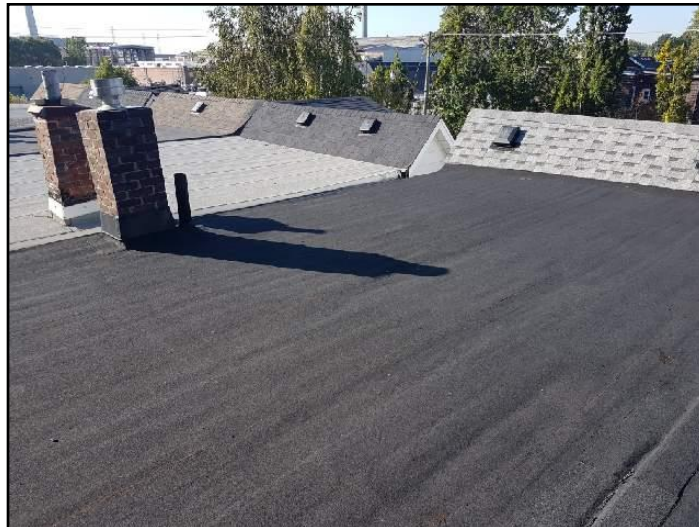
2. *Modified bitumen membrane*

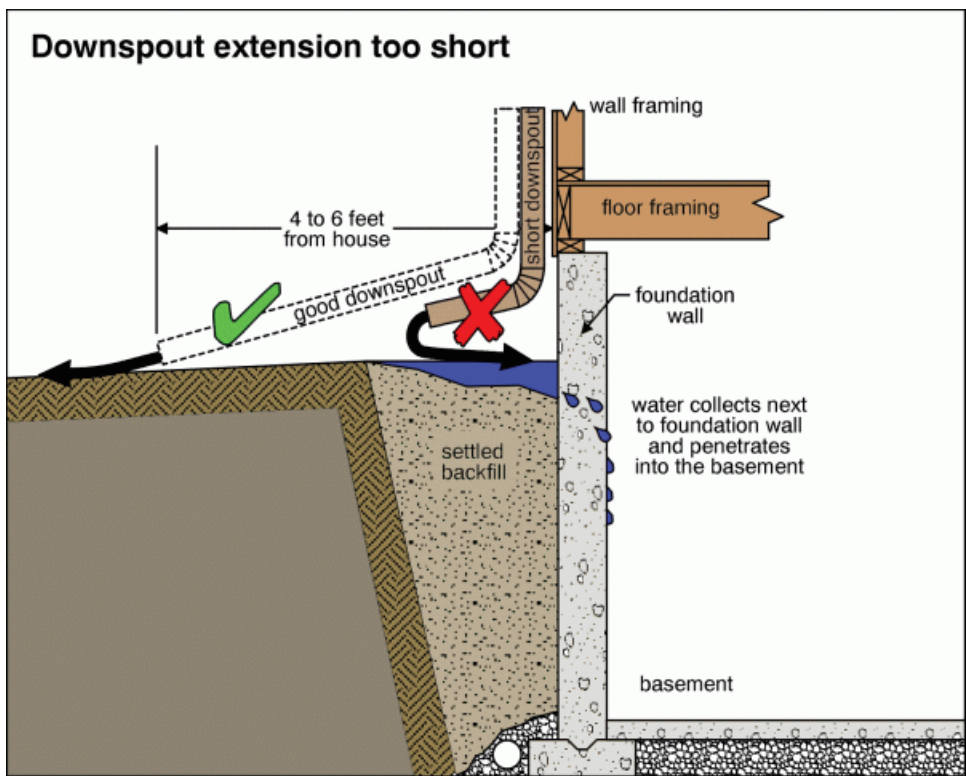
2. Condition: • [Downspouts discharge too close to building](#)

Implication(s): Chance of water damage to contents, finishes and/or structure

Location: Northeast Exterior

Extend downspout away from concrete pier under deck.

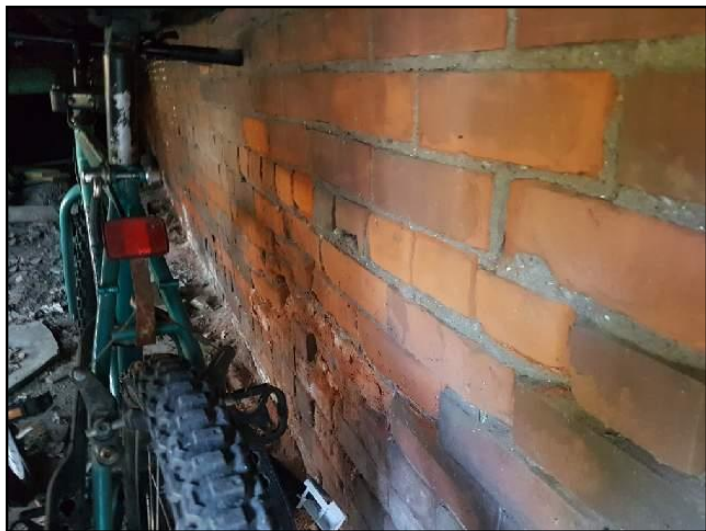
3. Condition: • [Masonry deterioration](#)

Implication(s): Weakened structure | Chance of structural movement

Location: Various Exterior Wall

3. Masonry deterioration

Typical tuckpointing and parging needed, not urgent.

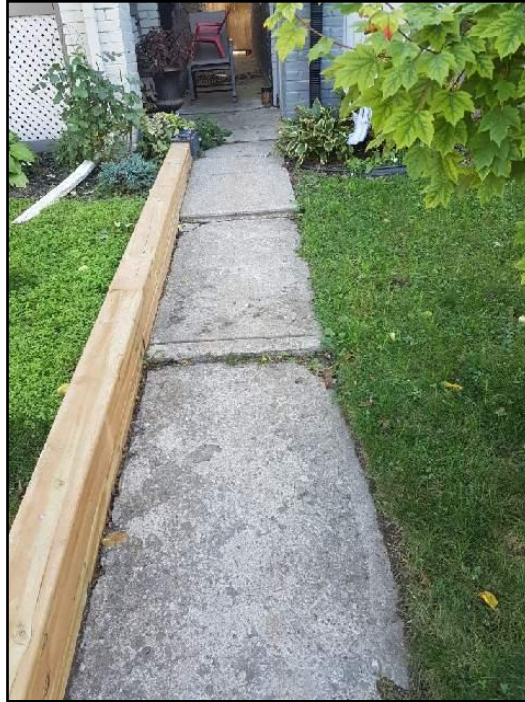
4. Condition: • [Cracked or damaged surfaces](#)

Implication(s): Trip or fall hazard

Location: Southwest Exterior

4. Cracked or damaged surfaces

Eliminate trip hazard, improve drainage, and seal joint where walk meets wall.

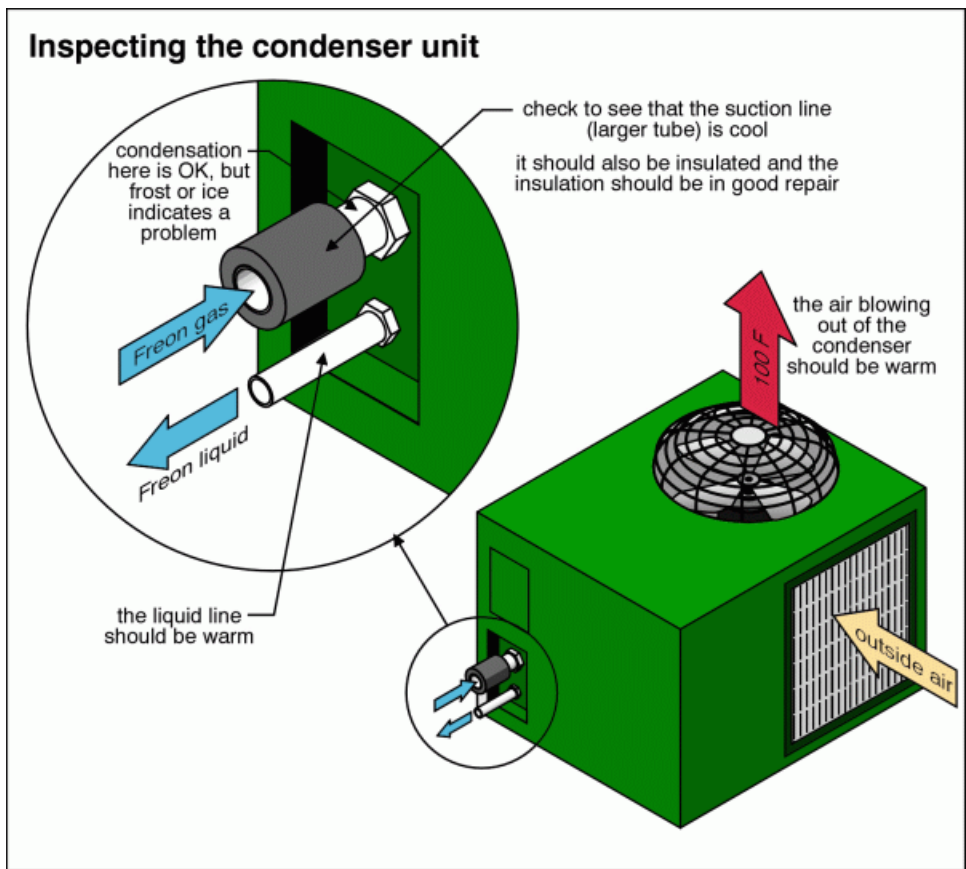
11. Condition: • [Dirty](#)
Implication(s): Reduced system life expectancy | Increased cooling costs | Reduced comfort
Location: East Exterior
Task: Clean
Time: Regular maintenance
Cost: Minor

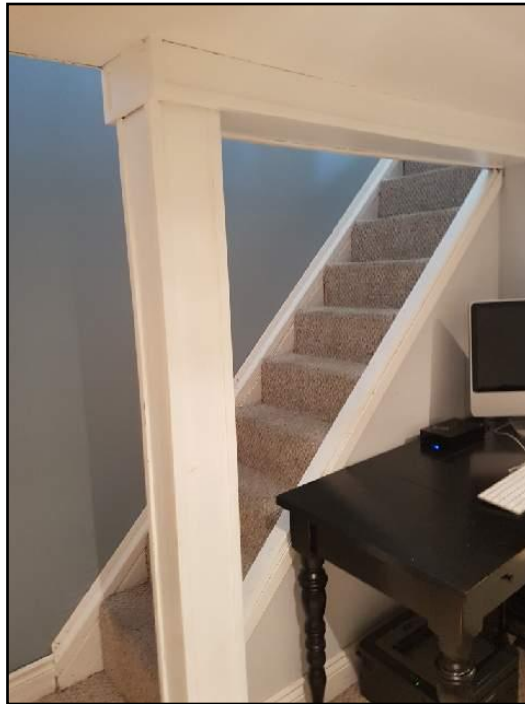
15. Condition: • [Missing](#)

Implication(s): Fall hazard

Location: Basement Staircase

5. *Missing guardrail*

Basement stairs are steep with shallow treads, add hand and guardrails for safety.
