Your Inspection Report

4 Garden Avenue
Toronto, ON M6R 1H6

Monday, October 16, 2017

RE: Report No. 2328
4 Garden Avenue
Toronto, ON
M6R 1H6

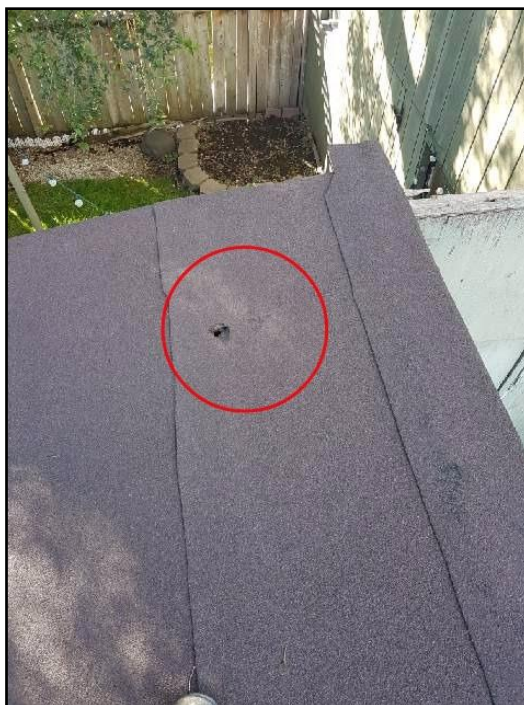
1. Condition: • [Leak](#)

Patch needed at garage.

Implication(s): Chance of water damage to contents, finishes and/or structure

Location: Northwest Garage

3. Leak

Task: Repair

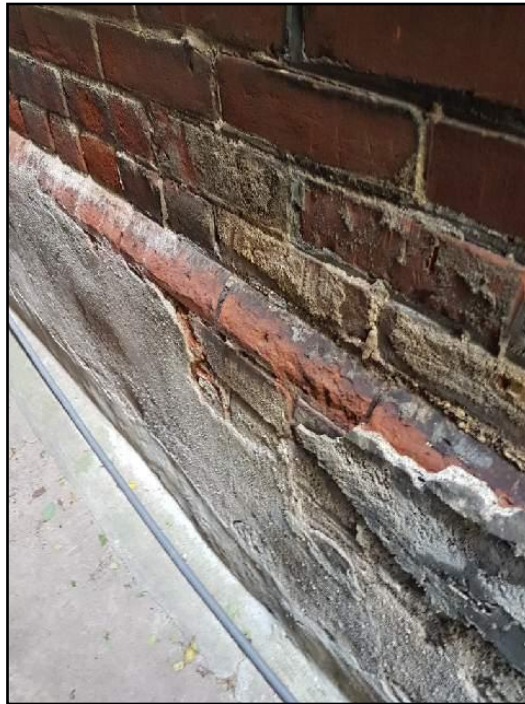
2. Condition: • [Parging damaged or missing](#)

Implication(s): Chance of damage to structure | Shortened life expectancy of material

Location: West exterior

4. Parging damaged or missing

Task: Repair

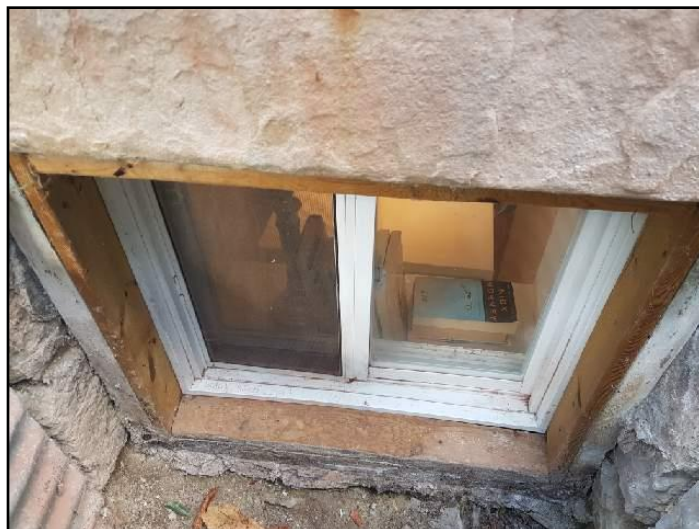
3. Condition: • Paint and Caulking - deteriorated / missing

Basement window frame needs finishing.

Implication(s): Increased heating and cooling costs | Reduced comfort

Location: South Basement

5. Paint and Caulking - deteriorated / missing

Task: Improve

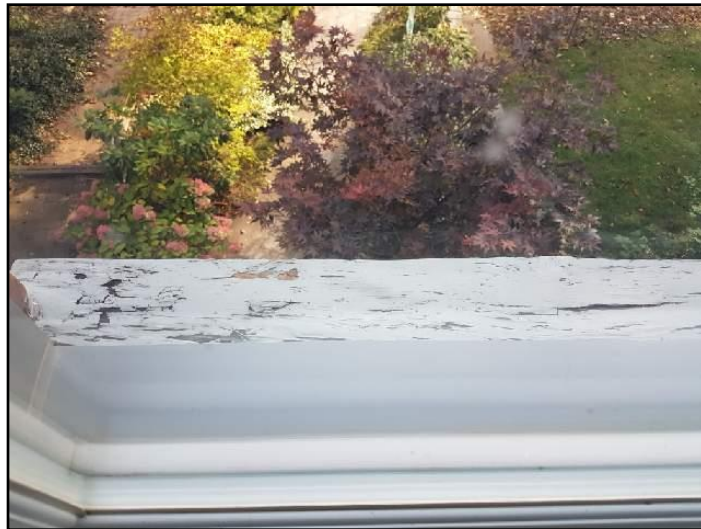
4. Condition: • Rot

Some rot at wood sills of windows.

Implication(s): Material deterioration

Location: South Exterior

6. Rot

Task: Repair or replace

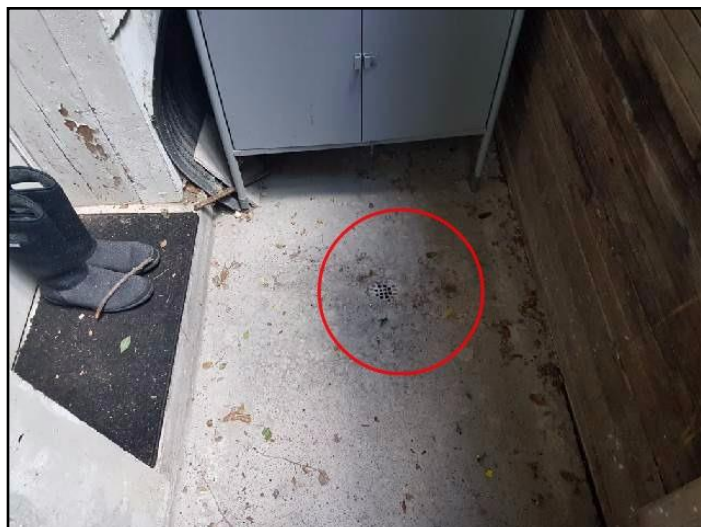
5. Condition: • Drain trapped at exterior. This can lead to freezing and drain back up. Keep salted at present, relocate trap to interior if renovating.

Location: Northwest Exterior

7. Drain trapped at exterior. This can lead to...

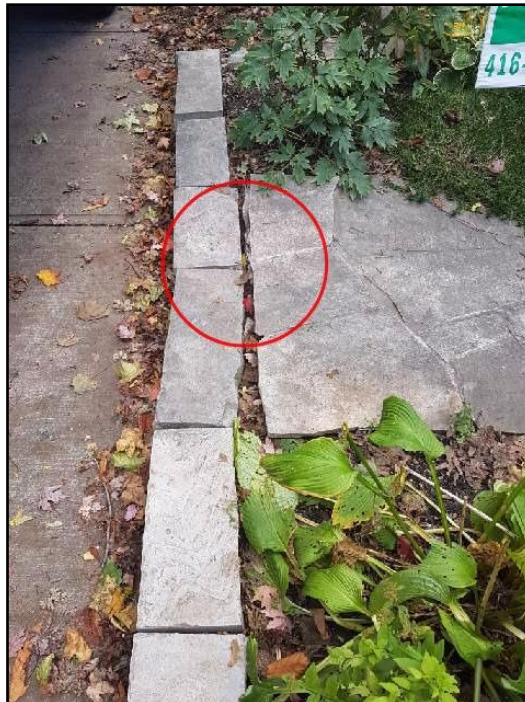
6. Condition: • [Uneven \(trip hazard\)](#)

Implication(s): Physical injury

Location: South Exterior

8. Uneven (trip hazard)

Fill gap at front walk.

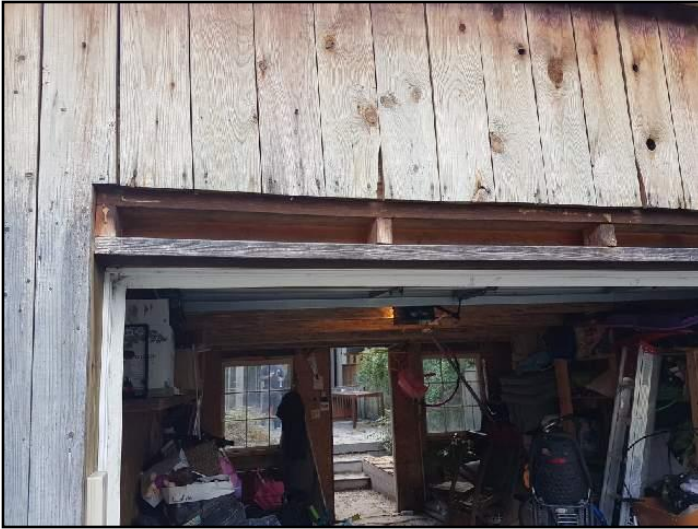
9. Siding incomplete

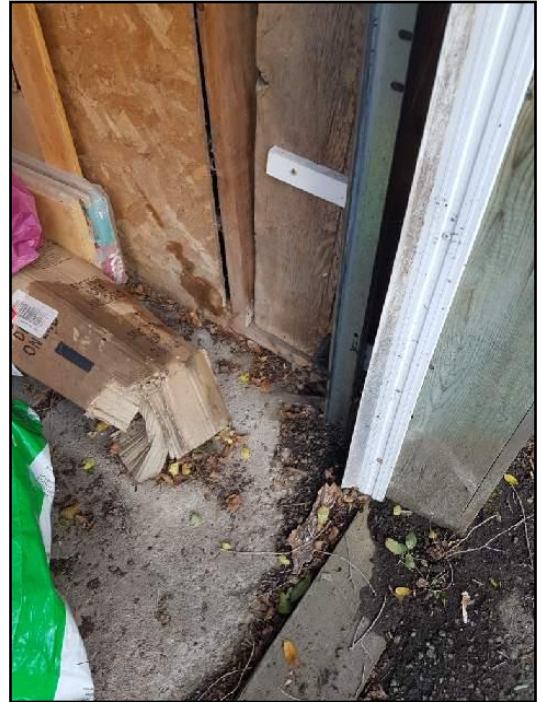
10. Wood soil contact

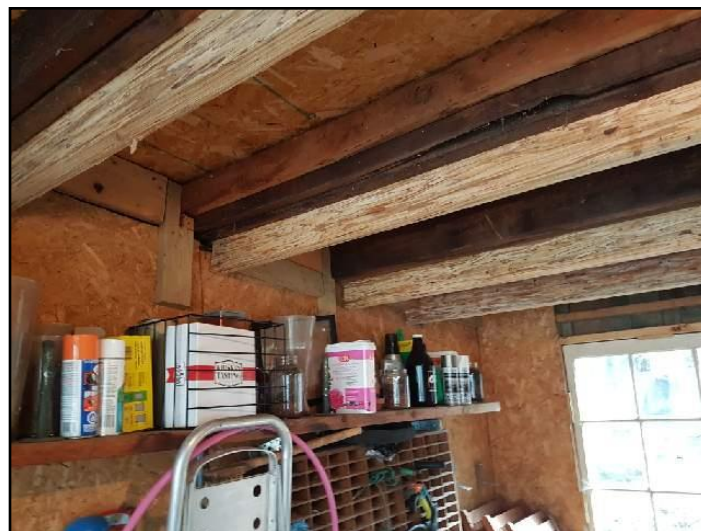
11. Sistered joists not supported

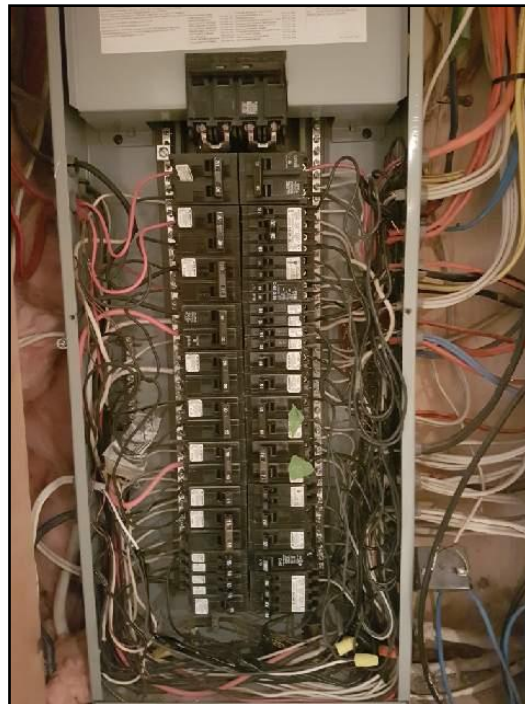
10. Condition: • [Double taps](#)

Location: Basement Panel

12. Double taps

Rewire double taps if nuisance tripping occurs.

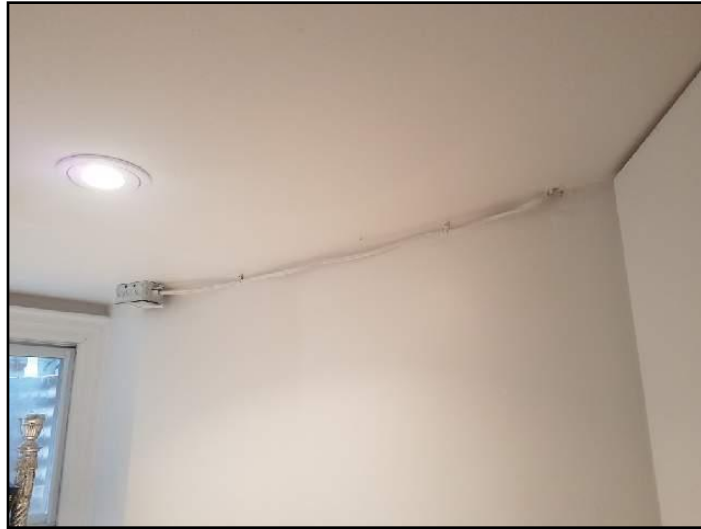
11. Condition: • [Exposed on walls or ceilings](#)

Implication(s): Electric shock

Location: Southwest Basement

13. *Exposed on walls or ceilings*

Task: Protect

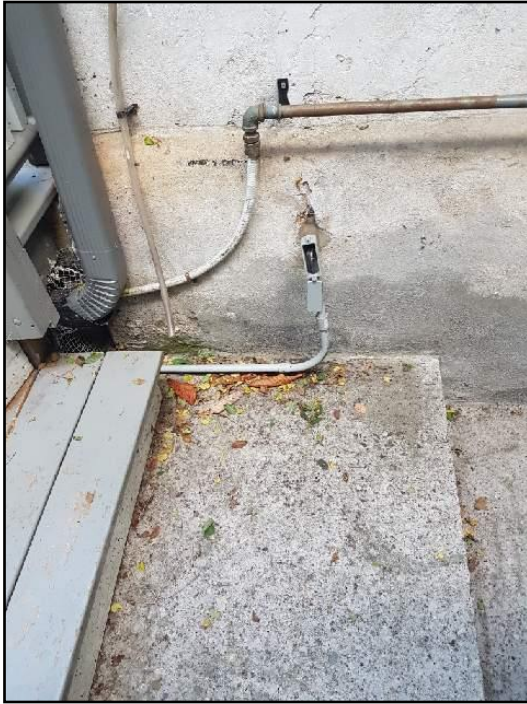
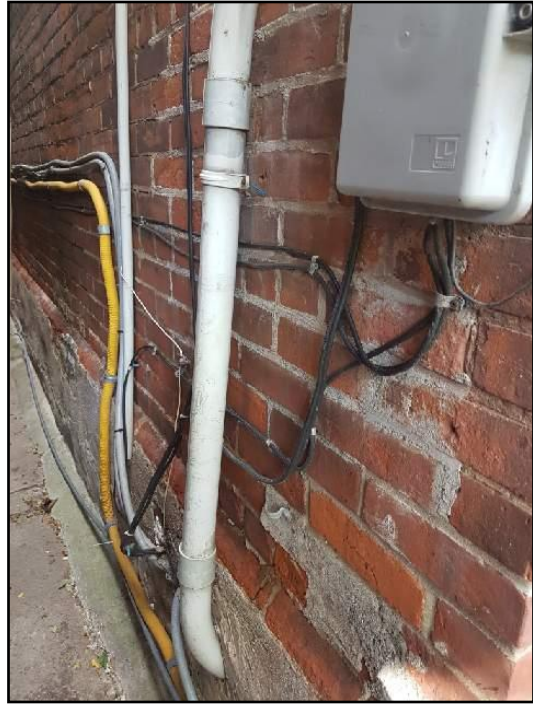
12. Condition: • Exterior wiring exposed to damage and contact by people.

Location: Exterior Wall

14. Exterior wiring exposed to damage and...

15. Exterior wiring exposed to damage and...

Task: Protect

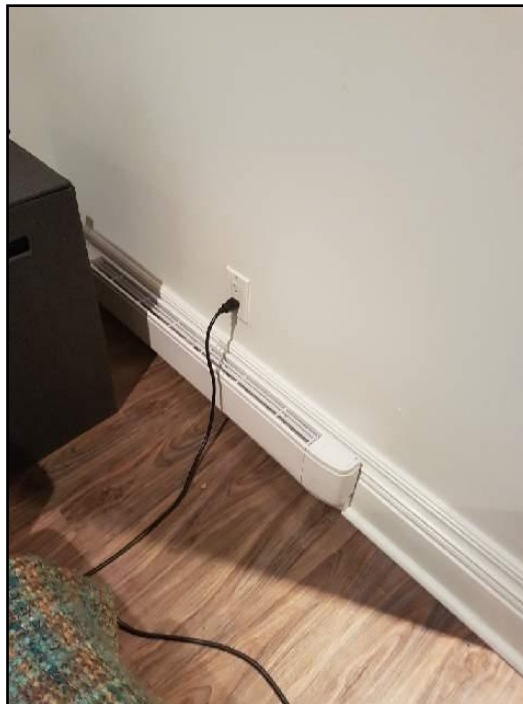
13. Condition: • [Above electric baseboard heaters](#)

Implication(s): Increased fire hazard

Location: South Basement

cords plugged into outlets above electric baseboard heaters could overheat if accidentally draped over the heater

16. Above electric baseboard heaters

Relocate outlet over baseboard heater.

outlets should be located at either end of the heater

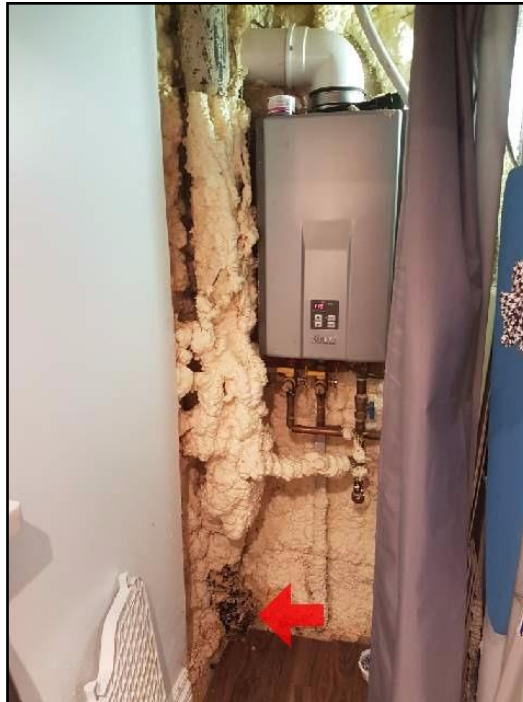
19. Condition: • [Leak](#)

Minor leak at clean out at base of stack, vendor to repair.

Implication(s): Sewage entering the building

Location: Basement

19. Leak

Task: Repair

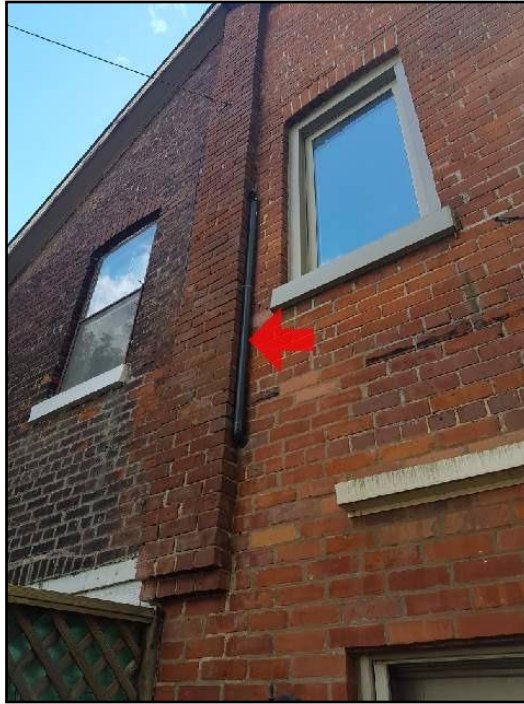
WASTE PLUMBING \ Venting system**20. Condition:** • [Poor vent pipe arrangements](#)

Implication(s): Sewer gases entering the building

Location: North Exterior Wall

20. *Poor vent pipe arrangements*

ABS pipe at north wall appears to be venting for kitchen drains, enlarge and extend if necessary.

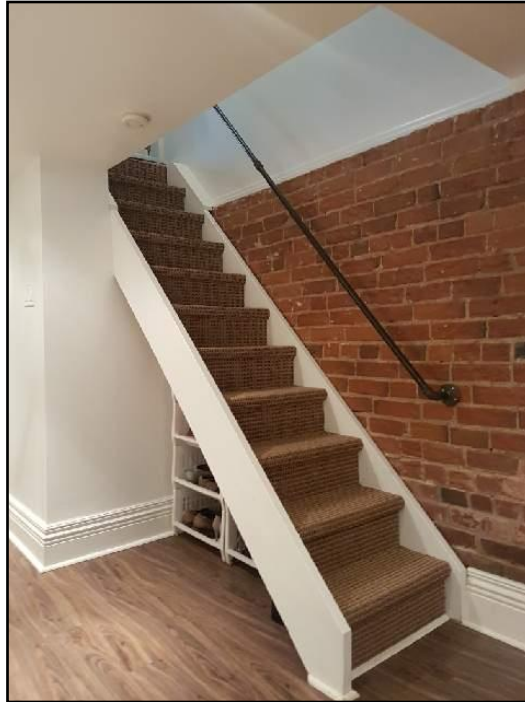
21. Condition: • [Missing](#)

Implication(s): Fall hazard

Location: Basement Staircase

21. *Missing guardrail*

Task: Provide
