Your Inspection Report

135 Cowan Avenue
Toronto, ON M6K 2N1

Friday, November 10, 2017

RE: Report No. 2354, v.3
135 Cowan Avenue
Toronto, ON
M6K 2N1

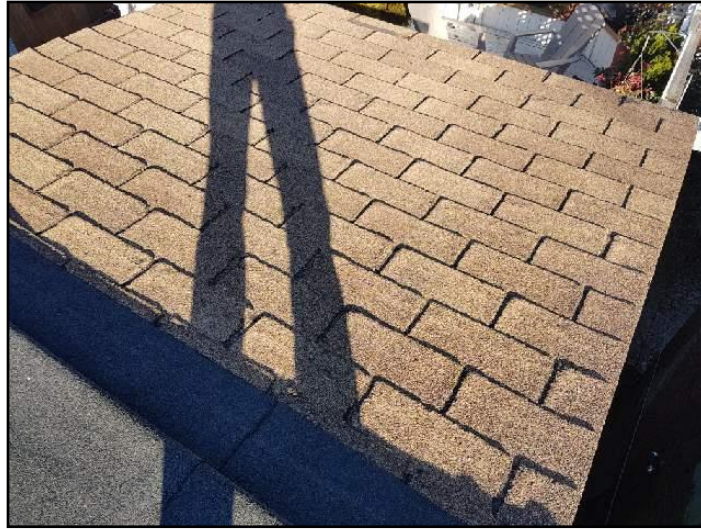
1. Condition: • [Near end of life expectancy](#)

Small section of roof at walk out is near end of life expectancy, balance of roof areas in good condition.

Location: East Third Floor

5. *Near end of life expectancy*

Task: Replace

Time: Aprox. 2-3 years

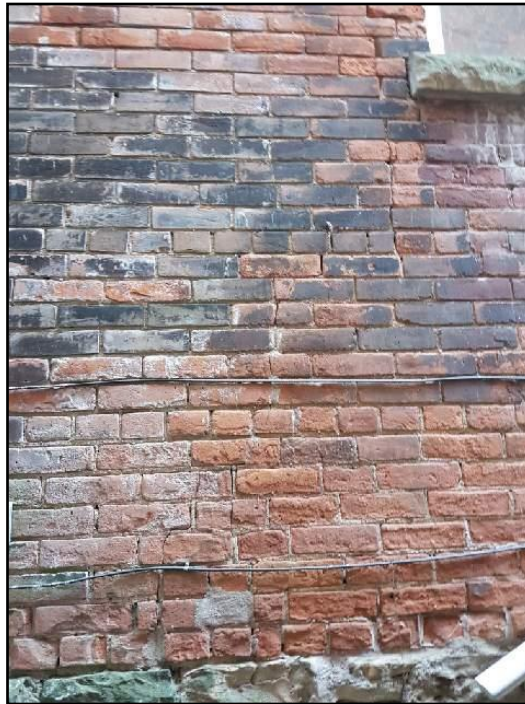
3. Condition: • [Cracked](#)

Minor tuckpointing needed.

Implication(s): Chance of movement | Weakened structure | Chance of water entering building

Location: Southeast Exterior Wall

6. Cracked

Task: Repair

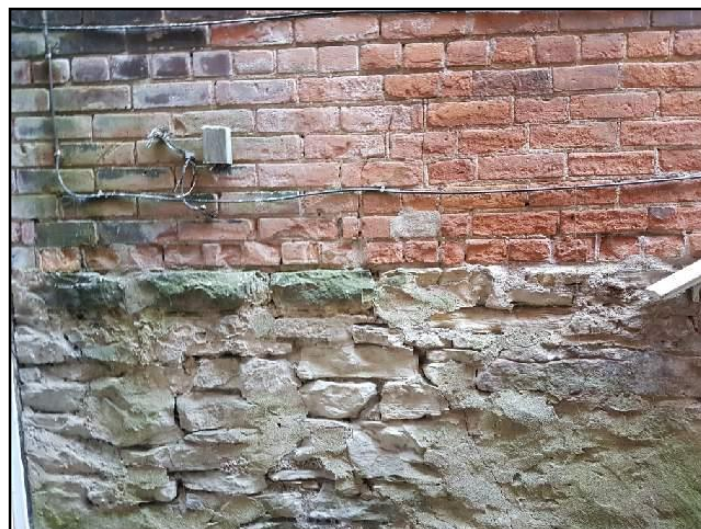
4. Condition: • [Parging damaged or missing](#)

Implication(s): Chance of damage to structure | Shortened life expectancy of material

Location: Southeast Exterior Wall

7. Parging damaged or missing

Task: Improve

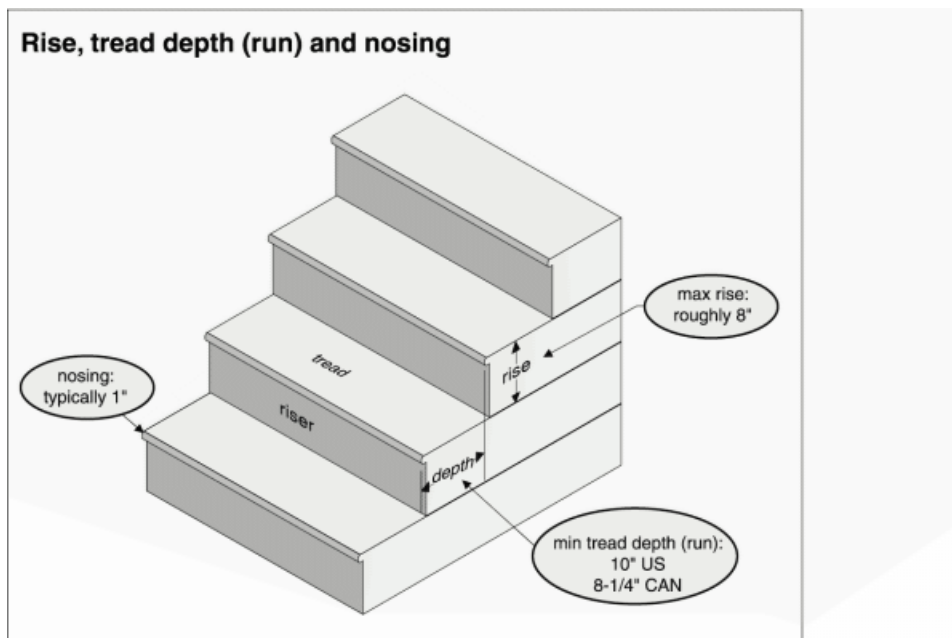
BASEMENT WALKOUTS \ General**5. Condition:** • [Step and landing problems](#)

Uneven and cracked steps at basement walkout should be replaced if this access to basement is to be used.

Task: Replace

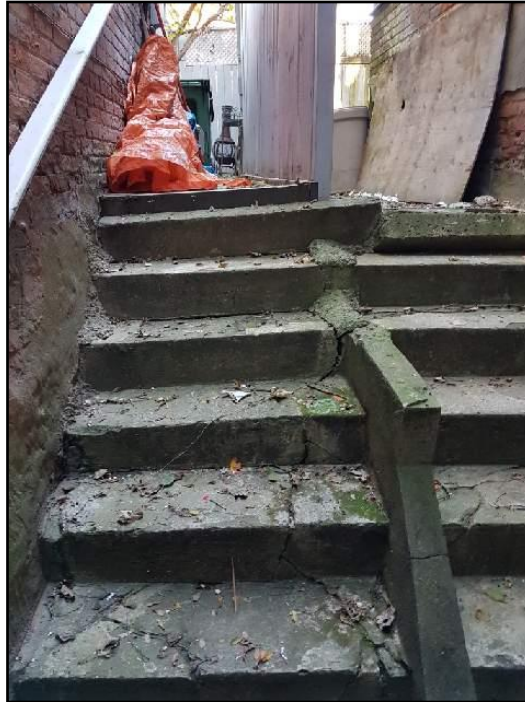
Implication(s): Trip or fall hazard

Location: Southeast Exterior Staircase

8. Step and landing problems

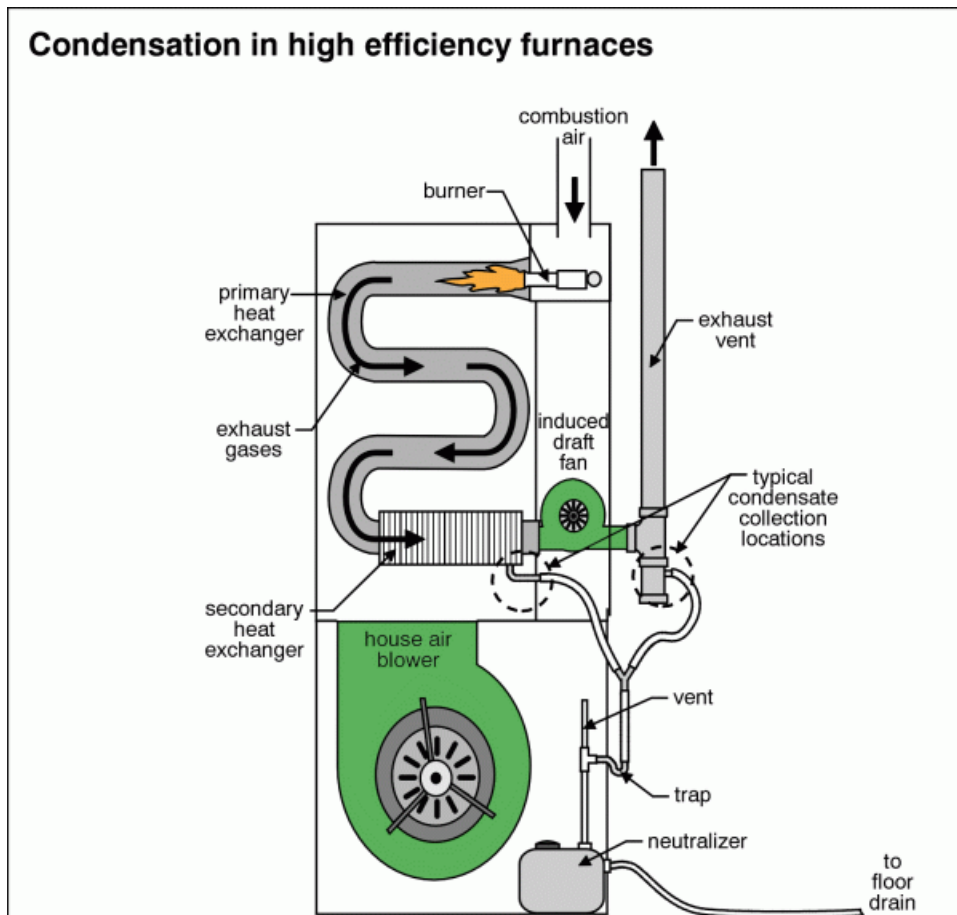
12. Condition: • [Condensate problems](#)

Minor condensate drip present.

Task: Repair

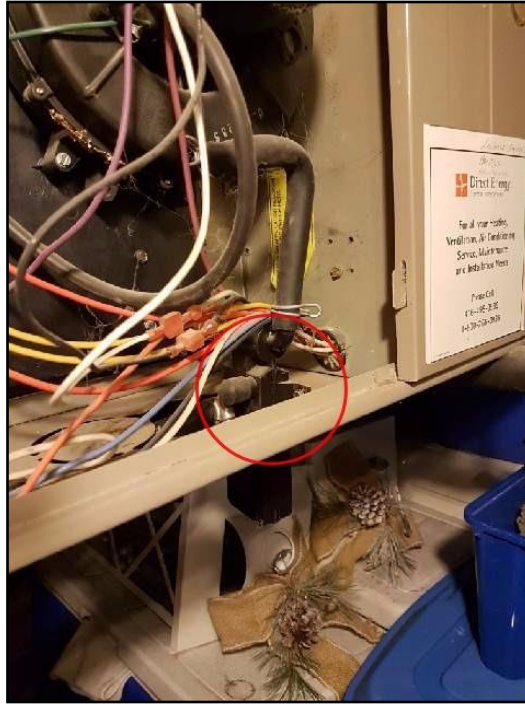
Implication(s): Reduced system life expectancy | Chance of water damage to contents, finishes and/or structure

Location: Basement Furnace Room

12. Condensate leak

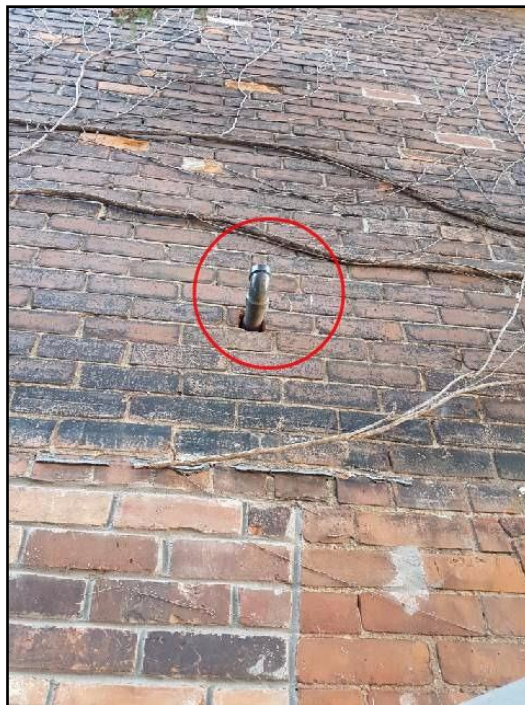
15. Condition: • [Vent termination problems](#)

Two ABS vent pipes are undersized, enlarge and extend if odours develop or frost closes pipe.

Implication(s): Reduced operability | Sewer gases entering the building

Location: East Exterior

13. Poor vent pipe arrangements

Task: Improve
