Your Inspection Report

14 Florence Street
Toronto, ON M6K 1P3

Monday, October 30, 2017

RE: Report No. 2344
14 Florence Street
Toronto, ON
M6K 1P3

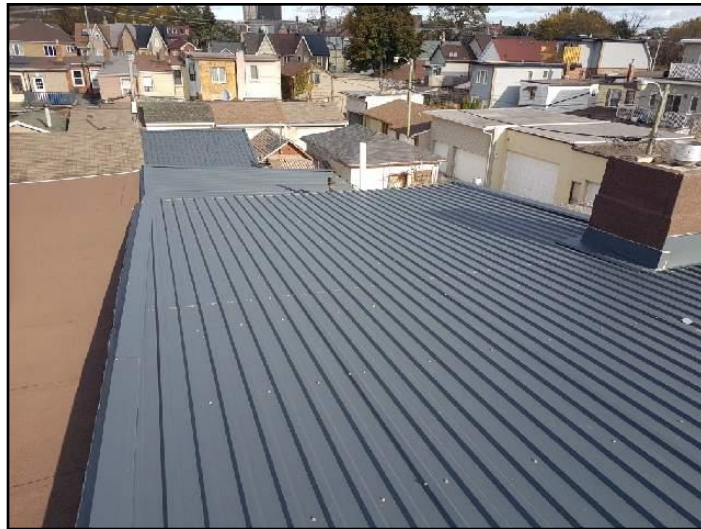
1. *Metal*

Sloped roofing material: • [Metal](#)

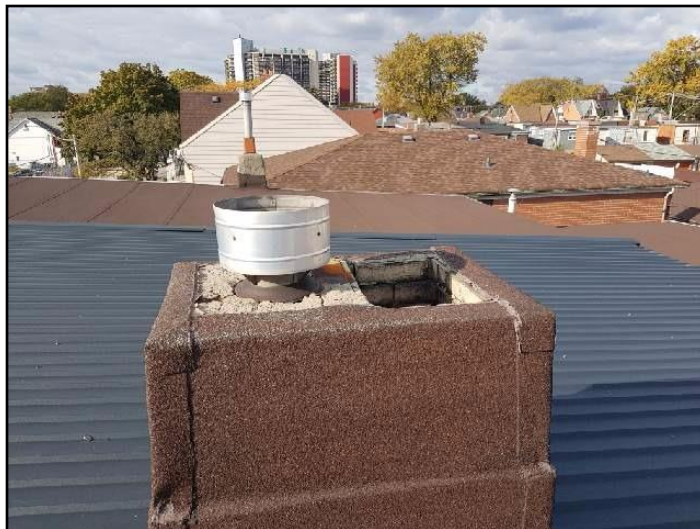
2. Seal unused flue against pest and water...

1. • Seal unused flue against pest and water entry.

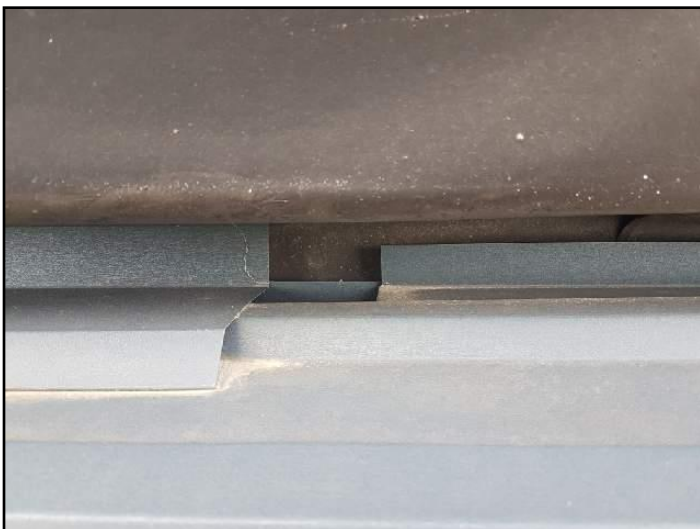
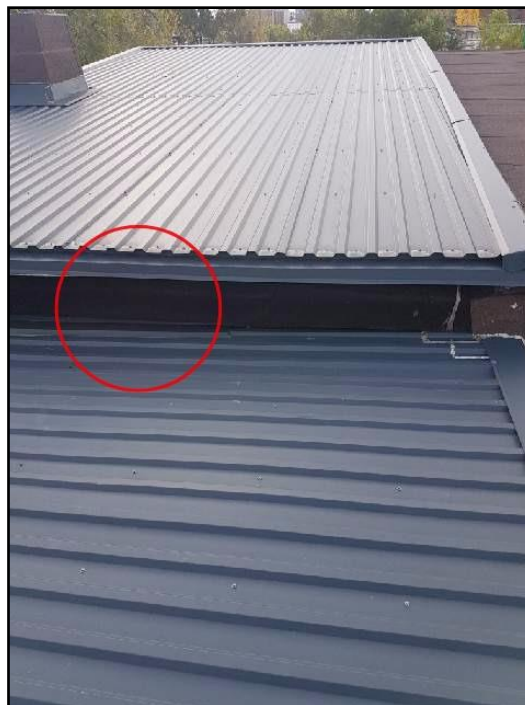
3.

Void in roofing overlap and wall flashing at transition from upper to lower flat roof.

Implication(s): Chance of water damage to contents, finishes and/or structure

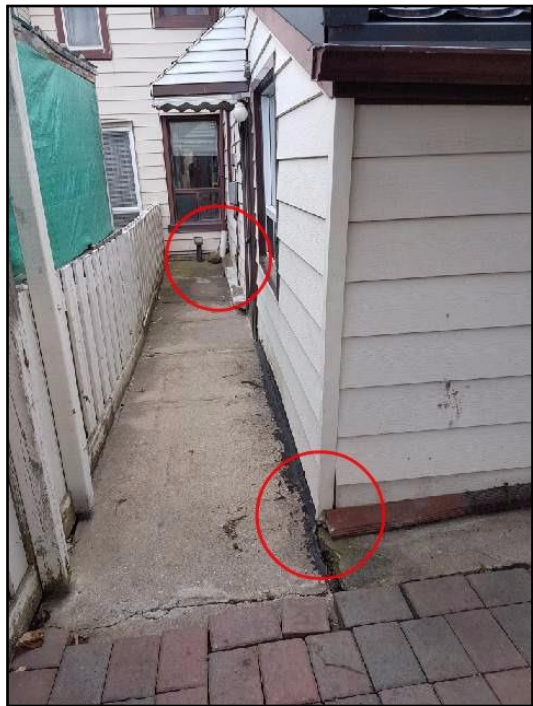
Suggest routing north downspouts above grade to n/w side of yard. This below grade connection may be contributing to basement leakage.

5. Reroute downspouts

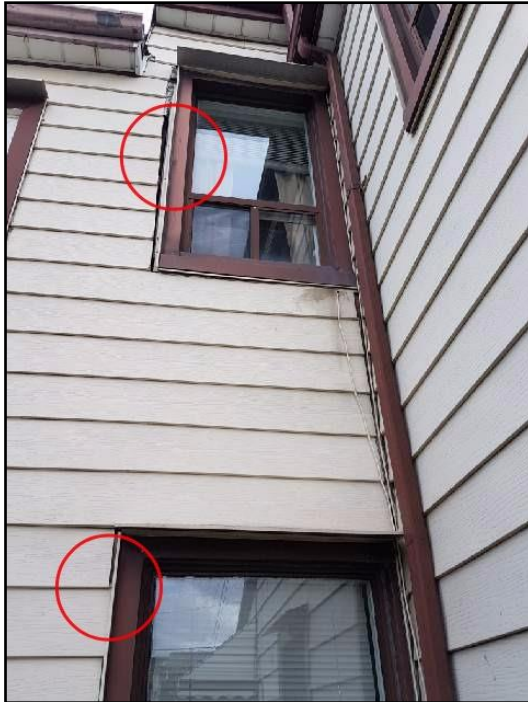
Joints in siding and flashings have opened up due to settlement and require repair.

6. Flashings incomplete or ineffective

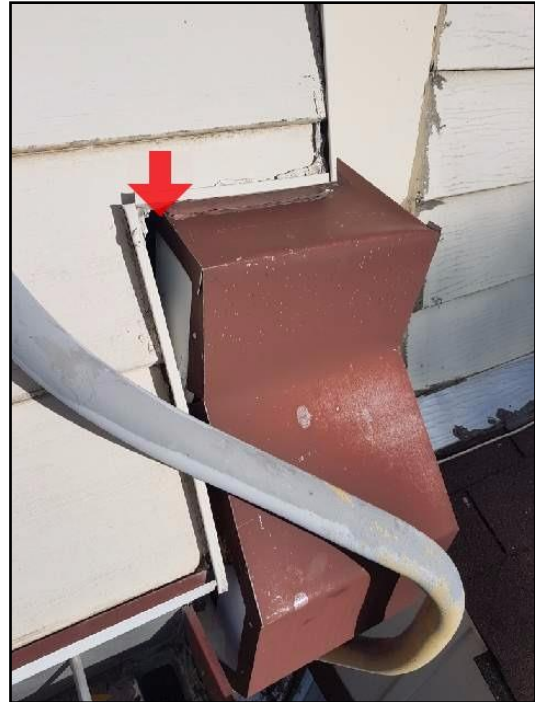
7. Flashings incomplete or ineffective

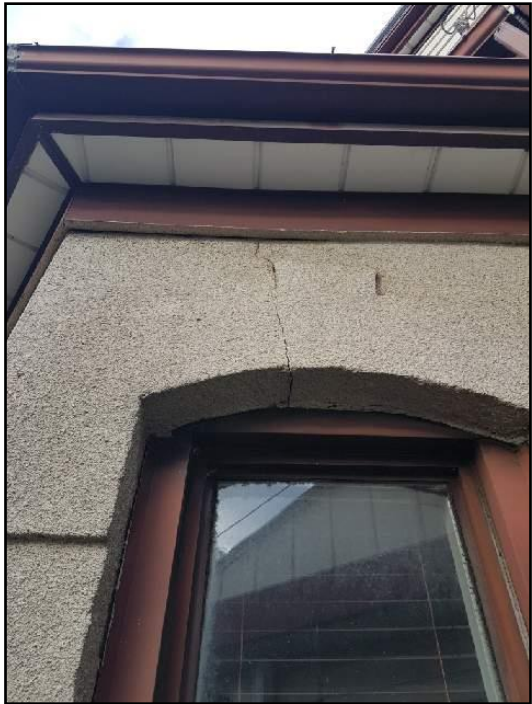
8. Cracked

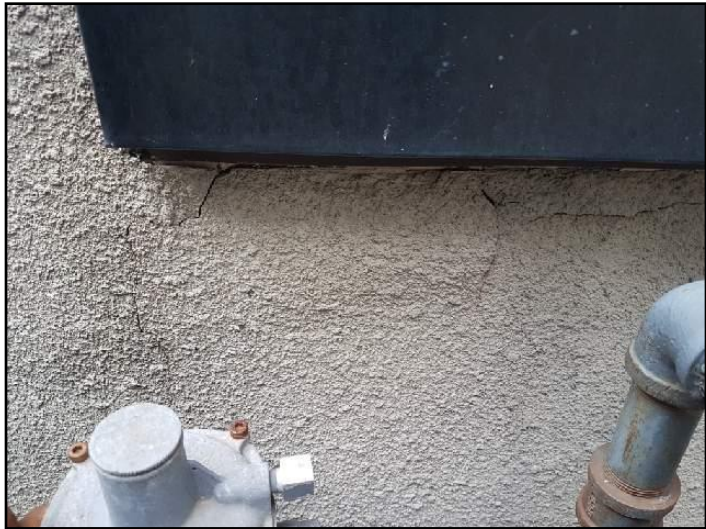
9. Cracked

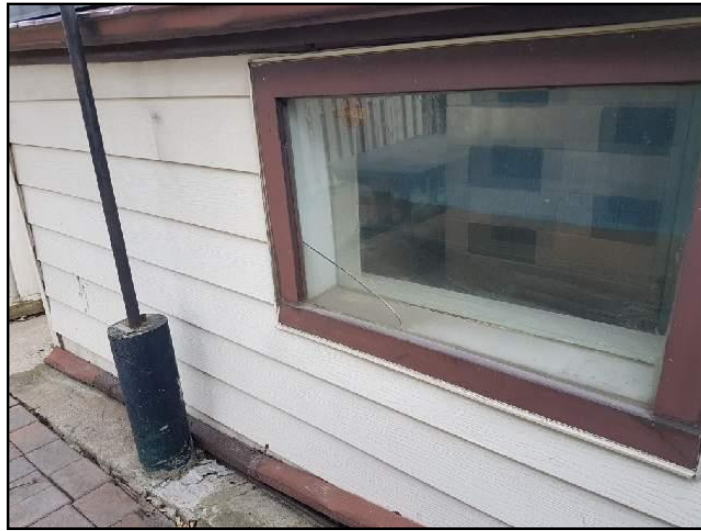
Evidence of settlement at single storey north addition. While repairs are not urgent, structure should be accessed and evaluated prior to improving or renovating.

10. *Settled*

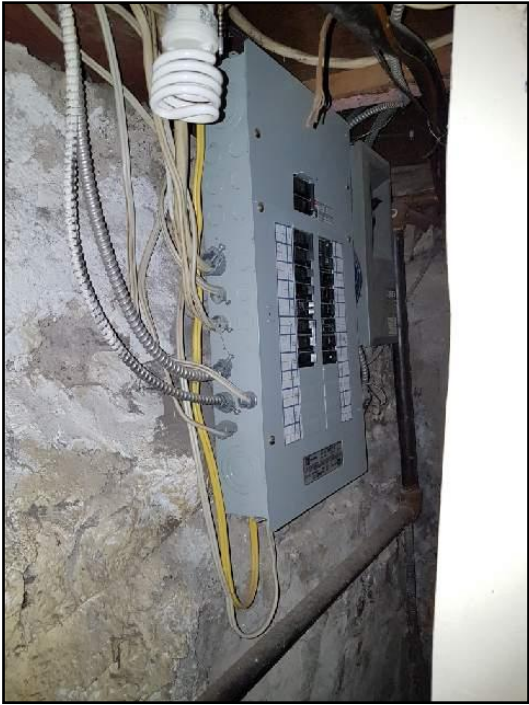
7. Condition: • [Poor access](#)

11. Poor access

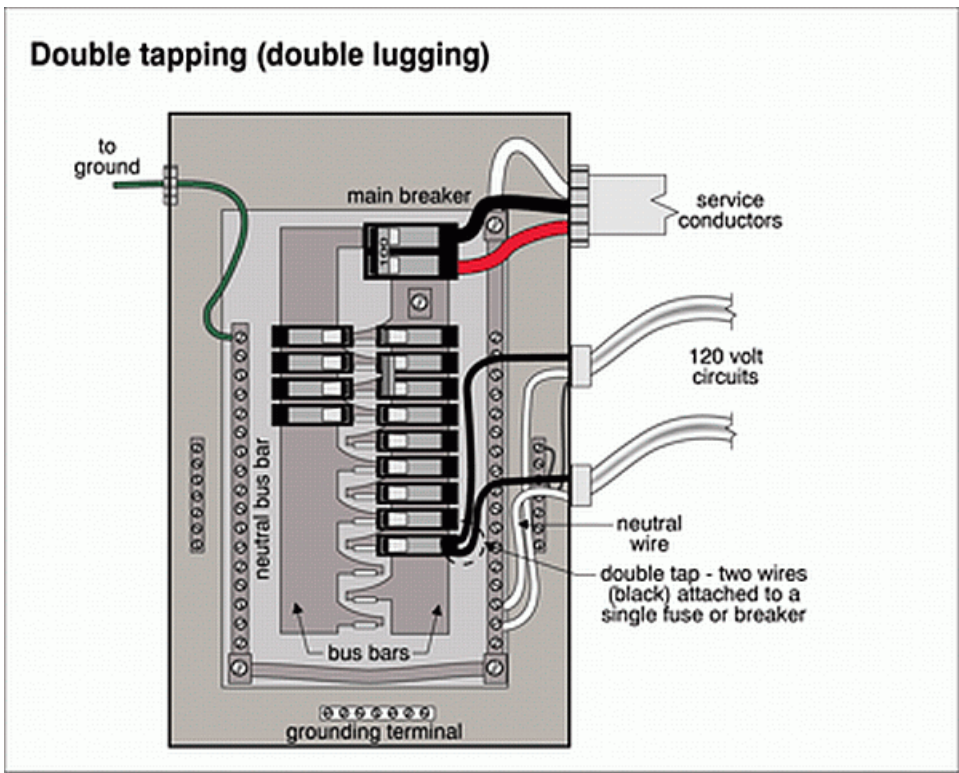
8. Condition: • [Double taps](#)

Implication(s): Fire hazard

Add breakers and split double taps if nuisance tripping occurs.

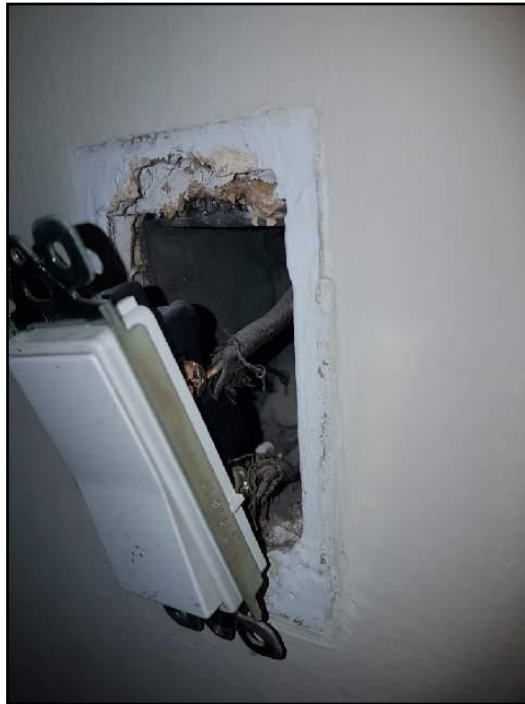
Knob and tube visible at dining room and middle bedroom. Likely present at entrance hall switches (coverplate caulked in place and not removed) and in master bedroom.

Implication(s): Nuisance | Potential problem when obtaining home insurance

12. Knob and tube

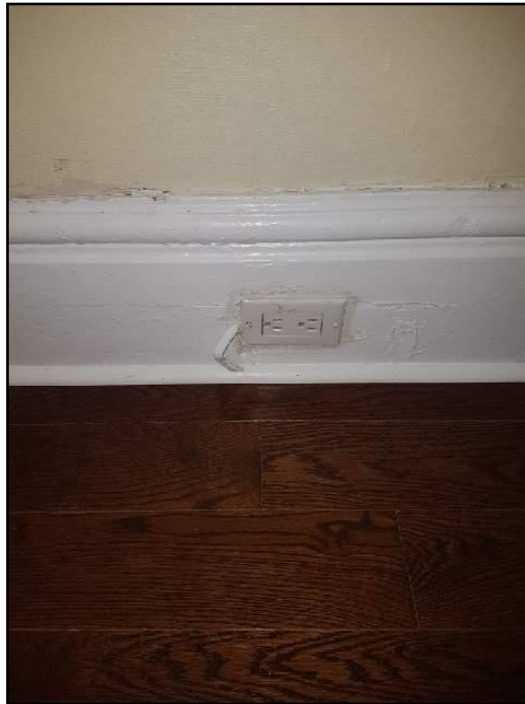
Implication(s): Electric shock

13. Exposed on walls or ceilings

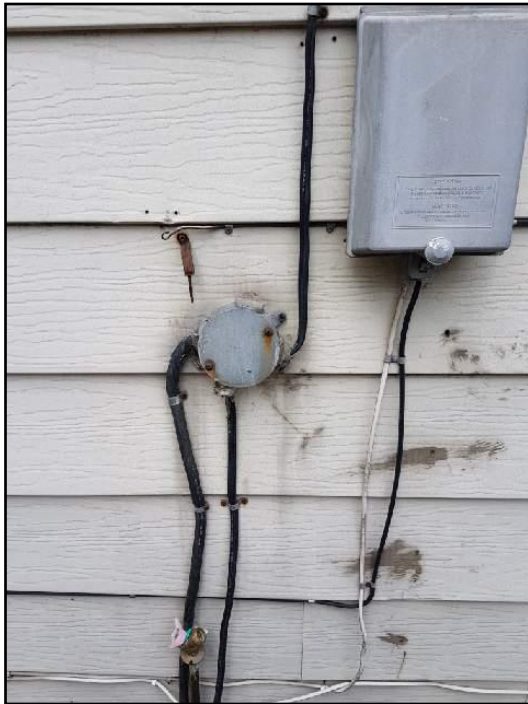
11. Condition: • Exterior wiring exposed to damage and contact by people.

14. Exterior wiring exposed to damage and...

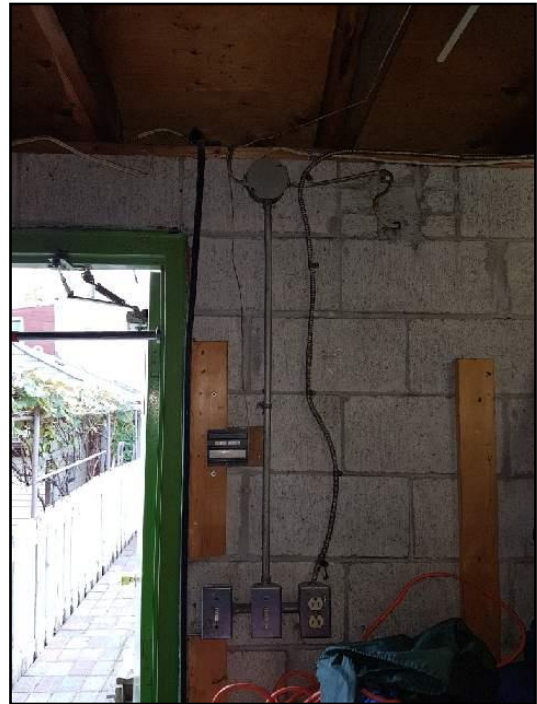
15. Exterior wiring exposed to damage and...

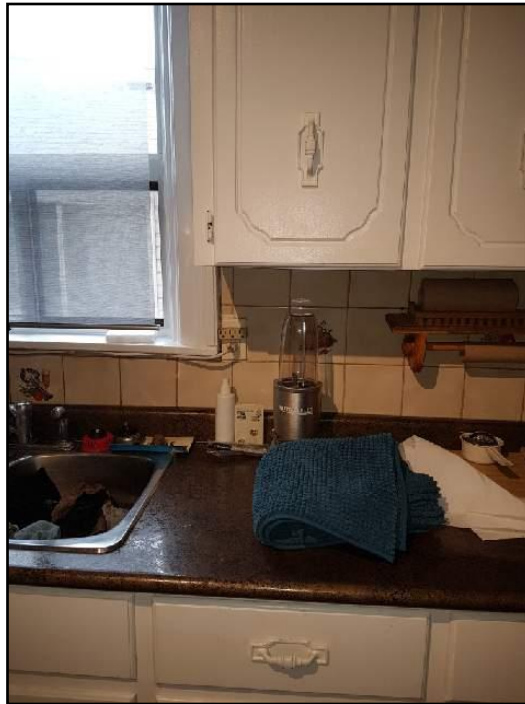
13. Condition: • [Too few outlets](#)

16. *Too few outlets*

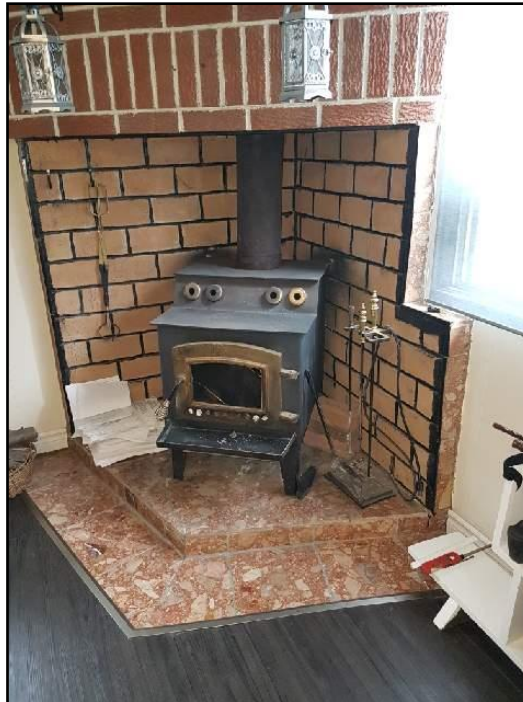
Vendor has receipt for Wett inspection and approval.

17. Wood stove

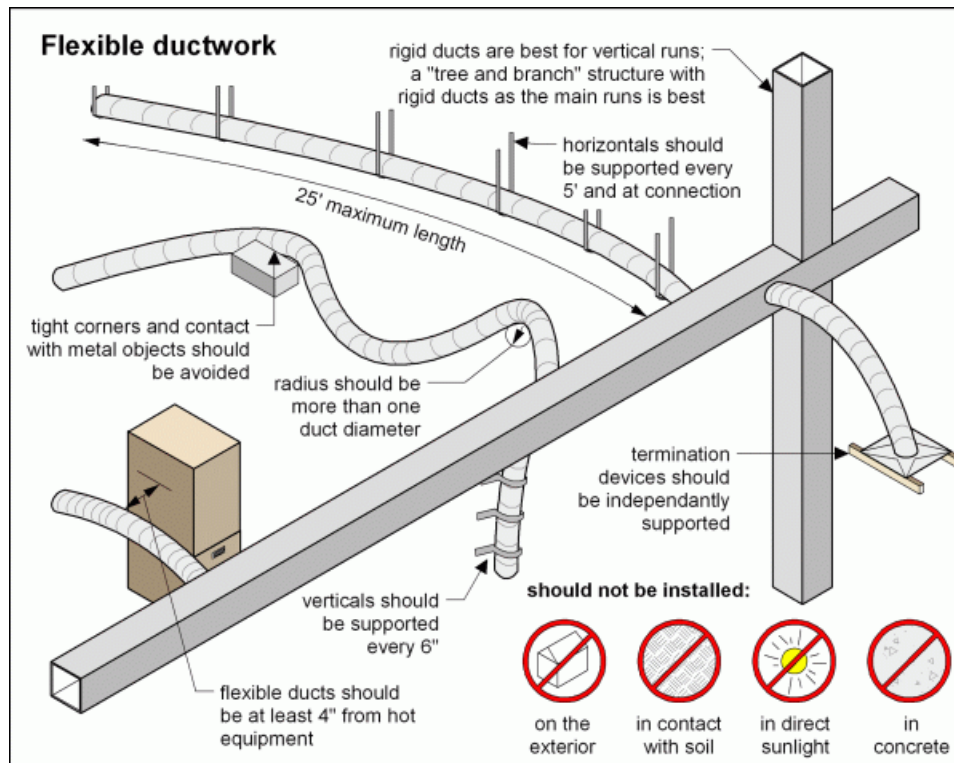
15. Condition: • [Weak airflow](#)

Implication(s): Increased heating costs | Reduced comfort

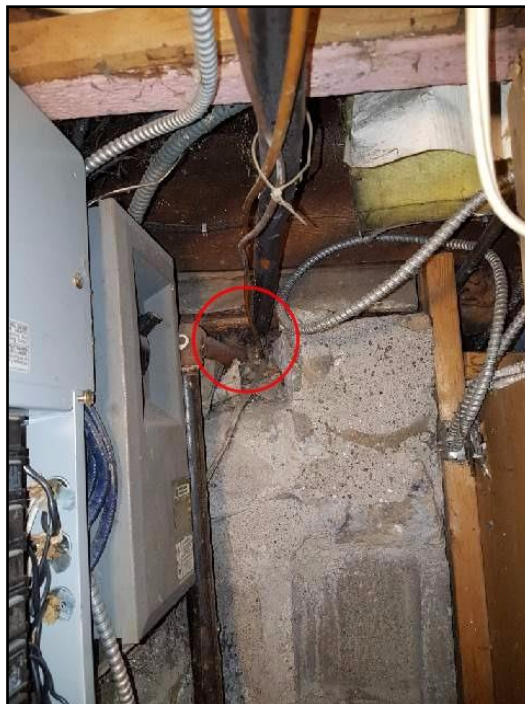
18.

19. Condition: • Seal hole at foundation where a/c and gas lines penetrate wall.

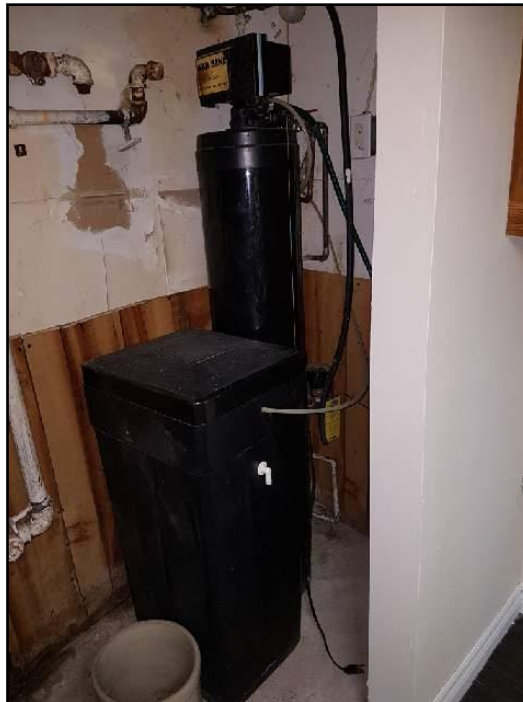
19. *Not tested*

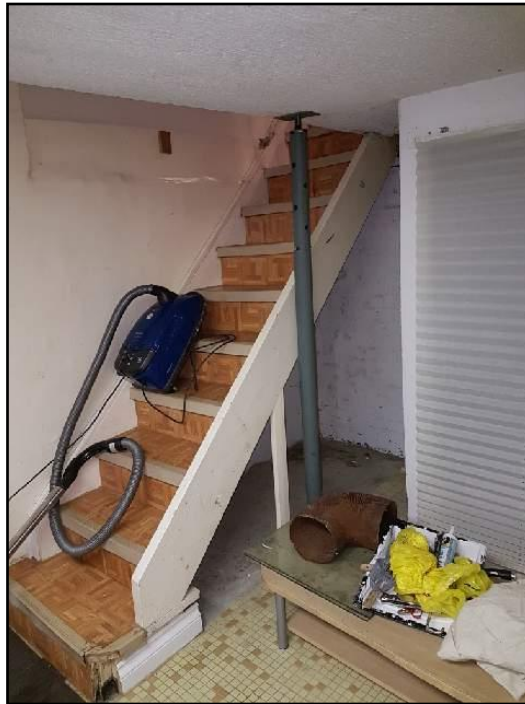
23. Condition: • [Missing](#)

Implication(s): Fall hazard

20. Missing guardrail

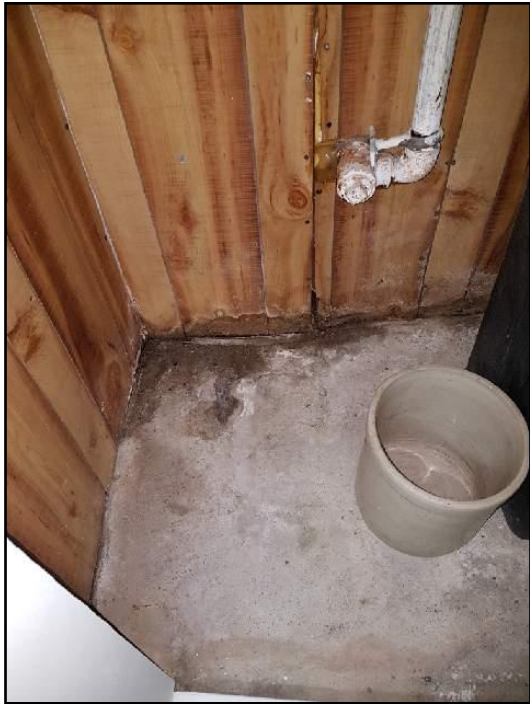
24. Condition: • [Stains](#)

Typical dampness for this age and type of foundation. Interior or exterior damp proofing membrane recommended if refinishing basement.

21. Stains

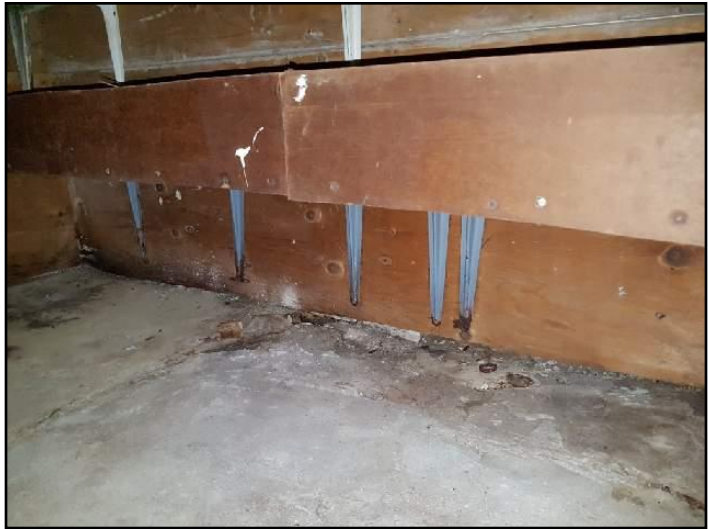
22. Stains
