Your Inspection Report

308 Jemima Drive
Oakville, ON L6M 4M1

Friday, November 3, 2017

RE: Report No. 2346
308 Jemima Drive
Oakville, ON
L6M 4M1

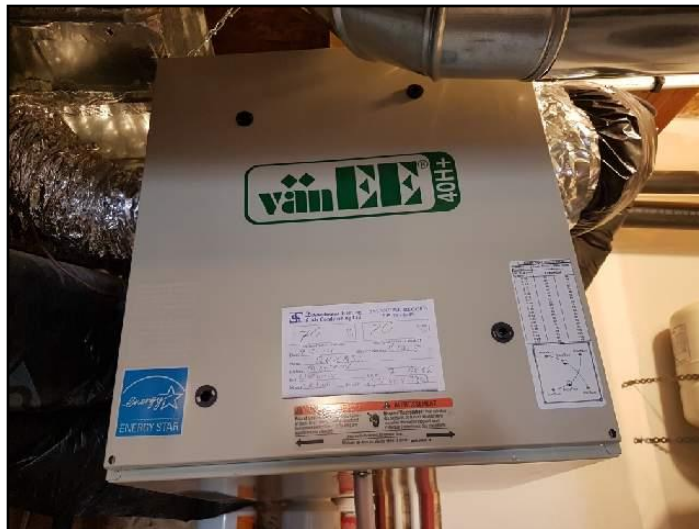
1. Heat recovery ventilator (HRV)

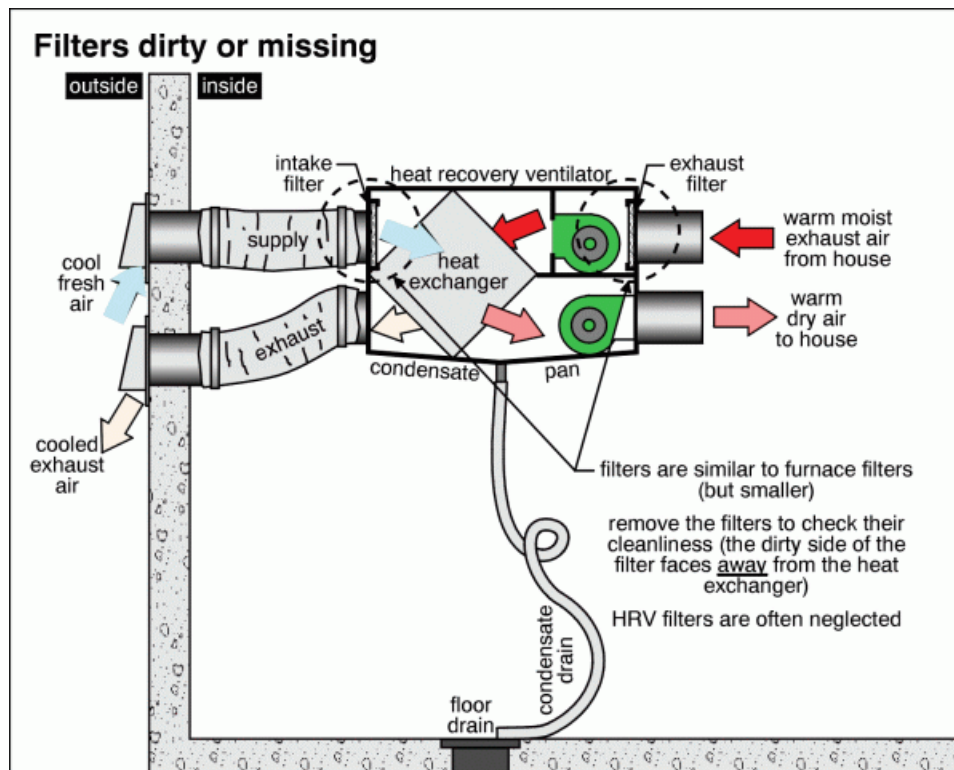
6. Condition: • [Dirty](#)

Implication(s): Equipment ineffective

Location: Basement Utility Room

Task: Clean

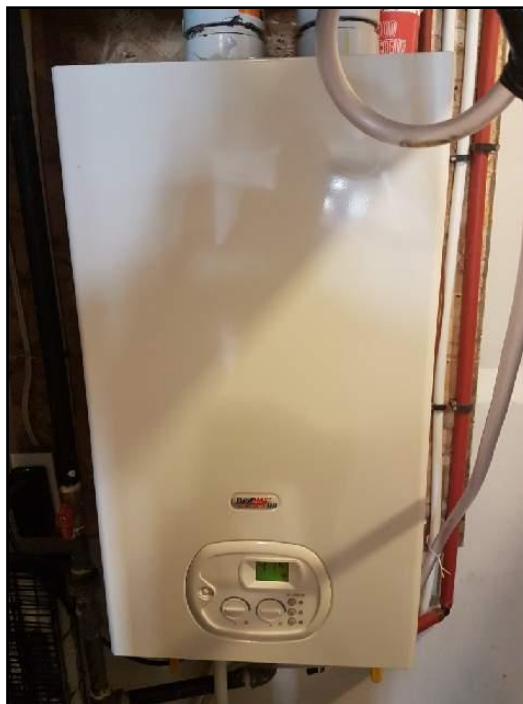
2. Tankless water heater

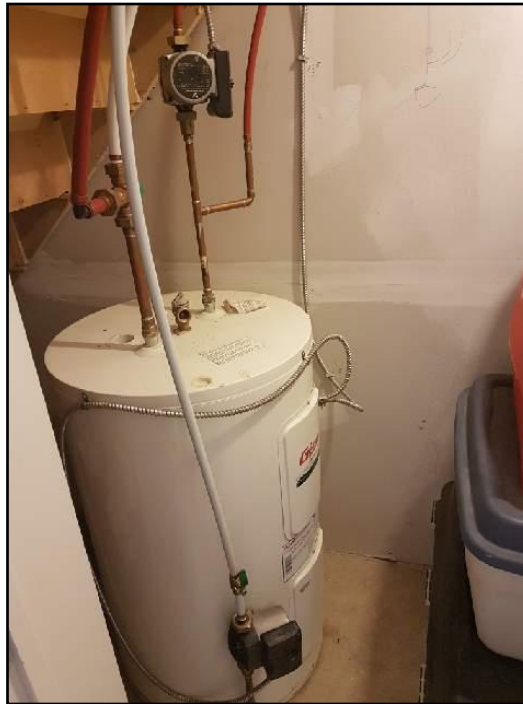
3. Circulating system

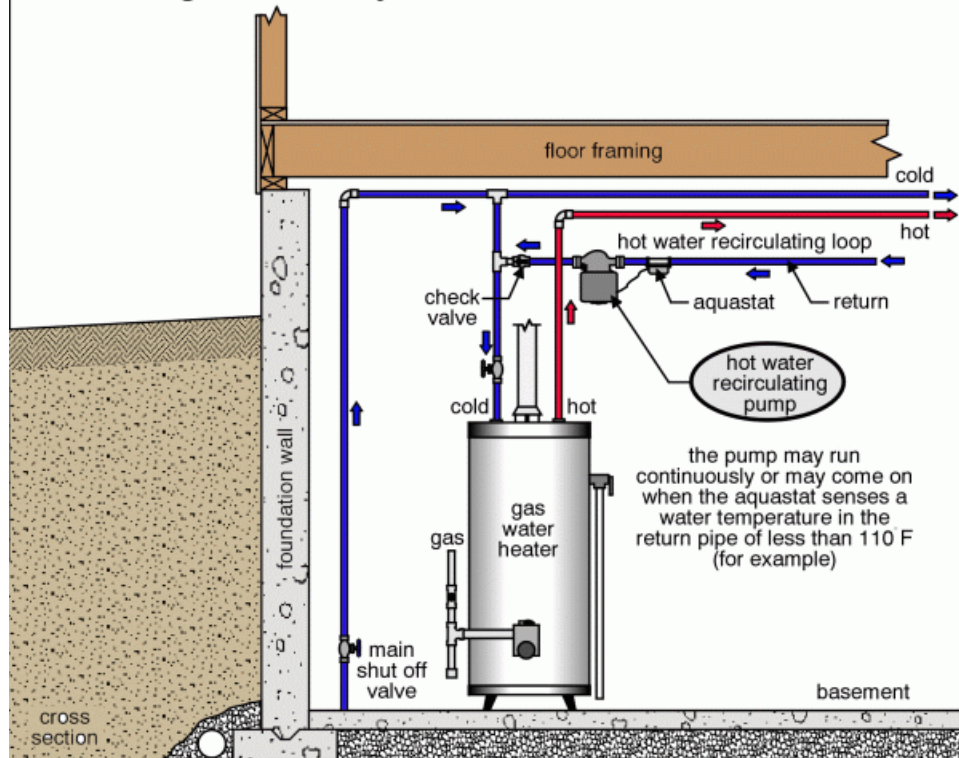
10. Condition: • [Inoperative](#)

Secondary pump not working. Main pump working well.

Implication(s): Delayed delivery of hot water

Circulating hot water system

Task: Replace
