Your Inspection Report

48 Galley Avenue
Toronto, ON M6R 1G8

Wednesday, November 1, 2017

RE: Report No. 2342
48 Galley Avenue
Toronto, ON
M6R 1G8

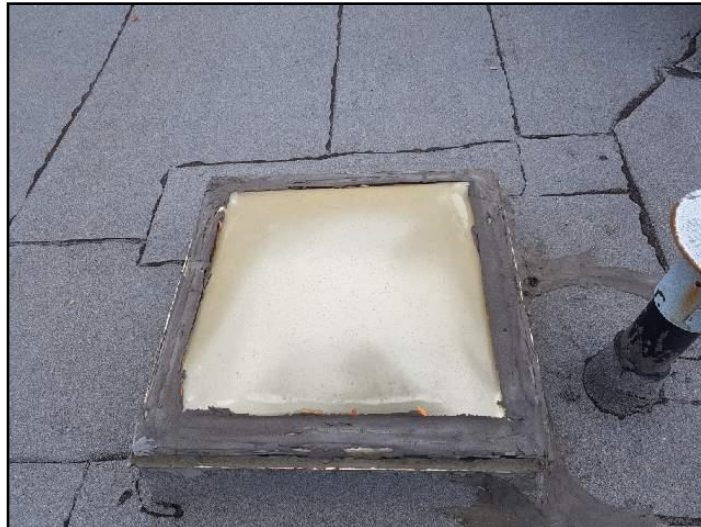
1. Condition: • Patched

Older skylight was reused at reroofing and is in poor condition, replace caulking and maintain as needed or replace skylight.

3. Patched

Task: Repair or replace

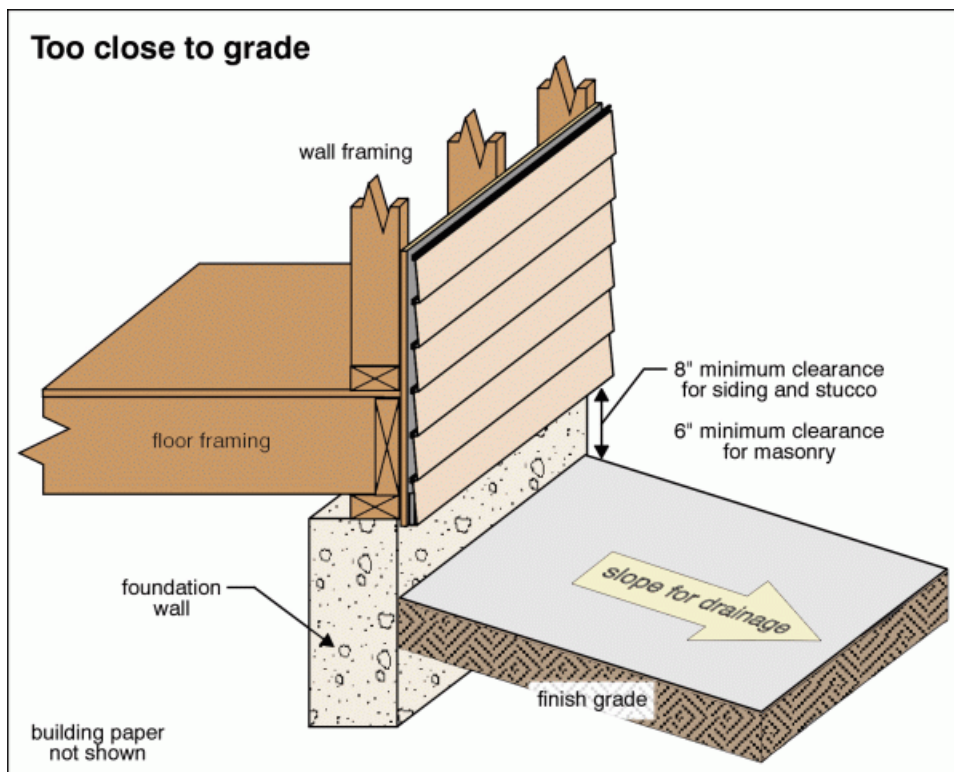
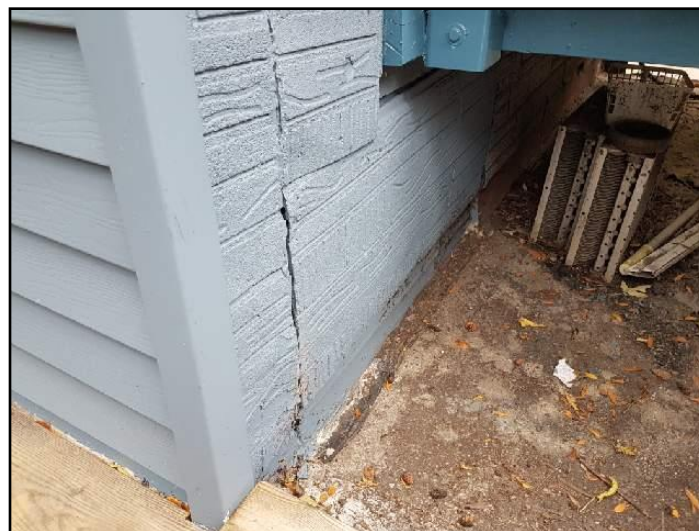
3. Condition: • [Too close to grade](#)

Ideally siding and wood structure would begin well above grade. Some rot evident, further evaluate foundation when residing.

4. Wood soil contact

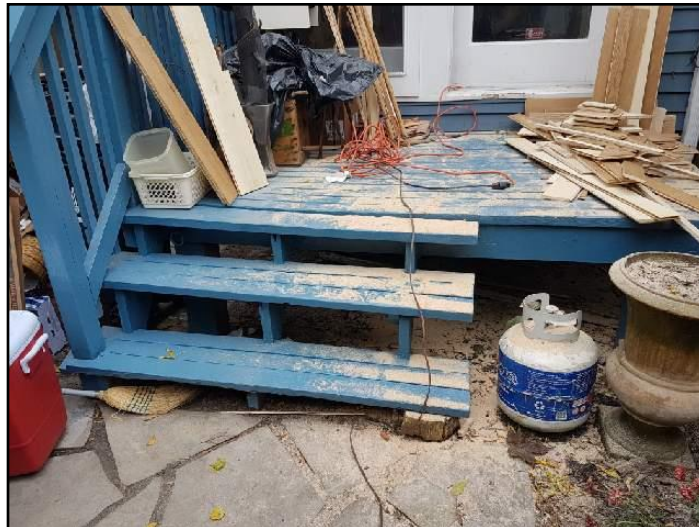
4. Condition: • Trip hazard

5. Trip hazard

Replace steps at north deck.

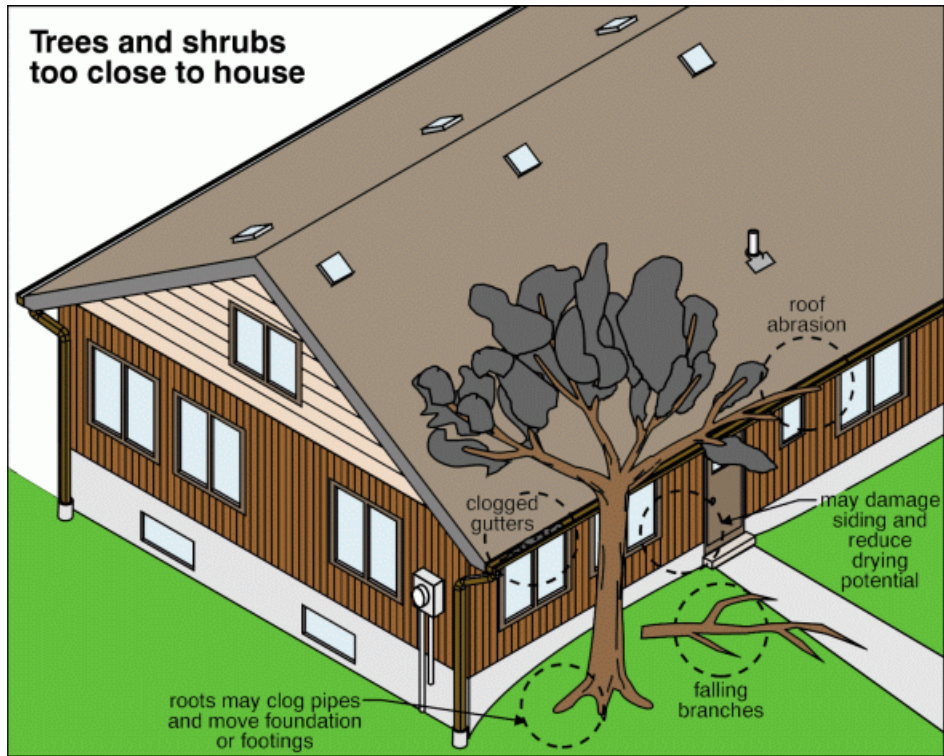
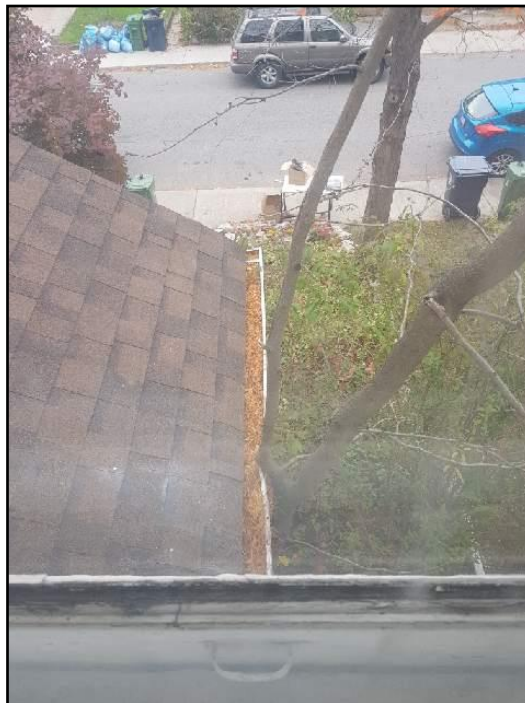
5. **Condition:** • [Trees or shrubs too close to building](#)

Implication(s): Chance of water damage to contents, finishes and/or structure | Chance of pests entering building |

6. Tree too close to building

Task: Remove

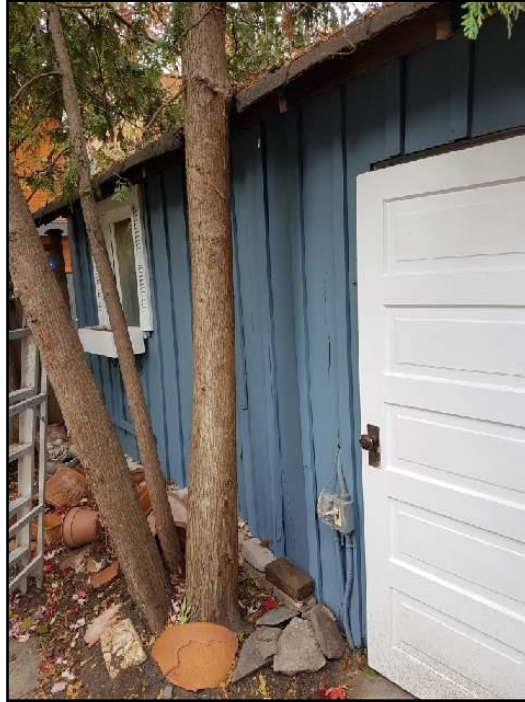
6. Condition: • Typical low quality structure

Implication(s): Chance of water entering building | Chance of structural movement | Chance of pests entering building | Physical injury

7. Typical low quality structure

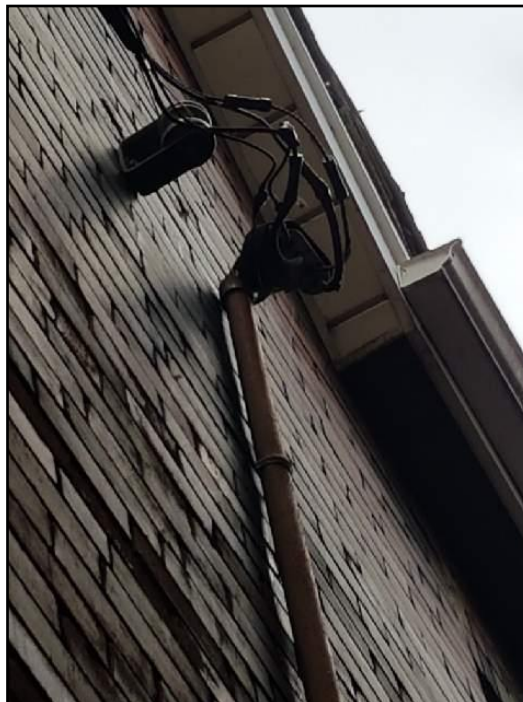
7. Condition: • Disconnect flat rate service wires. No longer permitted by utility.

8. Disconnect flat rate service wires. No...

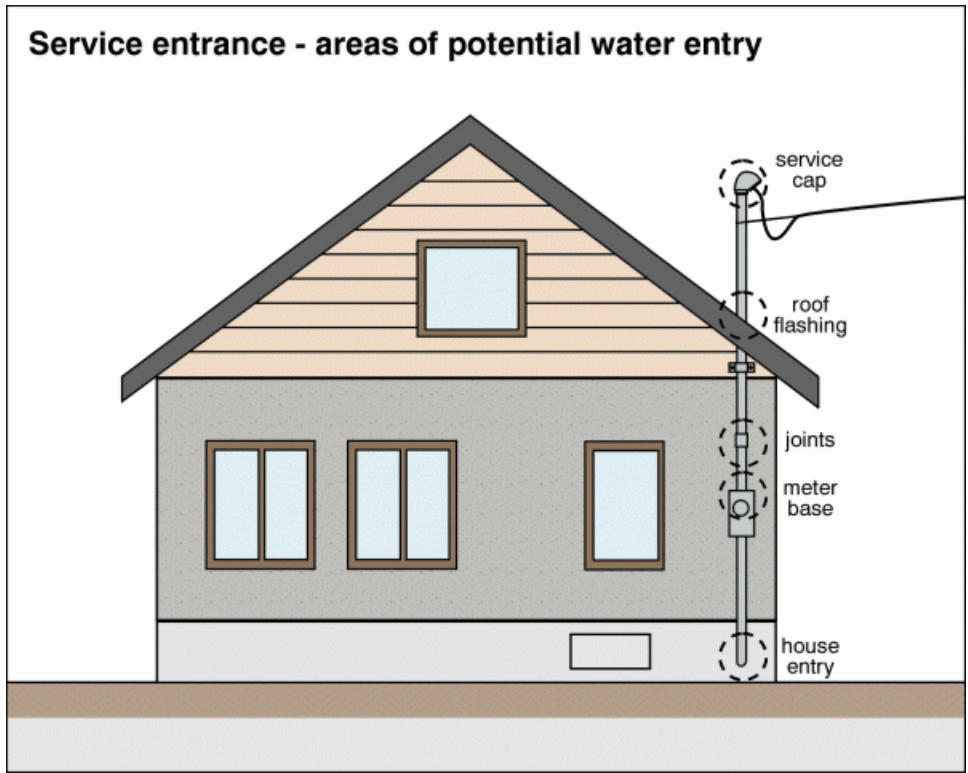
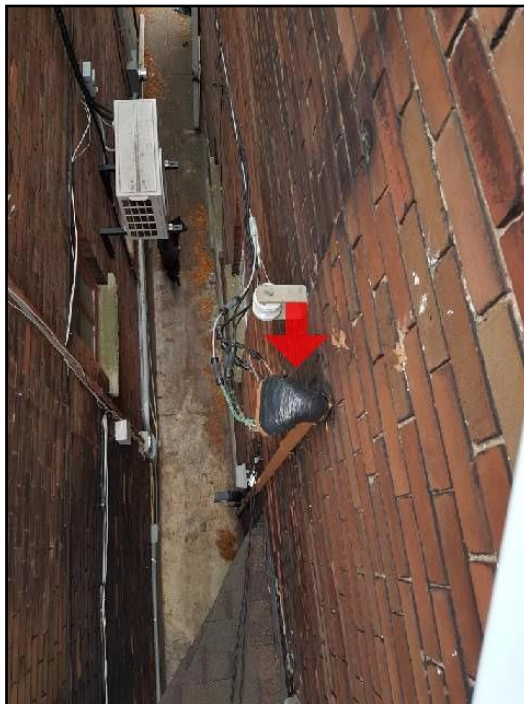
8. Condition: • [Mast not weather-tight](#)

Implication(s): Electric shock

9. Mast not weather-tight

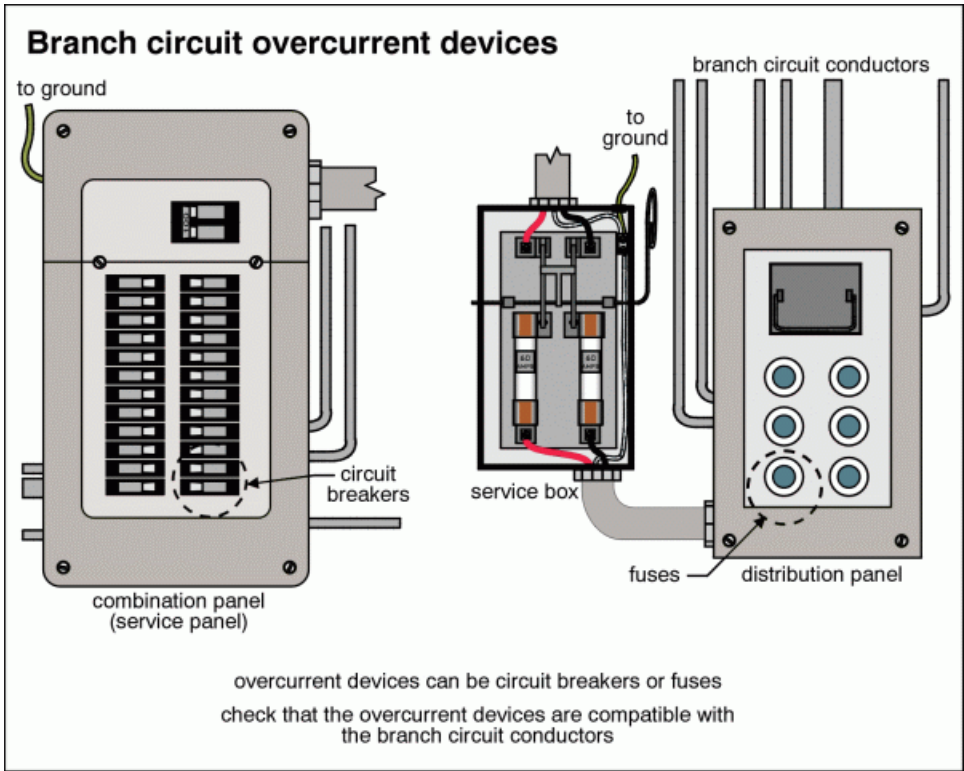
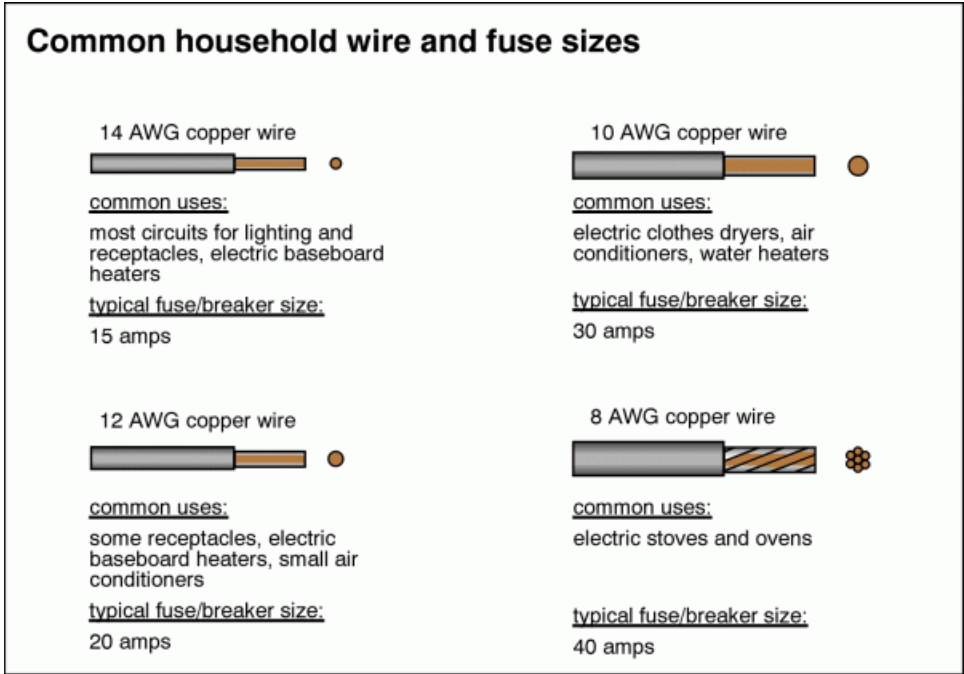
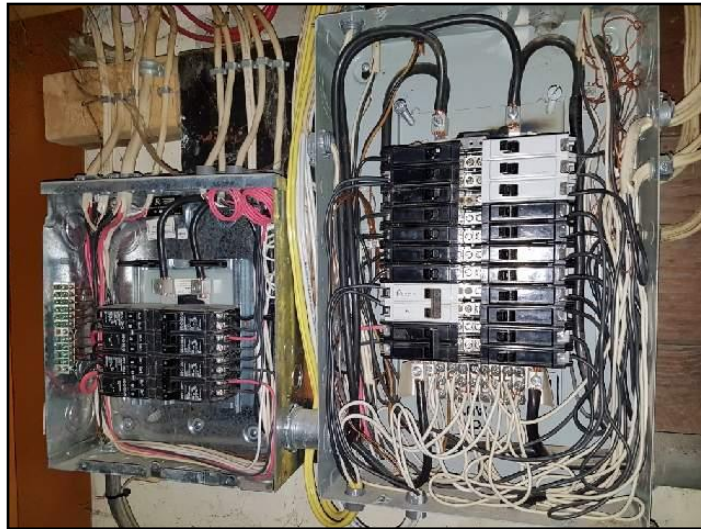
10. Condition: • [Fuses or breakers too big](#)

Implication(s): Equipment overheating | Fire hazard

10. Breaker too big

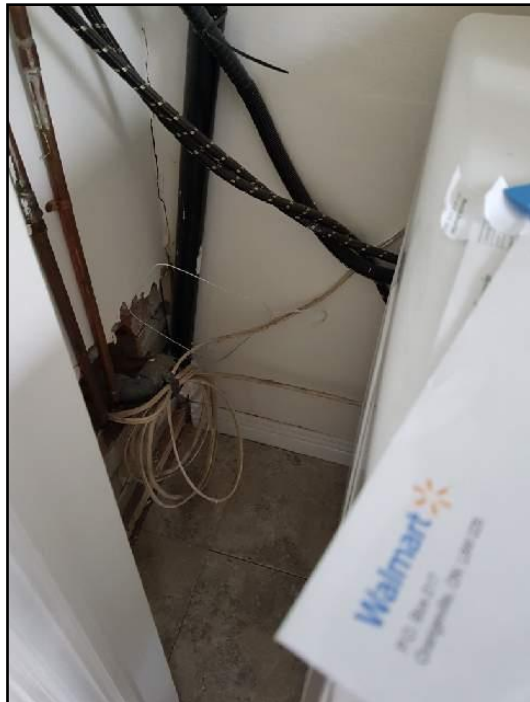
11. Condition: • [Exposed on walls or ceilings](#)

11. Exposed on walls or ceilings

Protect exposed wiring with conduit.

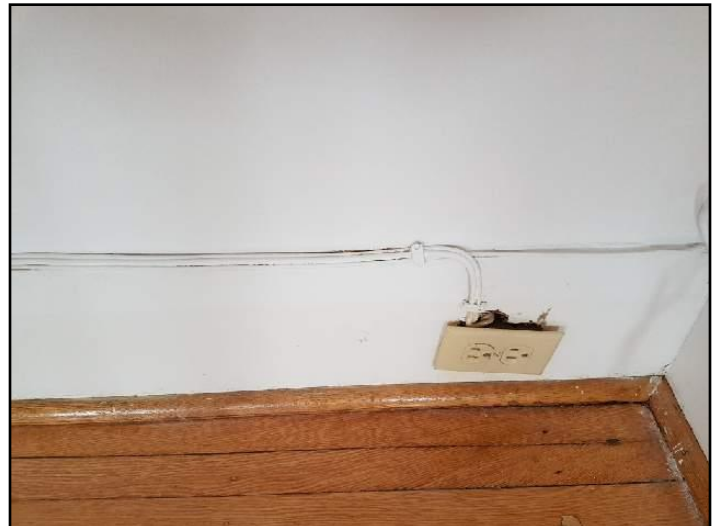
12. Exposed on walls or ceilings

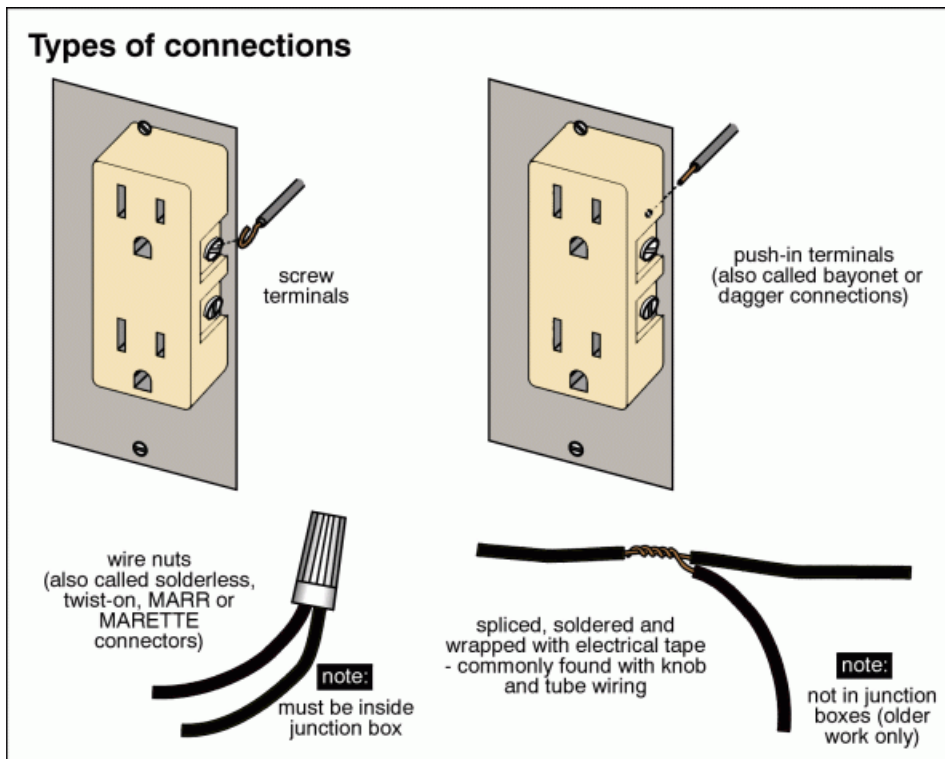
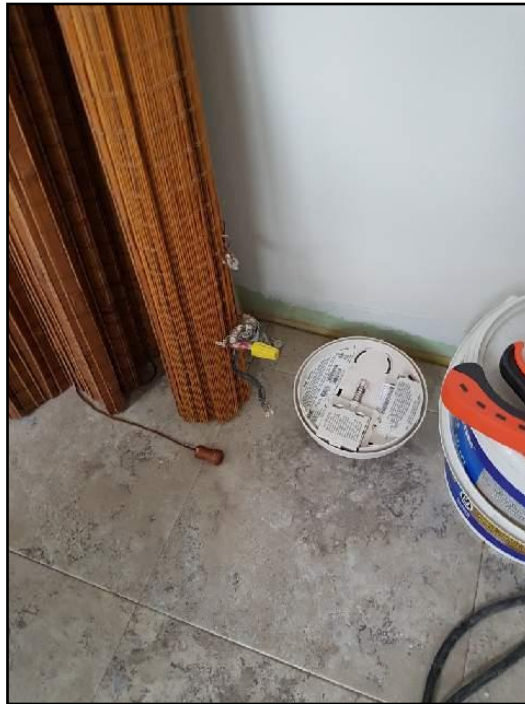
12. Condition: • [Missing, loose](#)

Implication(s): Electric shock | Fire hazard

13. Missing, loose

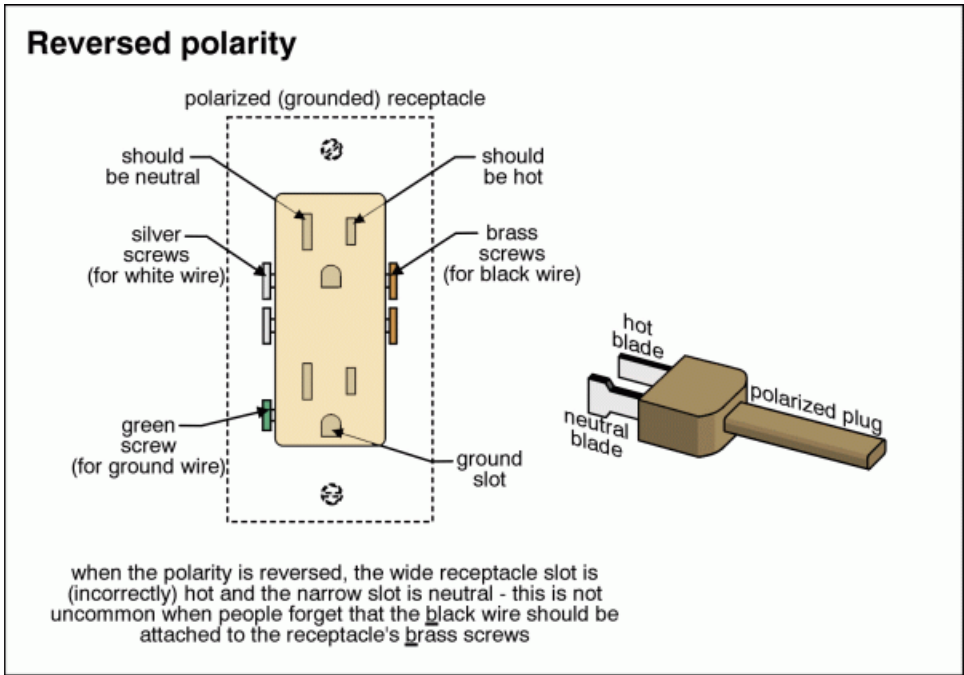
13. Condition: • [Reversed polarity](#)

Implication(s): Electric shock

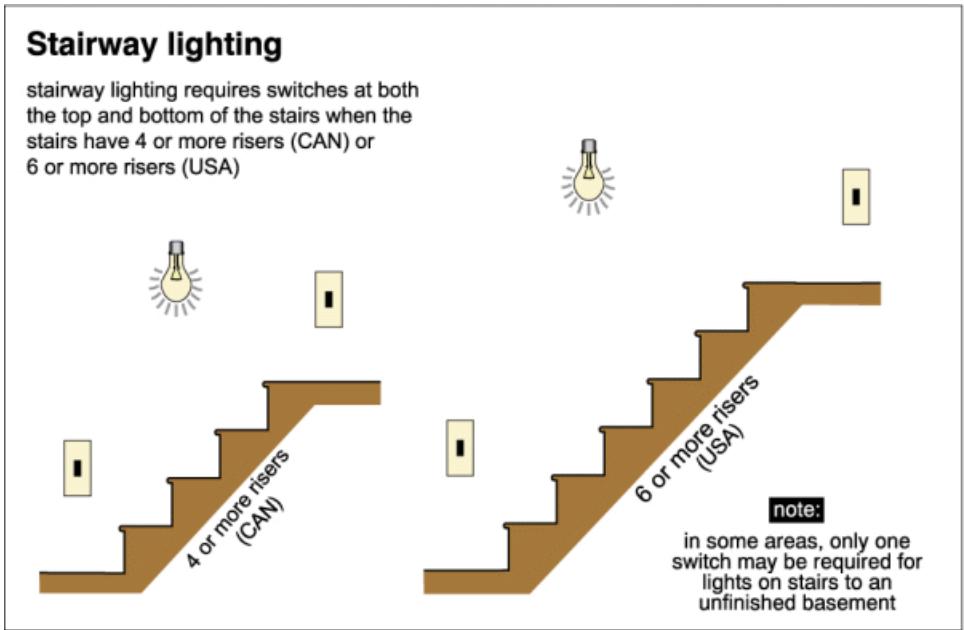
14. Condition: • [Poor stairway lighting](#)

Implication(s): Trip or fall hazard

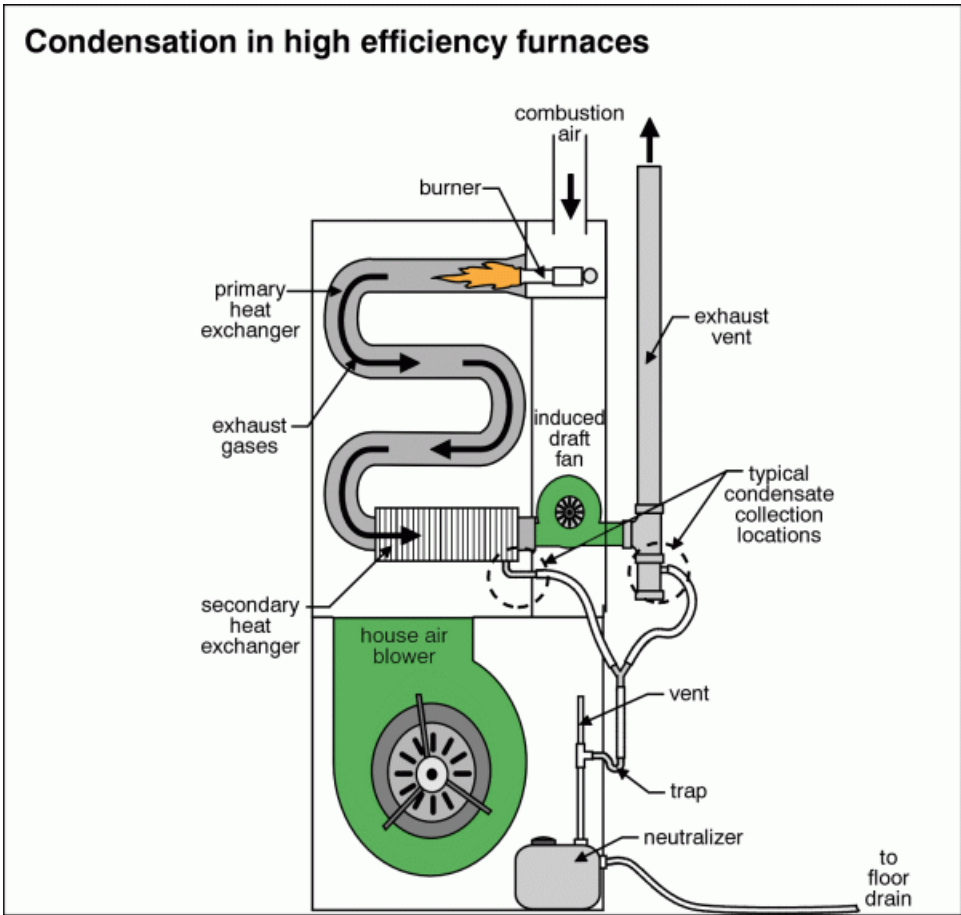
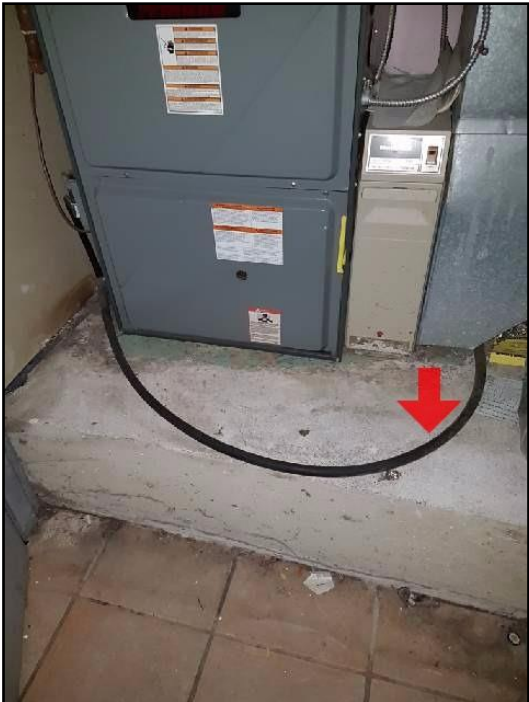
16. Condition: • [Condensate problems](#)

Implication(s): Chance of water damage to contents, finishes and/or structure | Reduced system life expectancy

16. Condensate problems

Add condensate pump at furnace room.

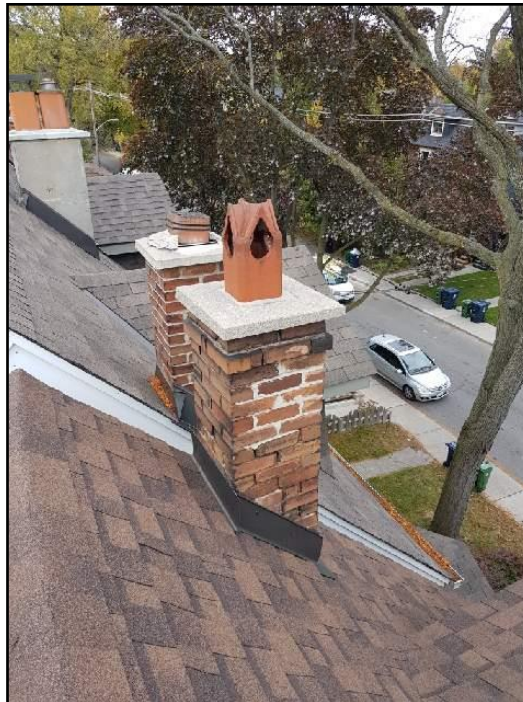
18. Condition: • Fireplace lacks flue liner and hearth clearances required by today's standards, insurance company may request retrofit.

17. Unlined flue
