# Your Inspection Report

119 Fern Avenue  
Toronto, ON M6R 1K2

Wednesday, November 22, 2017

RE: Report No. 2362, v.2  
119 Fern Avenue  
Toronto, ON  
M6R 1K2

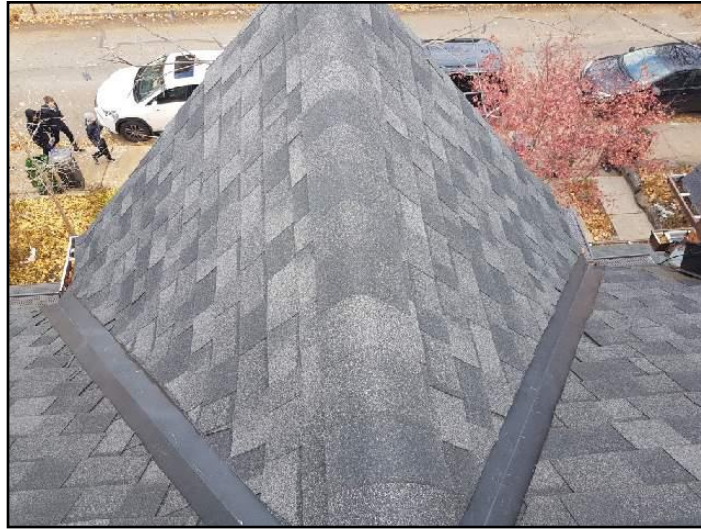
1. *Asphalt shingles*

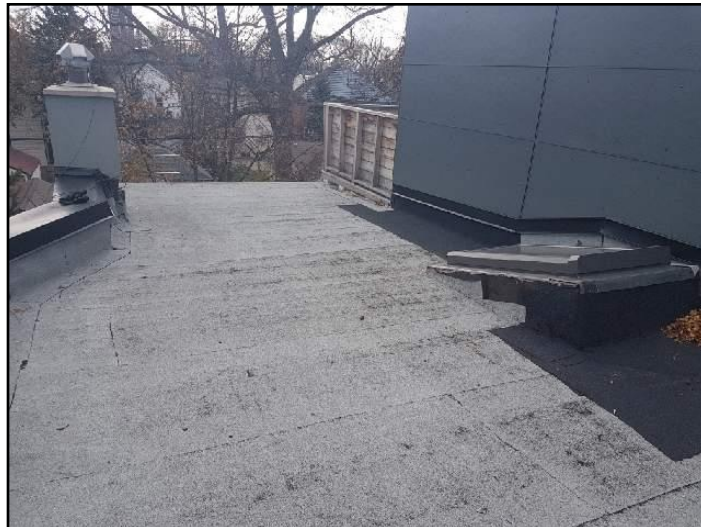
2. *Modified bitumen membrane*

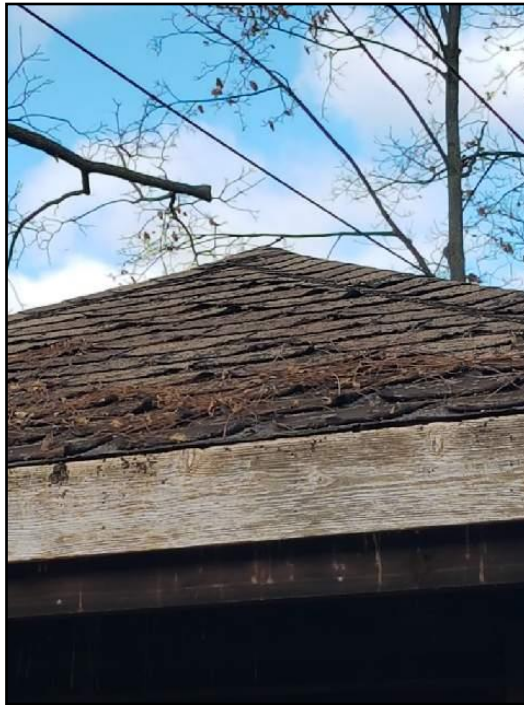
2. **Condition:** • [Old, worn out](#)

**Implication(s):** Chance of water damage to contents, finishes and/or structure

**Location:** Carport

3. *Old, worn out*

Strip and reshingle carport.

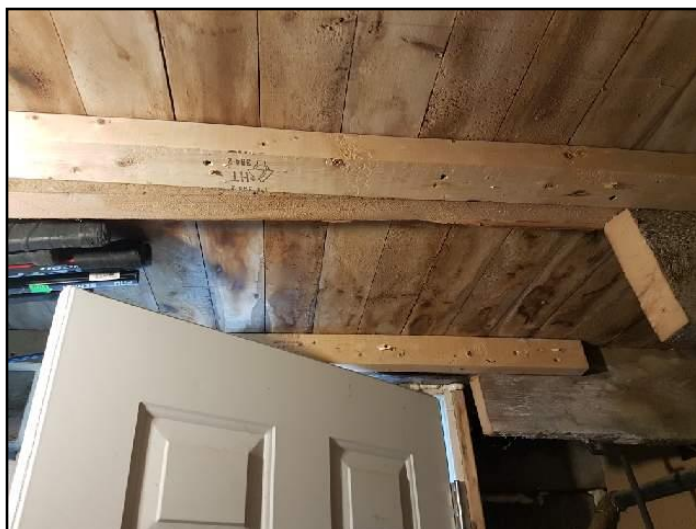
**3. Condition:** • Too weak for structure. Improve spacing and/or end bearing.

**Location:** North Porch

4. Notched joists

Strengthen joists cut to allow for door clearance.

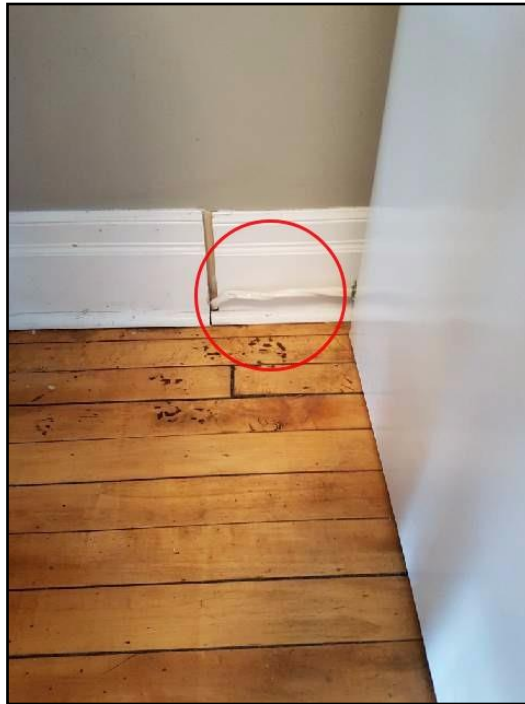
**5. Condition:** • [Exposed on walls or ceilings](#)

**Implication(s):** Electric shock

**Location:** Kitchen

5. Exposed on walls or ceilings

Protect exposed wiring with conduit.

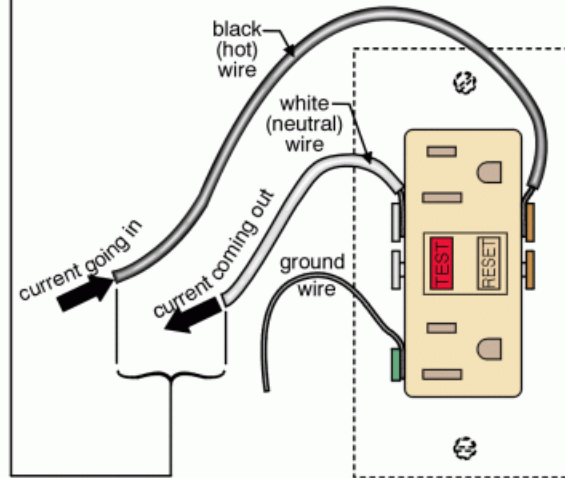
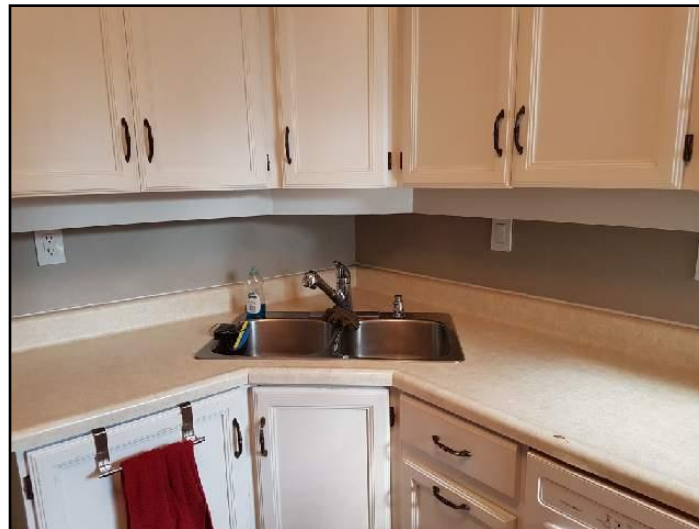
6. Condition: • [GFCI/GFI needed \(Ground Fault Circuit Interrupter\)](#)

**Implication(s):** Electric shock

**Location:** Kitchen

6. GFCI/GFI needed (Ground Fault Circuit...

Recommend gfci receptacles at all wet locations, including kitchen.

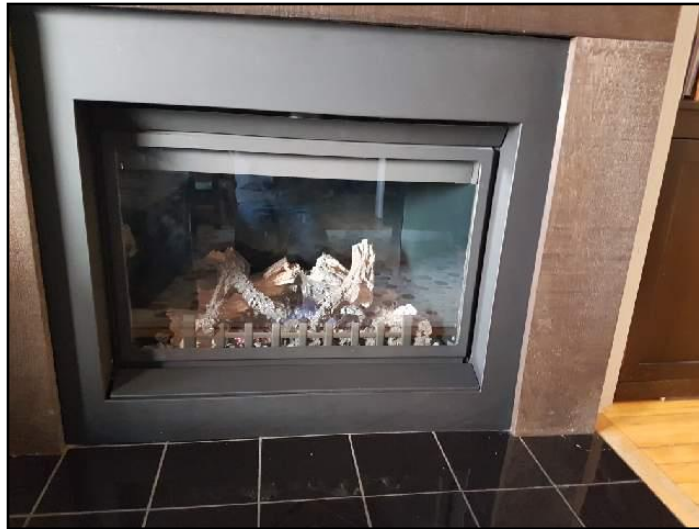
7. Gas fireplace

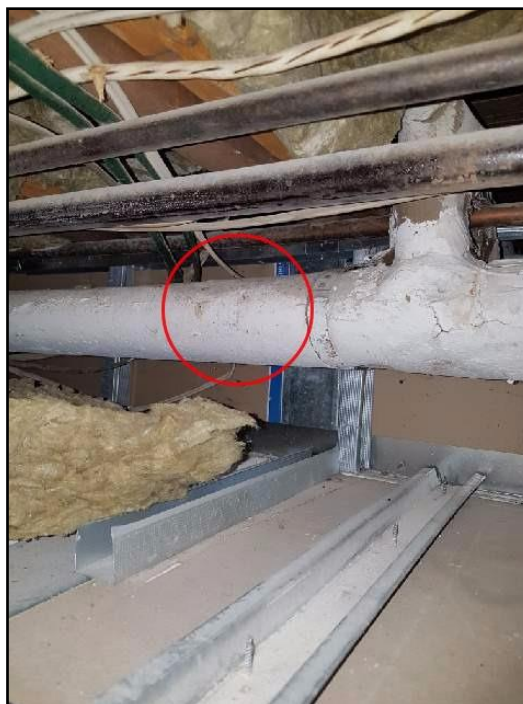
**7. Condition:** • Some asbestos pipe insulation present within ceiling, have professionally removed if necessary to disturb.

**Location:** Basement

8. Asbestos

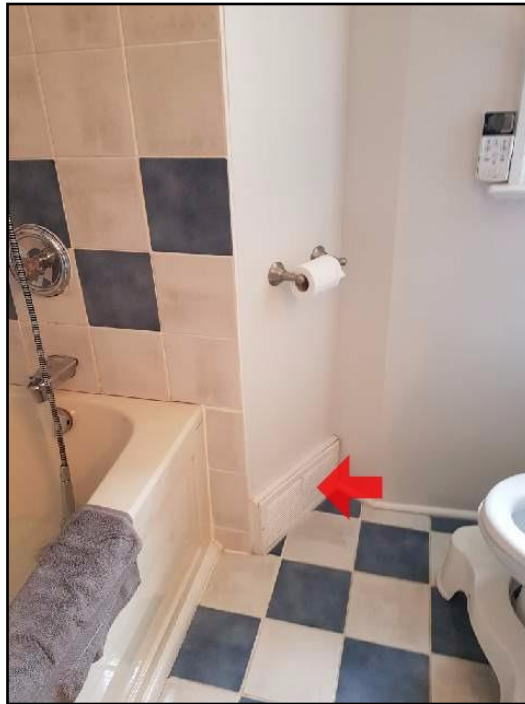
**8. Condition:** • [Obstructed airflow](#)

Bathroom rad is behind wall with small opening to allow heat into room.

**Implication(s):** Reduced comfort | Increased heating costs

**Location:** Second Floor Bathroom

9. *Obstructed airflow*

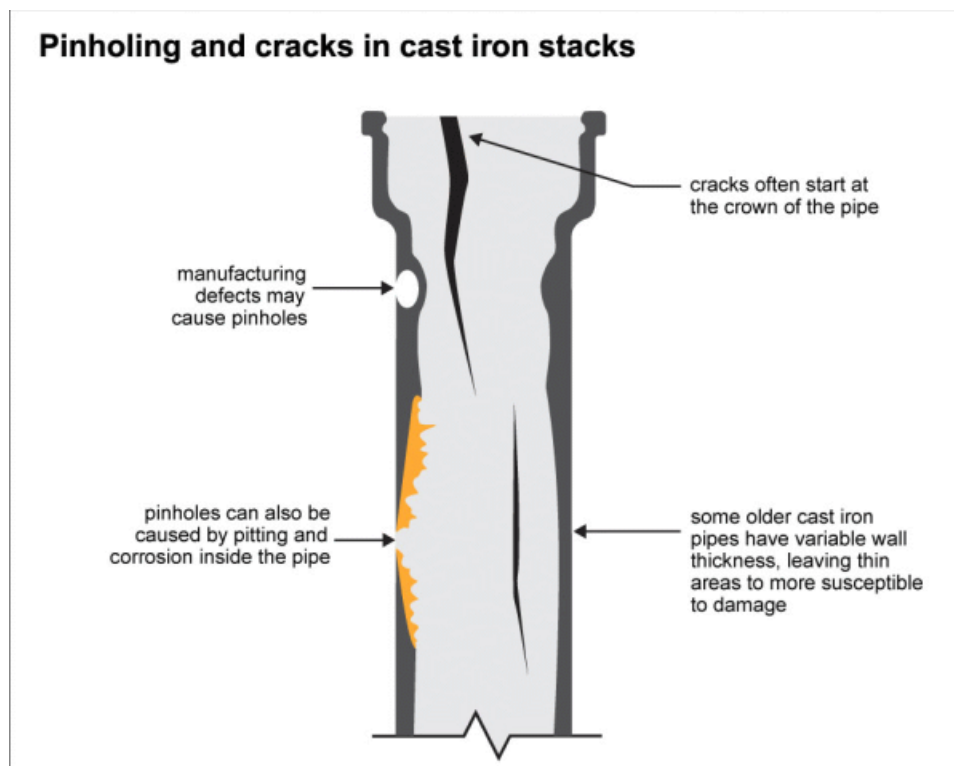
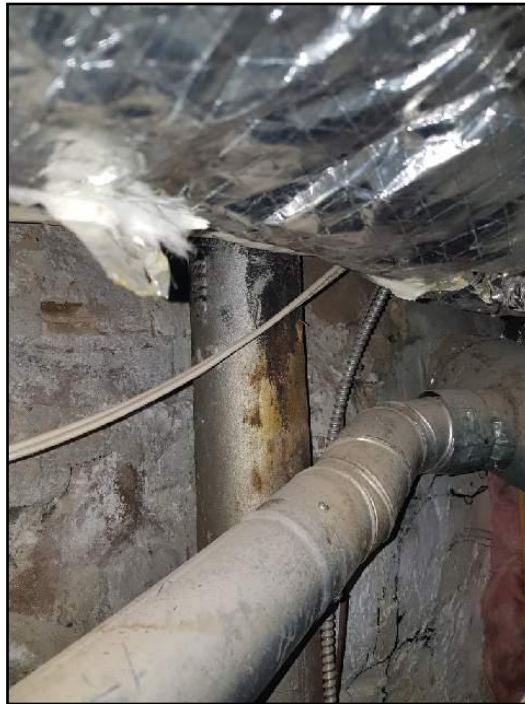
**11. Condition:** • [Rust](#)

Typical rust present on cast iron waste piping, replace when renovating. No leaks at time of inspection.

10. *Rust*

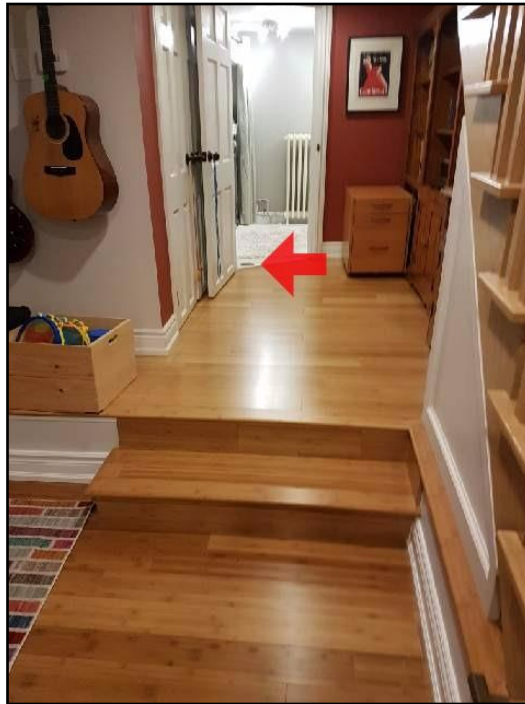
### **12. Condition:** • [Poor location](#)

Floor drain visible only at high portion of basement. Ideally would be present at lowered section. If one is not found, recommend installation.

**Implication(s):** Chance of water damage to contents, finishes and/or structure

11. Floor drain

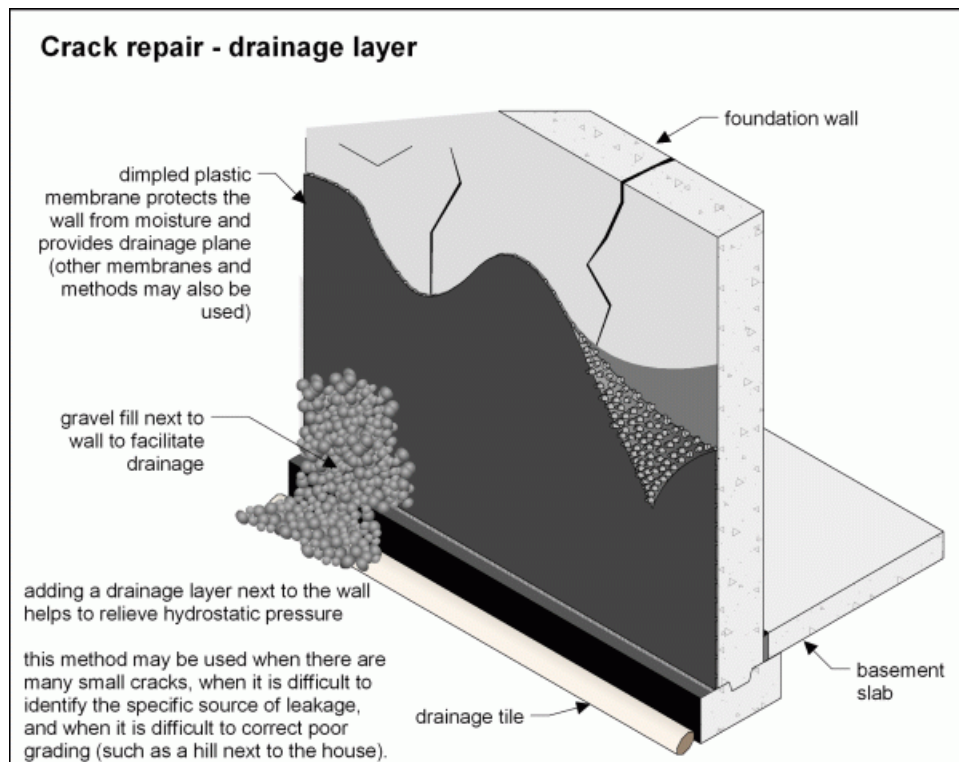
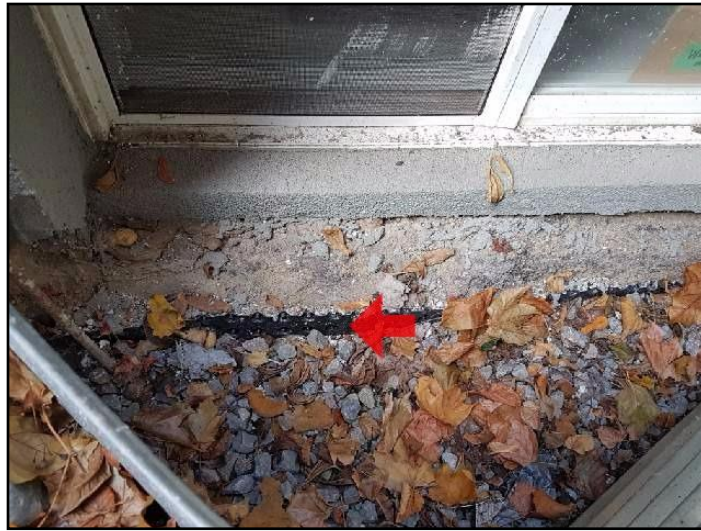
14. Condition: • [Drainage membrane](#)

Exterior membrane visible at s/e basement exterior, very low potential for leakage.

12. *Drainage membrane*
