Your Inspection Report

217 Northcliffe Boulevard
Toronto, ON M6E 3K8

Monday, February 5, 2018

RE: Report No. 2403
217 Northcliffe Boulevard
Toronto, ON
M6E 3K8

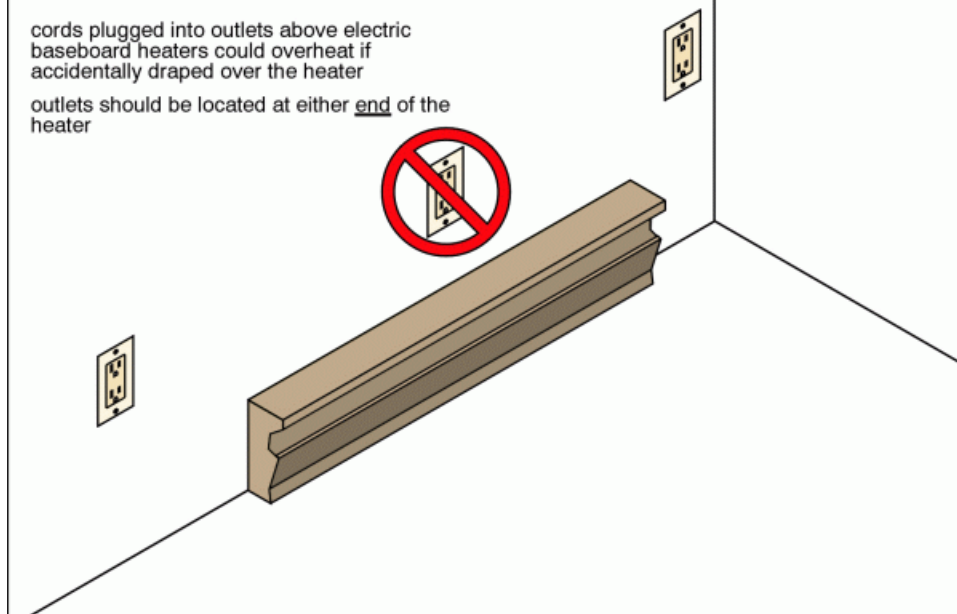
Outlets should not be above electric baseboard heaters

cords plugged into outlets above electric baseboard heaters could overheat if accidentally draped over the heater

outlets should be located at either end of the heater

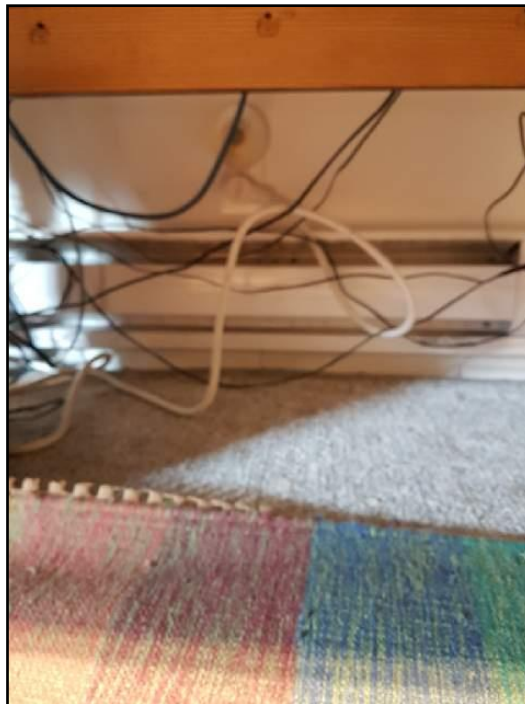
5. Condition: • [Above electric baseboard heaters](#)

Implication(s): Increased fire hazard

Location: Garage

1. Above electric baseboard heaters

Relocate outlet or heater.

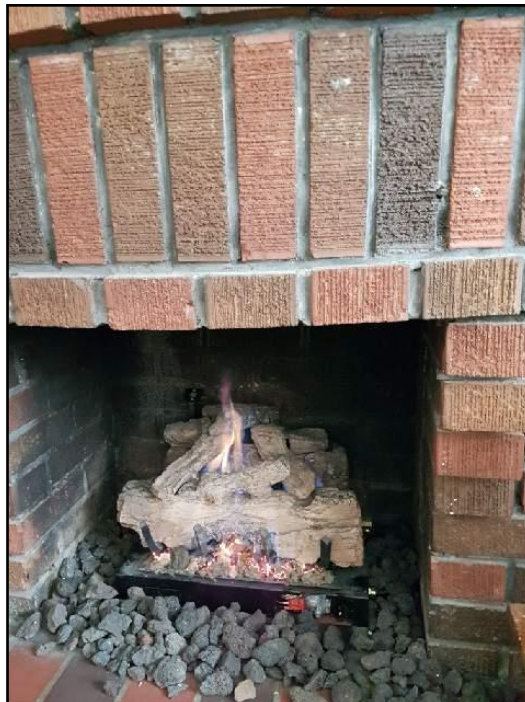
2. Gas logs

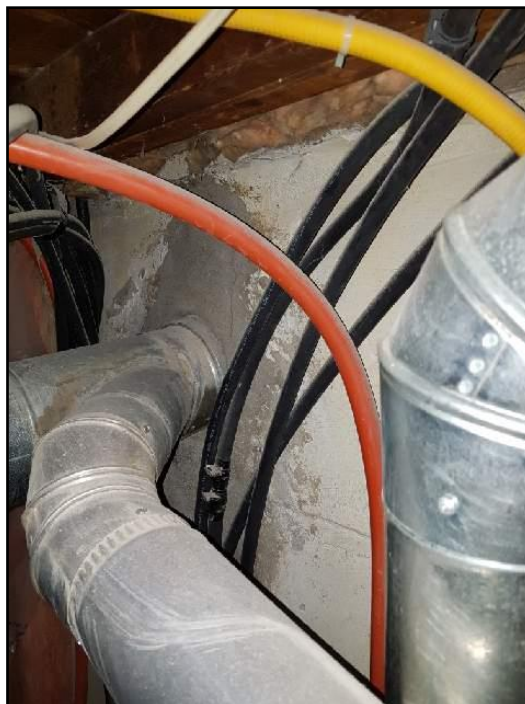
11. Condition: • [Combustible clearance](#)

Implication(s): Fire hazard

Location: Basement Utility Room

3. Combustible clearance

Isolate plastic piping from water heater exhaust flue with fibreglass insulation.

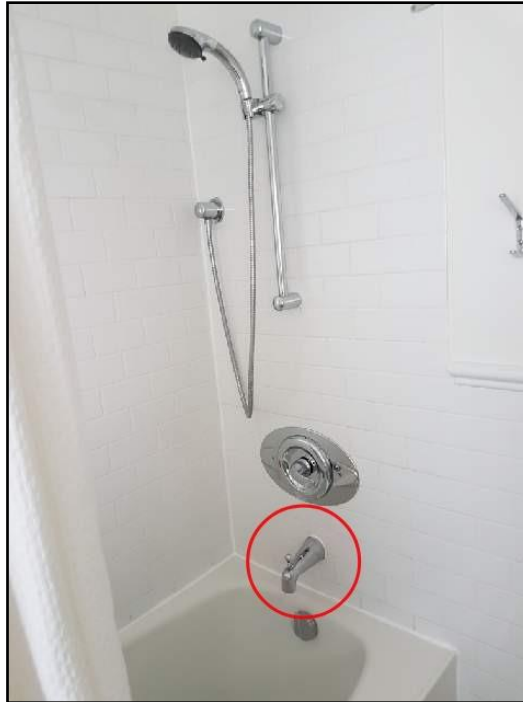
12. Condition: • [Shower diverter inoperative or defective](#)

Diverter does not send complete flow to shower head.

Location: Second Floor Bathroom

4. Shower diverter inoperative or defective

Task: Replace

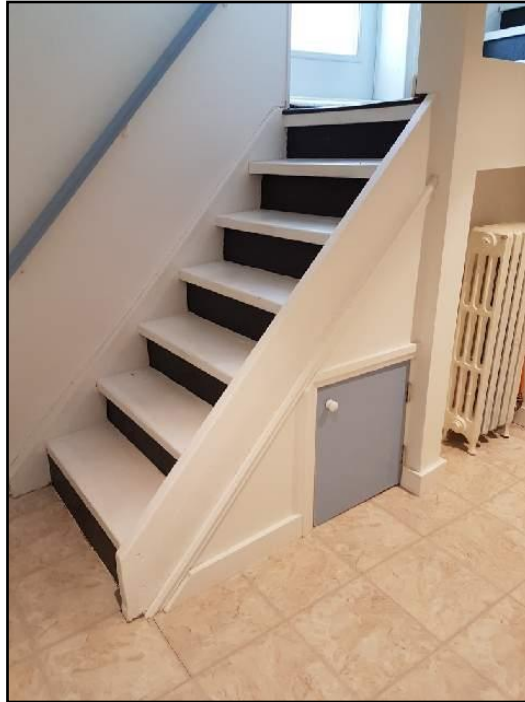
14. Condition: • [Missing](#)

Implication(s): Fall hazard

Location: Basement Staircase

5. Missing Guardrail

Task: Provide
