# Your Inspection Report

46 Connolly Street  
Toronto, ON M6N 5G3

RE: Report No. 2434, v.3  
46 Connolly Street  
Toronto, ON  
M6N 5G3

Stacked condominium townhouse constructed in 2002.

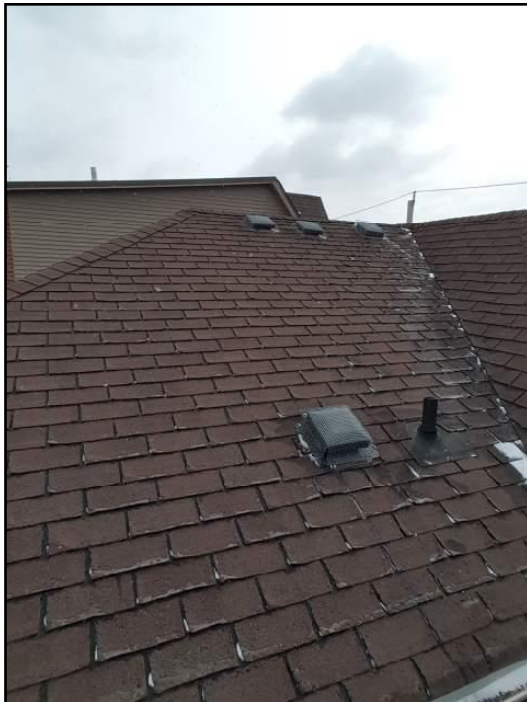
Shingles worn and due for replacement. This is likely the responsibility of the condo corp.

1. Near end of life expectancy

**Task:** Replace

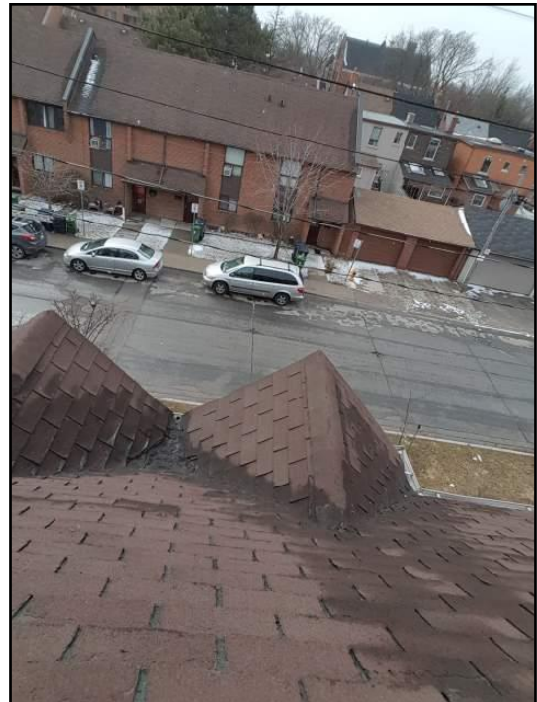
2. Worn out

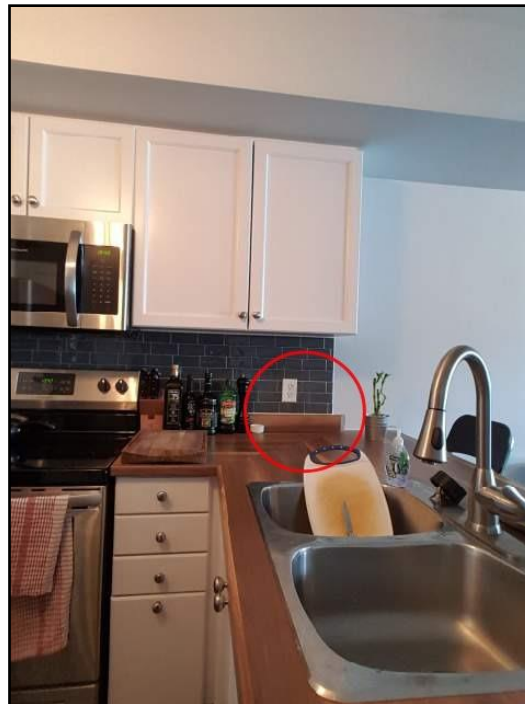
**6. Condition:** • [GFCI/GFI needed \(Ground Fault Circuit Interrupter\)](#)

**Implication(s):** Electric shock

3. GFCI/GFI needed (Ground Fault Circuit...

**Task:** Replace

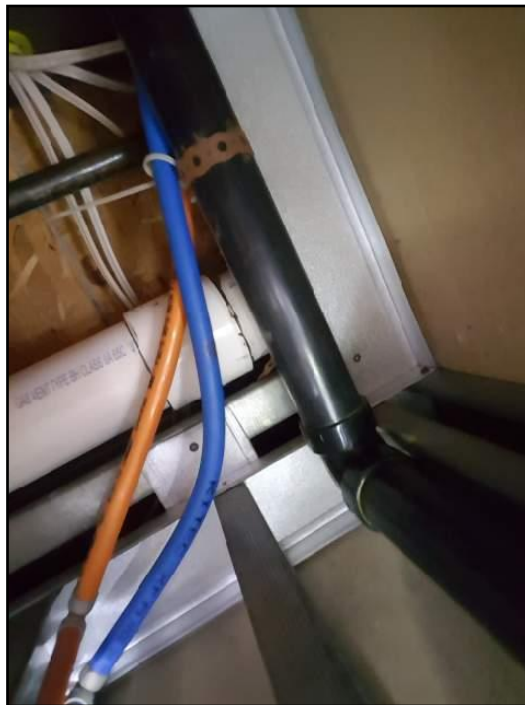
Supply piping throughout is primarily Kitec plastic which is prone to failure at connectors. Some insurers do not insure this material and will require replacement. Replacement recommended.

5. Kitec

**Task:** Replace

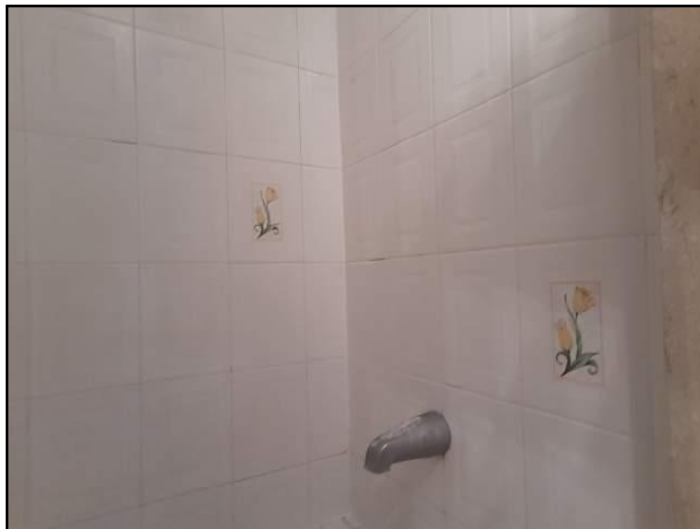
Some grout replacement needed at shower stall tile.

6. Grout missing or deteriorated

**Task:** Repair
