Your Inspection Report

618 Curzon Avenue
Mississauga, ON L5G 1P9

Monday, March 12, 2018

RE: Report No. 2432
618 Curzon Avenue
Mississauga, ON
L5G 1P9

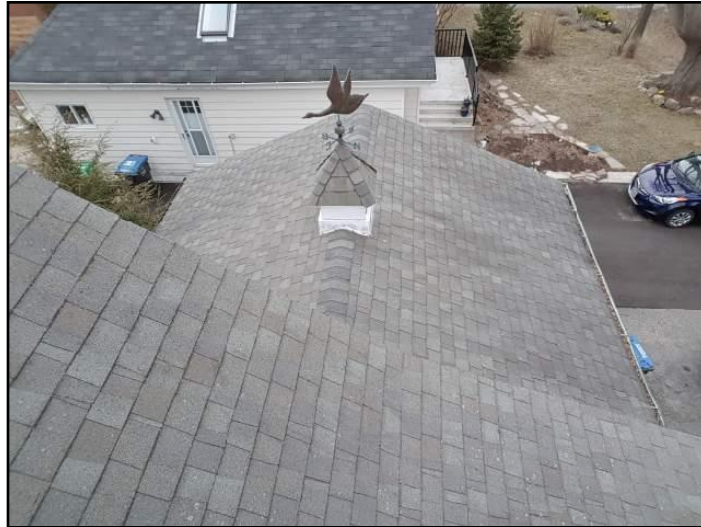
1. *Asphalt shingles*

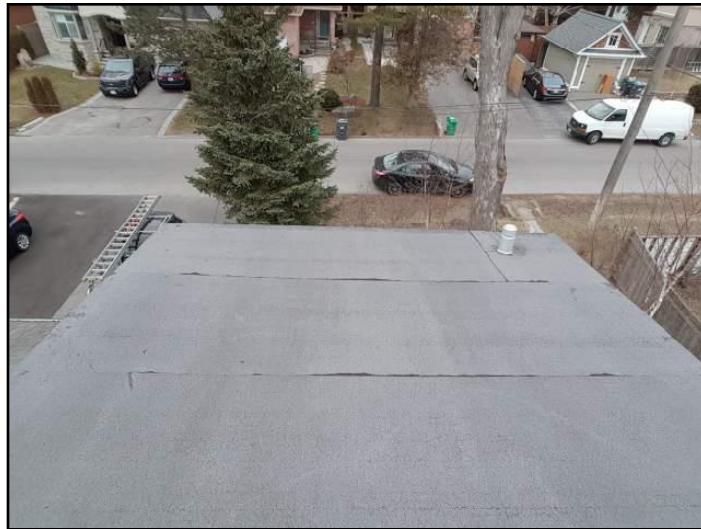
2. *Modified bitumen membrane*

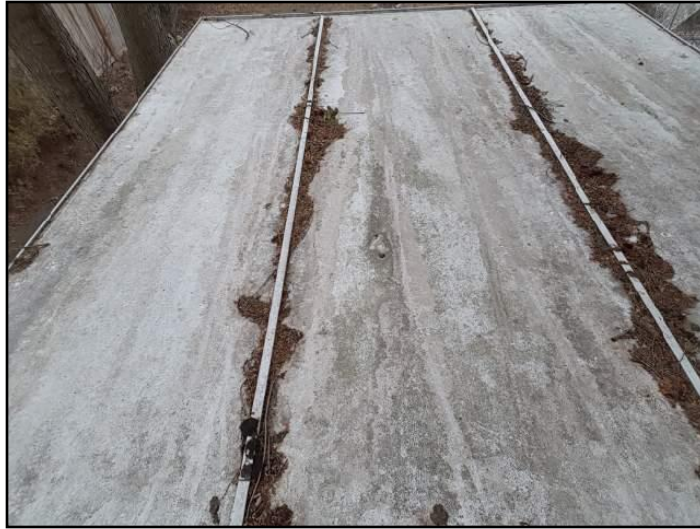
3. Metal

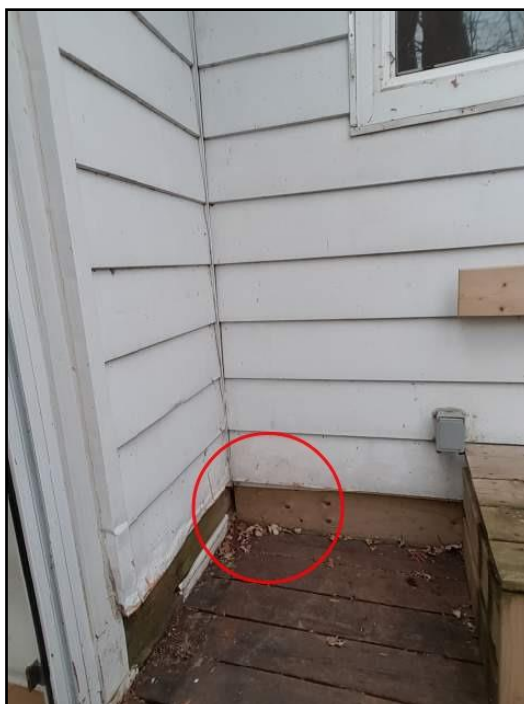
2. Condition: • [Flashings incomplete or ineffective](#)

Implication(s): Chance of water damage to contents, finishes and/or structure

Location: Southeast Exterior Wall

4. Flashings incomplete

Finish siding base with metal to protect exposed wood.

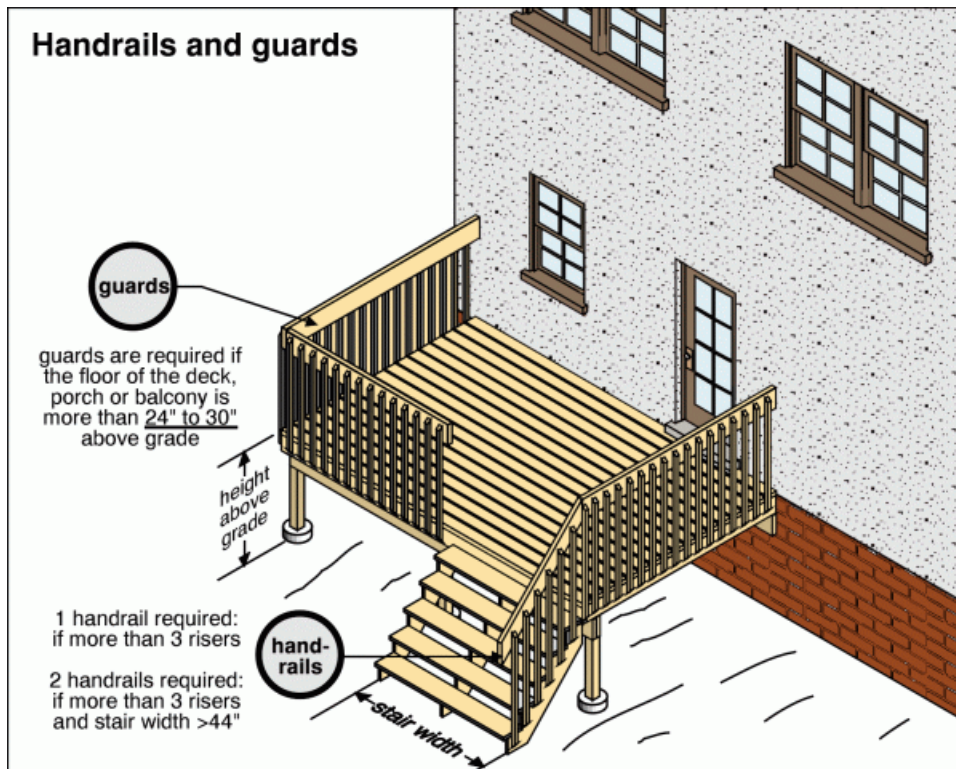
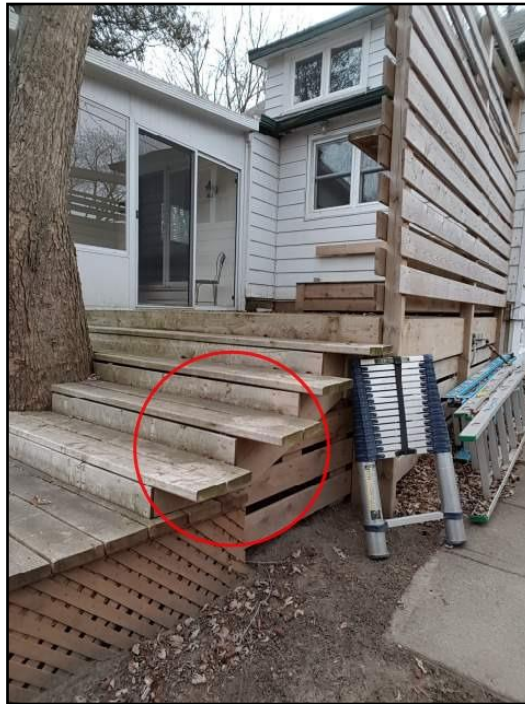
3. Condition: • [Missing](#)

Implication(s): Fall hazard

Location: South Exterior

5. Missing guardrail

Task: Provide

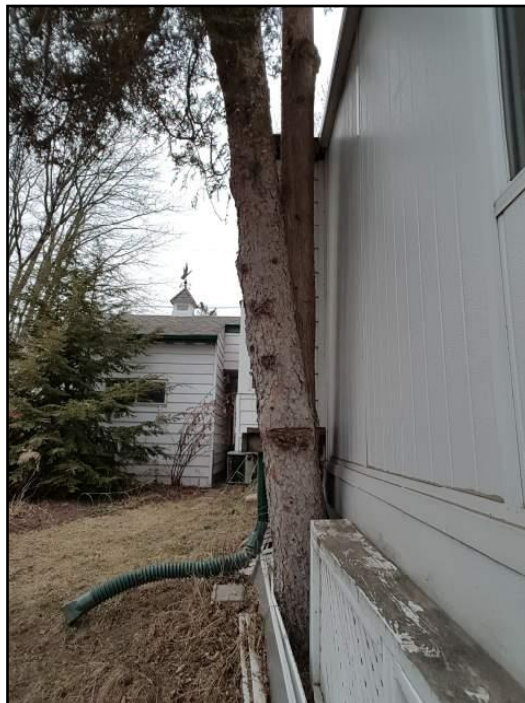
4. Condition: • [Trees or shrubs too close to building](#)

Implication(s): Chance of water damage to contents, finishes and/or structure | Chance of pests entering building | Material deterioration

Location: Southwest Exterior

6. Trees or shrubs too close to building

Task: Monitor

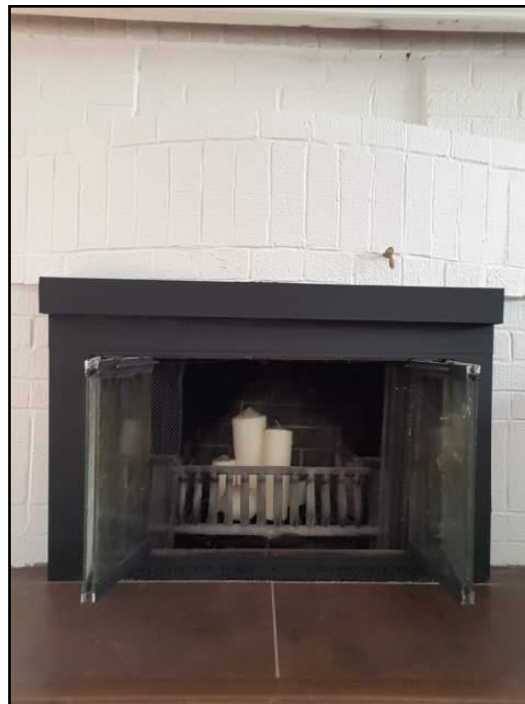
7. Wood-burning fireplace

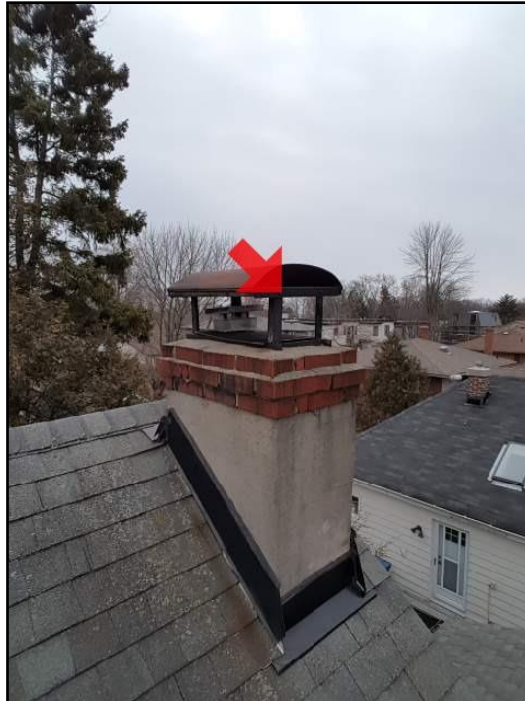
8. Condition: • Fireplace lacks flue liner and hearth clearances required by todays standards, insurance company may request retrofit.

Location: First Floor

8. Unlined flue

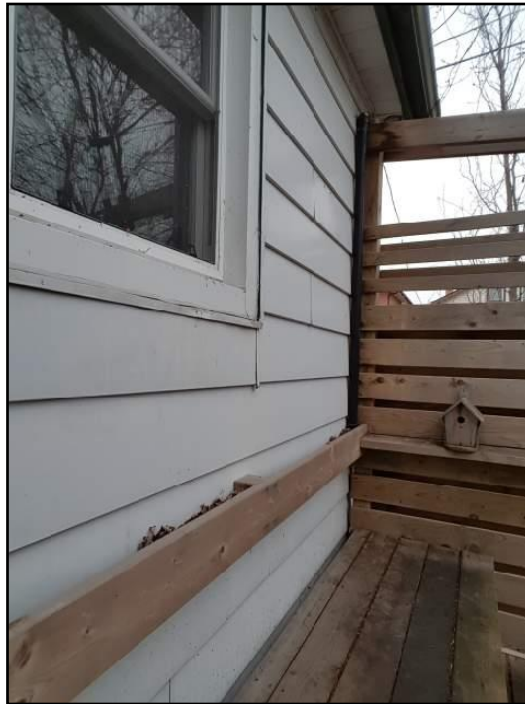
11. Condition: • [Poor vent pipe arrangements](#)

Implication(s): Sewer gases entering the building

Location: South Exterior Wall

9. Poor vent pipe arrangements

Enlarge and relocate vent pipe from kitchen sink if odours or slow drains are noticed.

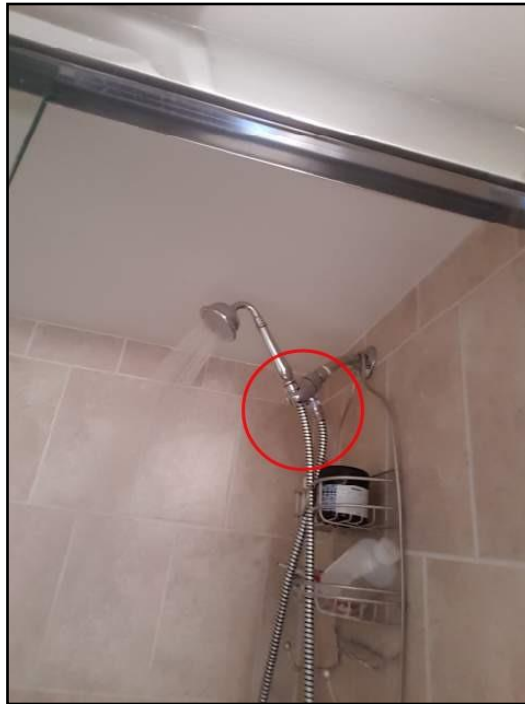
12. Condition: • [Drip, leak](#)

Implication(s): Chance of water damage to contents, finishes and/or structure

Location: Basement Shower

10. *Drip, leak*

Task: Repair
