# Your Inspection Report

133 Macdonell Avenue  
Toronto, ON M6R 2A4

RE: Report No. 2464  
133 Macdonell Avenue  
Toronto, ON  
M6R 2A4

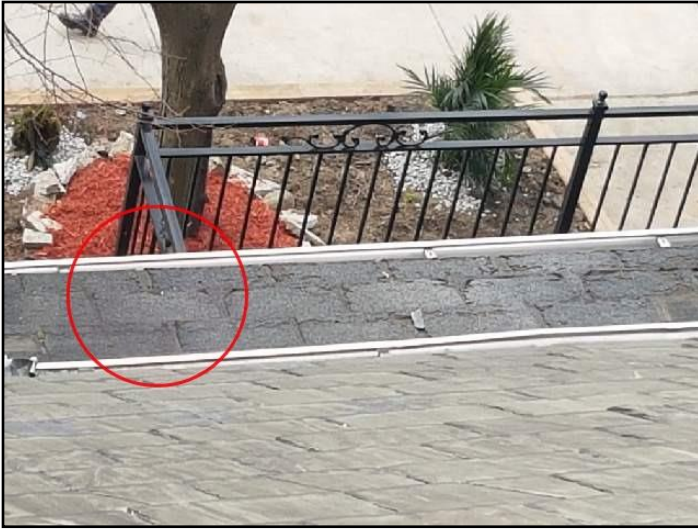
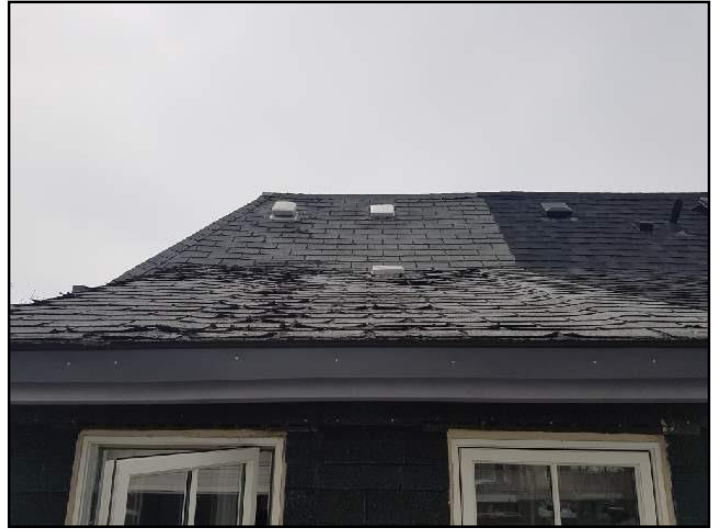
1. **Condition:** • [Old, worn out](#)

Strip and reshingle areas with asphalt shingles.

4. Old, worn out

5. Old, worn out

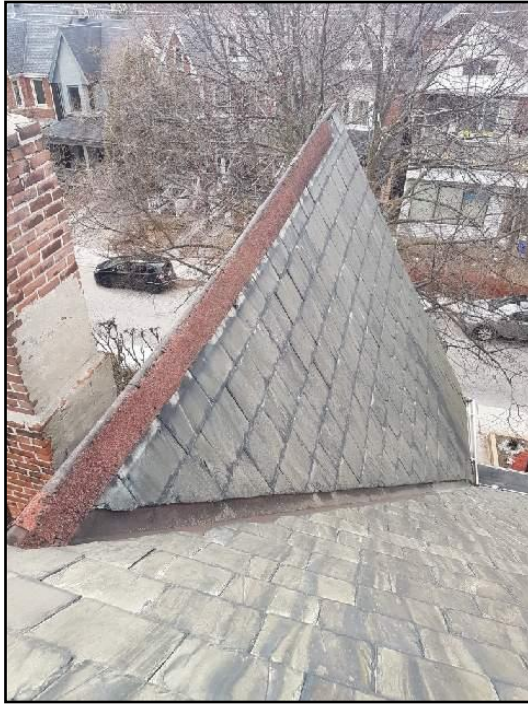
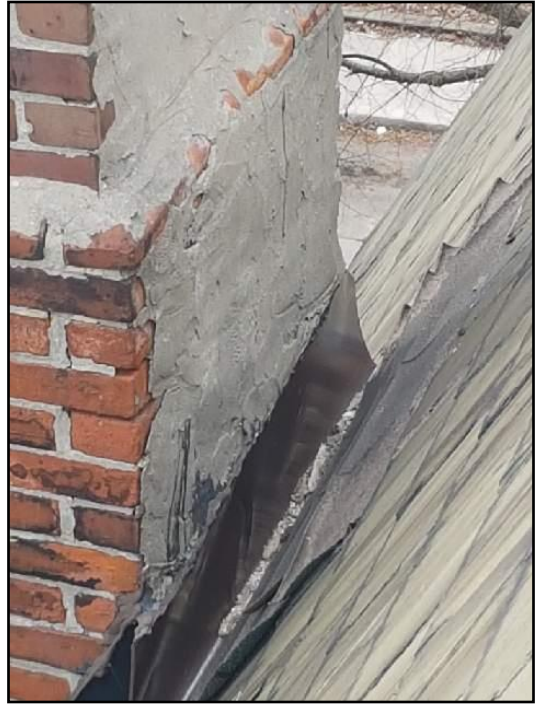
### 2. Condition: • [Patched](#)

Original slate will require annual inspection and periodic repair/maintenance. Previously patched areas in poor condition and need repair.

6. Patched

7. Patched

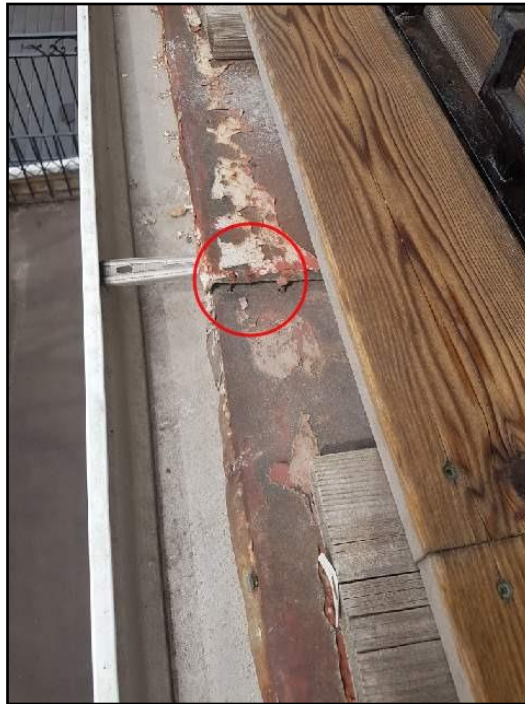
**3. Condition:** • [Open, loose seams](#)

8. *Damage*

**Task:** Repair

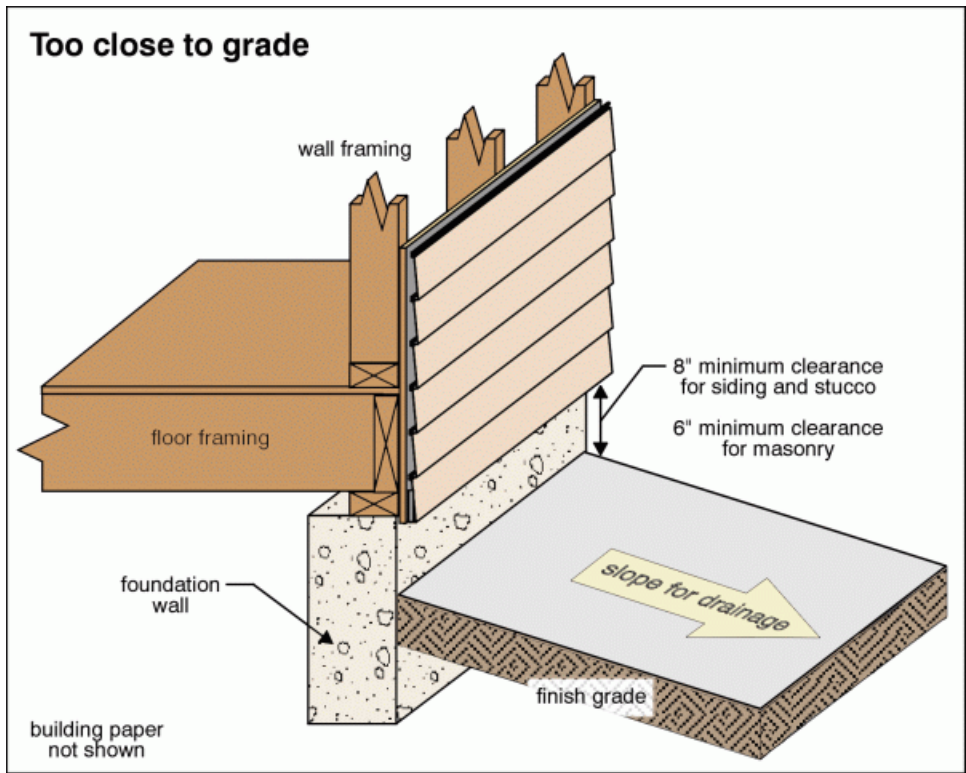
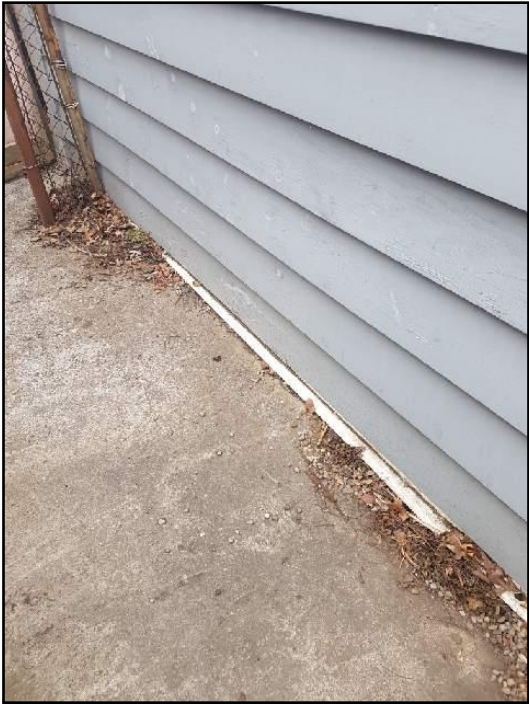
**4. Condition:** • [Too close to grade](#)

Ideally wood siding would begin 8 or more inches above grade.

9. Too close to grade

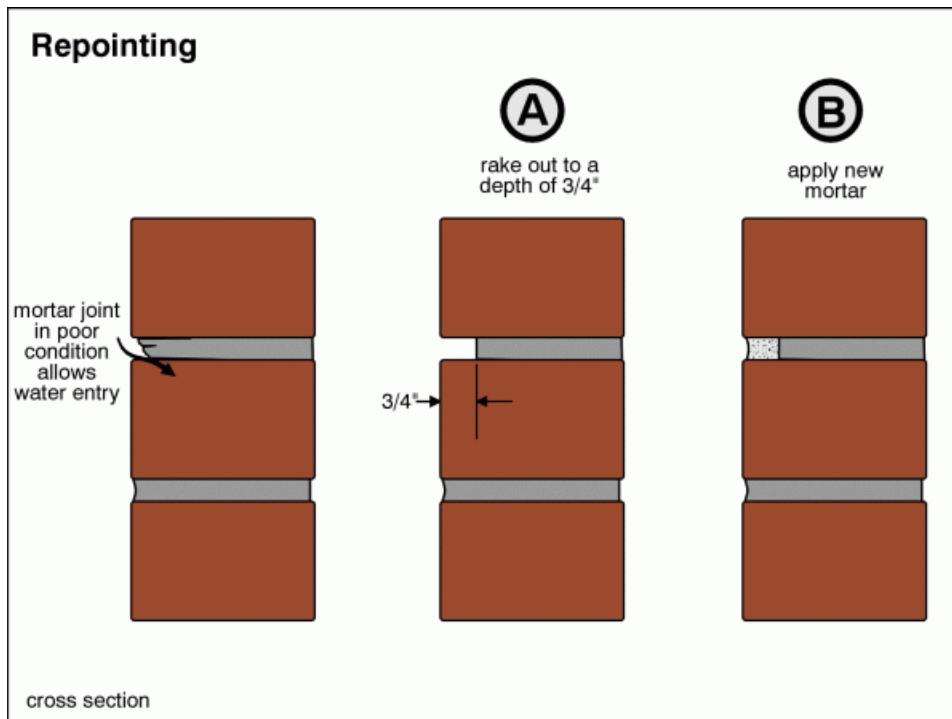
**WALLS \ Brick, stone and concrete**  
5. Condition: • [Mortar deterioration](#)

Typical tuckpointing needed.

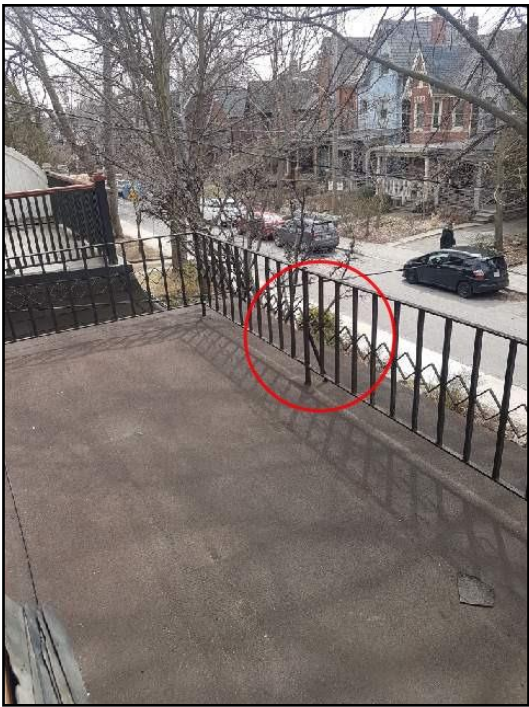
**6. Condition:** • [Too low](#)

10. Too low

**Task:** Replace

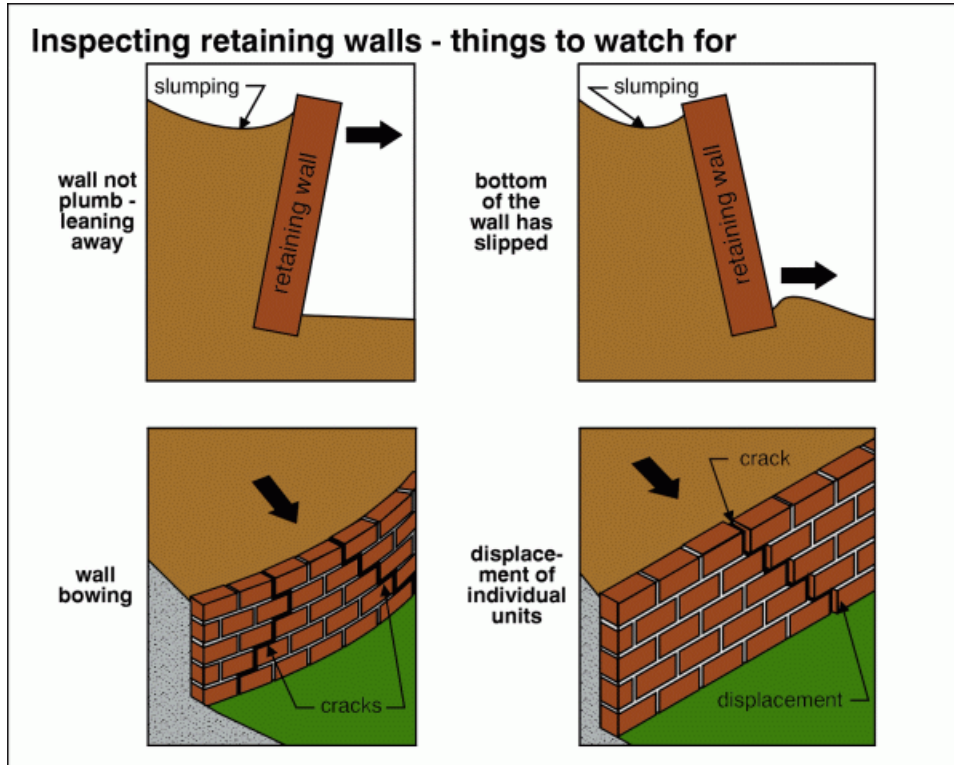
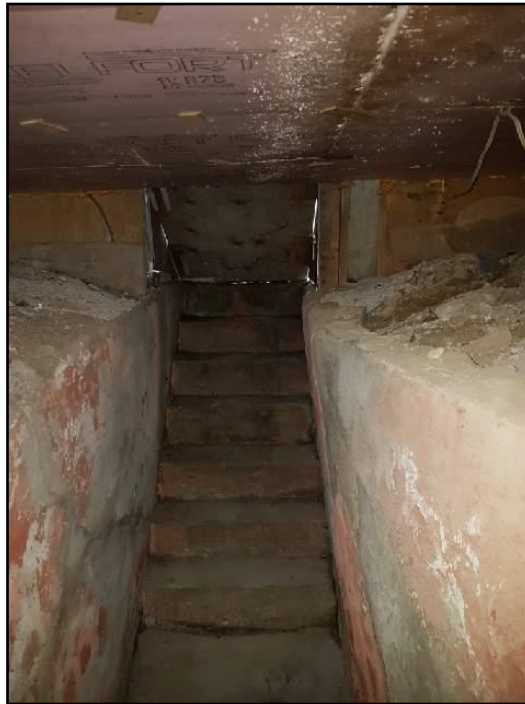
**LANDSCAPING \ Retaining wall**  
7. Condition: • [Bowing or bulging](#)

Retaining wall under east addition is in very poor condition, and while not urgent, eventual rebuild will be necessary. Improve exterior cover and create step up into basement at that time.

11. *Bowing or bulging*

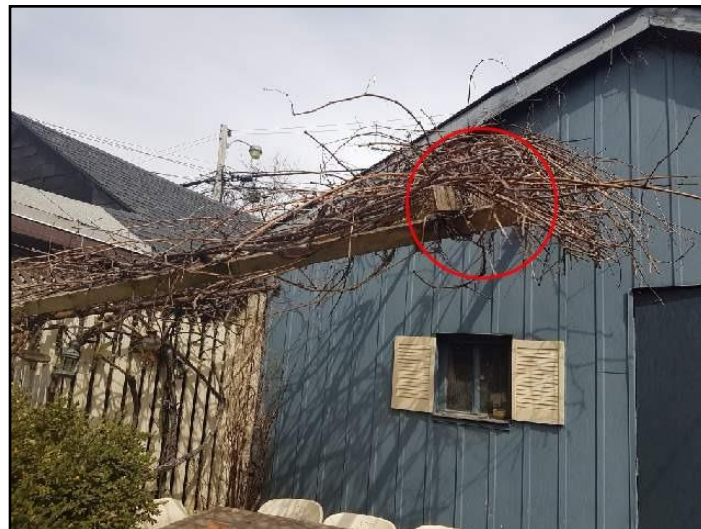
**8. Condition:** • Not well supported

12. *Not well supported*

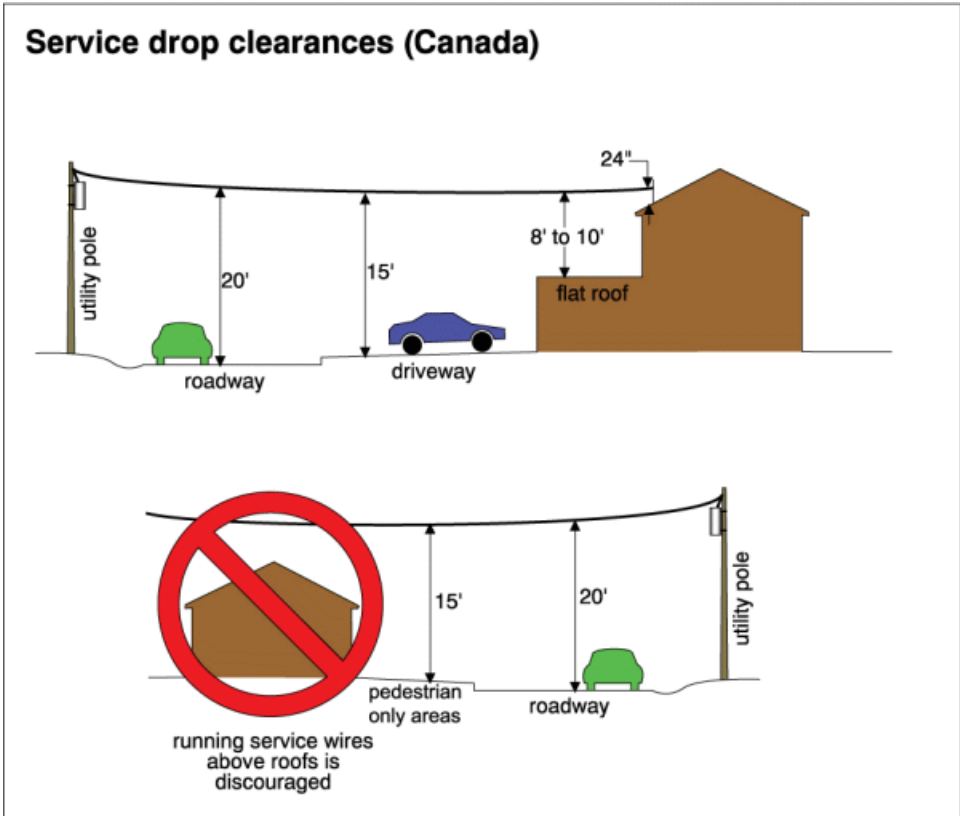
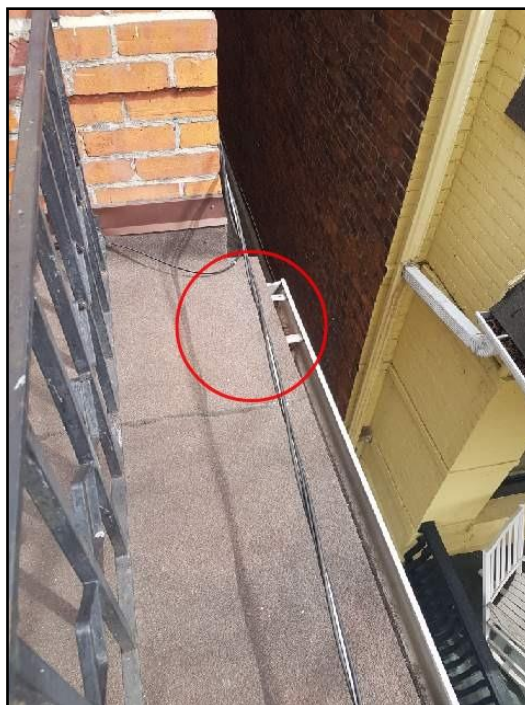
**12. Condition:** • [Wires too close to roof](#)

This condition will be rectified with service upgrade.

13. Wires too close to roof

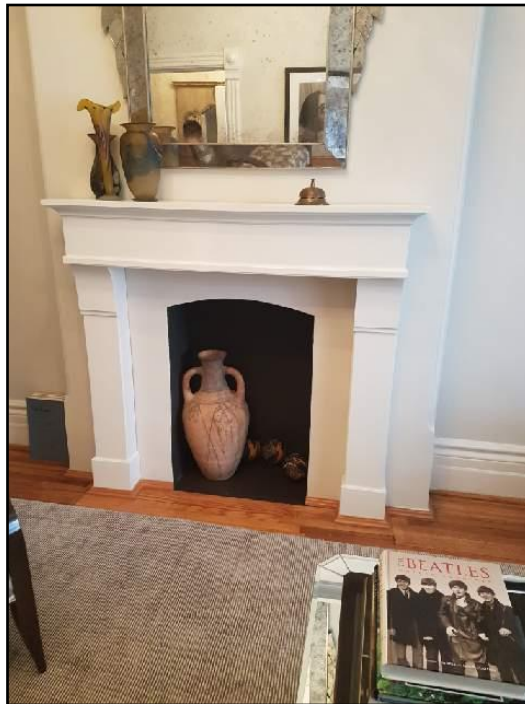
14. *Non-functional*

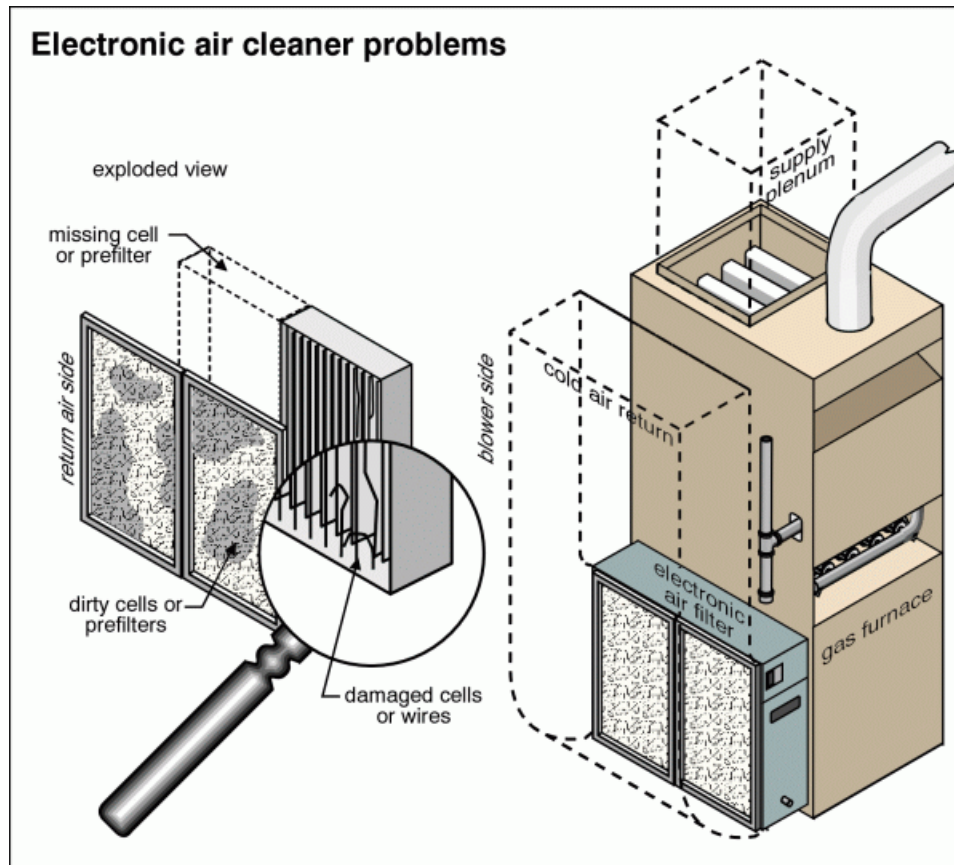
**13. Condition:** • [Dirty](#)

**Task:** Clean

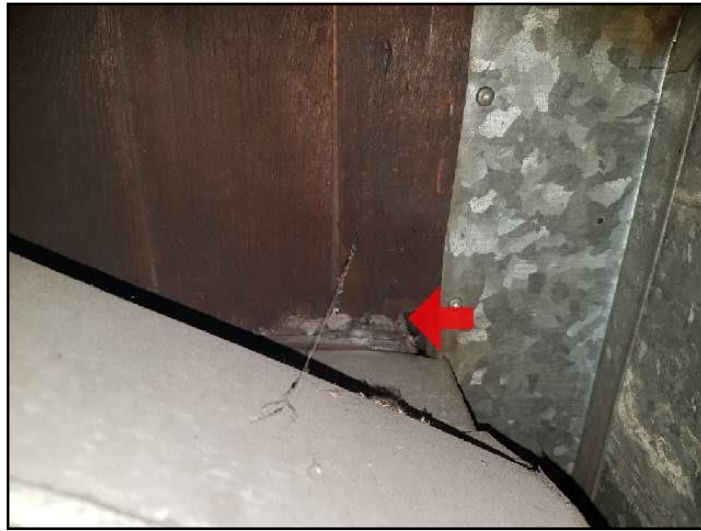
**14. Condition:** • Some asbestos insulation present on ducting. Remove or encapsulate if necessary to disturb.

15. *Some asbestos insulation present on ducting...*

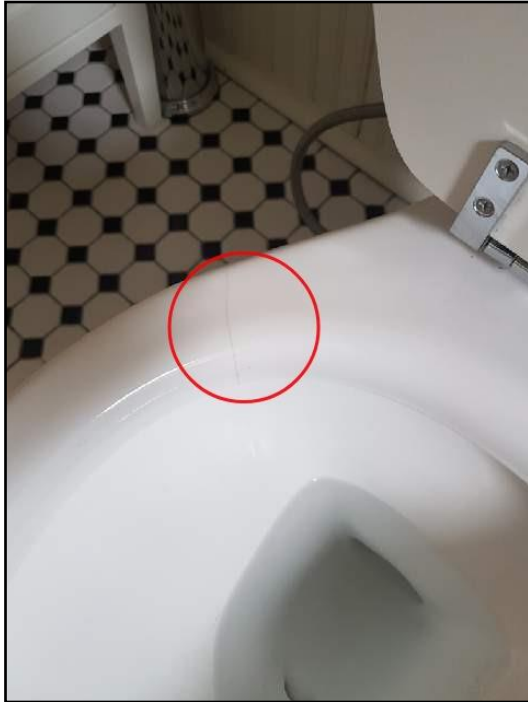
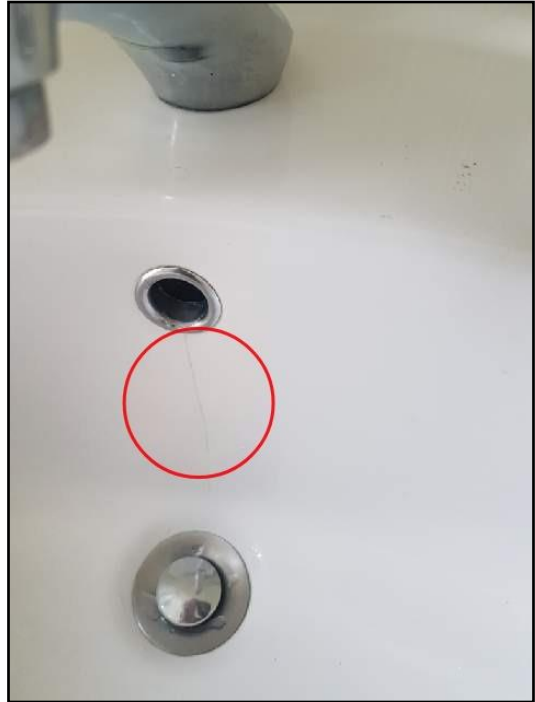
**16. Condition:** • [Surface defects](#)

Toilet and sink at second floor washroom have minor cracks.

16. Surface defects

17. Surface defects

**Task:** Replace

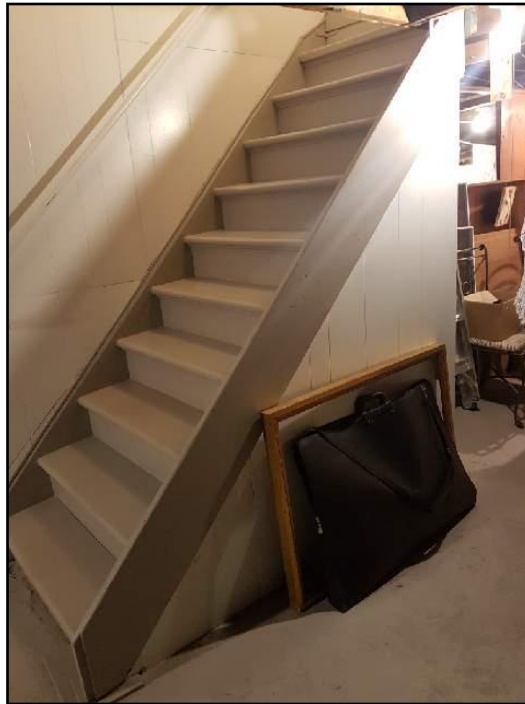
18. **Condition:** • [Missing](#)

18. *Missing guardrail*
