Your Inspection Report

174 Yarmouth Road
Toronto, ON M4R 1X7

RE: Report No. 2622
174 Yarmouth Road
Toronto, ON
M4R 1X7

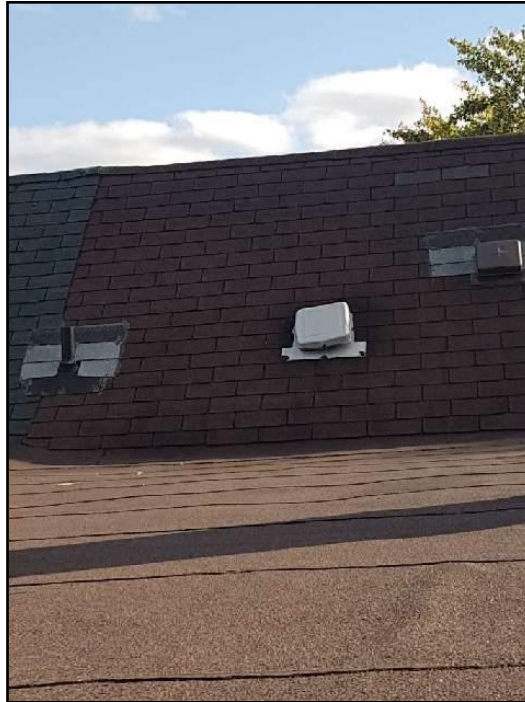
1. *Asphalt shingles*

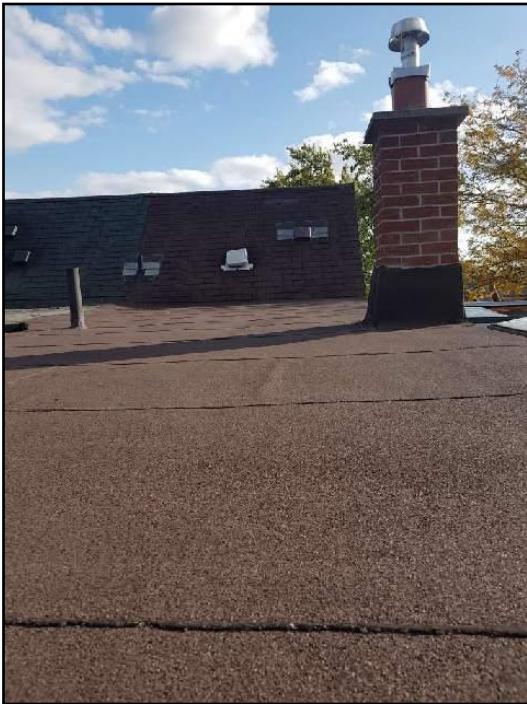
2. Modified bitumen membrane

Probability of leakage: • High

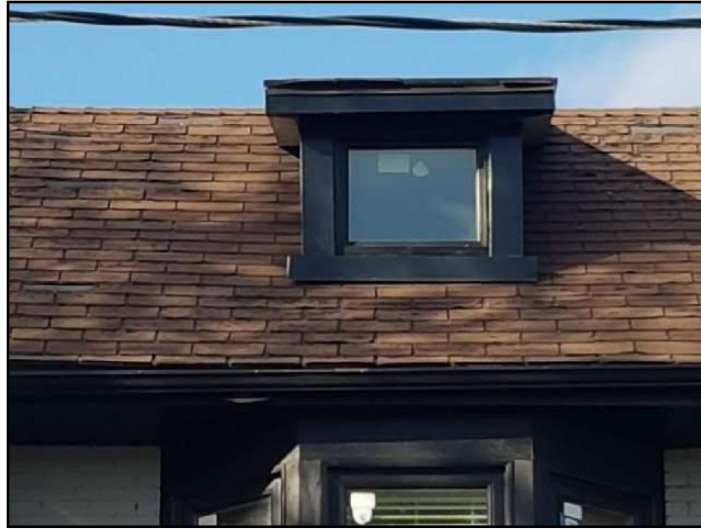
1. Condition: • [Old, worn out](#)

Implication(s): Chance of water damage to contents, finishes and/or structure

3. *Old, worn out*

Strip and reshingle sloped areas. Flat roof is newer and in good condition.

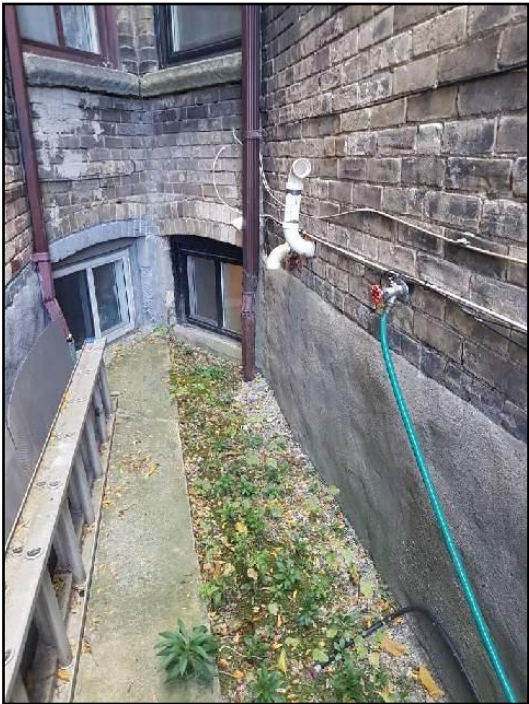
2. Condition: • [Discharge below grade](#)

Implication(s): Chance of water damage to contents, finishes and/or structure

Location: Northeast Exterior

4. Discharge below grade

Disconnect downspout and route well away from foundation, create drainage slope away foundation at gravel area.

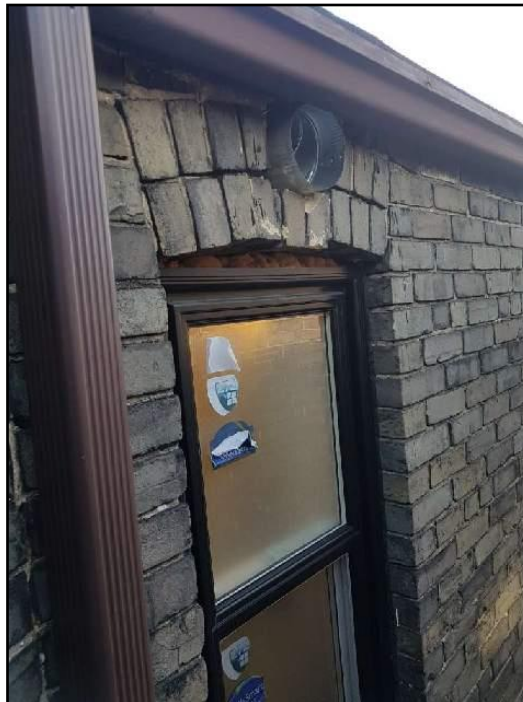
5.

3. Condition: • Add pest and weather cover to exhaust duct.

Location: East Second Floor

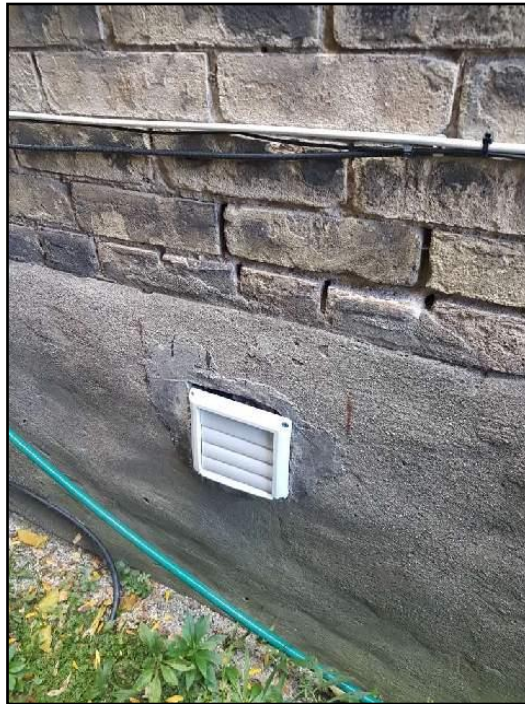
4. Condition: • Seal vent at wall

Location: East Exterior Wall

6. Seal vent at wall

Caulk vent covers at wall.

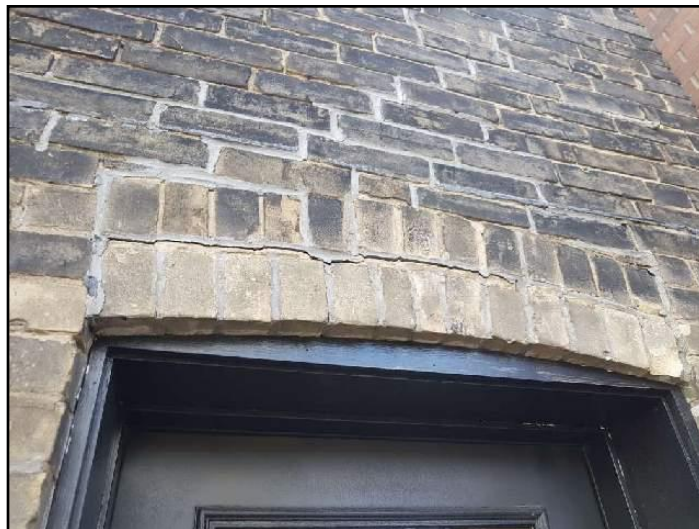
5. Condition: • [Cracked](#)

Implication(s): Chance of water entering building | Weakened structure | Chance of movement

Location: Various Exterior Wall

7. Cracked

Some tuckpointing needed.

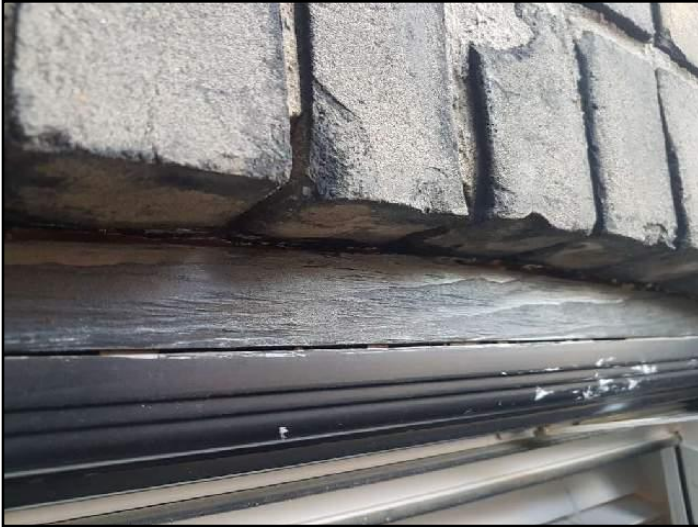
8. Caulking incomplete.

Some flashing and caulking needed.

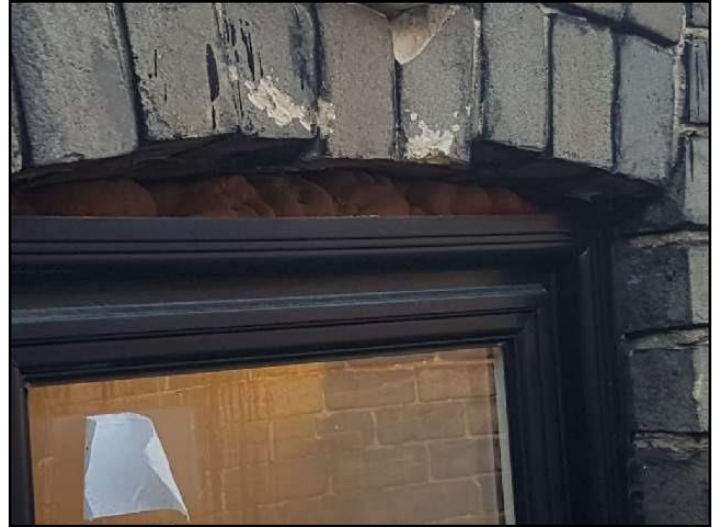
6. Condition: • Flashings incomplete.

Location: East Exterior Wall

9. Flashings incomplete.

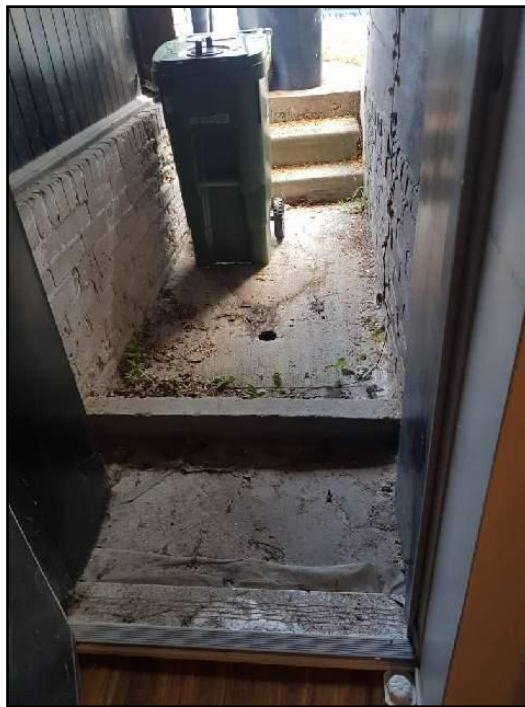
10.

7. Condition: • [Door threshold missing, too low, not watertight](#)

Basement entrance configured so that step at outside of door is at interior floor level. Ideally exterior landing would be created with a step up into basement to limit potential for water entry to basement. Consider door at top of exterior steps.

Implication(s): Chance of water damage to contents, finishes and/or structure

Location: South Exterior Staircase

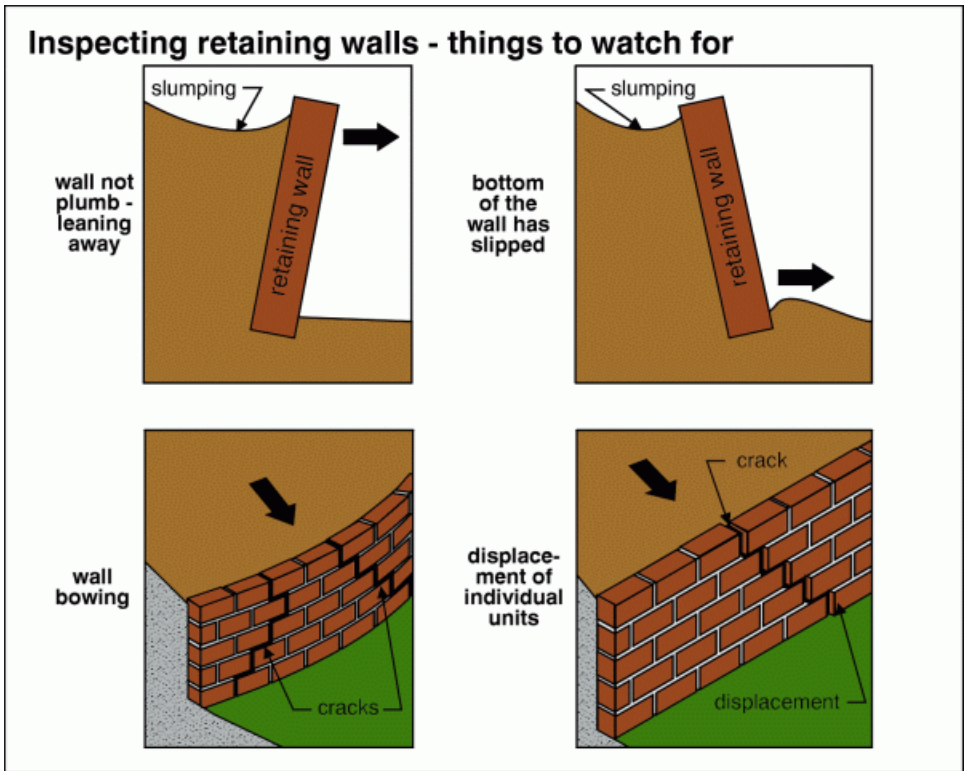
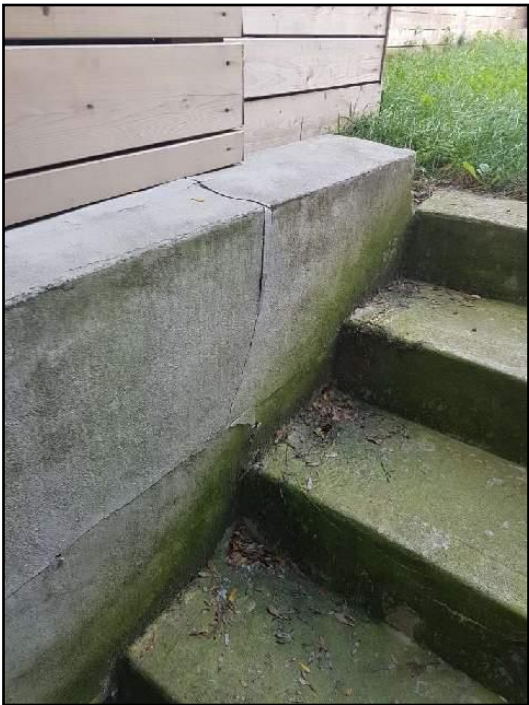
LANDSCAPING \ Retaining wall
8. Condition: • [Settling or shifting](#)

North retaining wall cracked but sound.

Implication(s): Weakened structure | Chance of movement

Location: North Exterior

11. Settling or shifting

Task: Monitor

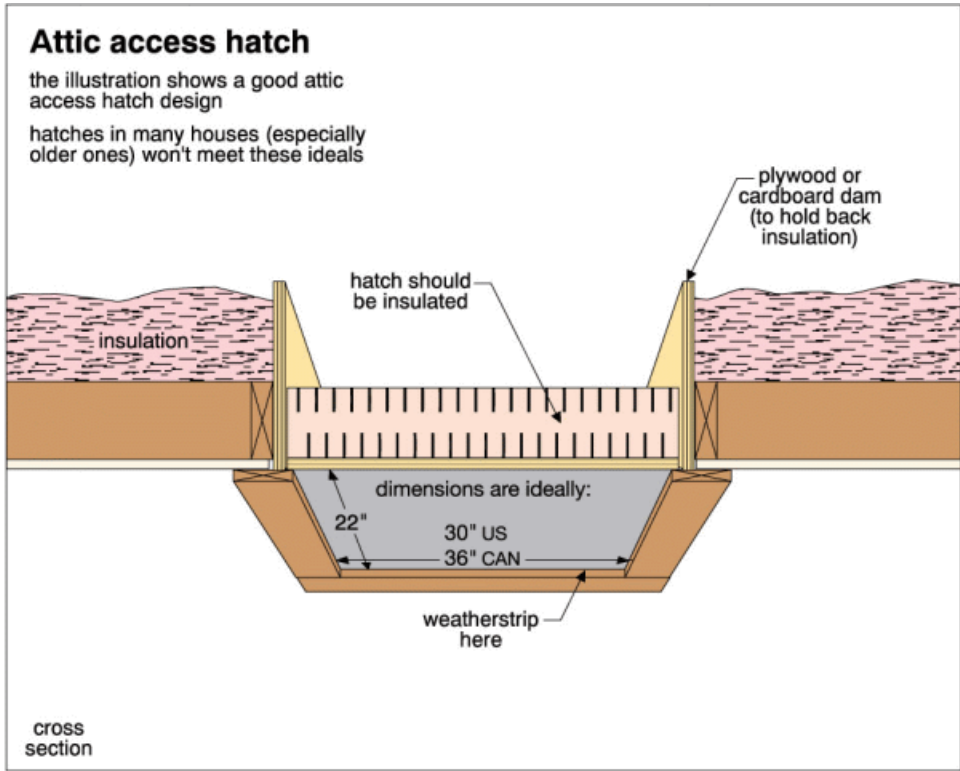
ATTIC/ROOF \ Hatch/Door
15. Condition: • [Not weatherstripped](#)
Implication(s): Chance of condensation damage to finishes and/or structure | Increased heating and cooling costs
Location: Ensuite Bathroom
Task: Improve
Time: Unpredictable
Cost: Minor
