Your Inspection Report

194 Roxton Rd
Toronto, ON M6J2Y5

INSPECTION DATE:
Thursday, September 20, 2018

RE: Report No. 5125
194 Roxton Rd
Toronto, ON
M6J2Y5

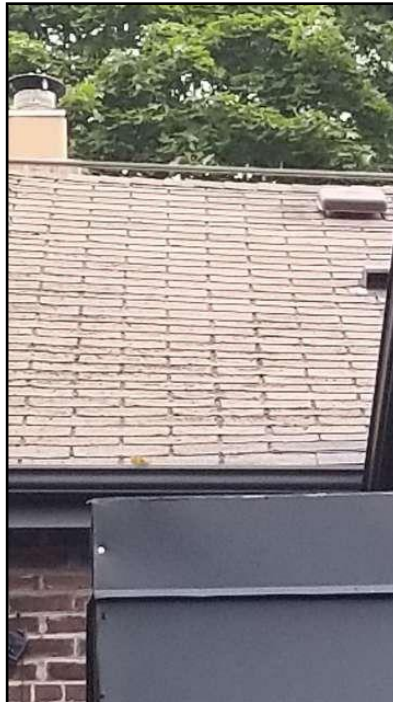
SLOPED ROOFING \ Asphalt shingles

Condition: • [Old, worn out](#)

Implication(s): Chance of water damage to contents, finishes and/or structure

Task: Replace

Time: Less than 2 years

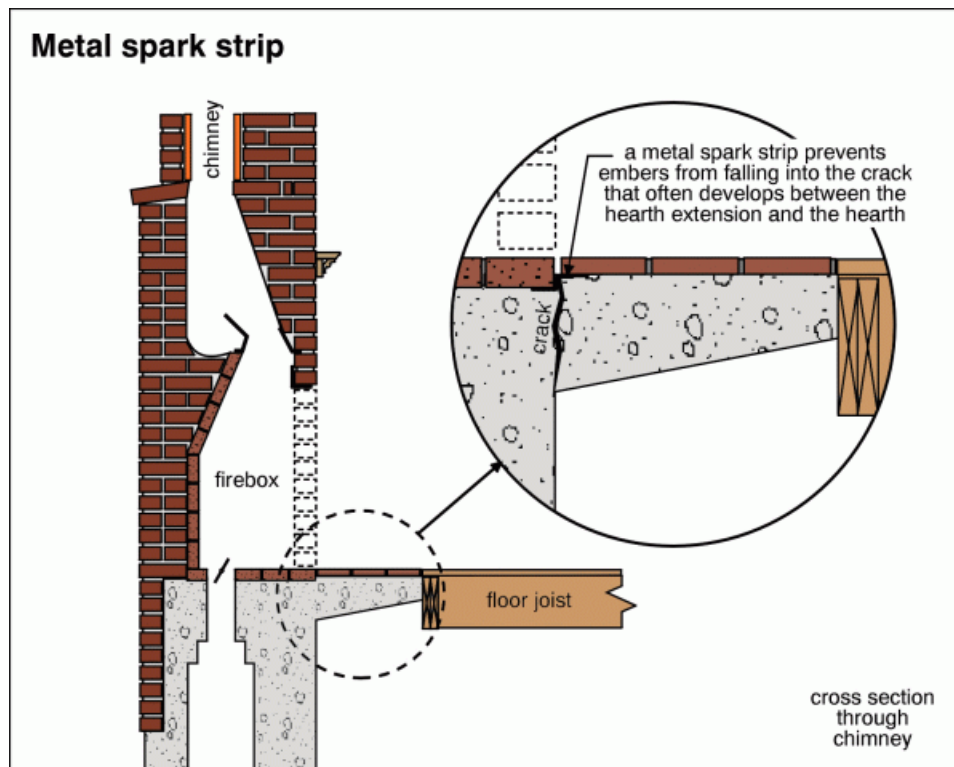
FIREPLACE \ Hearth and extension

Condition: • [Gaps or cracks](#)

Implication(s): Fire hazard

Location: Basement

Task: Repair or replace

Time: Discretionary

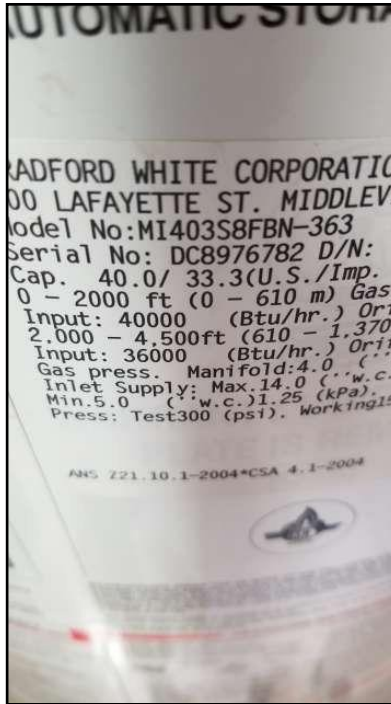
Water heater approximate age:

- 11 years

WATER HEATER \ Life expectancy

Condition: • [Near end of life expectancy](#)

Implication(s): No hot water

Task: Replace

Time: When necessary

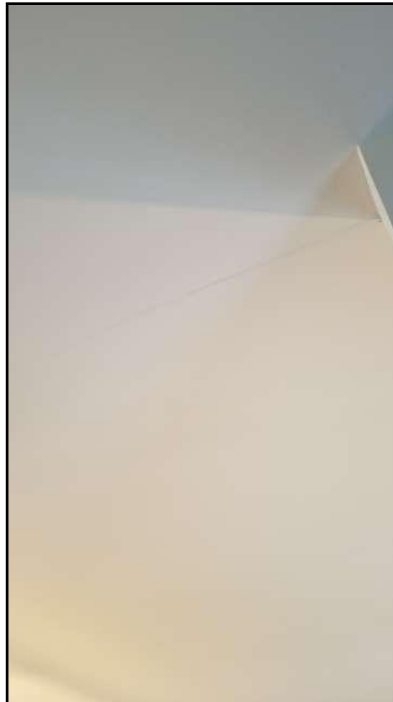
CEILINGS \ Plaster or drywall

Condition: • Crack

Location: First Floor Foyer

Task: Repair

Time: Regular maintenance

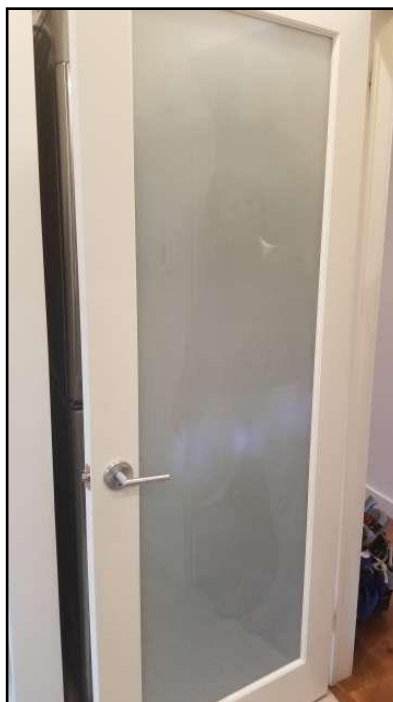
DOORS \ Doors and frames

Condition: • [Swings open or closed by itself](#)

Implication(s): Physical injury

Location: Second Floor Bathroom

Task: Adjust

Time: Regular maintenance

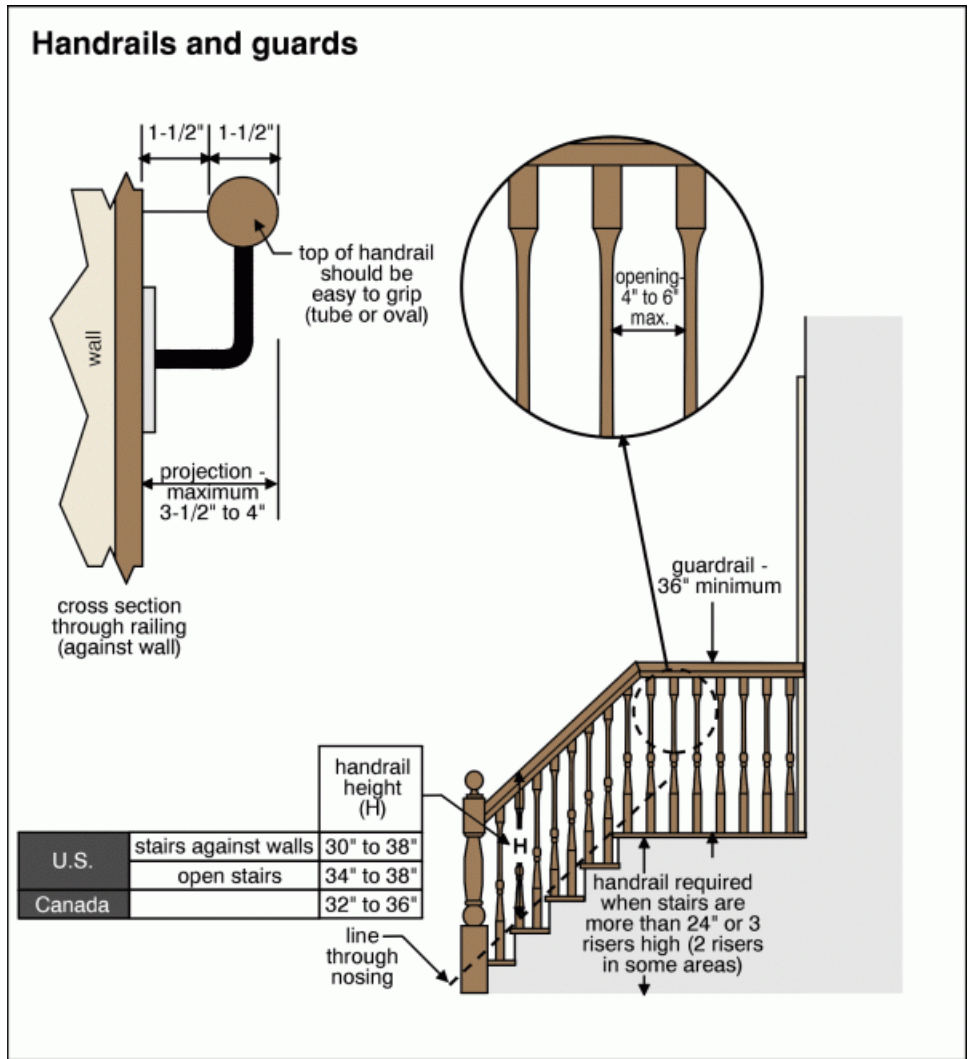
STAIRS \ Guardrails

Condition: • [Too low](#)

Implication(s): Fall hazard

Location: Second Floor Hall

Task: Replace

Time: When remodelling
