Your Inspection Report

5525 Palmerston Crescent, Suite 54
Toronto, ON M6R 1C3

RE: Report No. 2683
5525 Palmerston Crescent, 54
Toronto, ON
M6R 1C3

1998 condo townhouse in good condition.

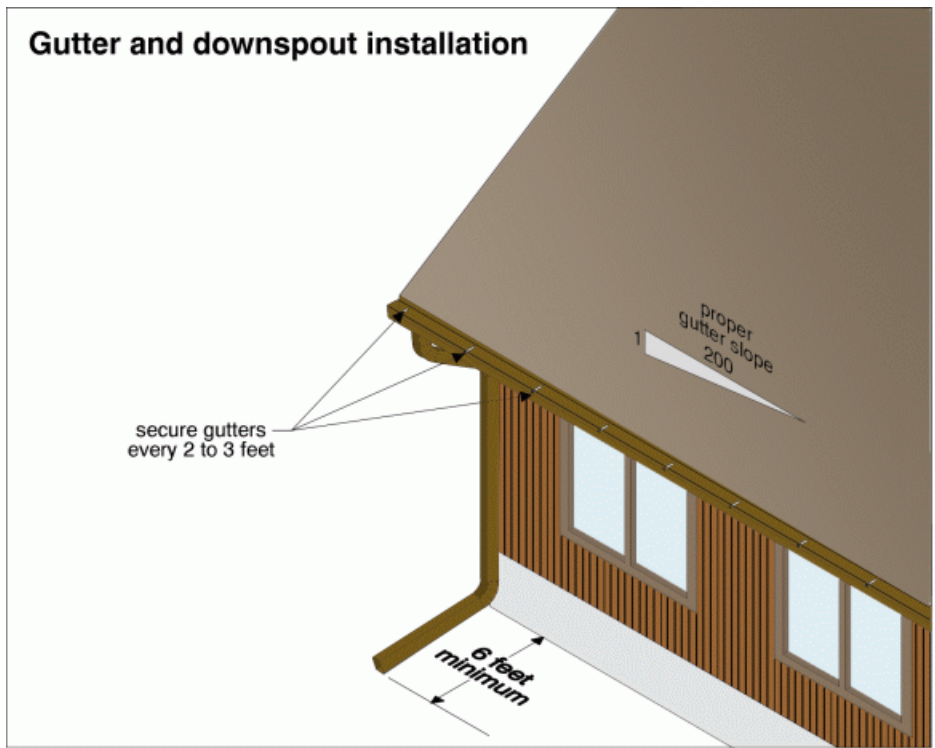
- 2. Condition: • [Discharge too close to building](#)

Implication(s): Chance of water damage to contents, finishes and/or structure

Location: East Exterior

Extend downspout further from foundation.

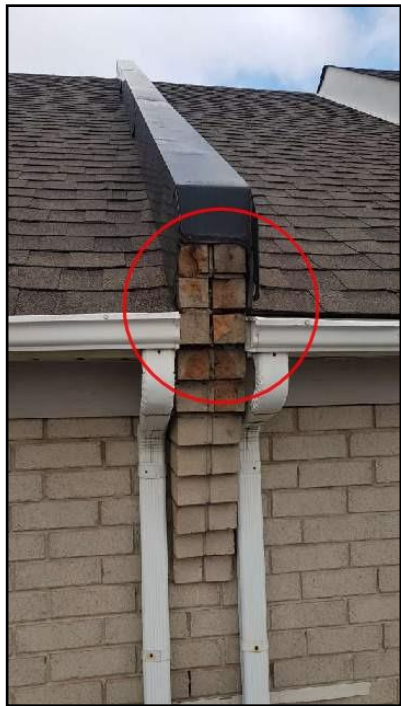
3. Condition: • Spalling

Implication(s): Weakened structure | Chance of structural movement

Location: Southwest Exterior

1. Spalling

Repair minor spalling at parapet wall.

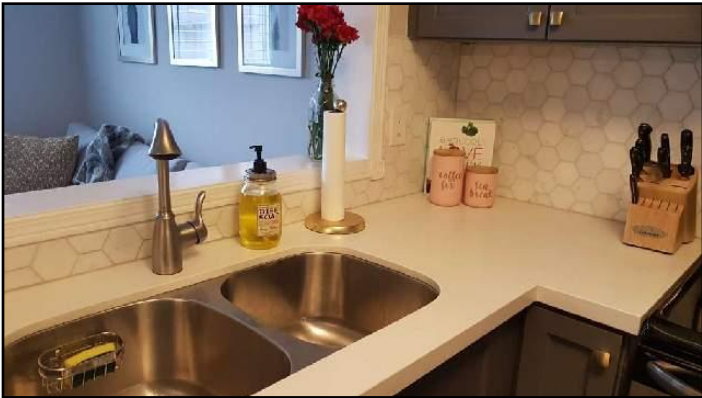
7. Condition: • [GFCI/GFI needed \(Ground Fault Circuit Interrupter\)](#)

Implication(s): Electric shock

Location: Kitchen

2. GFCI/GFI needed (Ground Fault Circuit...

Recommend gfci receptacles near sink in kitchen.

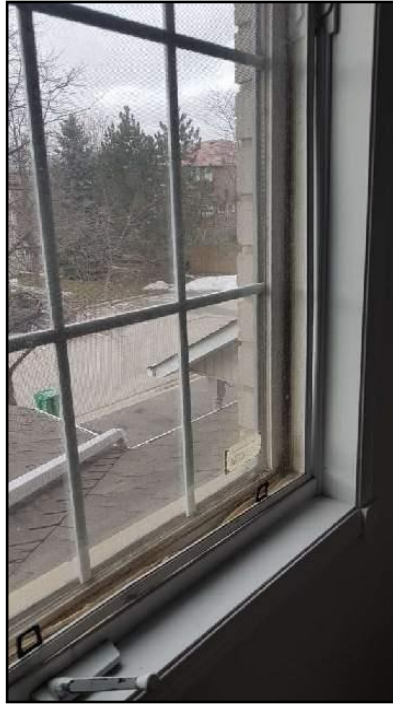
13. Condition: • Difficult to operate.

Location: West Second Floor

4. *Difficult to operate.*

Replace weatherstripping at bedroom window.
