Your Inspection Report

3345 Silverado Drive, Suite 57
Toronto, ON M6R 1C3

Monday, April 1, 2019

RE: Report No. 2737, v.2
3345 Silverado Drive, 57
Toronto, ON
M6R 1C3

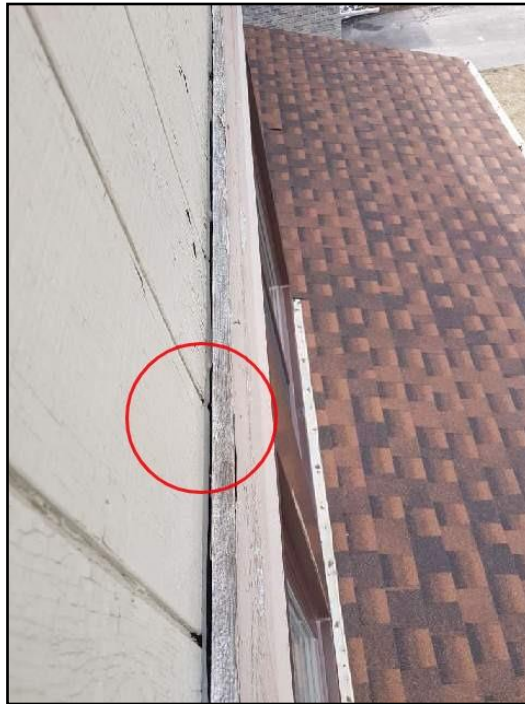
2. Condition: • [Caulking missing or deteriorated](#)

Implication(s): Material deterioration | Chance of water damage to contents, finishes and/or structure

Location: East Second Floor

1. Caulking missing or deteriorated

Task: Repair

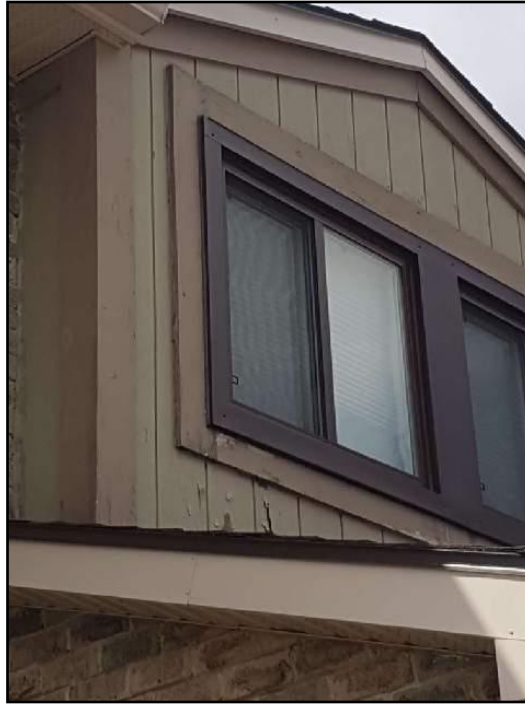
3. Condition: • Paint or stain needed

Typical paint and caulking maintenance needed at wood trim.

Implication(s): Material deterioration | Chance of water damage to contents, finishes and/or structure

2. Paint or stain needed

Task: Improve

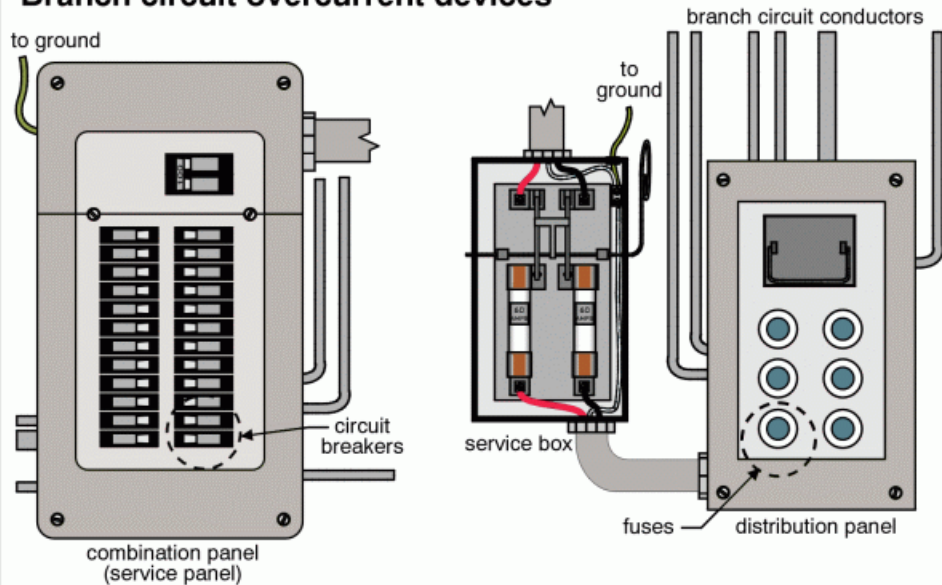
Branch circuit overcurrent devices

overcurrent devices can be circuit breakers or fuses
check that the overcurrent devices are compatible with
the branch circuit conductors

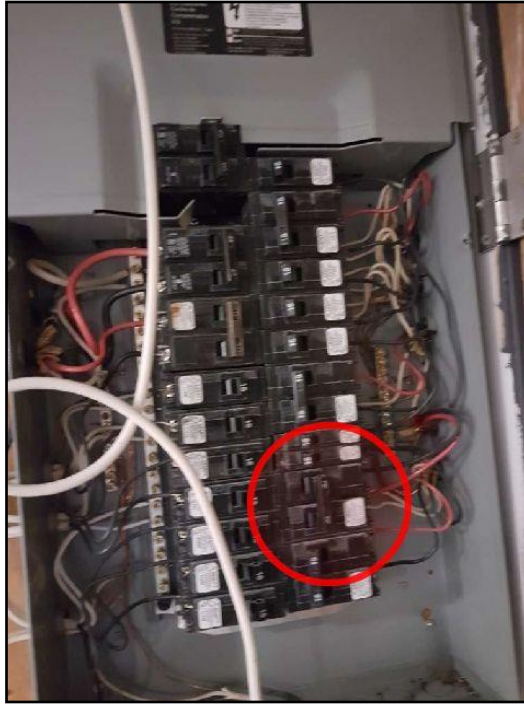
6. Condition: • [Fuses or breakers too big](#)

Implication(s): Fire hazard | Equipment overheating

Location: Basement Panel

3. Breaker too big

Task: Replace

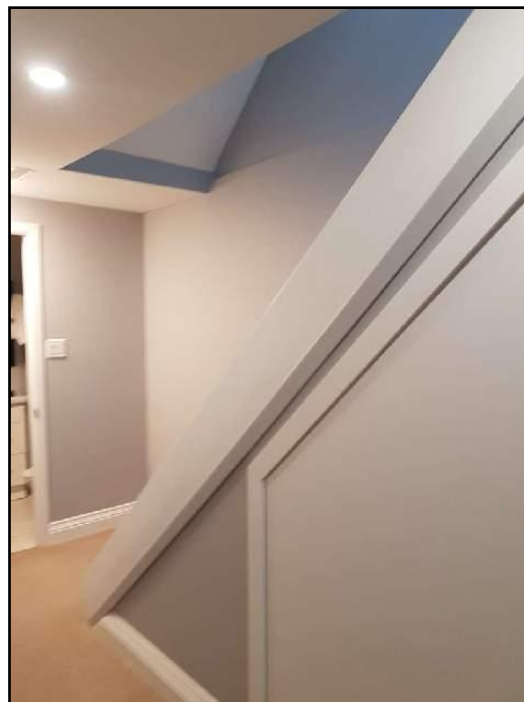
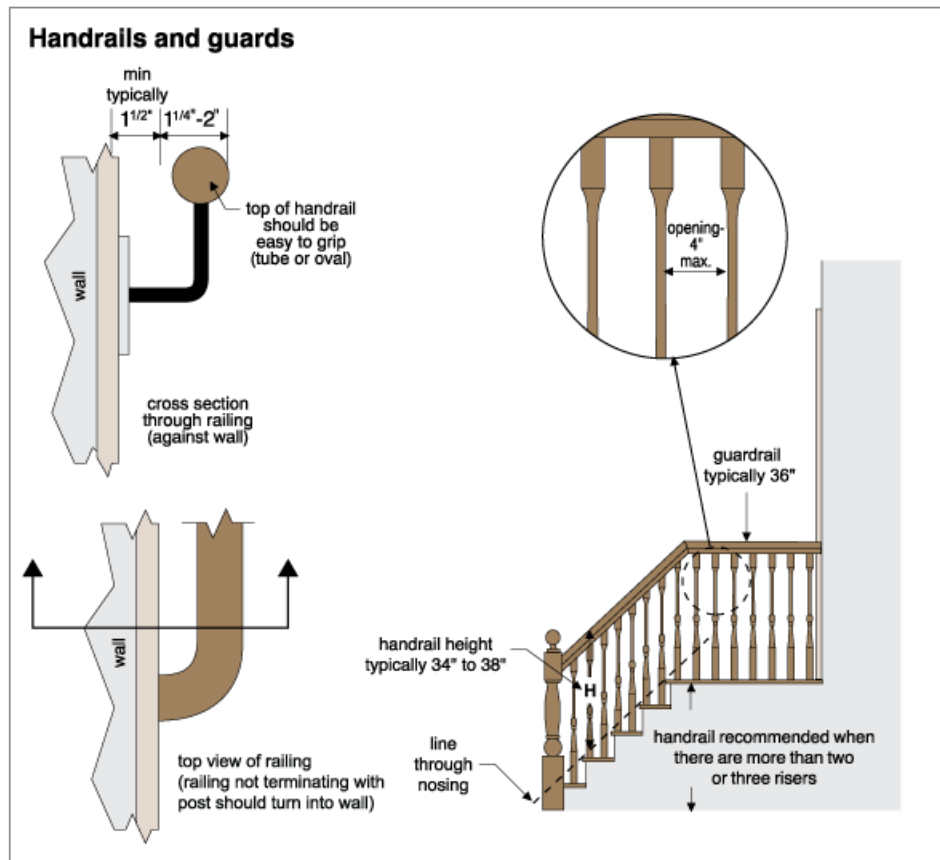
11. Condition: • [Missing](#)

Implication(s): Fall hazard

Location: Basement Staircase

4. Missing guardrail

Task: Provide
