Your Inspection Report

2631 Benedet Drive
Toronto, ON

Wednesday, May 22, 2019

RE: Report No. 2802
2631 Benedet Drive
Toronto, ON

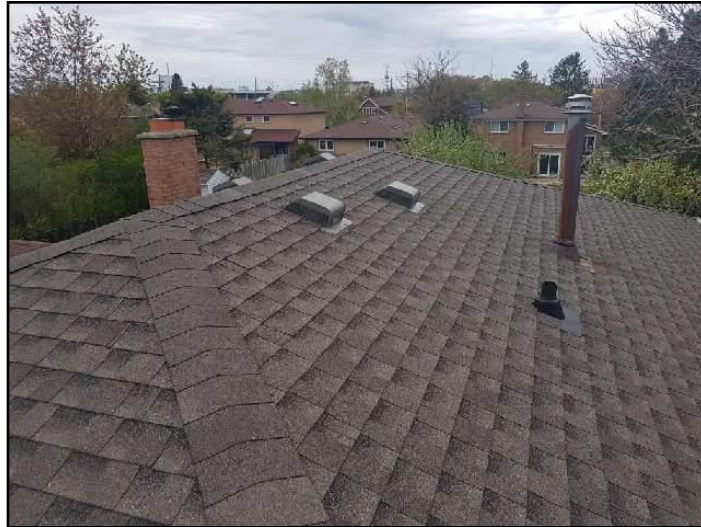
1. *Asphalt shingles*

1. **Condition:** • No roofing recommendations are offered as a result of this inspection. Shingles 5 years old and in good condition.

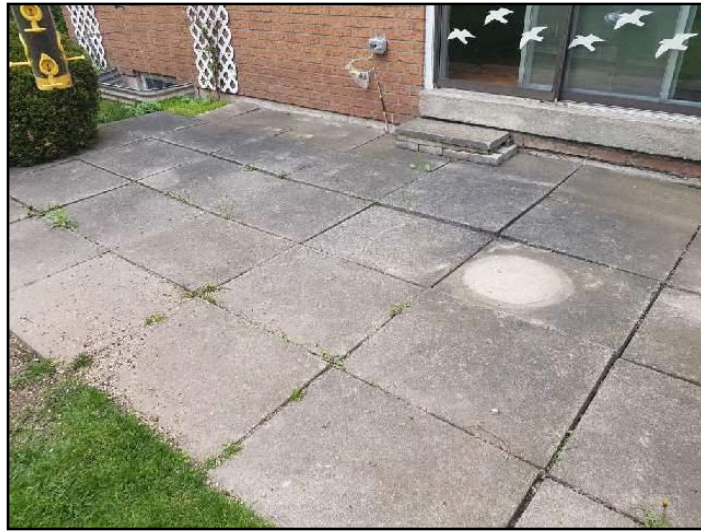
2.

- 3. **Condition:** • [Trip hazards](#)

Reslope patio to create drainage away from foundation and eliminate trip hazards.

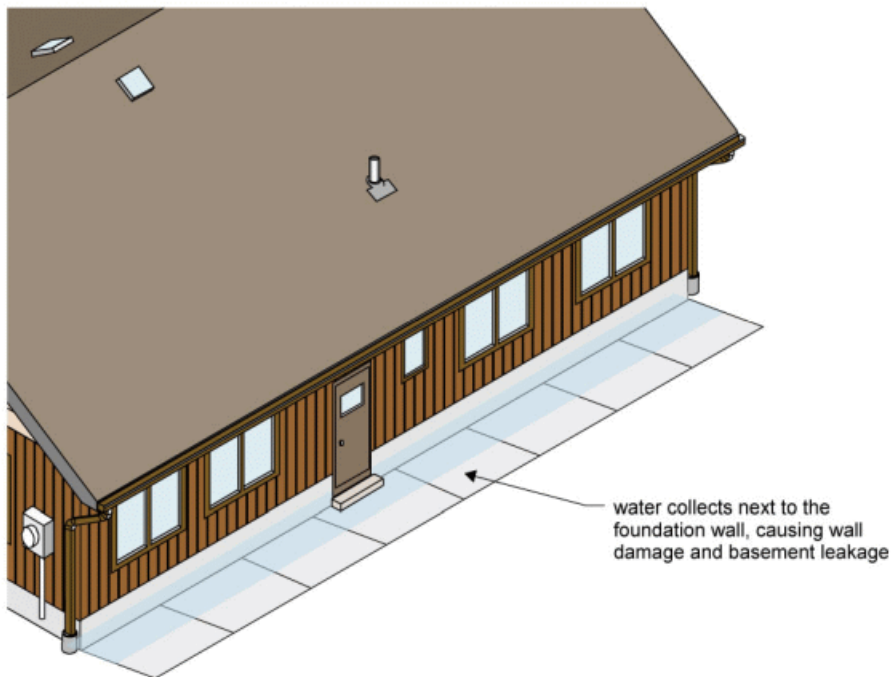
Walk/patio sloping towards house

Repair or replace concrete walk to restore drainage away from foundation, and eliminate trip hazards.

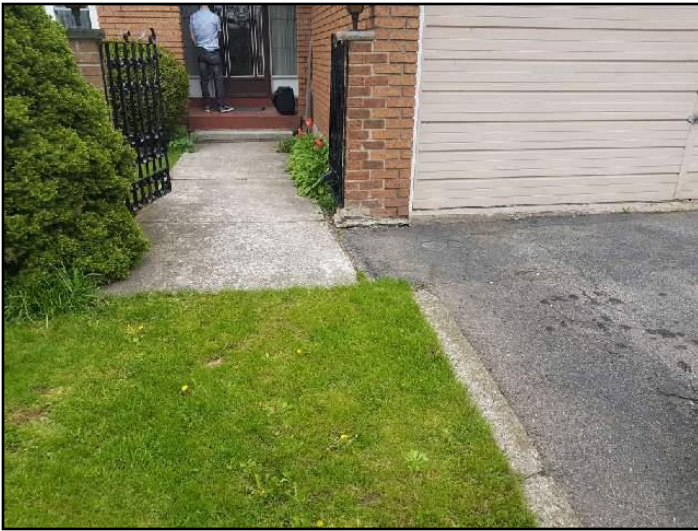
3. *Improper slope or drainage*

4. Condition: • [Improper slope or drainage](#)

Implication(s): Chance of water damage to contents, finishes and/or structure

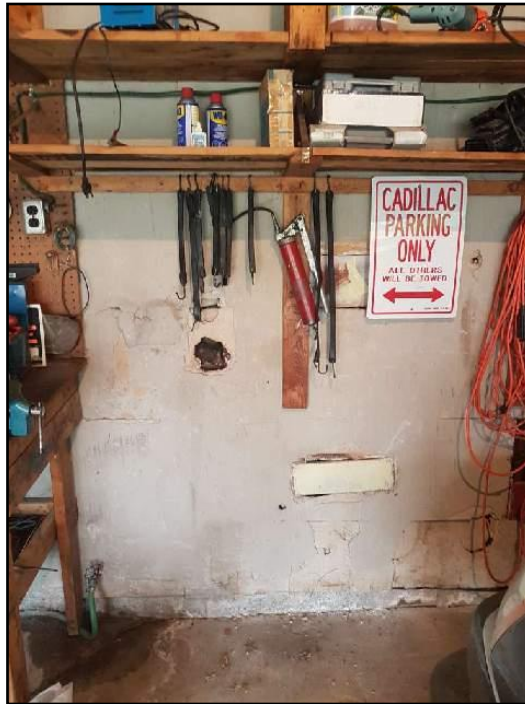
5. Not gastight

5. Condition: • Not gastight

Some repair needed at drywall finishes in garage.

Implication(s): Hazardous combustion products entering home

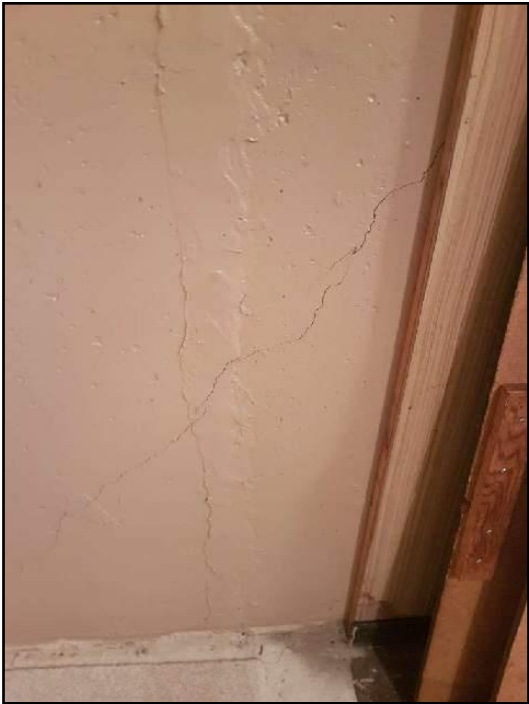
6. Typical minor cracks

6. Condition: • Typical minor cracks

Typical minor cracks are not structurally significant but indicate areas where foundation is most vulnerable to leakage.

Implication(s): Chance of water entering building

Epoxy repair crack if leakage develops or if renovating basement.

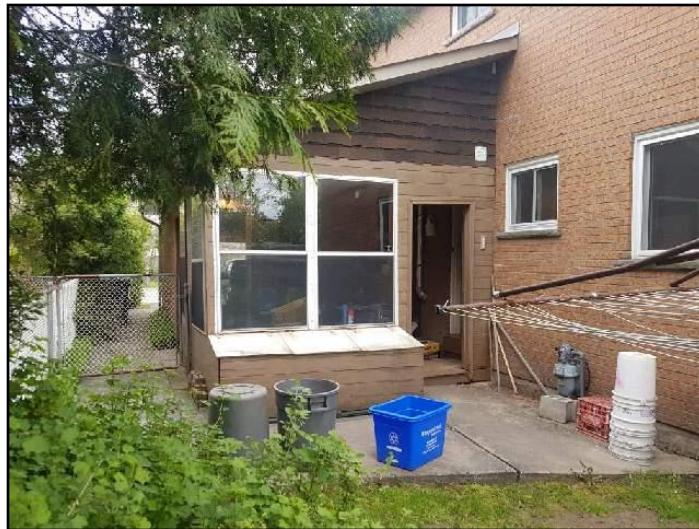
7. Wood too close to soil

7. Condition: • [Wood too close to soil](#)

Rot at floor and wall base of shed. Remove structure or replace floor with concrete.

Implication(s): Chance of structural movement | Weakened structure

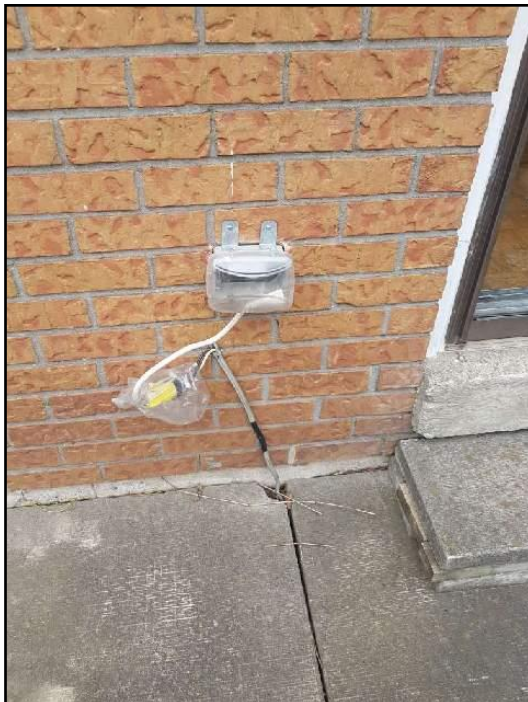
8. Exterior wiring exposed to damage and...

9. Condition: • Exterior wiring exposed to damage and contact by people.

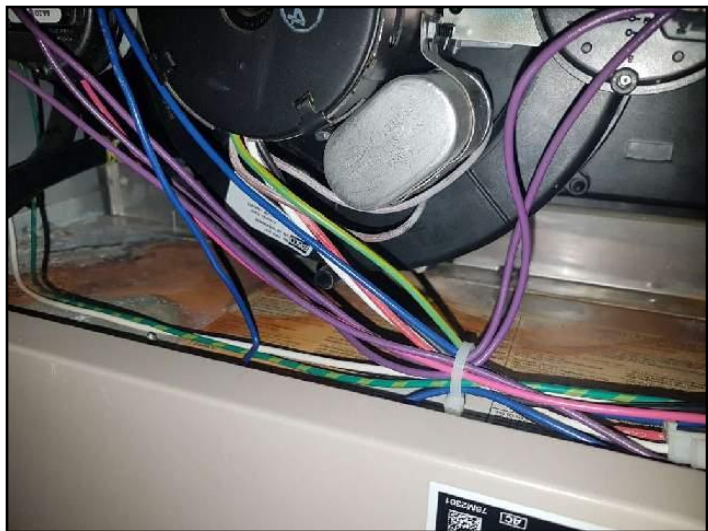
10. Condensate leak

12. Condition: • [Condensate problems](#)

Minor condensate leak present in furnace cabinet, have serviced.

Implication(s): Chance of water damage to contents, finishes and/or structure | Reduced system life expectancy

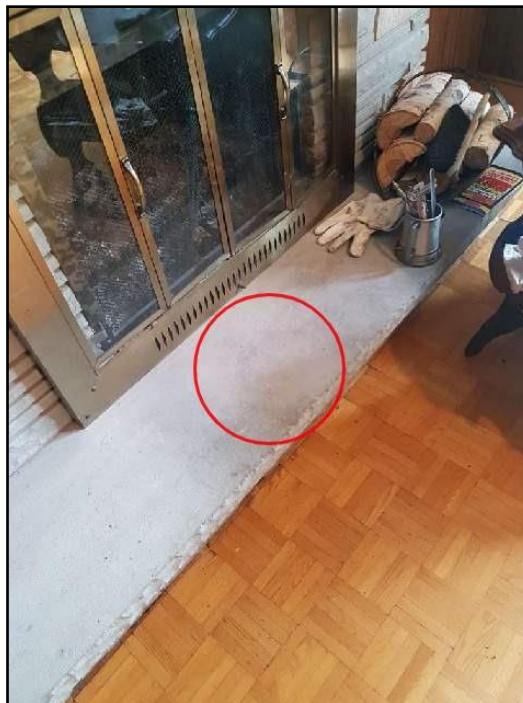
11. *Too small*

14. Condition: • [Too small](#)

Insurance company may ask for increased floor protection.

Implication(s): Fire hazard

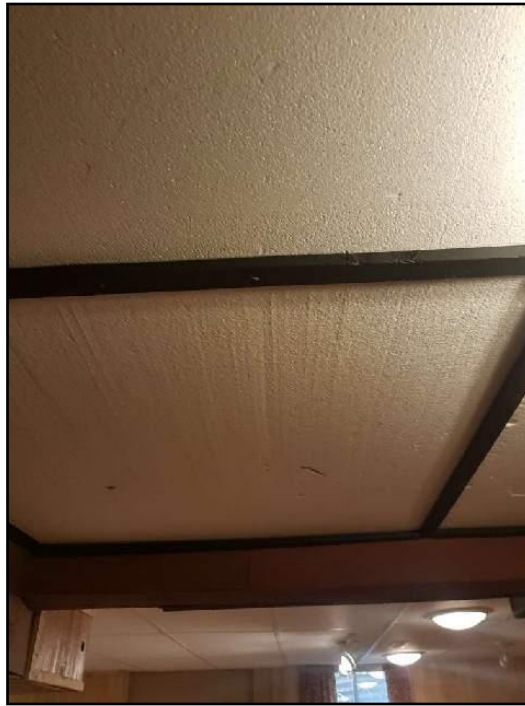
12. *Exposed combustible insulation*

17. **Condition:** • [Exposed combustible insulation](#)

Implication(s): Fire hazard

Remove styrofoam panels at basement ceiling.

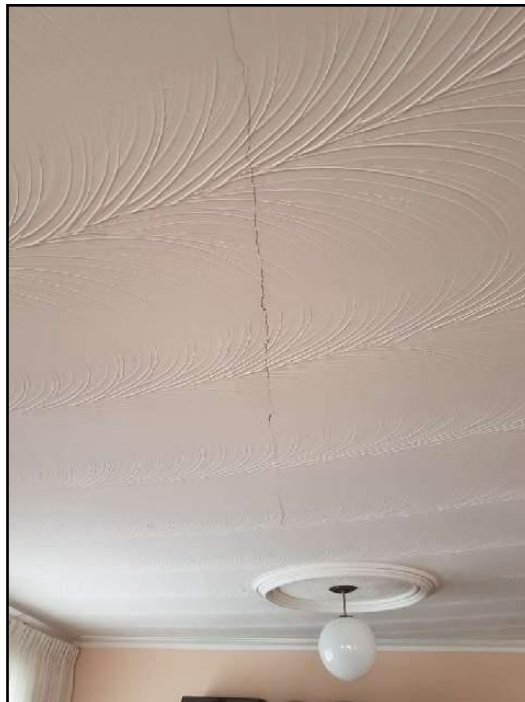
13. *Typical minor cosmetic flaws present.*

19. Condition: • Typical minor cosmetic flaws present.
