Your Inspection Report

62 Parkdale Road
Toronto, ON M6R 1E2

RE: Report No. 2798
62 Parkdale Road
Toronto, ON
M6R 1E2

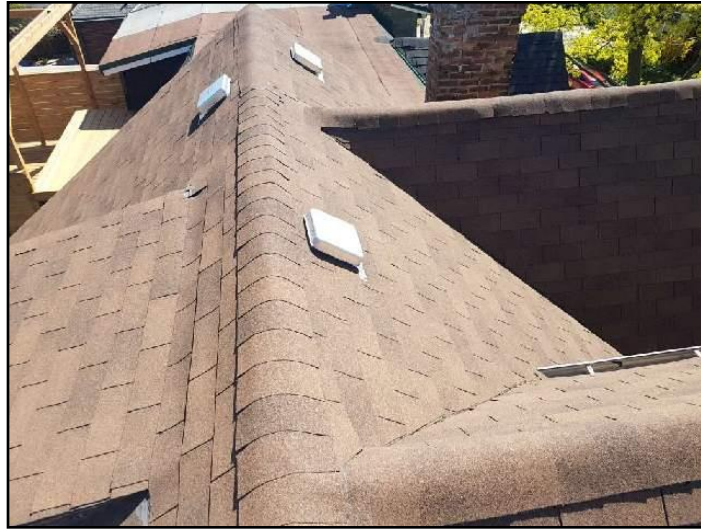
1. *Asphalt shingles*

1. **Condition:** • No roofing recommendations are offered as a result of this inspection. Roof surfaces in good condition. See Insulation re prevention of ice dams.

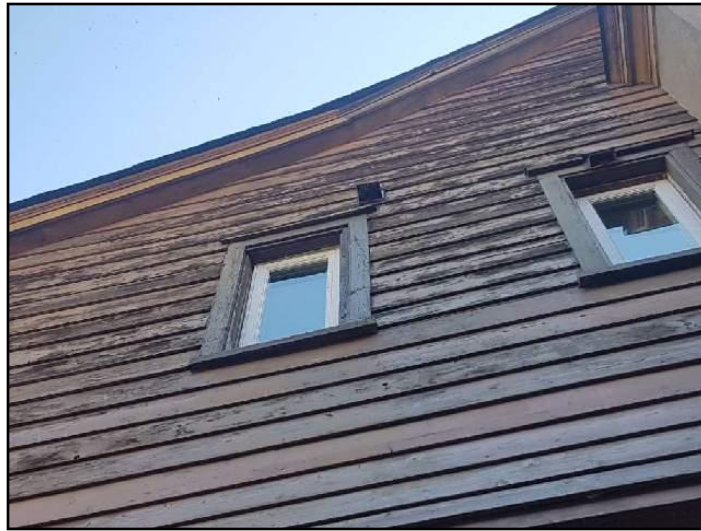
2. Paint or stain - needed

3. Condition: • [Paint or stain - needed](#)

Wood siding and trim due for paint maintenance.

Task: Improve

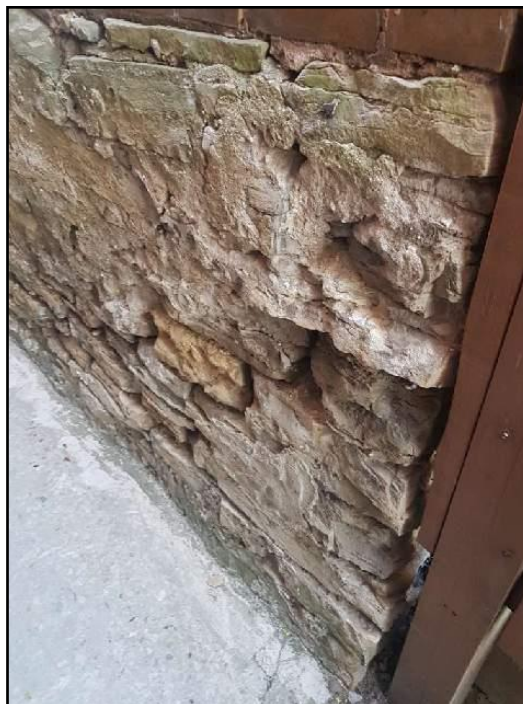
3. Parging damaged or missing

4. Condition: • [Parging damaged or missing](#)

Implication(s): Chance of damage to structure | Shortened life expectancy of material

Task: Repair

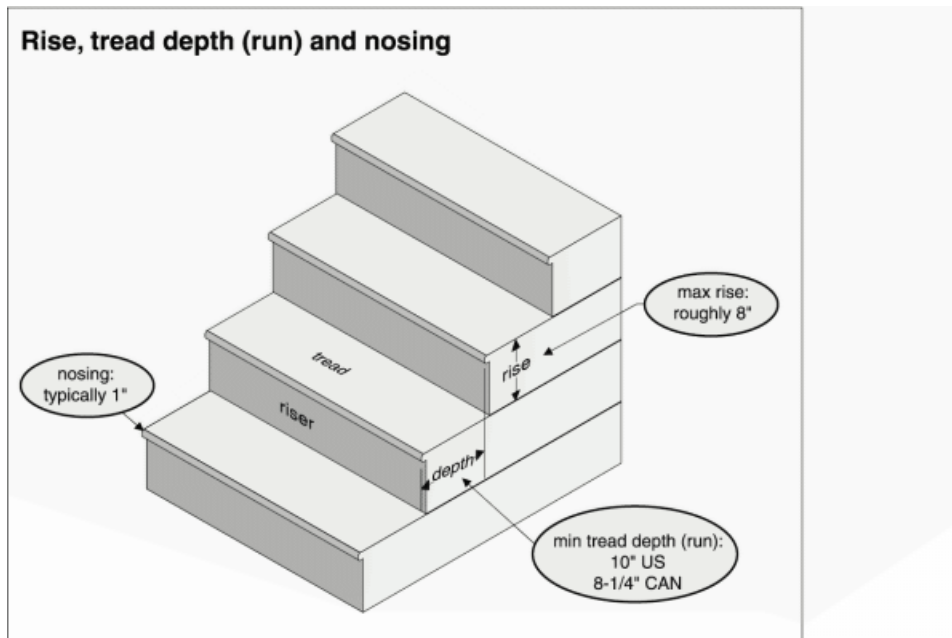
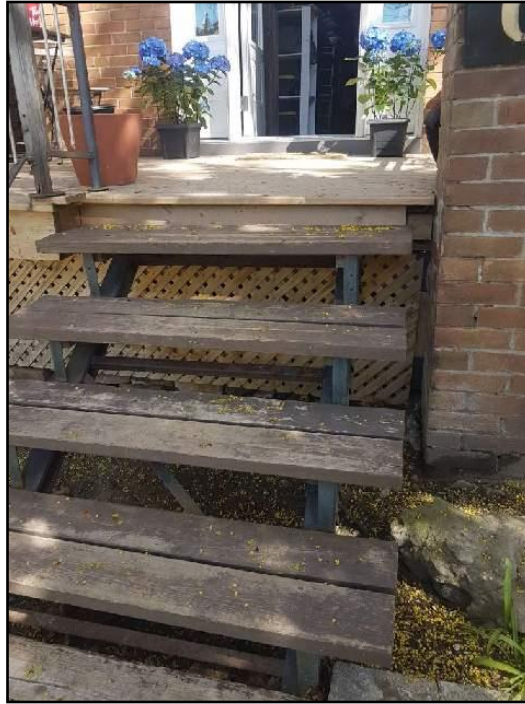
4. Stair run too small or not uniform

5. Condition: • [Stair run too small or not uniform](#)

Implication(s): Trip or fall hazard

Rebuild steps with uniform rise.

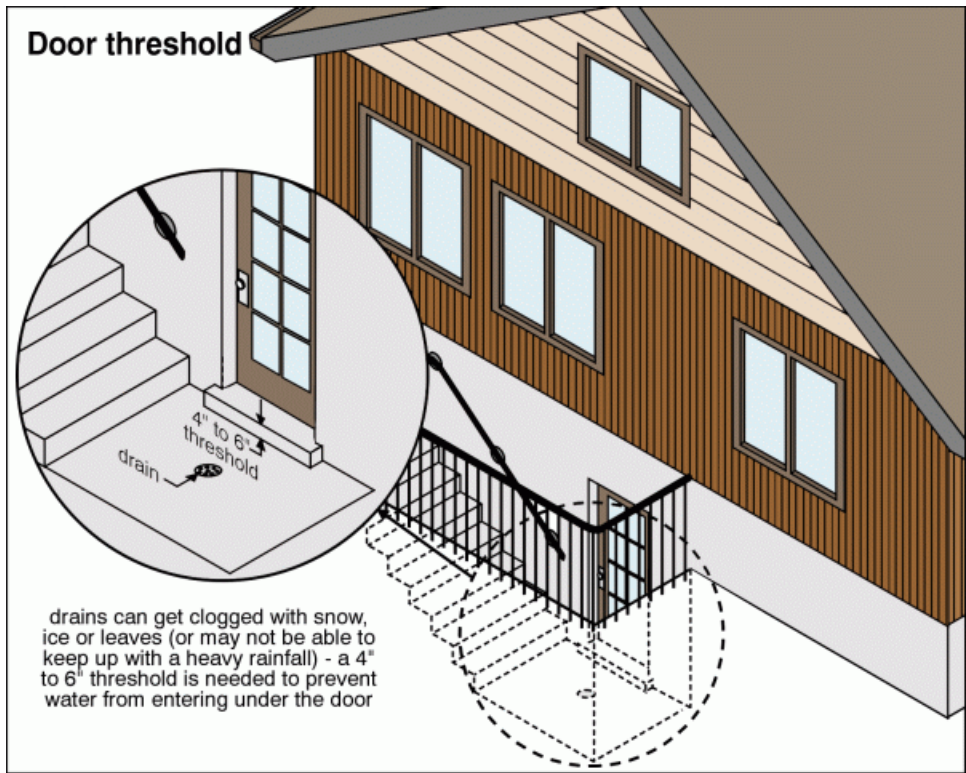
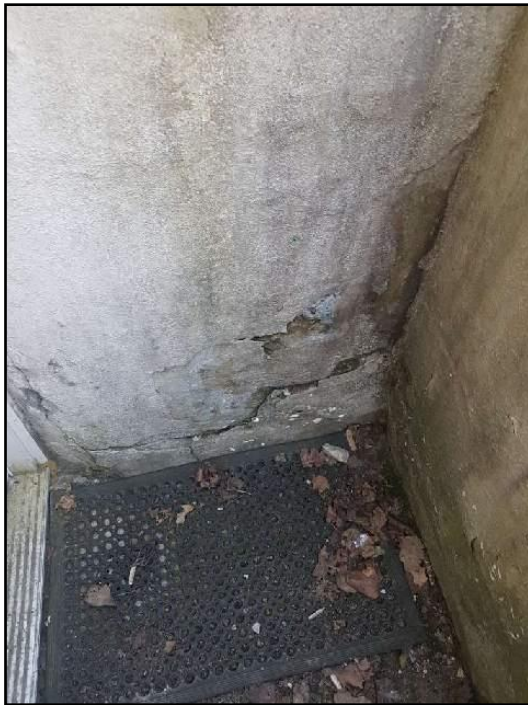
Poorly configured basement entrance allowing leakage into basement. Rebuild with step up into basement or add roof structure. Walls cracked but sound.

5. Walls cracked

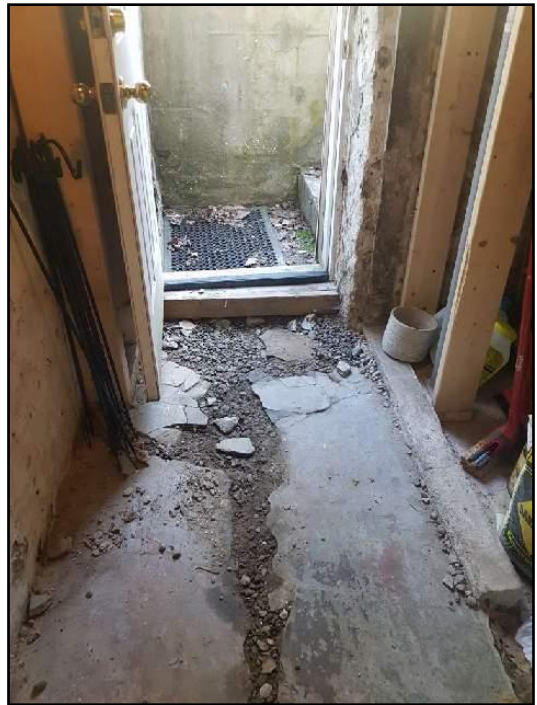
6. Condition: • [Door threshold missing, too low, not watertight](#)

Implication(s): Chance of water damage to contents, finishes and/or structure

6. Door threshold leaks

Task: Repair or replace

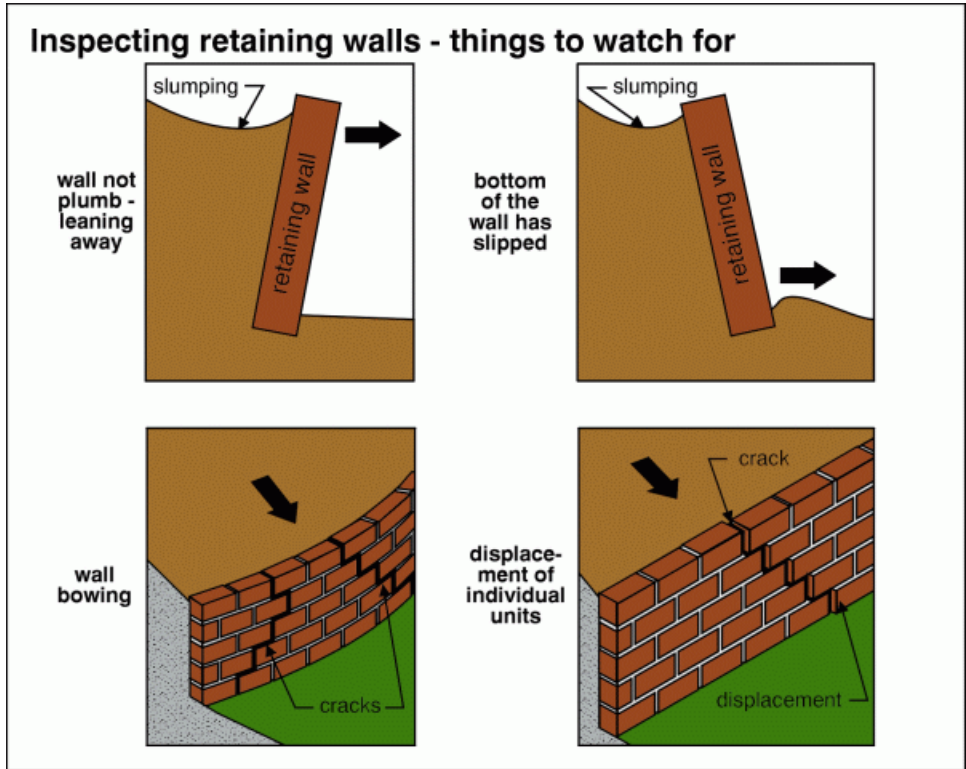
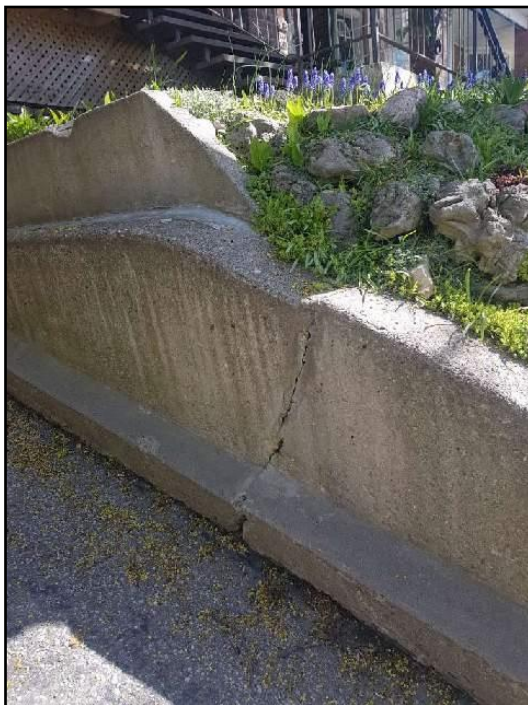
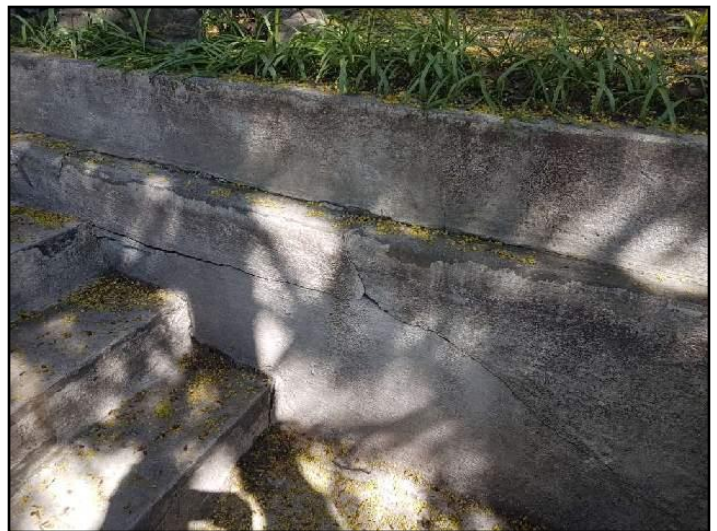
7. Condition: • [Cracked](#)

South retaining walls cracked but sound. Monitor for need for eventual replacement.

Implication(s): Weakened structure | Chance of movement

7. Cracked

8. Cracked

Task: Monitor

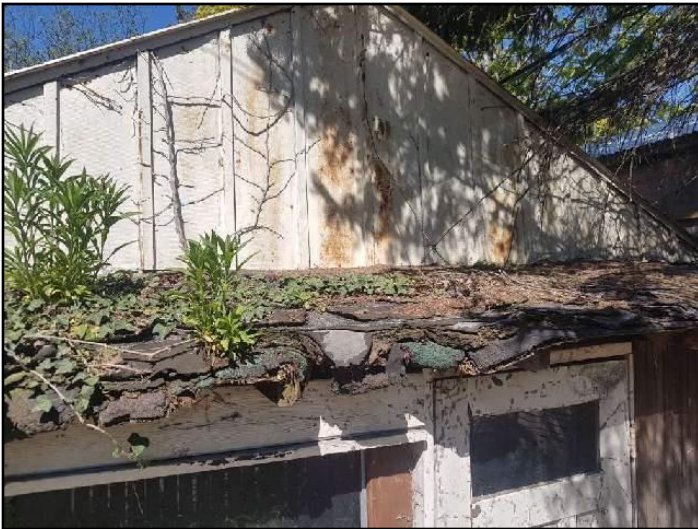
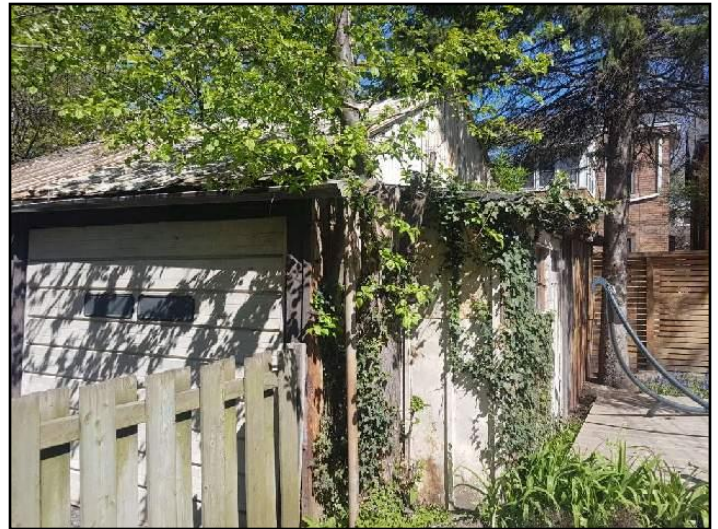
8. Condition: • Typical low quality structure

Garage roof leaking and will need structural repair before resurfacing. Tree causing damage to structure.

Implication(s): Chance of water entering building | Chance of structural movement | Chance of pests entering building | Physical injury

10. Typical low quality structure

Task: Repair

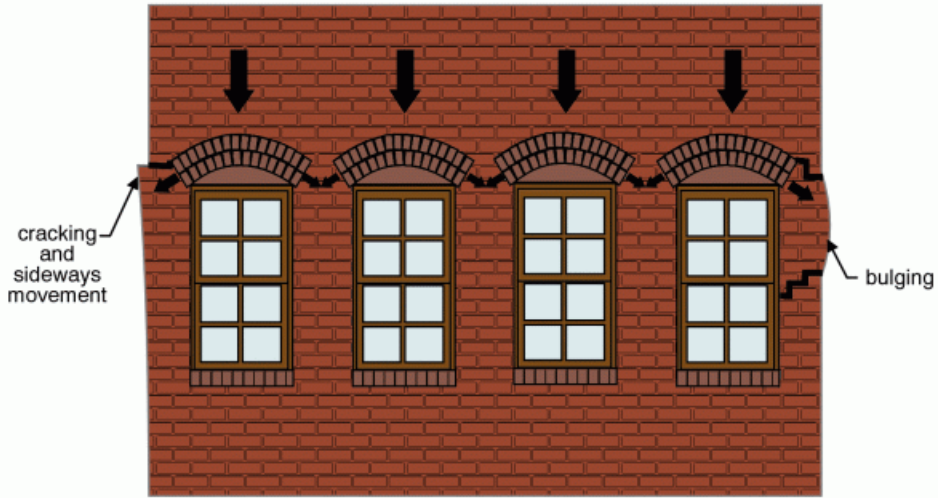
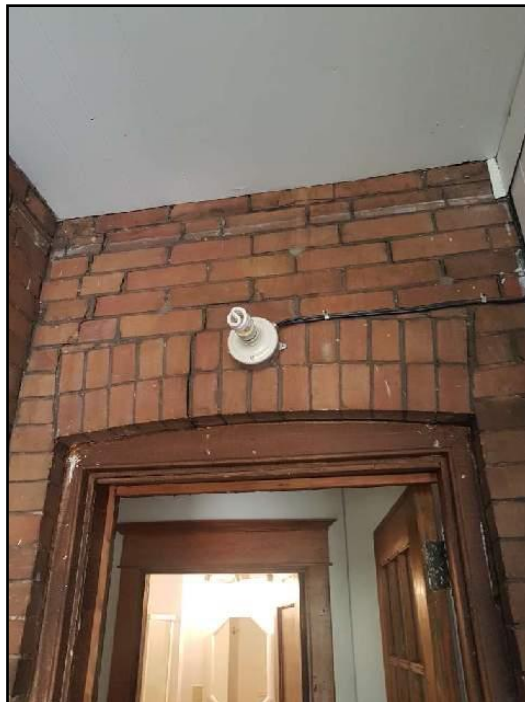
10. Condition: • [Cracked](#)

Implication(s): Weakened structure | Chance of structural movement

Masonry arches - cracking due to lateral thrust

when the "columns" of brick next to windows are narrow, the lateral forces imposed by the arches can cause sideways displacement of the brick resulting in cracking or wall bulging

11. Cracked

Repair or replace arches with steel lintels if replacing windows or doors.

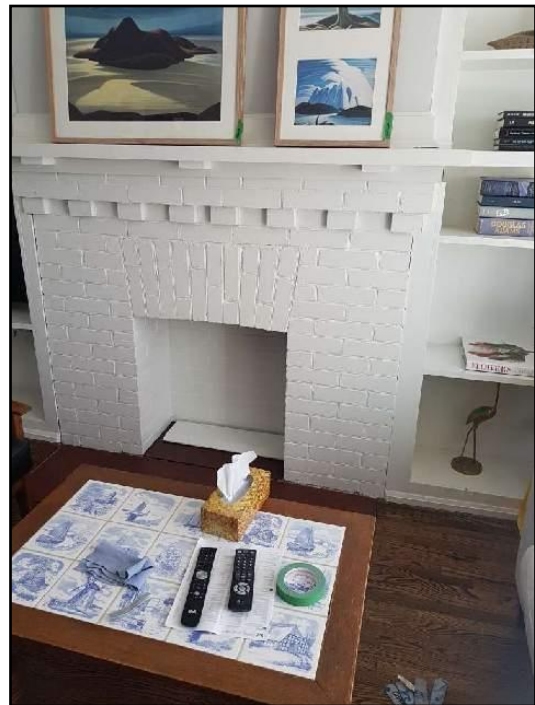
13. Non-functional

14. Condition: • Not functional

One flue is available if fireplace restoration is desired. Main floor fireplace is blocked by liner for boiler.

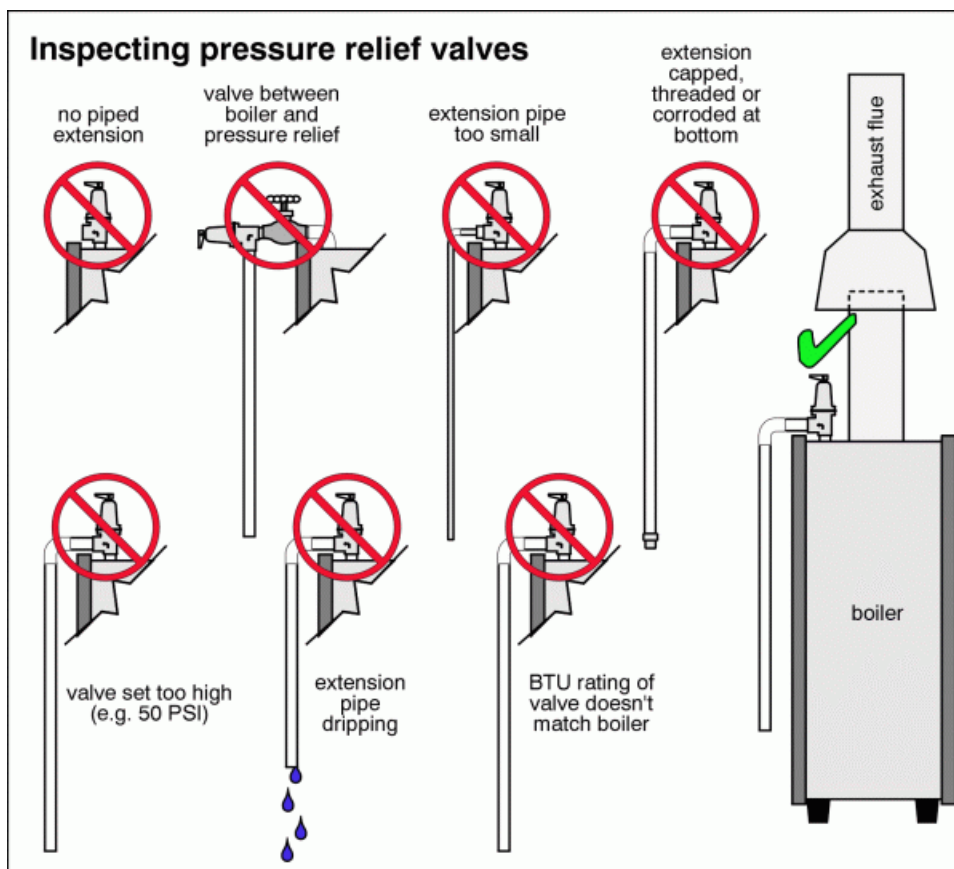
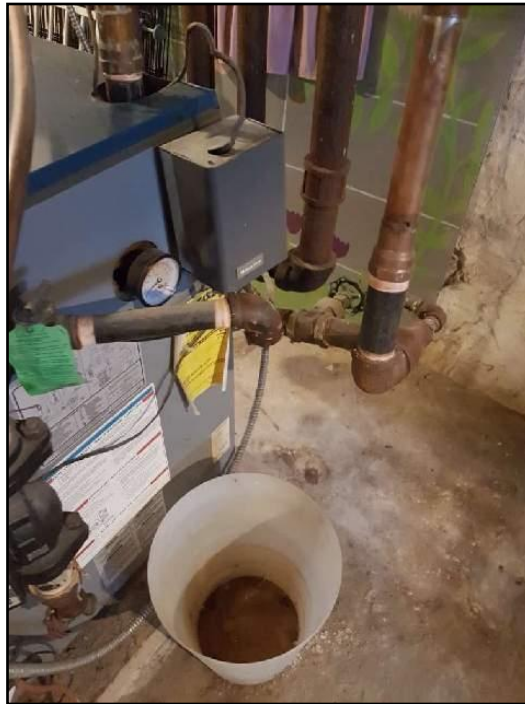
12. Condition: • [Pipe dripping or leaking](#)

Boiler needs minor service.

Implication(s): Steam explosion

14. Pipe dripping or leaking

Task: Service

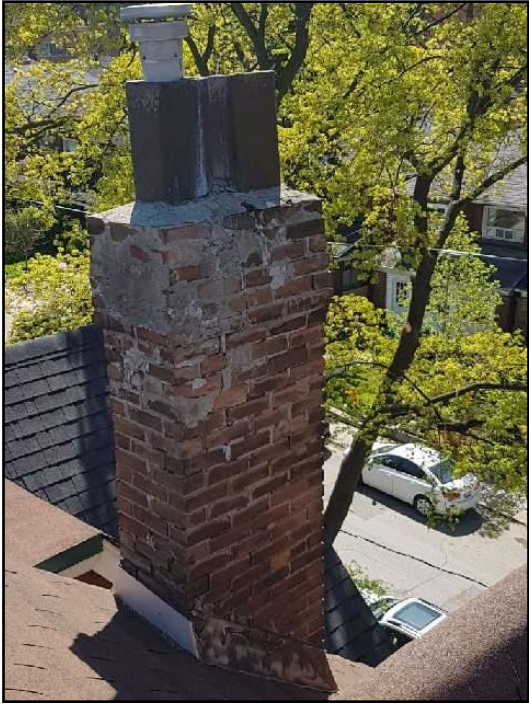
13. Condition: • [Loose, missing or deteriorated masonry](#)

Chimney will require eventual rebuild. N/W chimney is abandoned and sealed, can be removed at reshingling in future.

Implication(s): Material deterioration

15. Loose, missing or deteriorated masonry

Task: Repair

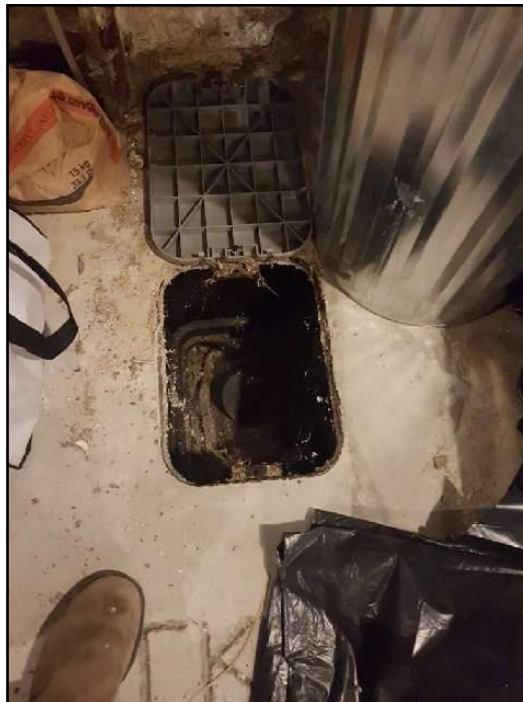
• Present. These valves help prevent sewer backup. Many insurance companies insist these be installed before they will offer a sewer backup endorsement, which we strongly recommend you obtain.

16. Backflow preventer

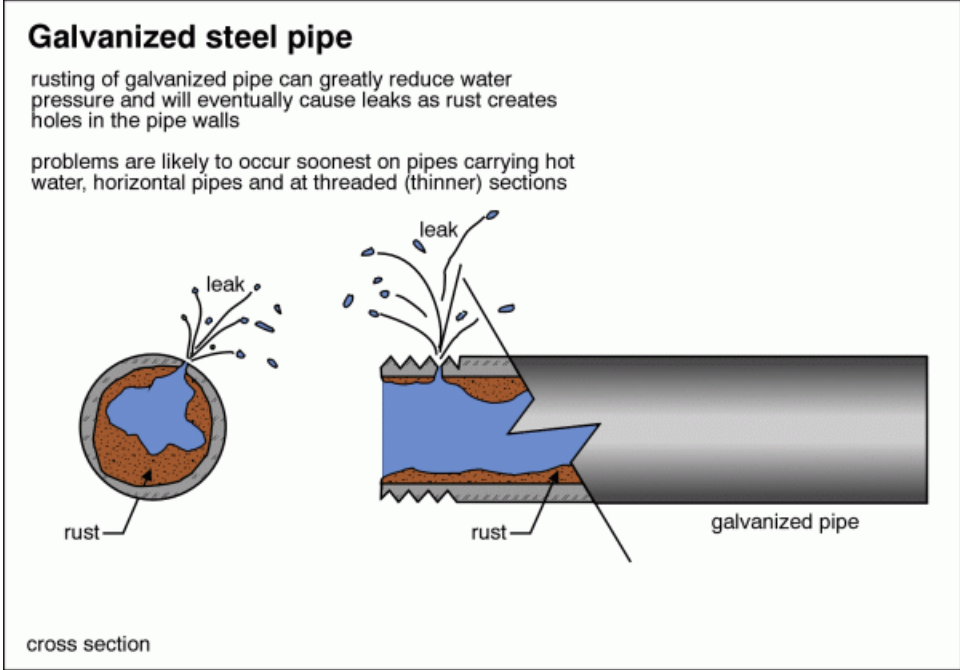
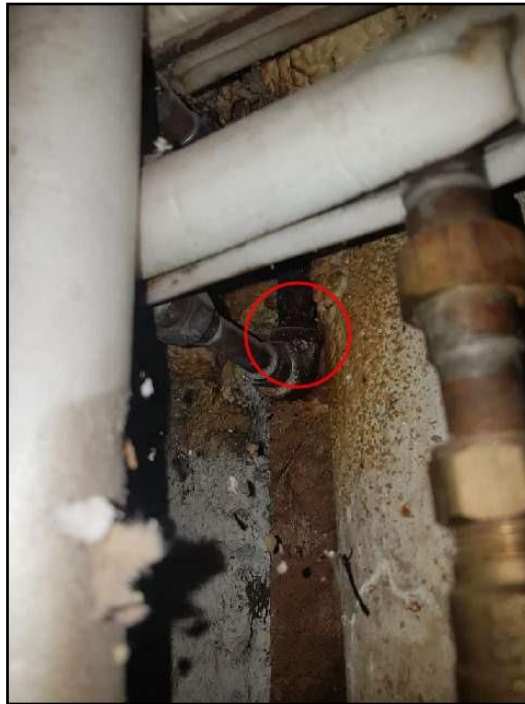
18. Condition: • [Galvanized steel](#)

Cold supply pipe (riser) at northwest exterior wall is galvanized steel, insurance company will request immediate replacement.

17. Galvanized steel

Task: Replace

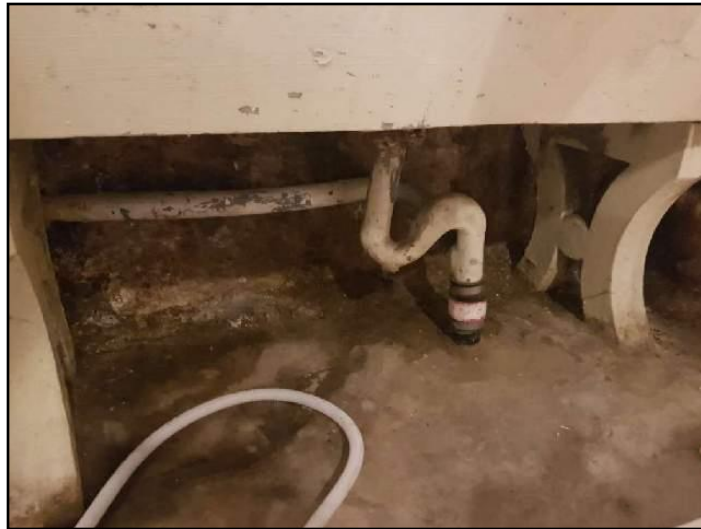
21. Condition: • [Dampness on floor or walls](#)

Implication(s): Chance of water damage to contents, finishes and/or structure | Material deterioration

18. *Dampness on floor or walls*

Minor seepage at north basement. If rerouting of downspout and basement entrance improvements do not alleviate issue, waterproof this area prior to finishing basement.
