Your Inspection Report

1819 Stonepath Crescent
Mississauga, ON L4X 1Y1

RE: Report No. 3634, v.2
1819 Stonepath Crescent
Mississauga, ON
L4X 1Y1

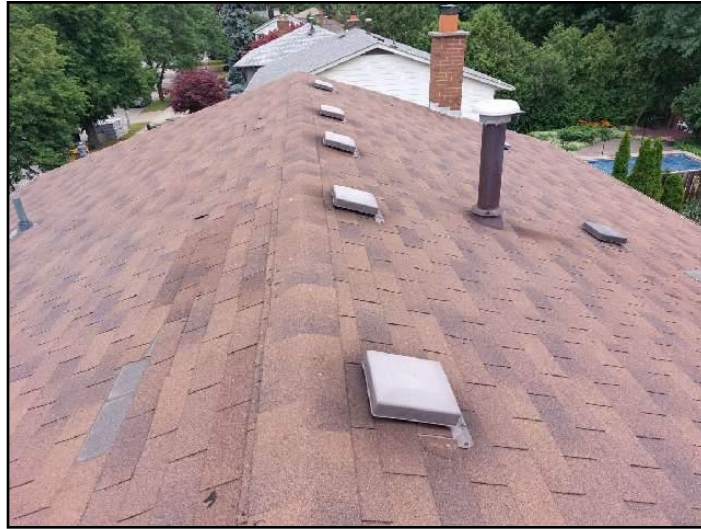
Sloped roofing material:

- [Asphalt shingles](#)

Probability of leakage: • High

Approximate age: • 7 years

1. **Condition:** • Roof has required repairs for wind damage, inspect annually and repair as needed.

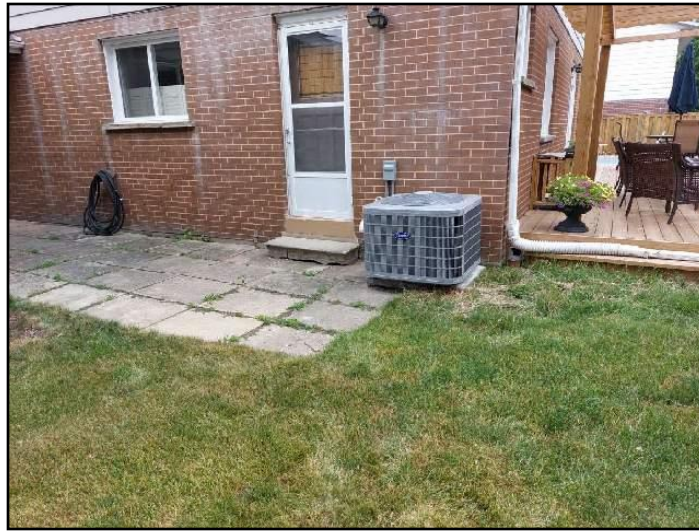
2. Condition: • [Slope toward building](#)

Implication(s): Chance of water damage to structure, finishes and contents

Location: West Exterior

Eliminate trip hazards and create drainage slope away from foundation at patio and surrounding soil.

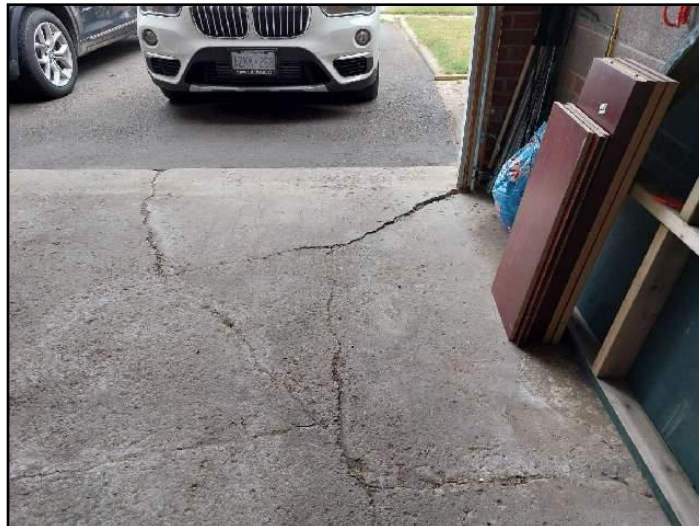
3. Condition: • [Improper slope](#)

Garage floor has settled and may be prone to water entry from driveway. Top up concrete if this occurs.

Implication(s): Loss of proper slope for drainage

Location: Garage

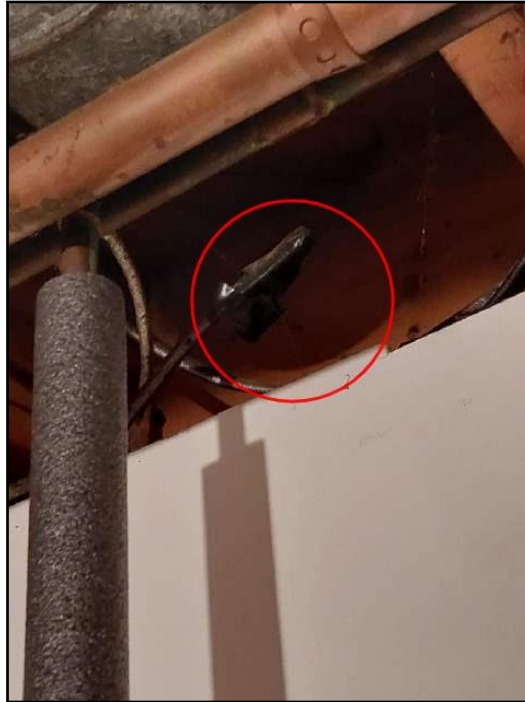
4.

5. Condition: • [Abandoned wire](#)

Implication(s): Electric shock

Location: Southwest Basement

Enclose wire in junction box.

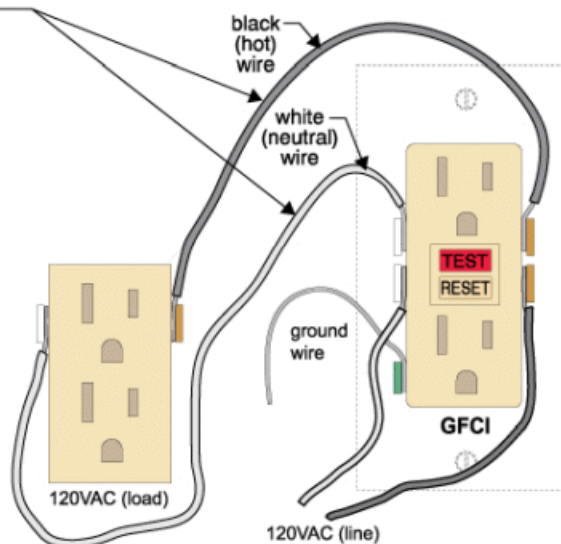
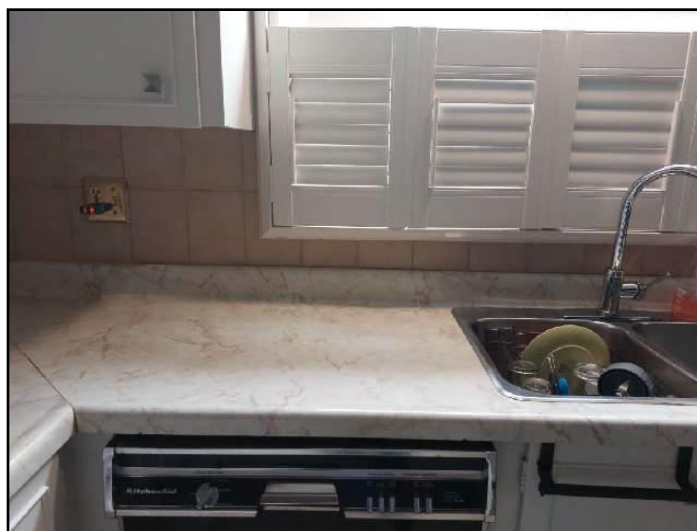
5.

6. Condition: • [GFCI/GFI needed \(Ground Fault Circuit Interrupter\)](#)

Implication(s): Electric shock

Location: Various

Recommend gfci receptacles at all wet locations.

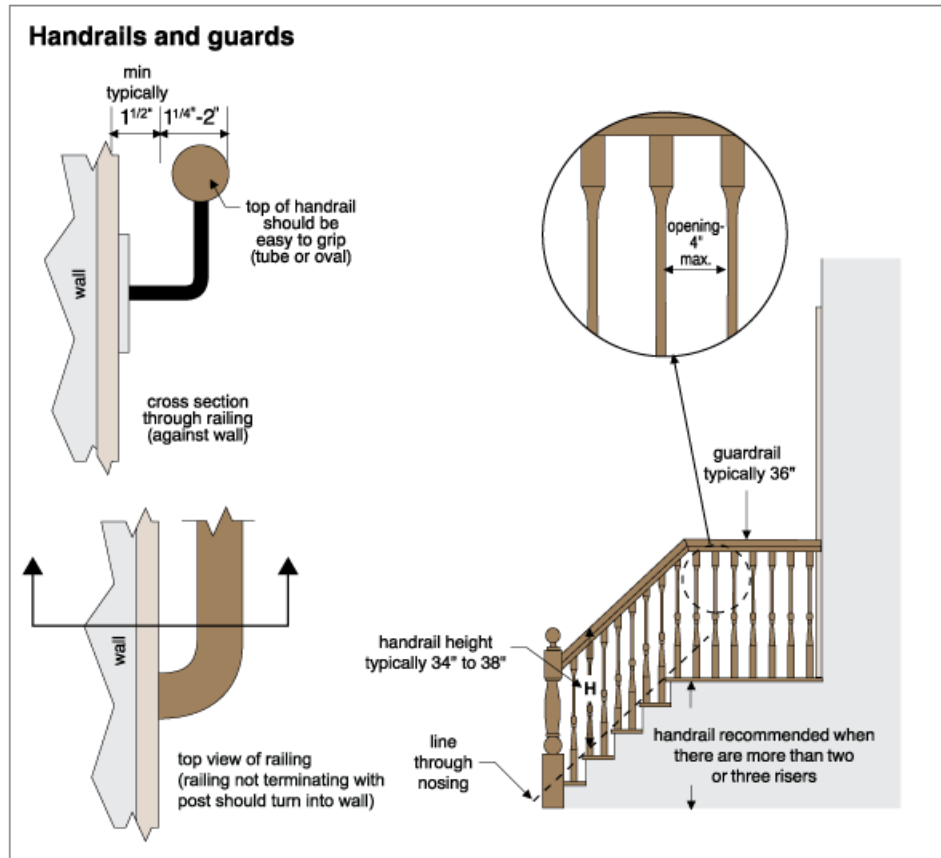
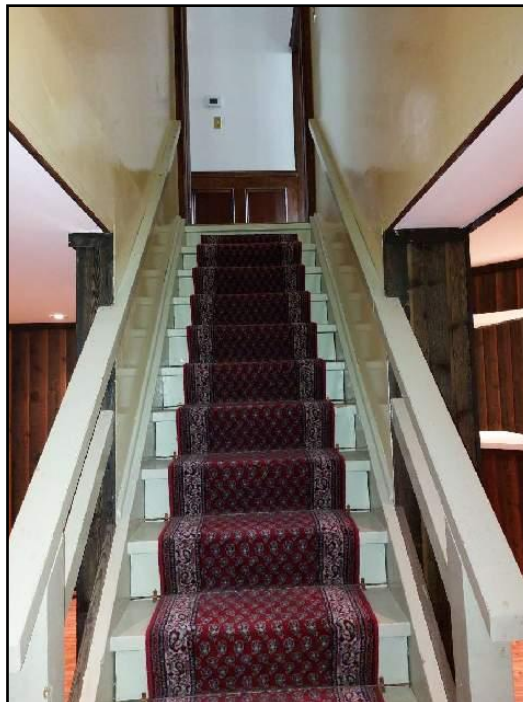
7.

11. Condition: • [Hard to hold](#)

Implication(s): Fall hazard

Location: Basement Staircase

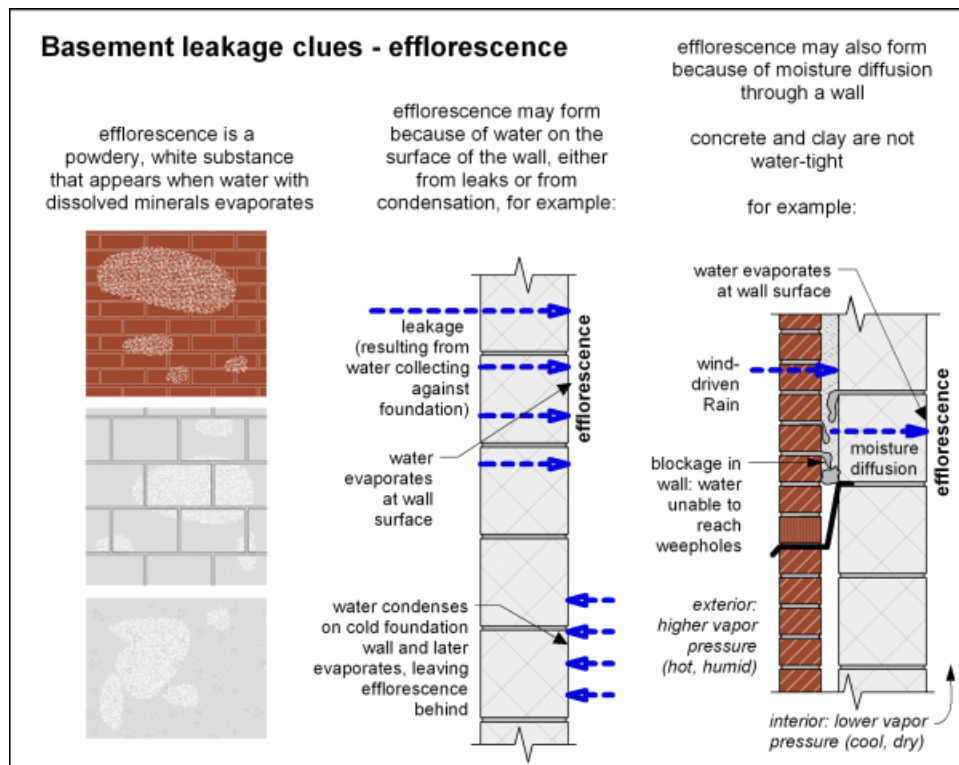
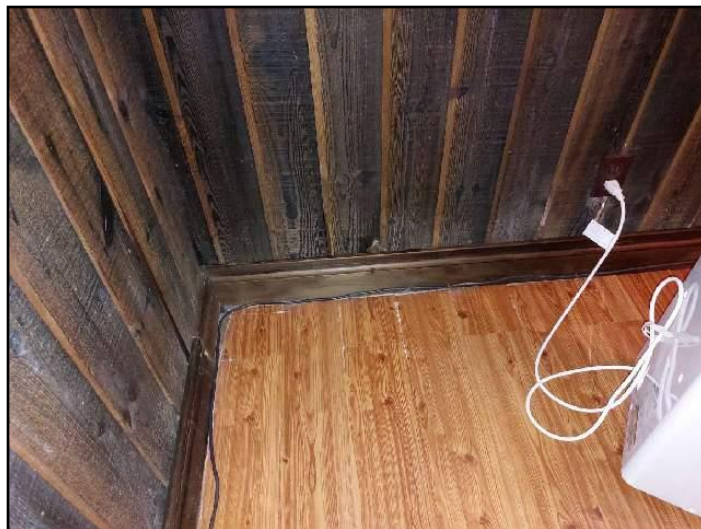
8.

12. Condition: • [Efflorescence](#)

Some dampness evident at basement.

Implication(s): Chance of water damage to structure, finishes and contents

Location: Basement
