Your Inspection Report

RE: Report No. 3862
93 The Queensway, 58
Toronto, ON
M6S 5A7

93 The Queensway, Toronto, ON September 6, 2023

2006 condominium townhouse in good condition.

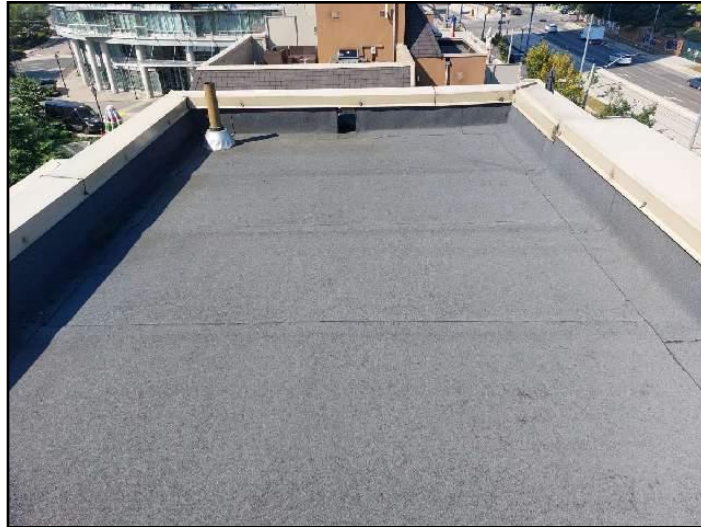
1.

• [Modified bitumen membrane](#)

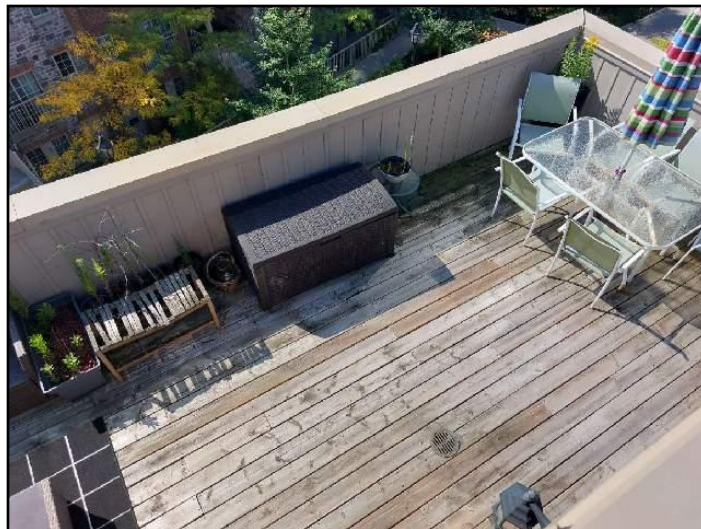
2.

• Deck, could not inspect roof membrane below.

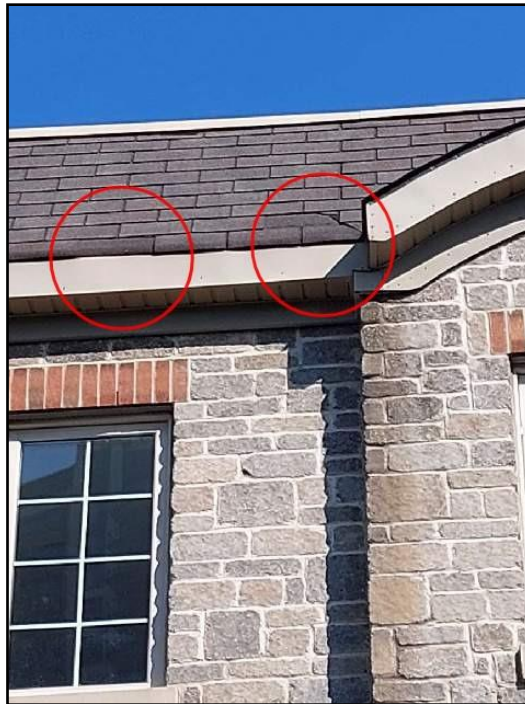
3.

1. **Condition:** • [Missing, loose or torn](#)

Asphalt shingles at roof perimeter due for replacement. This will be the responsibility of the condo group.

Implication(s): Chance of water damage to structure, finishes and contents

Task: Replace

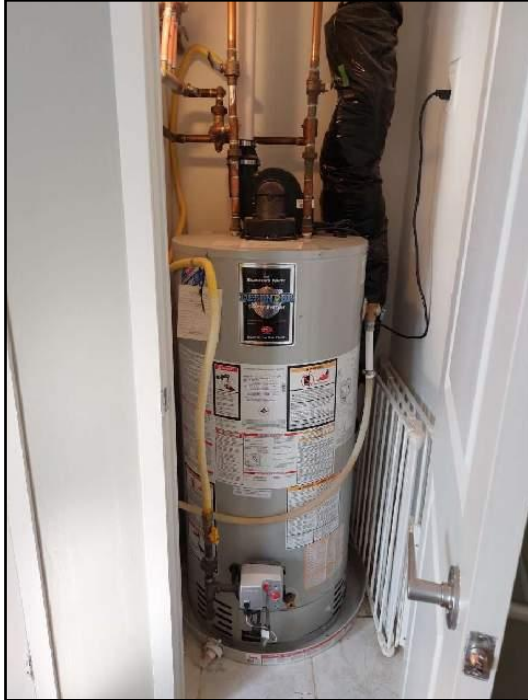
4. Heat source

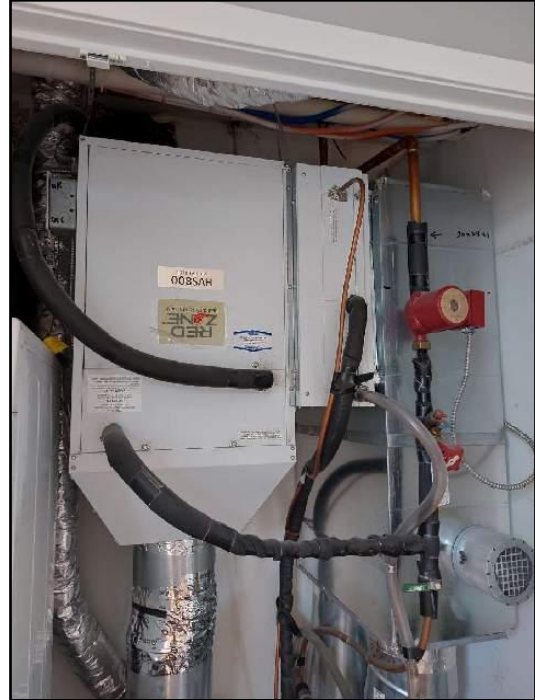
5. Air handler

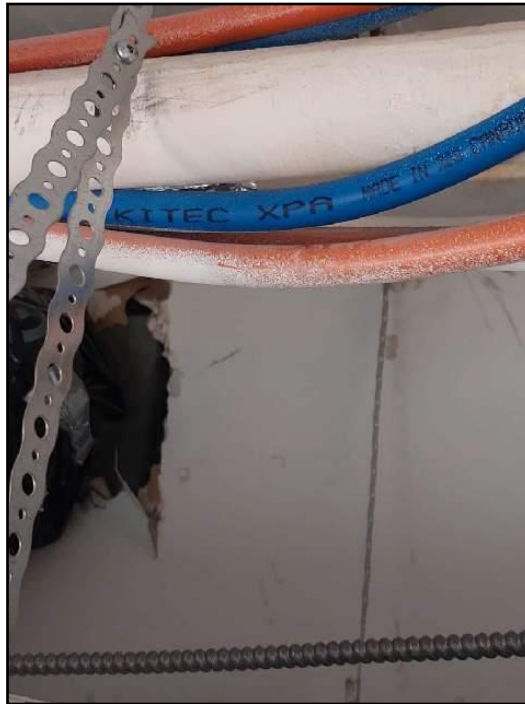
6.

8. Condition: • [Kitec](#)

Supply piping throughout is primarily Kitec plastic which is prone to failure at connectors. Some insurers do not insure this material and will require replacement. Vendor has quote for replacement.

Implication(s): Chance of water damage to structure, finishes and contents | Reduced water pressure and volume

Task: Replace

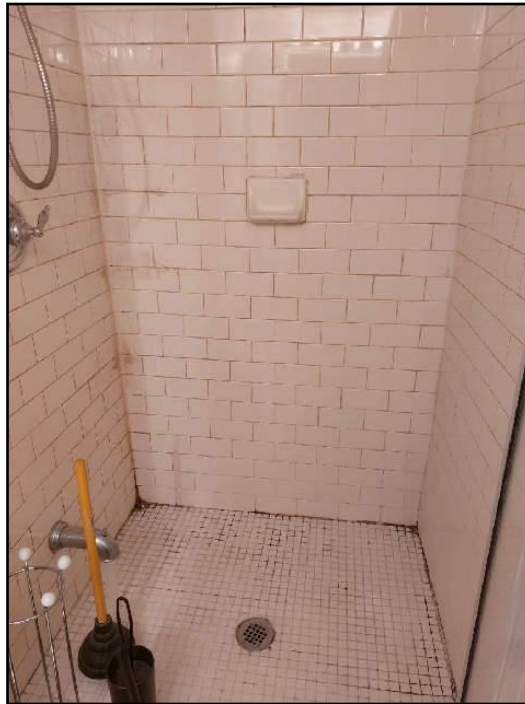
7.

9. Condition: • [Caulking loose, missing or deteriorated](#)

Implication(s): Chance of water damage to structure, finishes and contents

Task: Replace

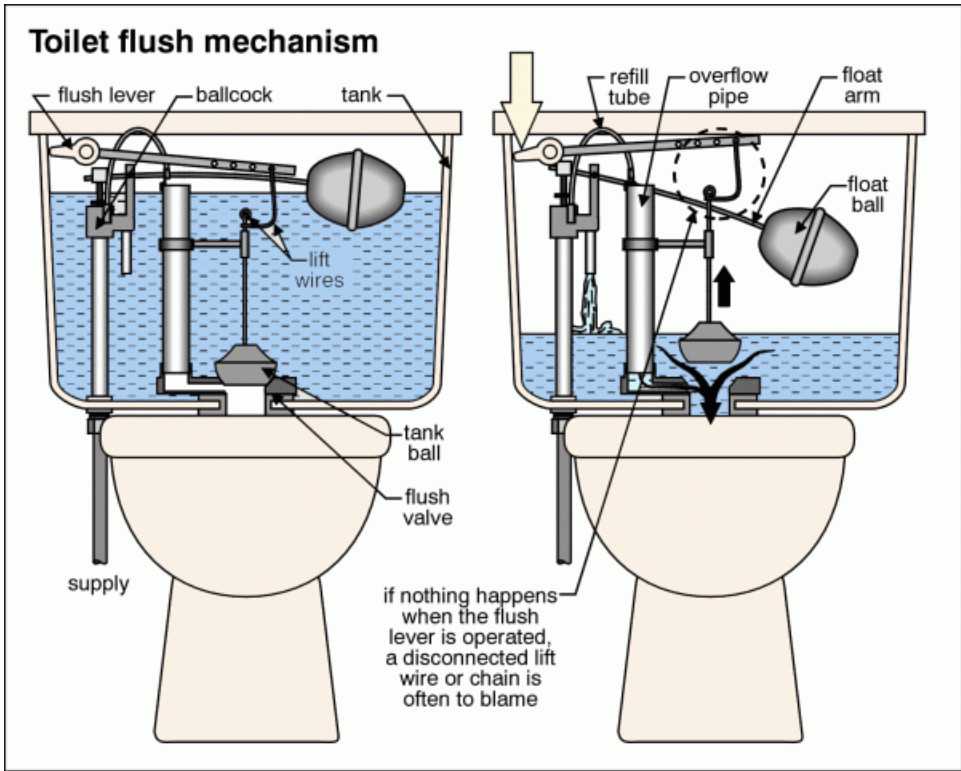
10. Condition: • [Running continuously](#)

Implication(s): Chance of condensation damage to finishes and/or structure | Increased water consumption

Task: Repair

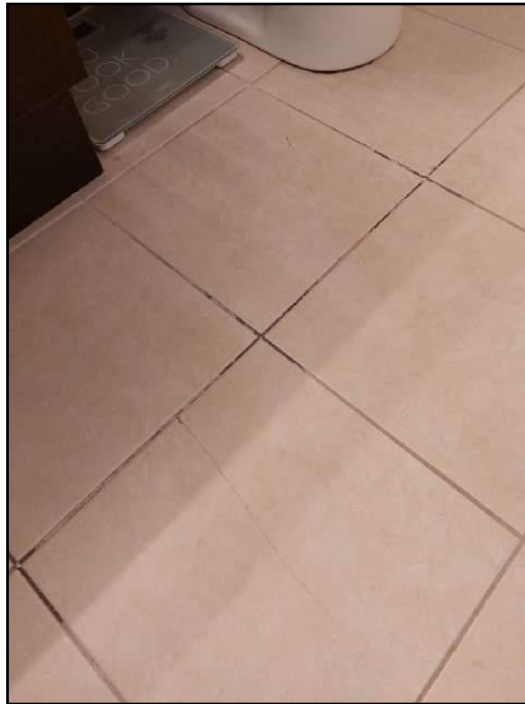
8.

11. Condition: • [Tiles cracked](#)

Task: Replace

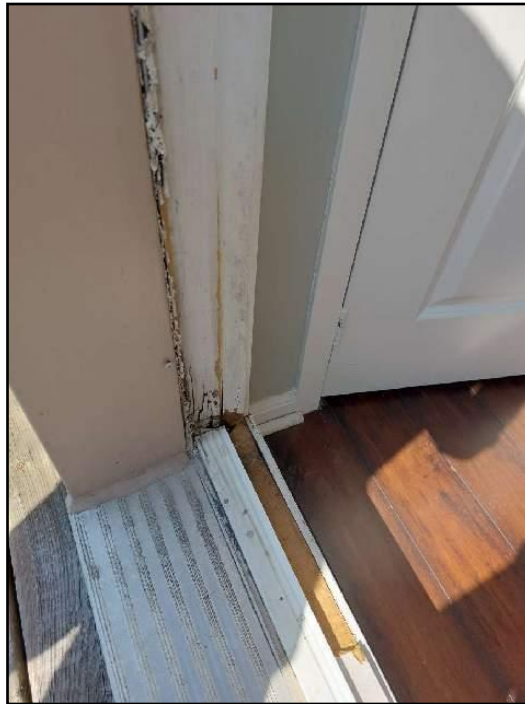
9.

14. Condition: • Damage

Implication(s): Shortened life expectancy of material | Increased heating and cooling costs | Reduced comfort

Vendor to replace both exterior doors.
