Your Inspection Report

65 Trailwood Drive
Mississauga, ON L4Z 3L1

Friday, January 24, 2025

RE: Report No. 4163
65 Trailwood Drive
Mississauga, ON
L4Z 3L1

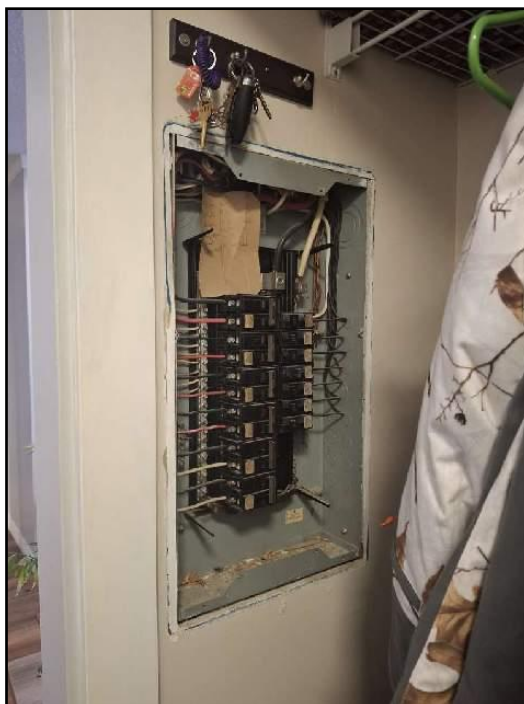
1.

Distribution panel type and location: • Breakers at hall closet

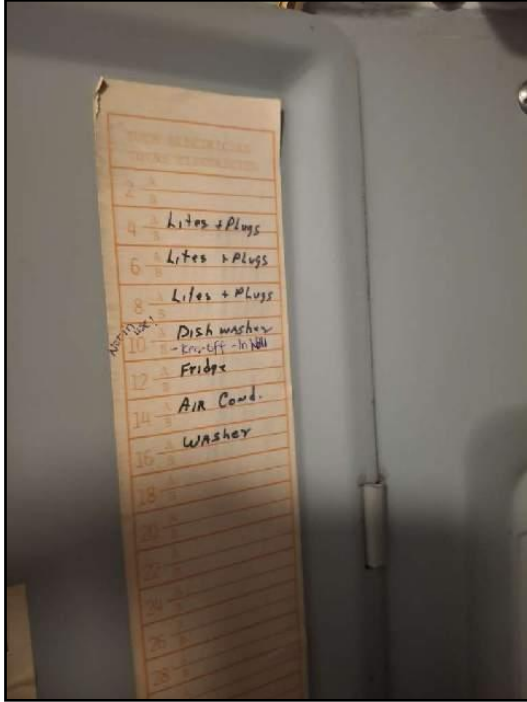
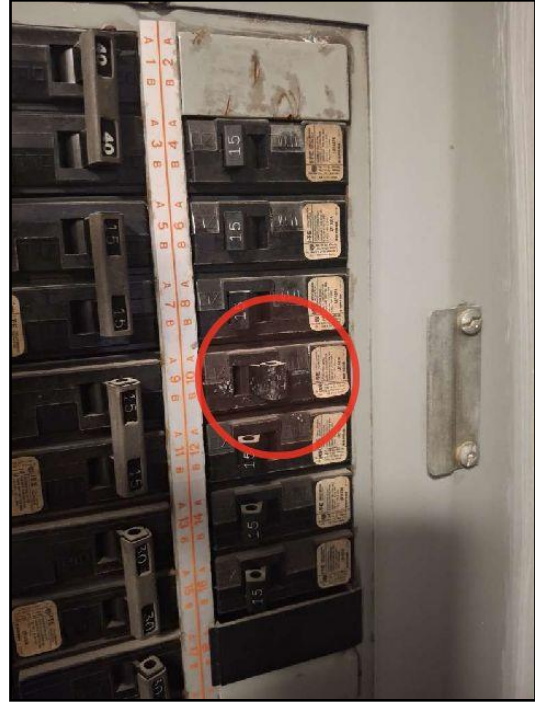
4. Condition: • Breaker in OFF position

Disconnect wiring from unused circuit.

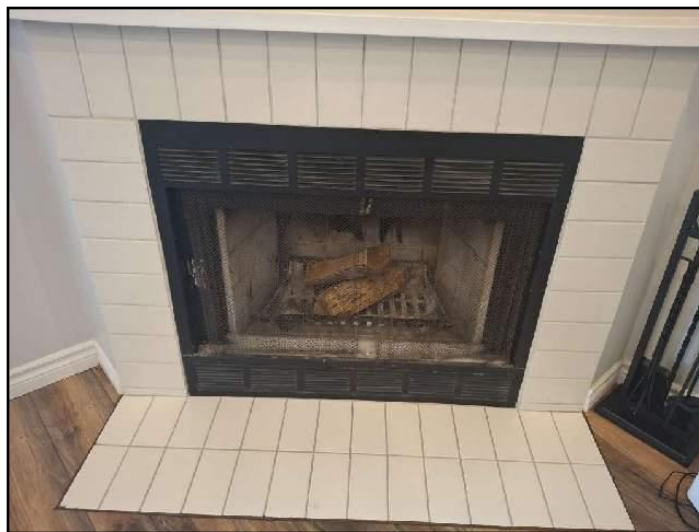
4.

• [Wood-burning fireplace](#)

• [Factory-built](#)

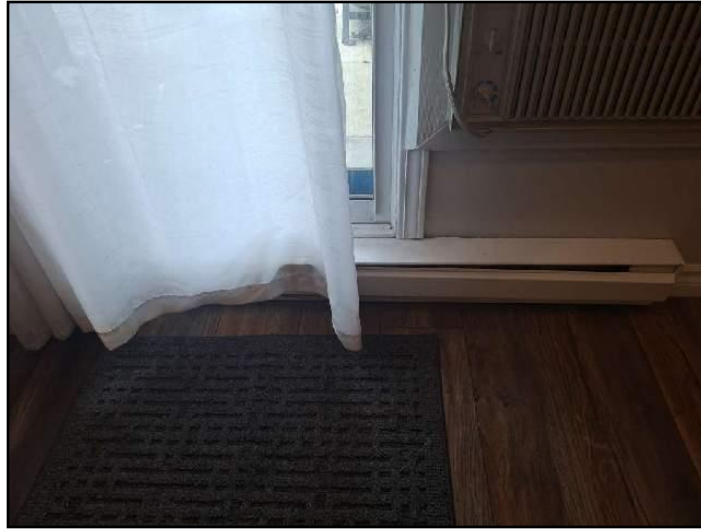
5.

6. Condition: • Inadequate combustible clearance.

Location: Living Room

Raise curtains above baseboard heaters.
