# Your Inspection Report

2 O'Hara Place  
Toronto, ON M6K 1L9

RE: Report No. 4227  
2 O'Hara Place  
Toronto, ON  
M6K 1L9

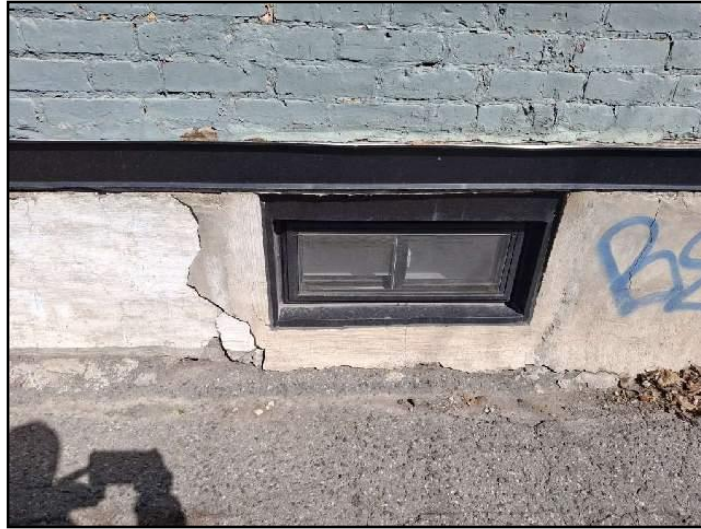
3. Condition: • [Parging damaged or missing](#)

Implication(s): Chance of damage to structure | Shortened life expectancy of material

Location: South Exterior

Task: Repair

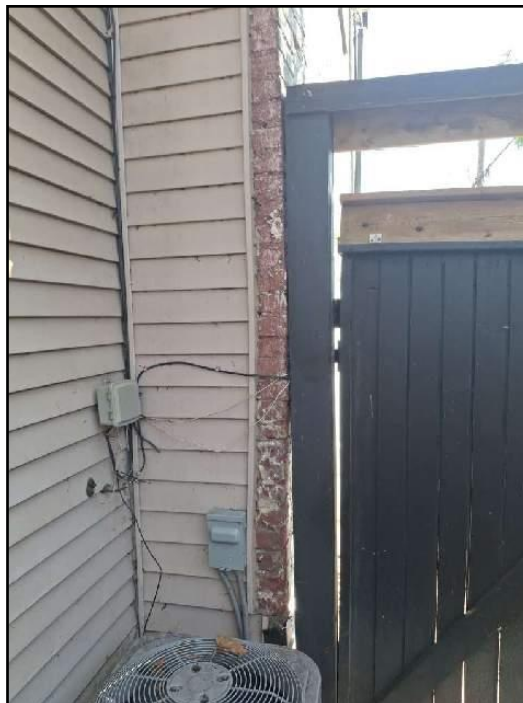
4.

**4. Condition:** • Some prior brick repairs evident at brick veneer. Periodic repair may be required due to age of brick, not urgent.

**Location:** South Exterior

**Task:** Monitor

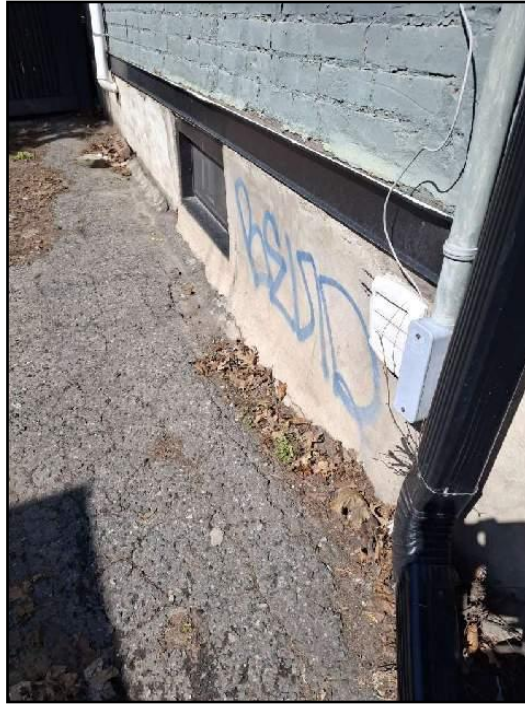
5.

**5. Condition:** • [Improper slope or drainage](#)

**Implication(s):** Chance of water damage to structure, finishes and contents

**Location:** South Exterior

Add or remove asphalt to create drainage slope away from foundation.

**Task:** Repair

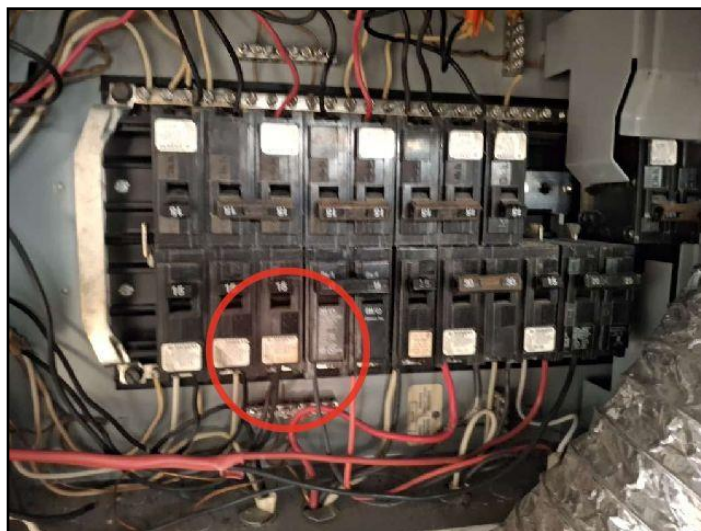
6.

**7. Condition:** • [Double taps](#)

**Implication(s):** Fire hazard

**Location:** Basement Panel

Add breaker and split double tap if nuisance tripping occurs.

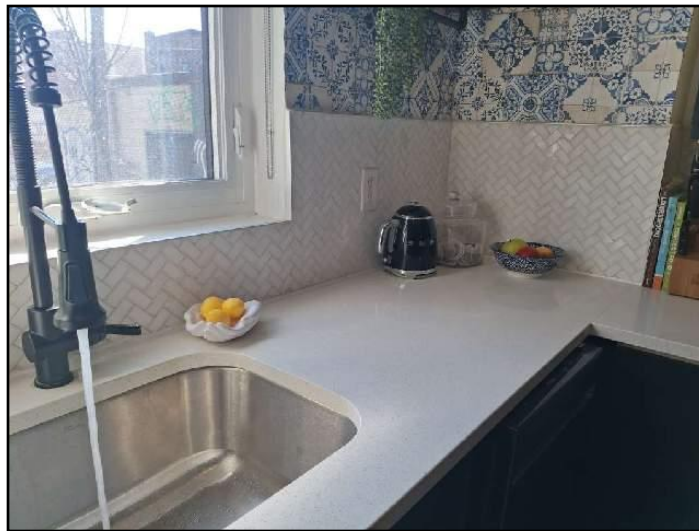
7.

8. Condition: • [GFCI/GFI needed \(Ground Fault Circuit Interrupter\)](#)

Implication(s): Electric shock

Location: Kitchen

Task: Replace

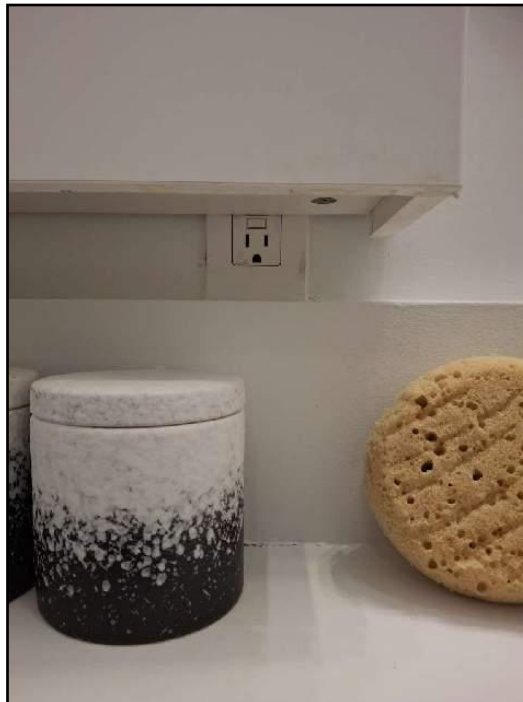
8.

**10. Condition:** • Poor location

**Location:** Second Floor Bathroom

Raise cabinet or relocate outlet to allow access to reset.

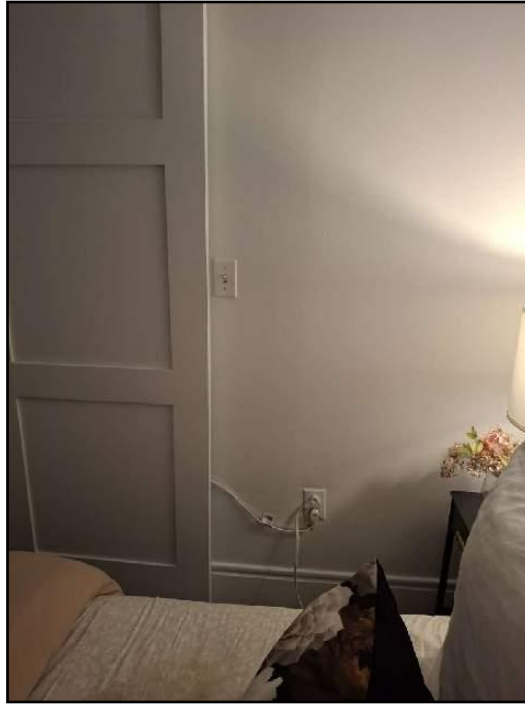
9.

**DISTRIBUTION SYSTEM \ Switches****11. Condition:** • Poor location of switches.

**Location:** Second Floor

Relocate upper stair and bedroom switches.

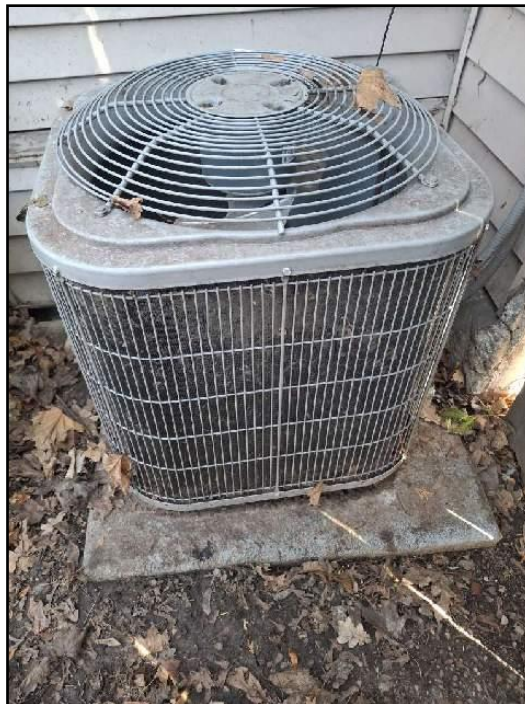
11.

**15. Condition:** • [Dirty](#)

**Implication(s):** Reduced system life expectancy | Increased cooling costs | Reduced comfort

**Location:** South Exterior

**Task:** Clean

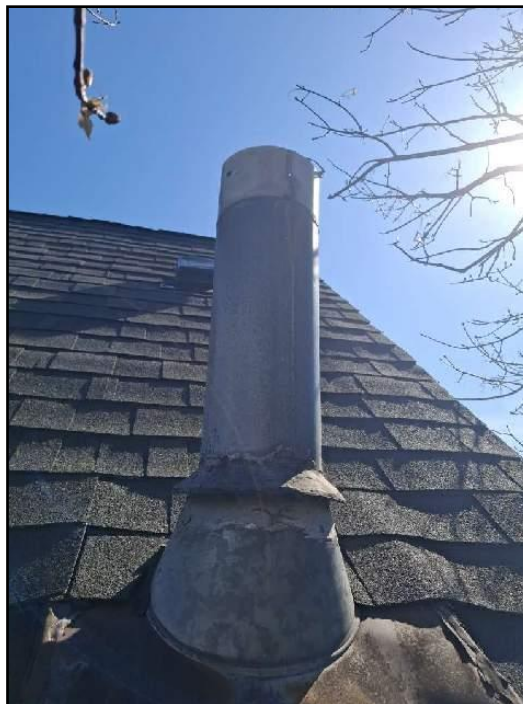
13.

**18. Condition:** • Replace missing cap at top of metal chimney, reseal metal flashing. This chimney can be removed at reshingling in future if water heater is replaced with direct vent type.

**Location:** Southwest

**Task:** Repair

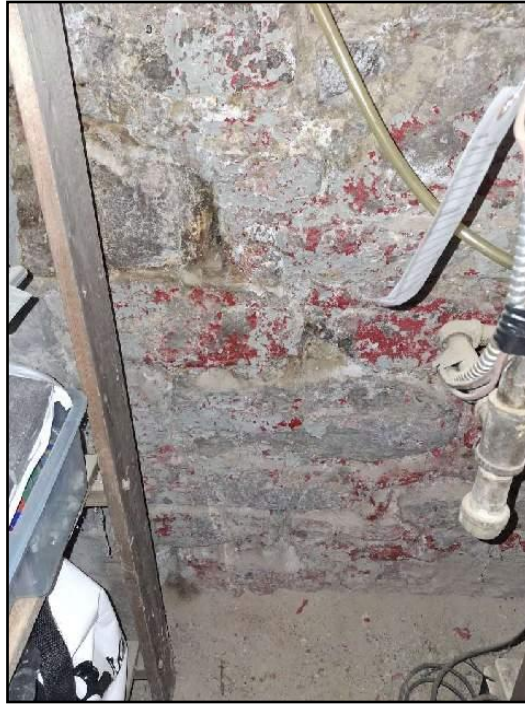
14.

20. Condition: • Fill and parge exposed masonry as needed.

Task: Repair

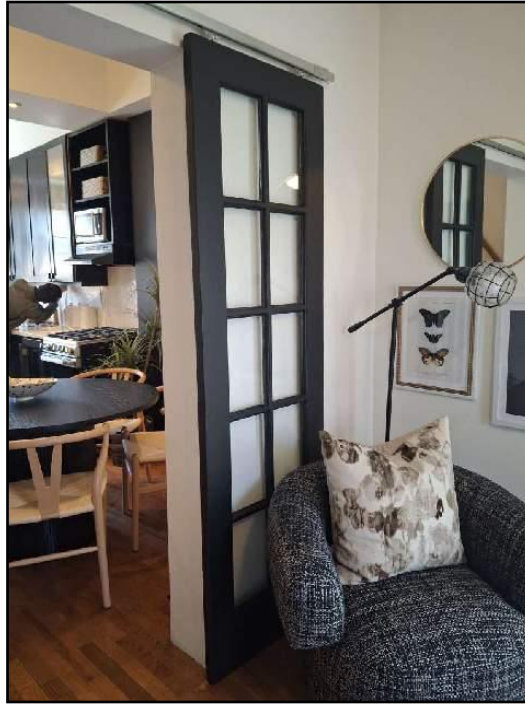
15.

**21. Condition:** • Needs adjustment.  
Adjust south sliding door.

**Task:** Repair

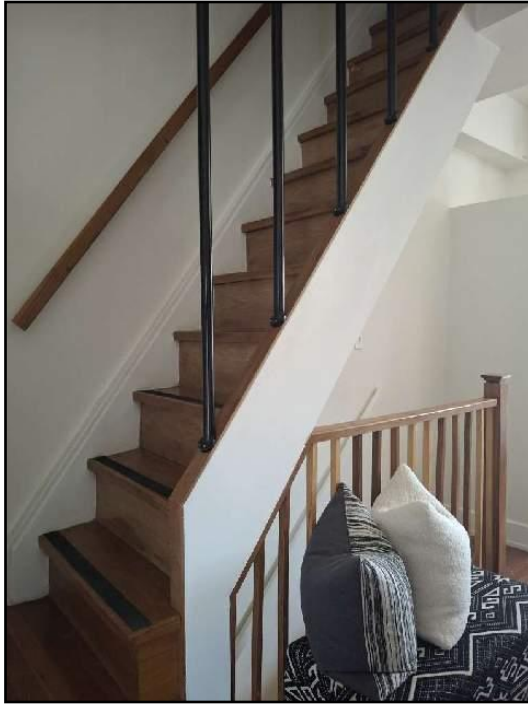
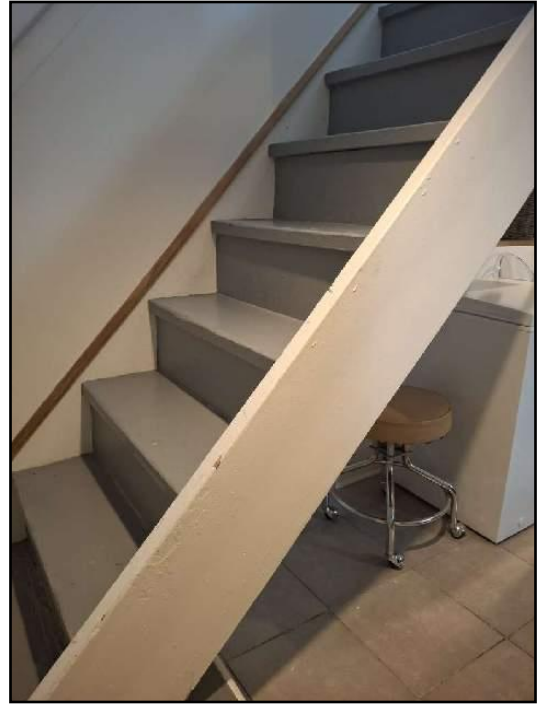
**22. Condition:** • Very steep.

Recommend improving existing guardrail at second floor stairs, adding guardrail improving handrail at basement stairs.
