Your Inspection Report

189 Argyle Street
Toronto, ON M6J 1P5

Thursday, May 15, 2025

RE: Report No. 4273
189 Argyle Street
Toronto, ON
M6J 1P5

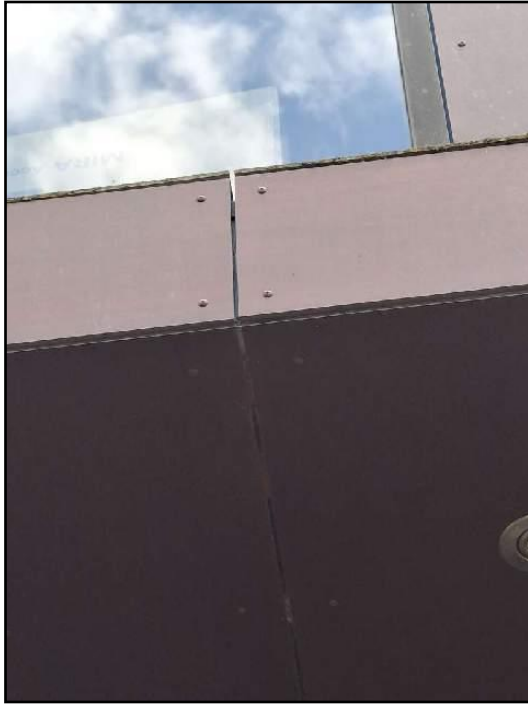
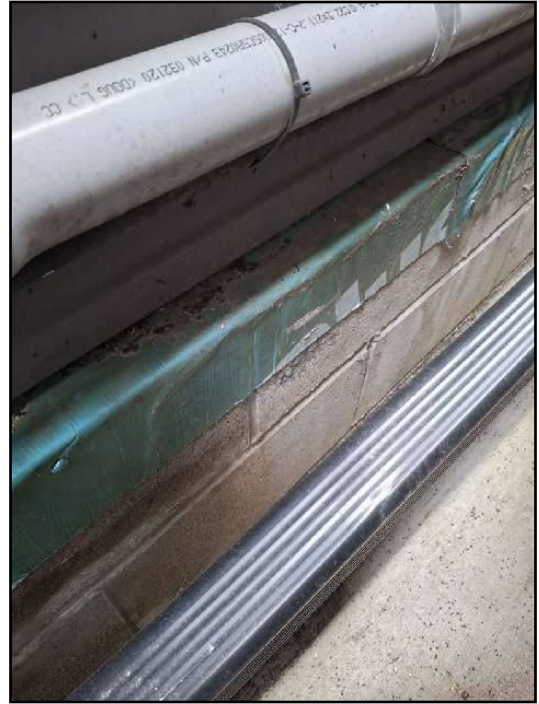
2. Condition: • [Flashings missing](#)

Kickout flashing missing at base of metal siding on west wall.

Joints at hardboard siding lack flashings leaving secondary membrane exposed and vulnerable to damage (typically from sunlight).

Implication(s): Chance of water damage to structure, finishes and contents

Task: Improve

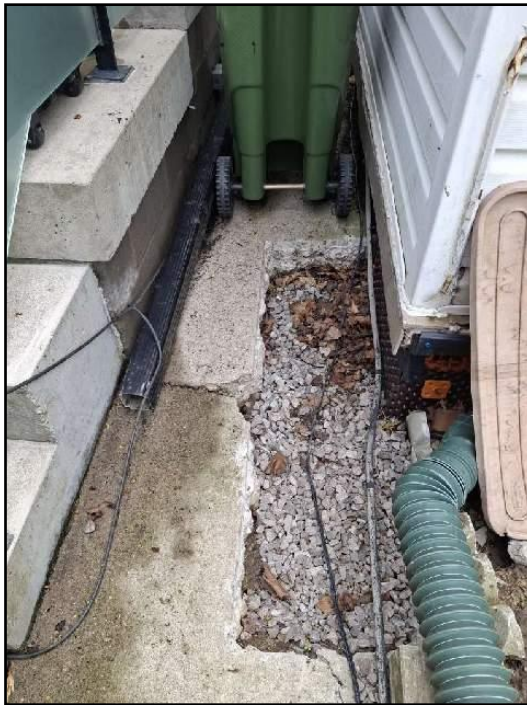
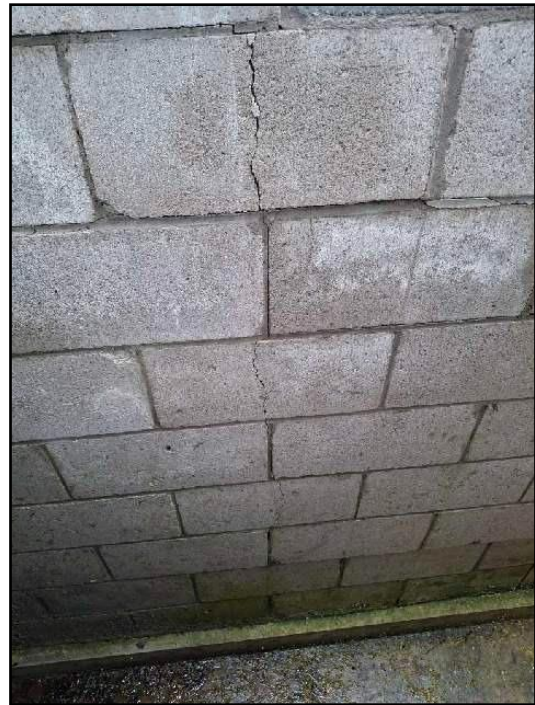
4. Condition: • Poor drainage and downspout terminations at both n/e and n/w walkways is contributing to leakage and cracking at retaining wall.

Task: Improve

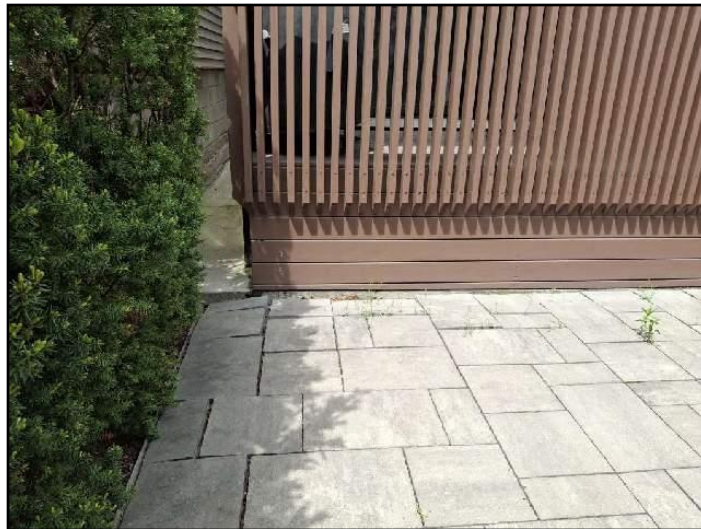
9.

5. Condition: • Improper slope or drainage

Implication(s): Chance of water damage to structure, finishes and contents

Lift and relay interlocking to create drainage away from foundation.

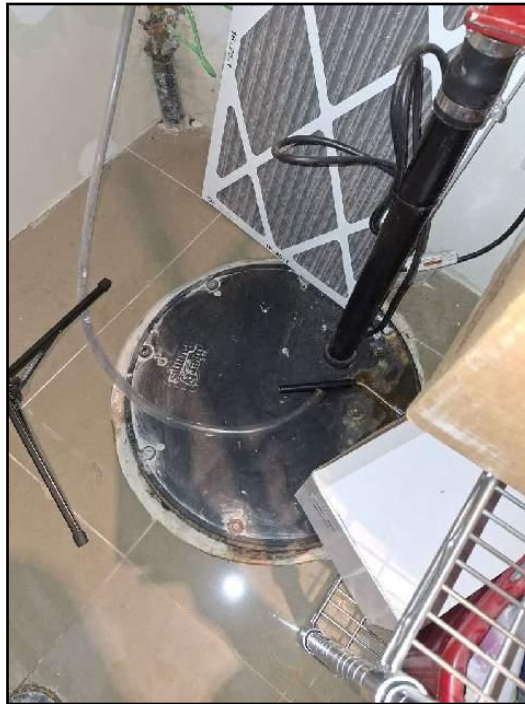
11.

12. Condition: • Recommend installation of backup pump and power supply.

Task: Install
