Your Inspection Report

11 Bluewater Court
Toronto, ON M8V 4A7

Friday, June 13, 2025

RE: Report No. 4300, v.2
11 Bluewater Court
Toronto, ON
M8V 4A7

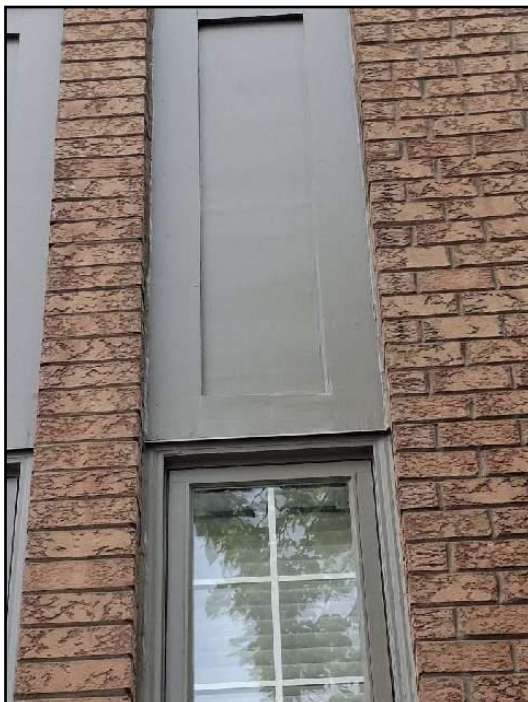
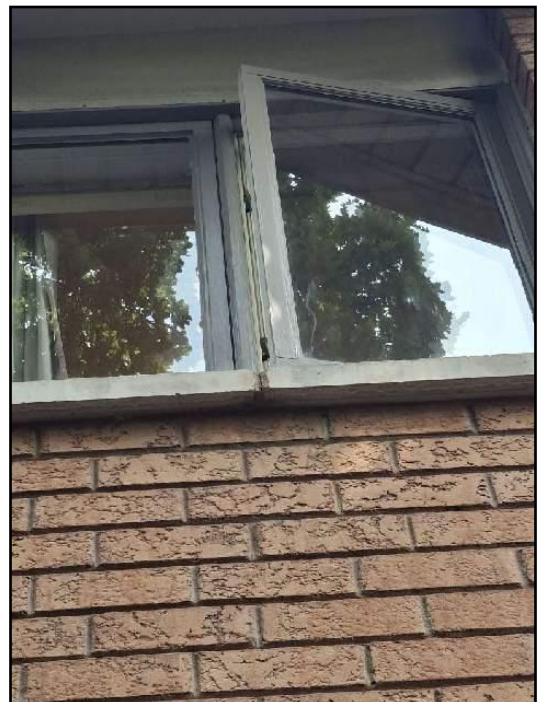
2. Condition: • Original wood windows and trim will need eventual replacement. All operable at time of inspection.

Location: Various Exterior

Task: Monitor

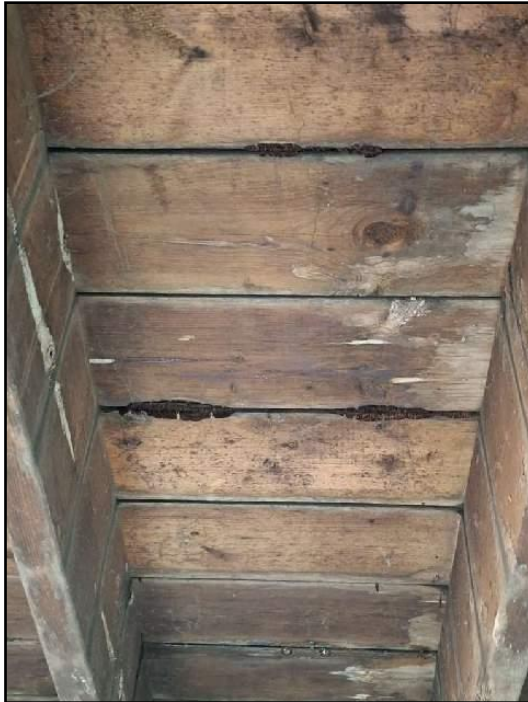
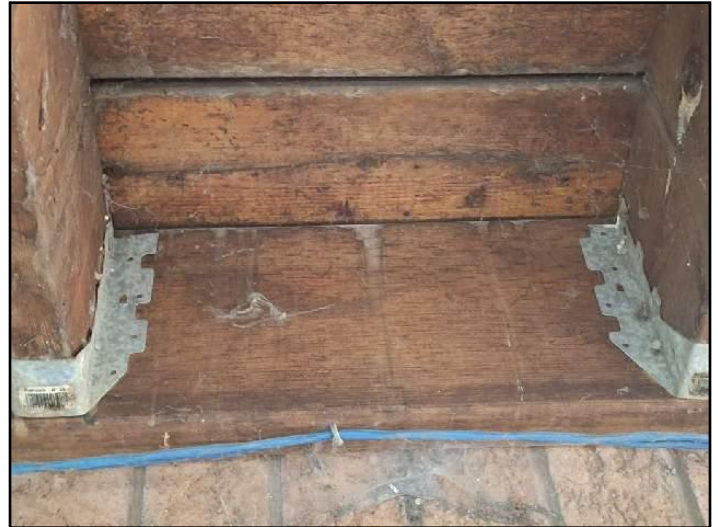
3. Condition: • [Rot](#)

Implication(s): Weakened structure | Chance of movement | Material deterioration

Location: South Exterior

Replace damaged deck boards (leave space for drainage) and add nails to joist hangers.
