# Your Inspection Report

10 Herman Avenue  
Toronto, ON M6R 1Y2

Thursday, July 24, 2025

RE: Report No. 4323, v.2  
10 Herman Avenue  
Toronto, ON  
M6R 1Y2

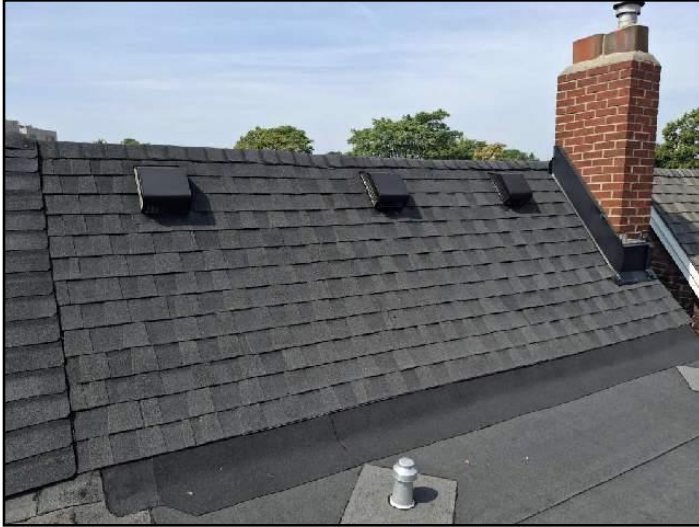
1.

2. **Condition:** • Roof in good condition.

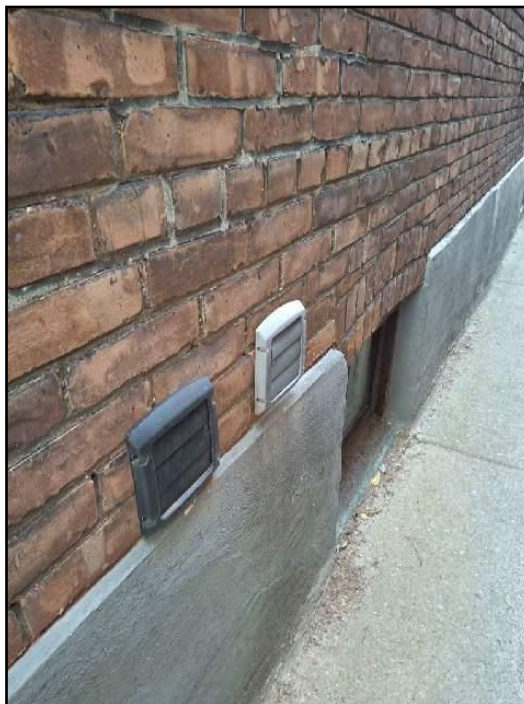
5.

3. Condition: • Seal vents at wall.

Location: Northwest Exterior Wall

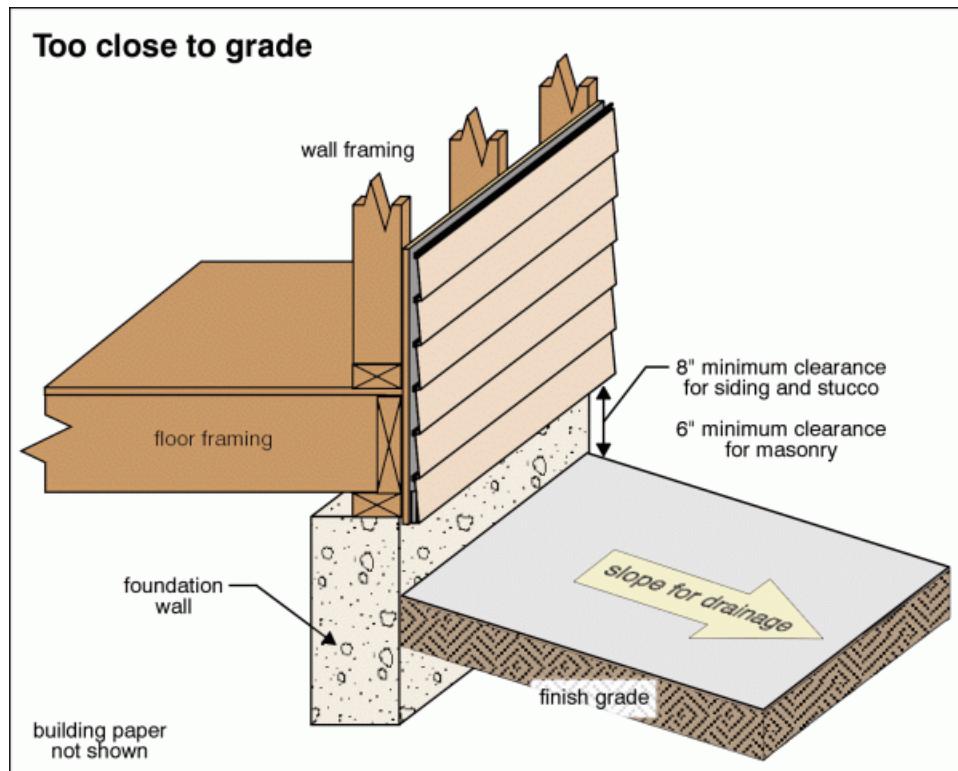
4. Condition: • [Too close to grade](#)

Ideally siding and wood structure would begin well above grade.

**Implication(s):** Chance of water damage to structure, finishes and contents | Material deterioration | Rot | Insect damage

**Location:** Northeast Exterior

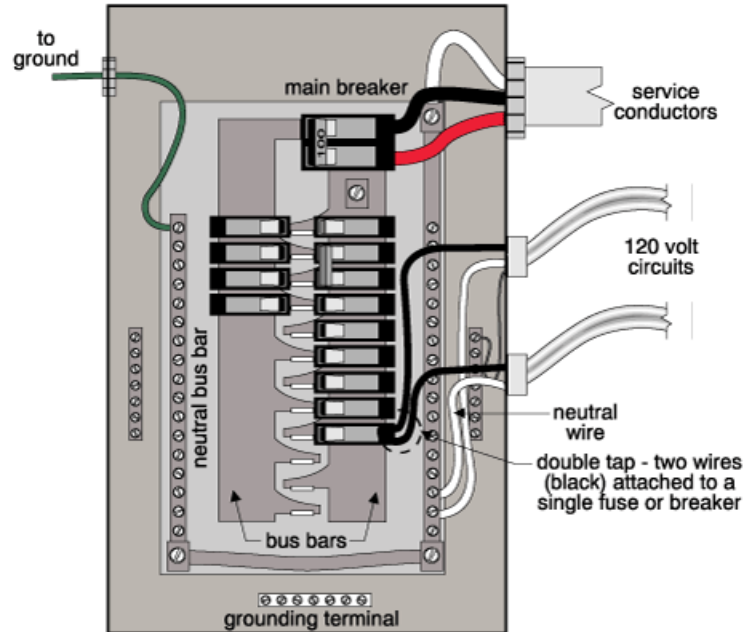
8.

**8. Condition:** • [Double taps](#)

**Implication(s):** Fire hazard

**Location:** Basement Panel

Add breaker and split double tap if nuisance tripping occurs.

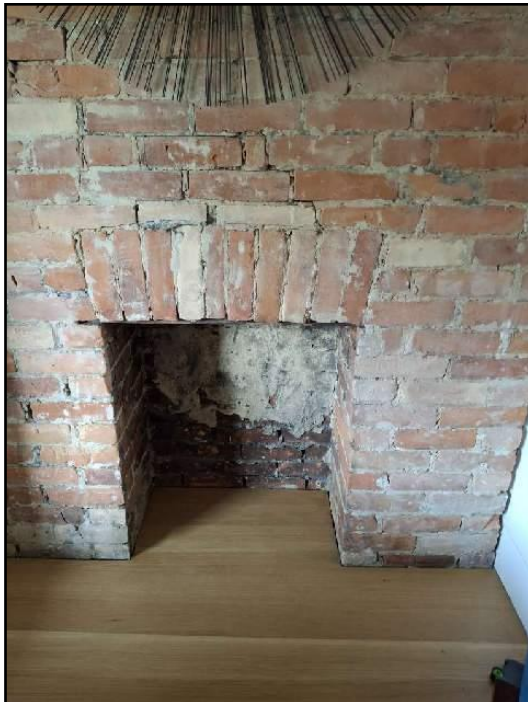
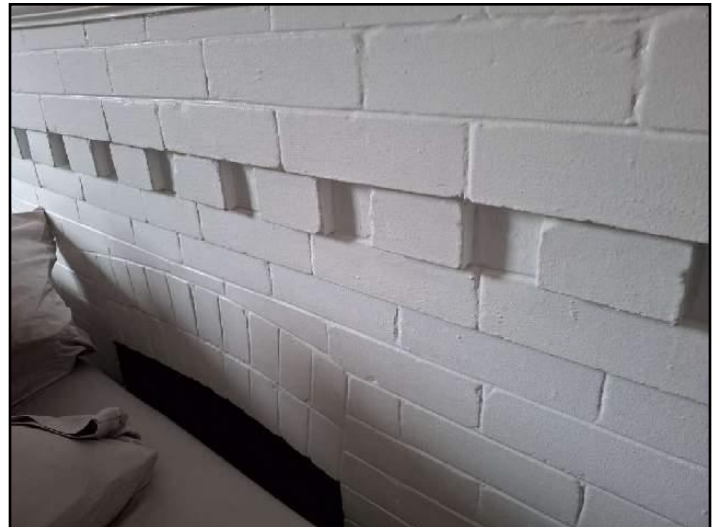
- Non-functional

Two flues are available if fireplace restoration is desired.

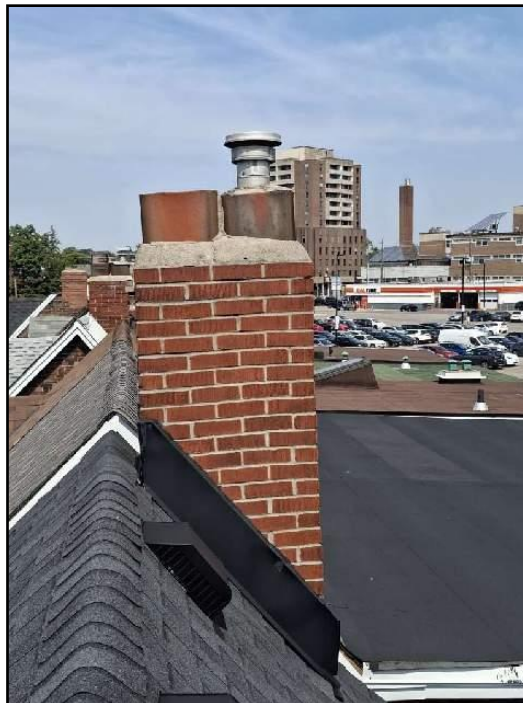
13.

**10. Condition:** • Seal unused flue against pest and water entry.

**Location:** Southwest Exterior
