# Your Inspection Report

41 Tyndall Avenue  
Toronto, ON M6K 2E9

Monday, October 20, 2025

RE: Report No. 4378  
41 Tyndall Avenue  
Toronto, ON  
M6K 2E9

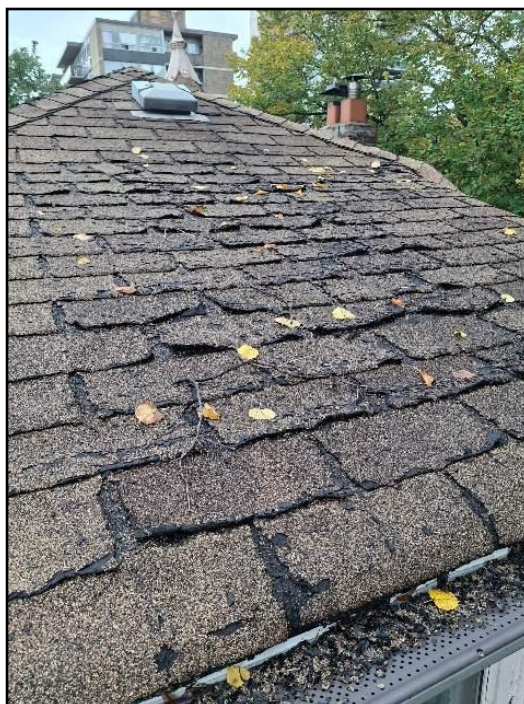
3.

**2. Condition:** • [Leak](#)

Roof leaking, due for immediate strip and reshingle.

**Task:** Replace

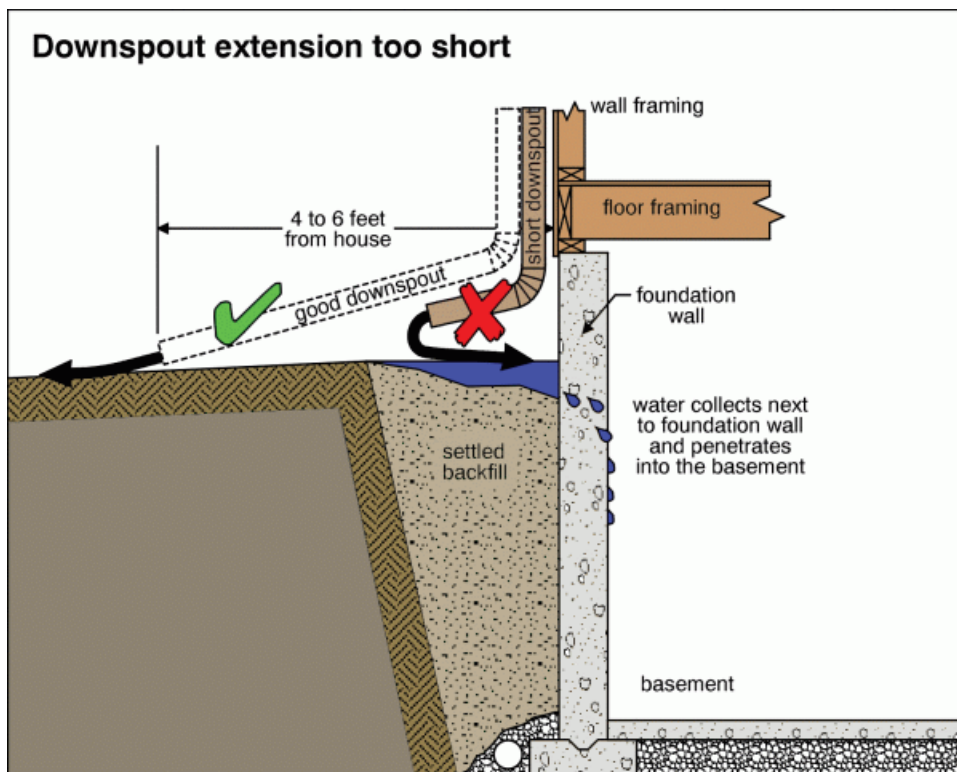
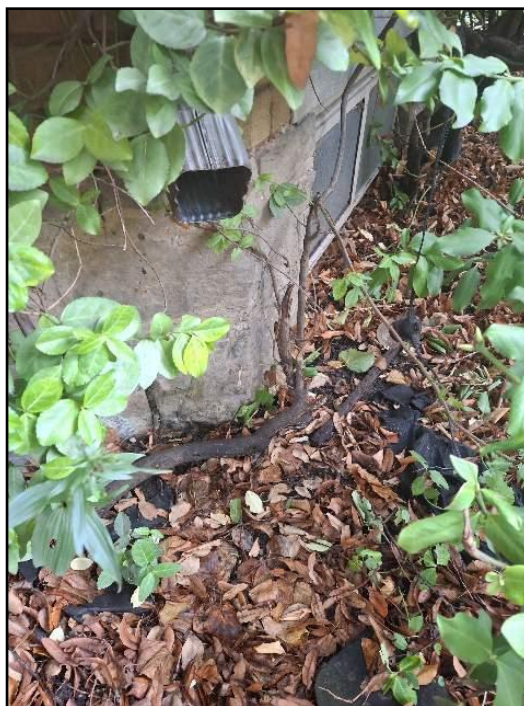
4. Condition: • [Discharge too close to building](#)

Implication(s): Chance of water damage to structure, finishes and contents

Task: Improve

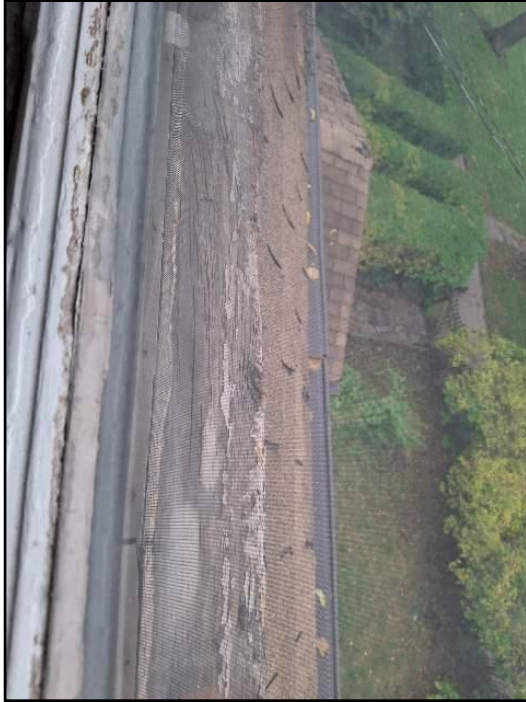
5.

Soffits, fascia and wood window trim due for restoration and paint maintenance.

**Task:** Improve

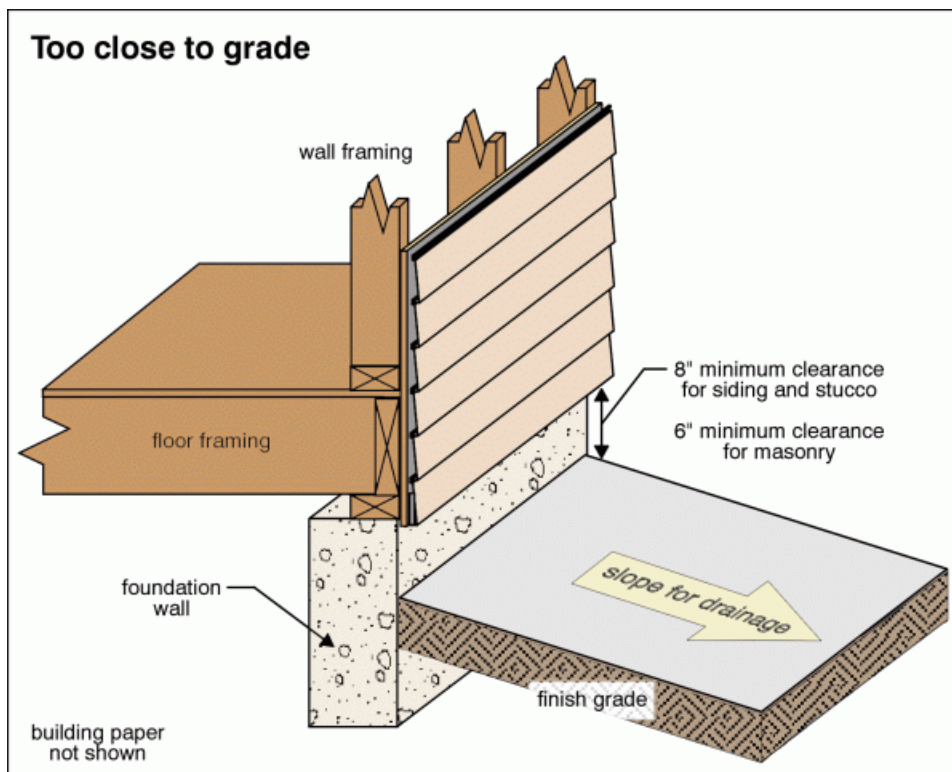
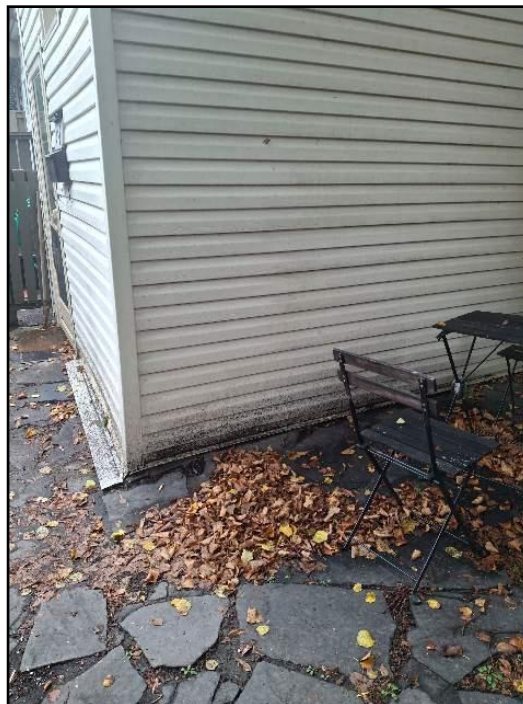
7. Condition: • Damaged

**Task:** Replace

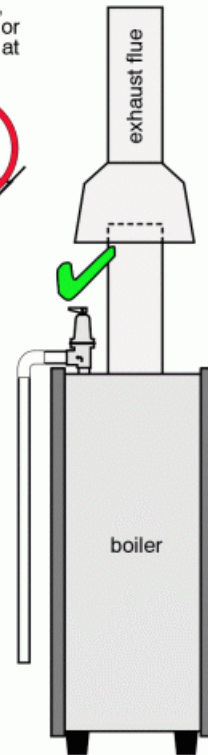
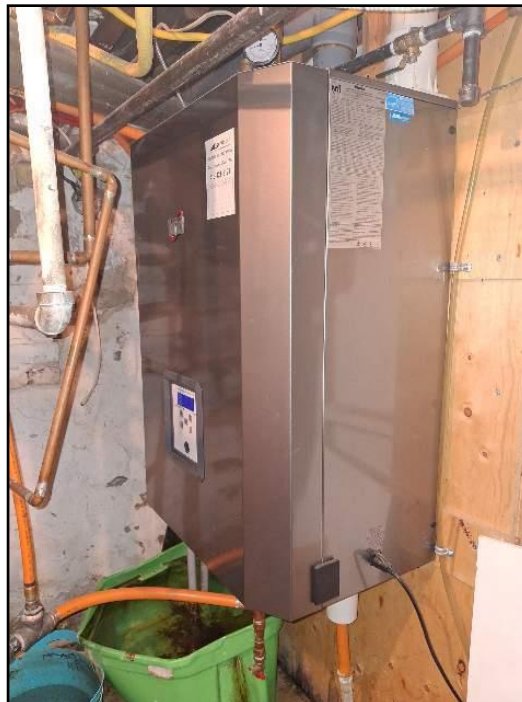
19.

**11. Condition:** • [Pipe dripping or leaking](#)

**Implication(s):** Equipment not operating properly | Chance of water damage

Service system to eliminate leakage at boiler.

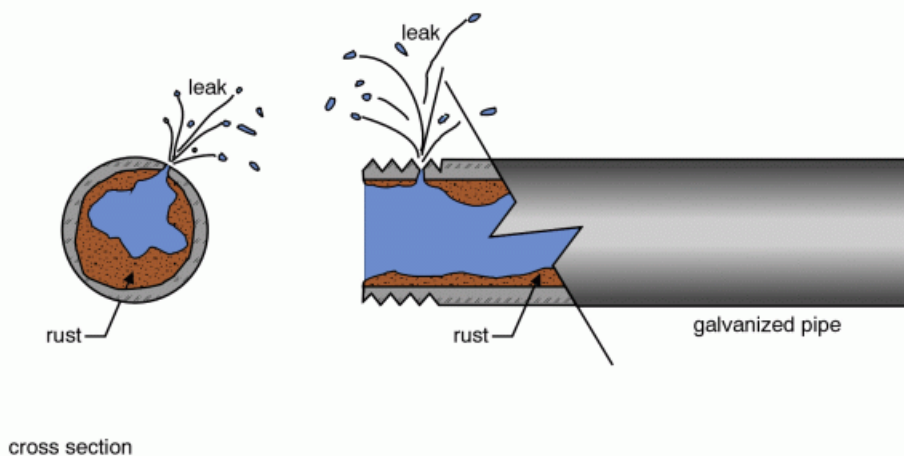
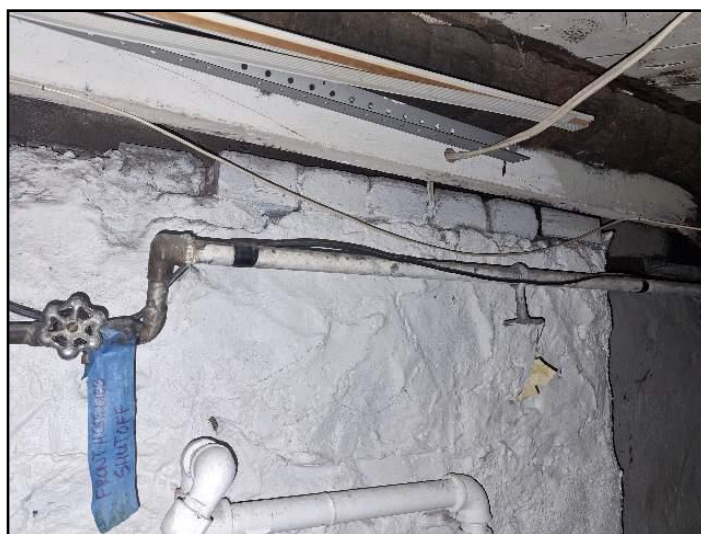
20.

**18. Condition:** • [Galvanized steel](#)

rusting of galvanized pipe can greatly reduce water pressure and will eventually cause leaks as rust creates holes in the pipe walls

Replace galvanized supply to exterior faucet.

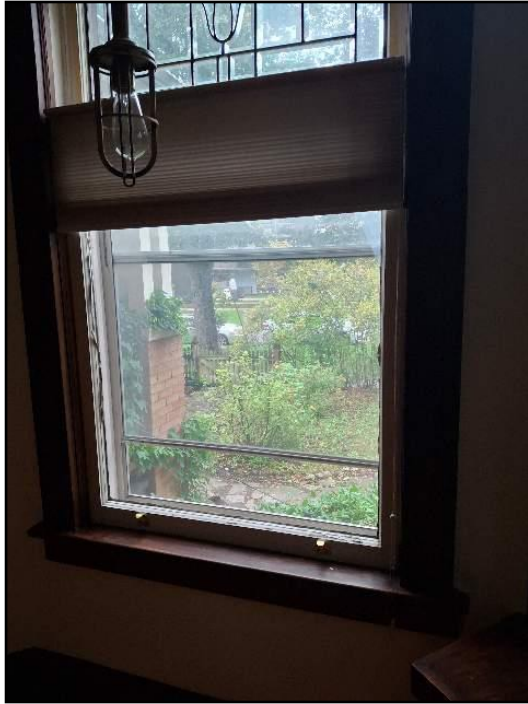
22.

#### 24. Condition: • [Original lower quality units](#)

Some poor windows (single pane) several damaged.

**Task:** Replace

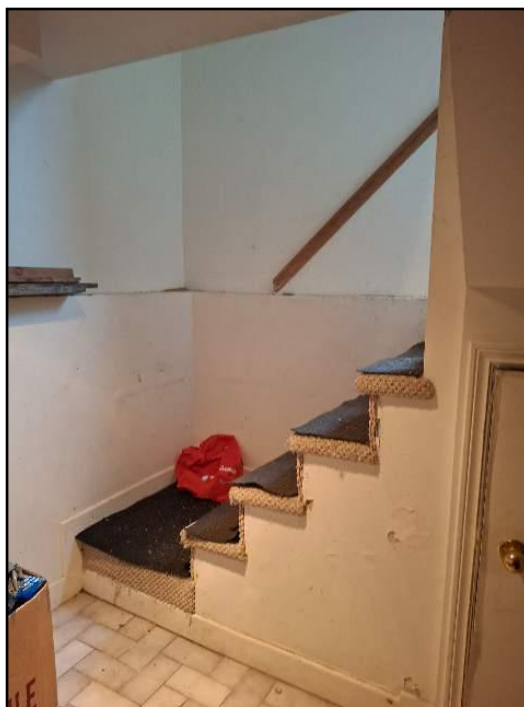
24.

**25. Condition:** • Ideally basement stairs would be reconfigured to create proper headroom, add guardrail.

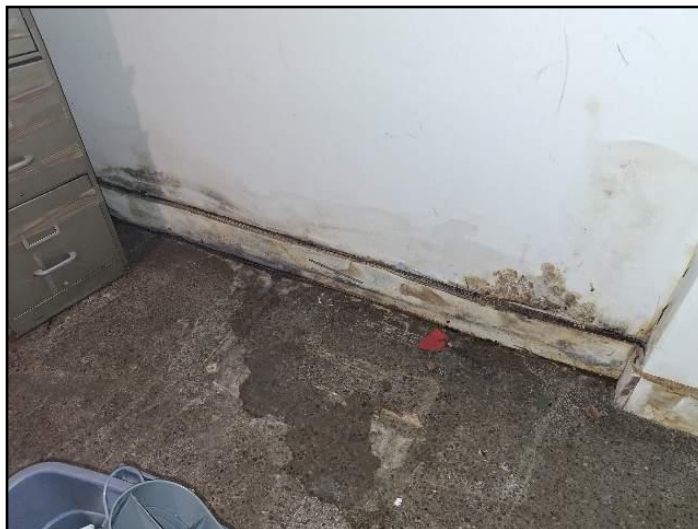
25.

### **26. Condition:** • [Water on floor](#)

Significant basement leakage evident. As foundation is stone, installation of exterior foundation is recommended to allow for patching of foundation.

**Implication(s):** Chance of water damage to structure, finishes and contents
