# Your Inspection Report

76 Pearson Avenue  
Toronto, ON M6R 1G5

Thursday, October 23, 2025

RE: Report No. 4385, v.3  
76 Pearson Avenue  
Toronto, ON  
M6R 1G5

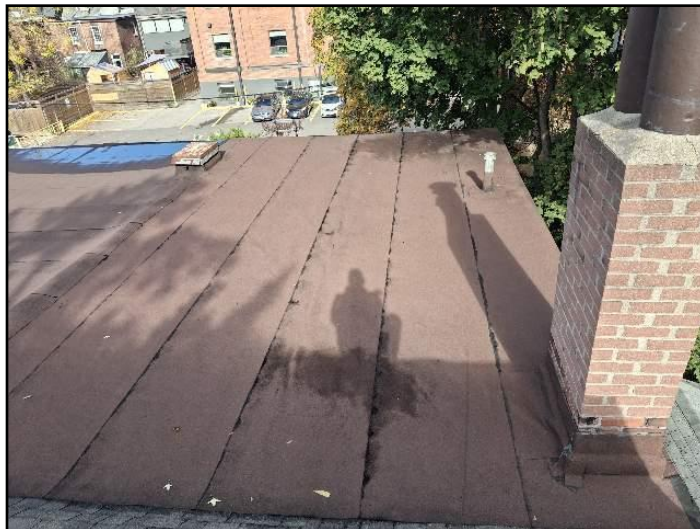
4.

#### 1. Condition: • [Openings at seams or flashings](#)

Tune up needed at flat roof.

**Implication(s):** Chance of water damage to structure, finishes and contents

**Task:** Repair

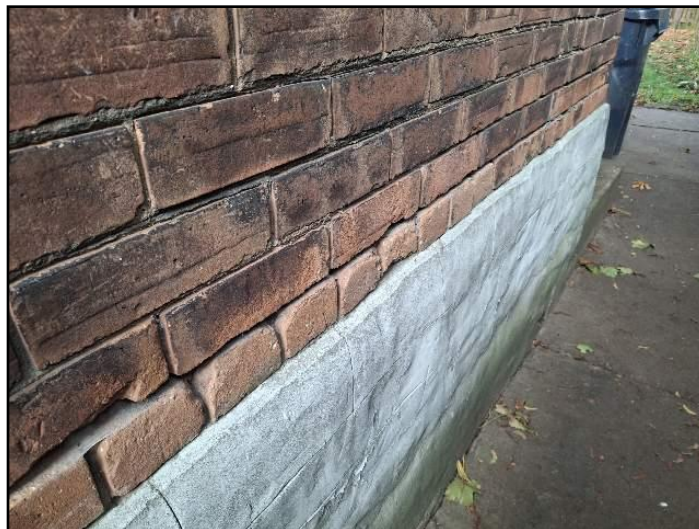
8.

2. Condition: • [Masonry deterioration](#)

Typical tuckpointing or parging needed.

**Implication(s):** Weakened structure | Chance of structural movement

**Location:** Various Exterior Wall

**Task:** Repair

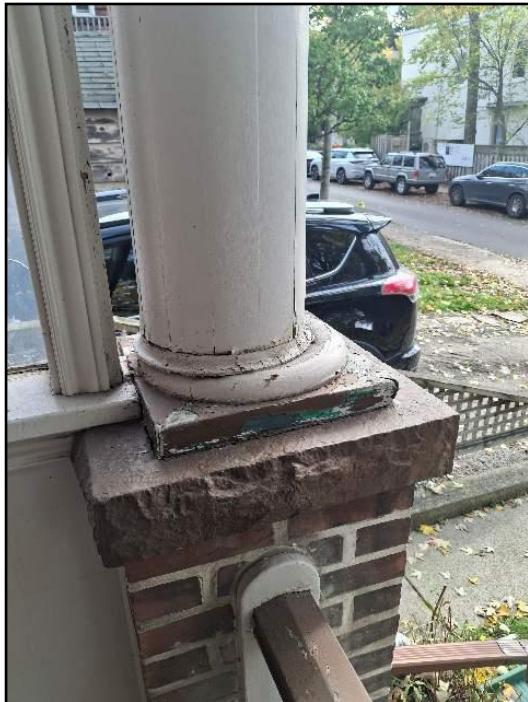
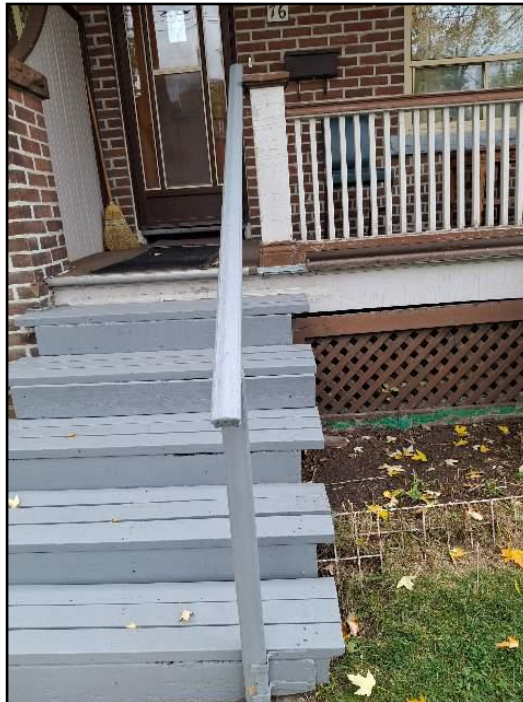
3. Condition: • Disrepair

Front porch primarily original and will require eventual rebuild.

**Implication(s):** Weakened structure

**Location:** South Exterior

**Task:** Rebuild

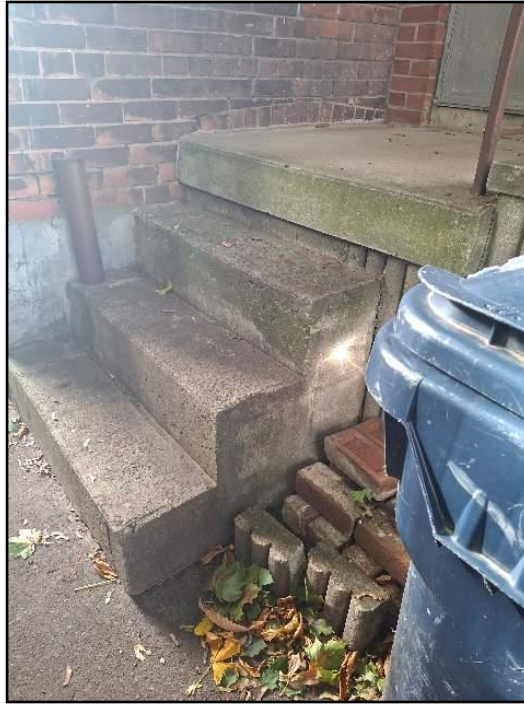
11.

4. Condition: • [Missing](#)

**Implication(s):** Fall hazard

**Location:** North Exterior

**Task:** Install

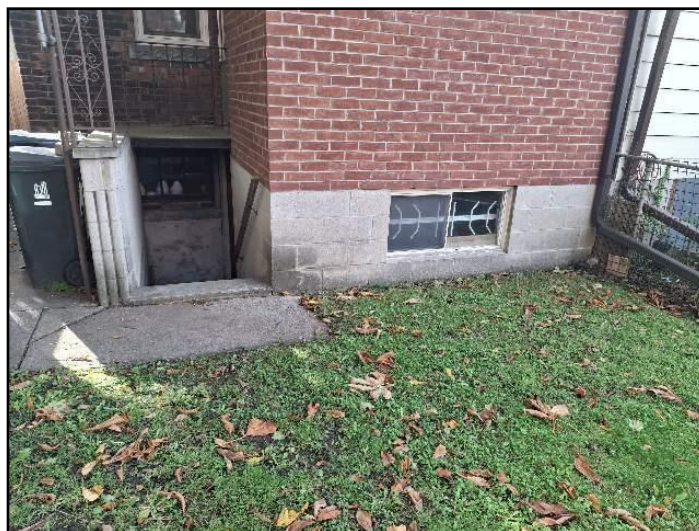
12.

### 5. Condition: • [Improper slope or drainage](#)

Create drainage away from foundation at north walkway and lawn.

**Implication(s):** Chance of water damage to structure, finishes and contents

**Location:** North Exterior

**Task:** Improve

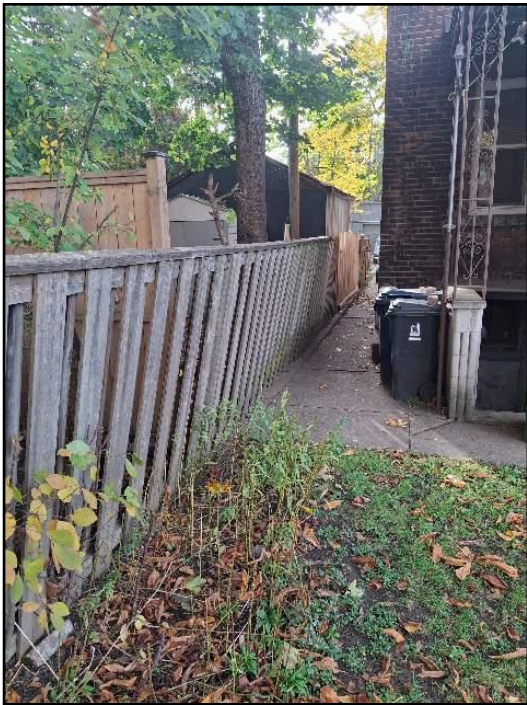
13.

**6. Condition:** • Leaning

**Implication(s):** Chance of movement | Damage or physical injury due to falling materials

**Location:** Northeast Exterior

**Task:** Replace

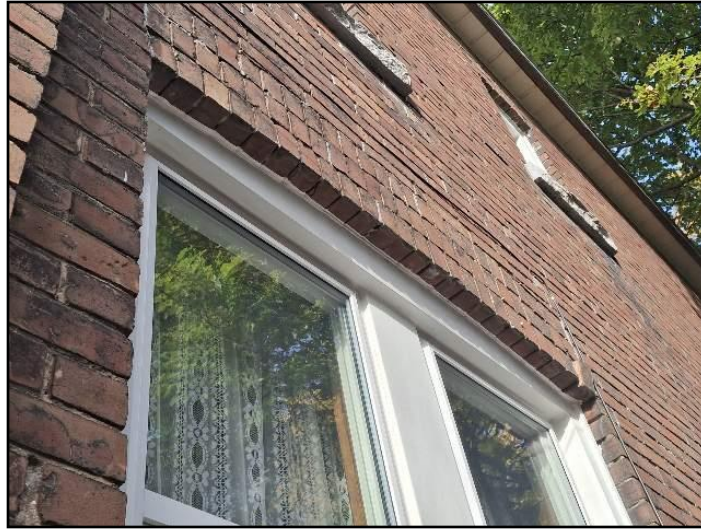
14.

**7. Condition:** • [Dropped, rotating or leaning](#)

Recommend replacing dining room window arch with steel lintels.

**Implication(s):** Weakened structure | Chance of structural movement

**Location:** East Exterior First Floor

**Task:** Repair or replace

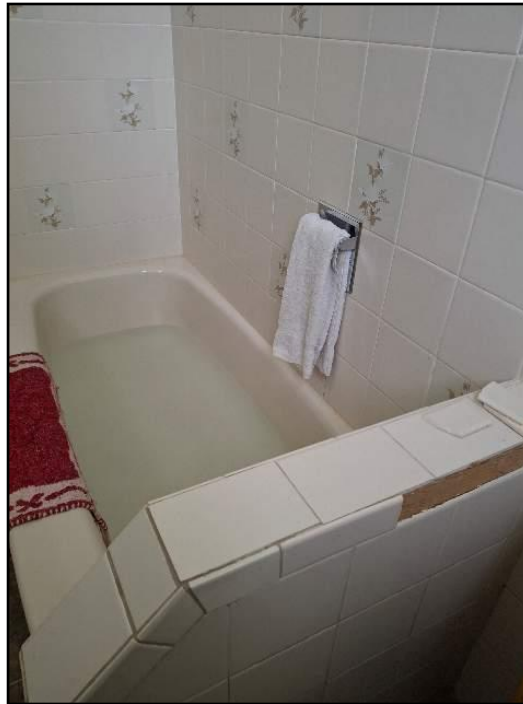
20.

**13. Condition:** • Fixtures dated and due for updating.

**Location:** Various Throughout

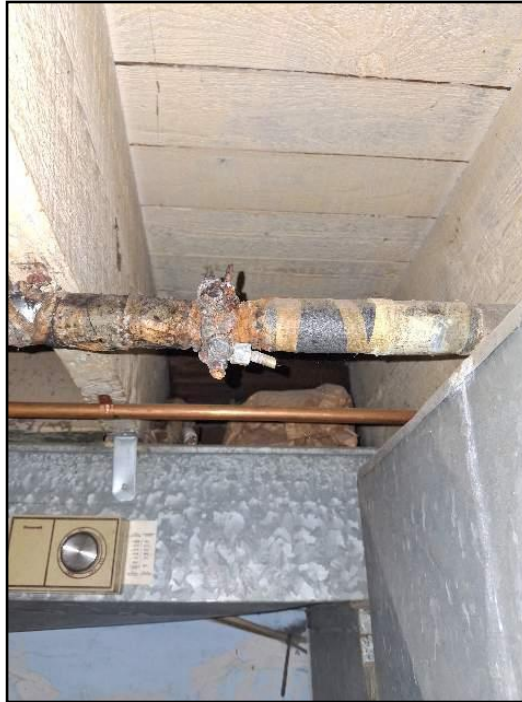
21.

**14. Condition:** • [Rust](#)

Remove unused humidifier shut off near furnace.

**Location:** East Basement

**Task:** Remove

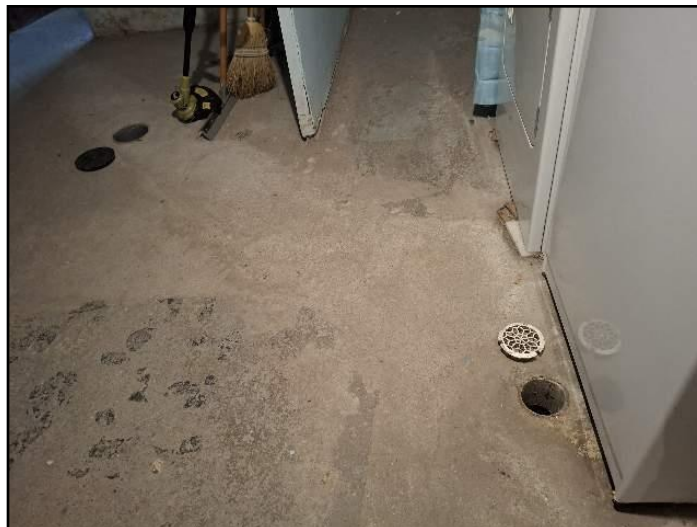
22.

**15. Condition:** • Could not determine if backflow valve is positioned to protect drains at basement.

**Location:** Basement

**Task:** Further evaluation

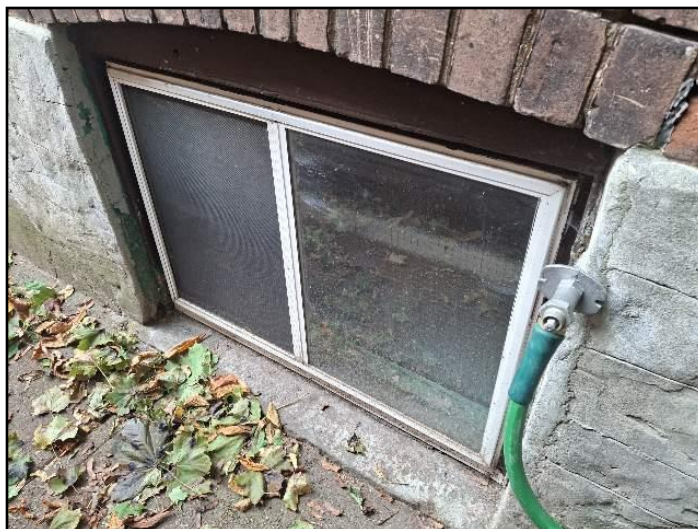
23.

17. **Condition:** • Original lower quality units in use.

**Task:** Replace

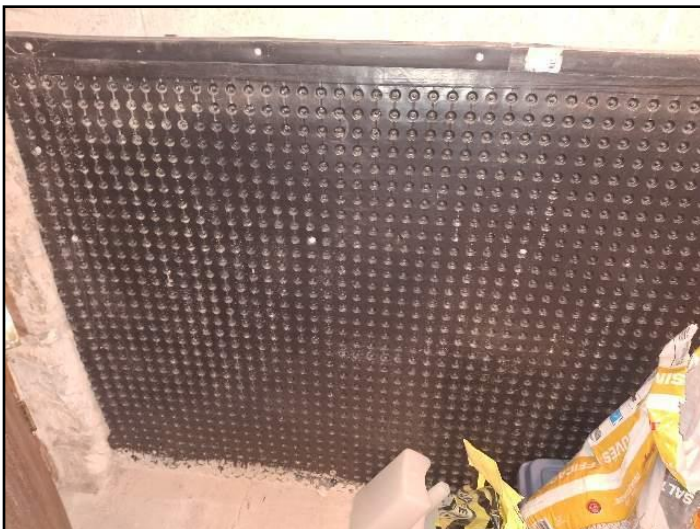
**24.** Addition

### **18. Condition:** • [Drainage membrane](#)

Interior drainage membrane present at north basement (addition only). Recommend installation at balance of basement prior to finishing.
