# Your Inspection Report

187 Sylvan Avenue  
Toronto, ON M1E 1A4

Wednesday, November 12, 2025

RE: Report No. 4396  
187 Sylvan Avenue  
Toronto, ON  
M1E 1A4

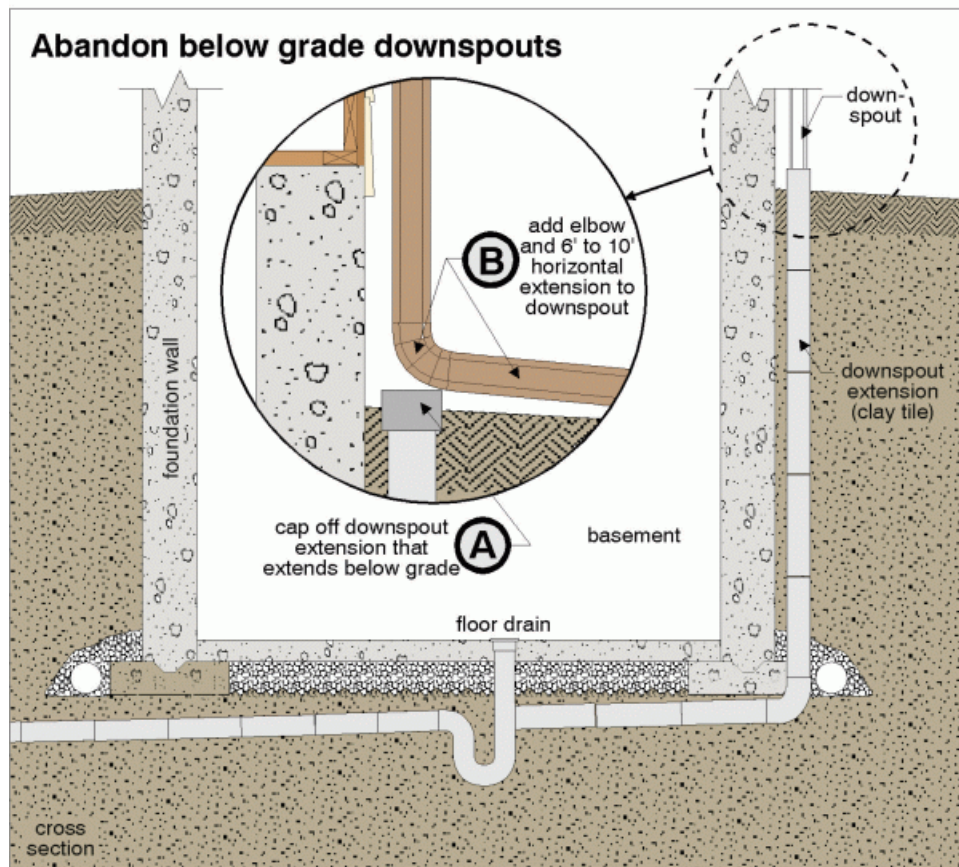
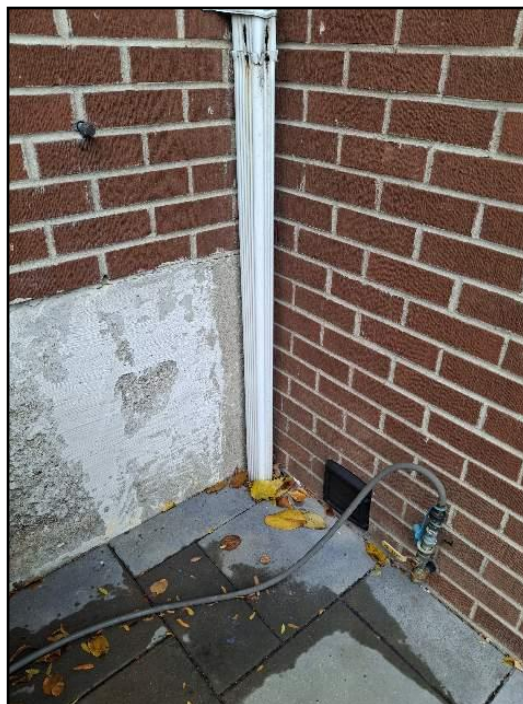
4.

**3. Condition:** • [Discharge below grade](#)

**Implication(s):** Chance of water damage to structure, finishes and contents

Disconnect downspouts and route well away from foundation.

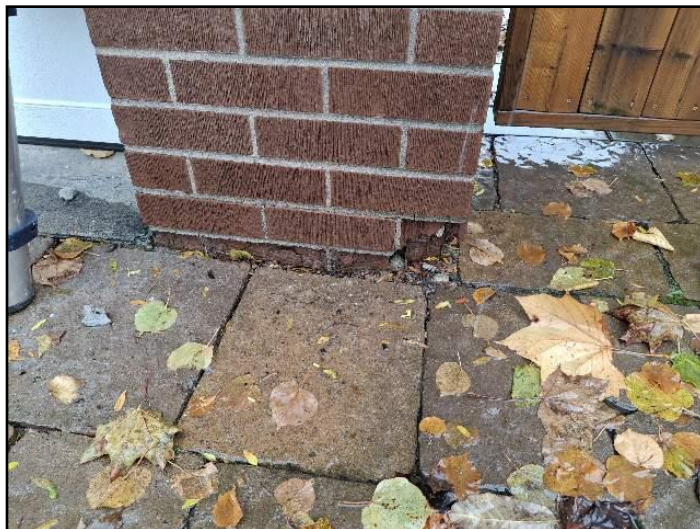
5.

### 4. Condition: • [Masonry deterioration](#)

Minor brick repair needed at garage wall base.

**Implication(s):** Weakened structure | Chance of structural movement

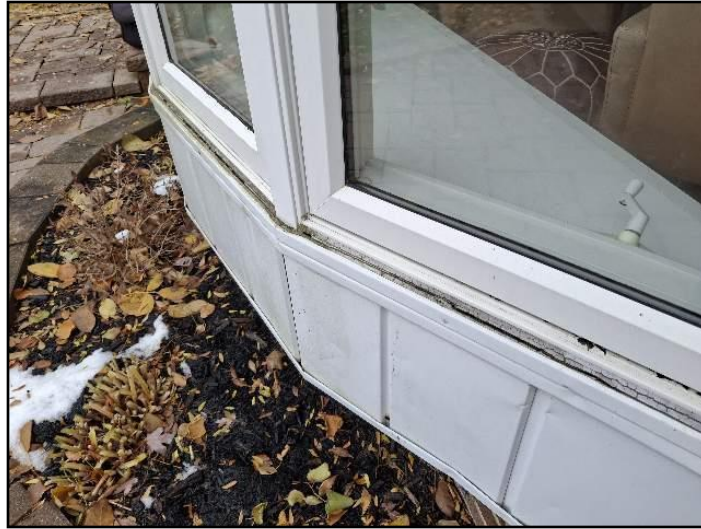
6.

### 5. Condition: • Typical caulking maintenance needed.

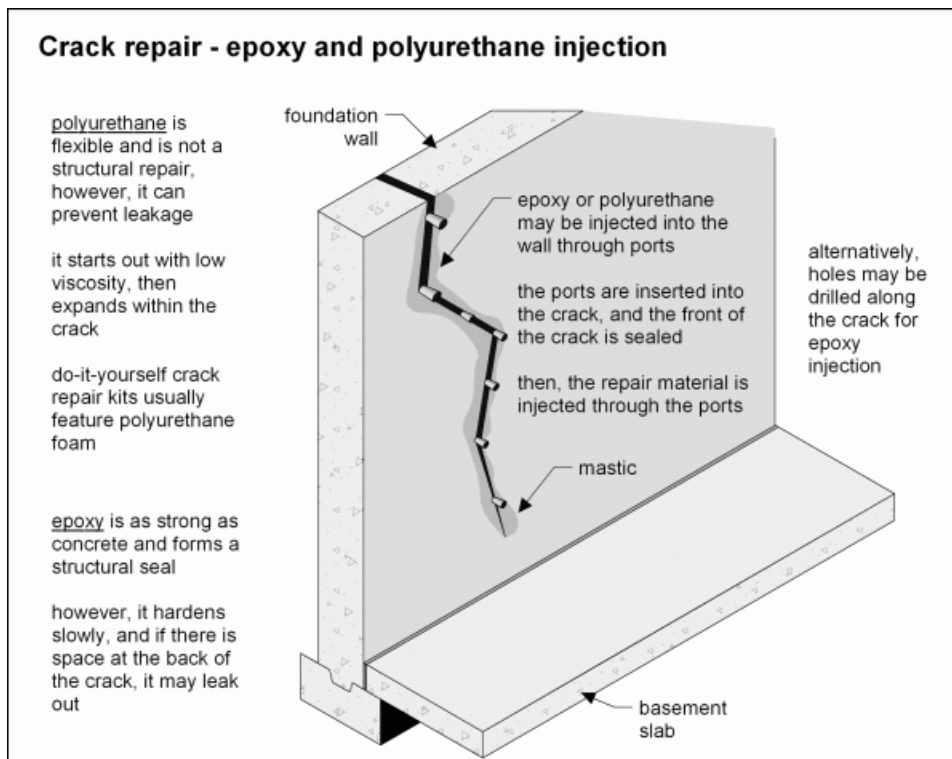
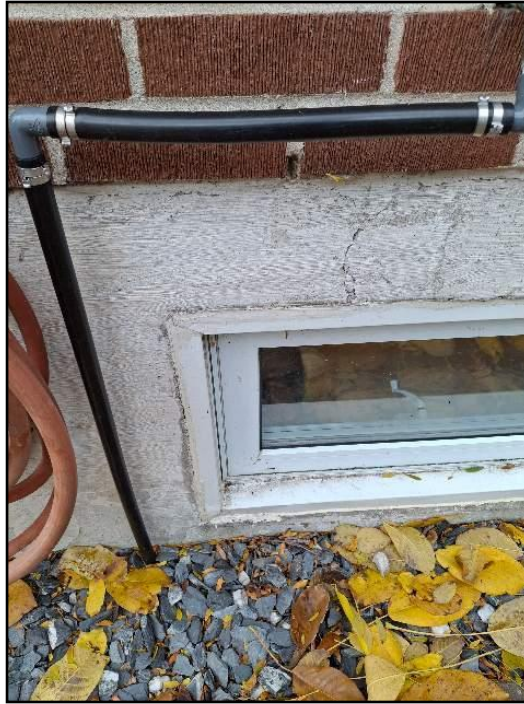
7.

**6. Condition:** • Typical minor cracks

Typical minor cracks are not structurally significant. No leakage at time of inspection.

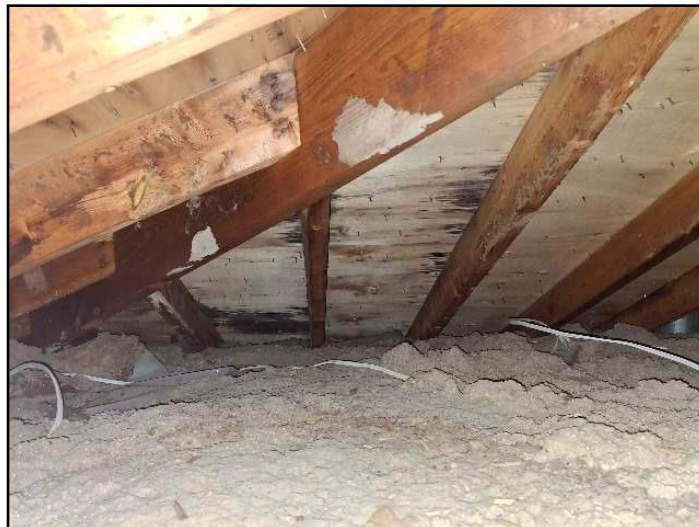
8.

**ROOF FRAMING \ Sheathing (roof/attic)****7. Condition:** • [Mold](#)

Some minor mould in upper attic. Consider professional removal. See INSULATION re prevention.

**Implication(s):** Weakened structure | Chance of structural movement

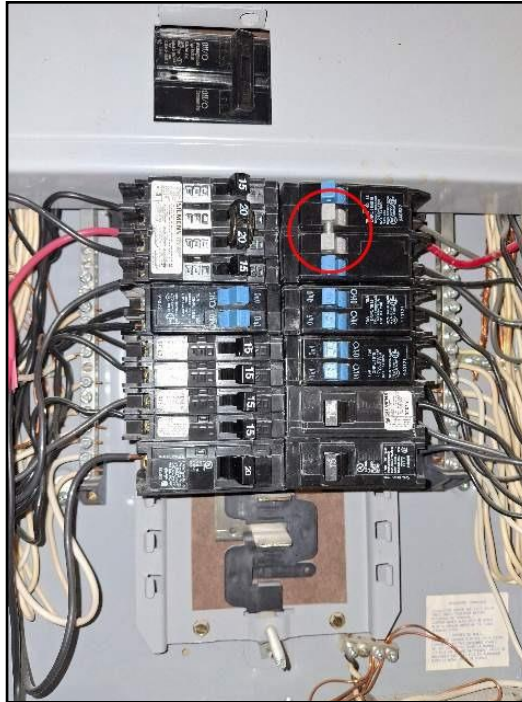
10.

**8. Condition:** • Oversized breaker (breaker too big).

Replace 40 amp breaker with 30 amp.

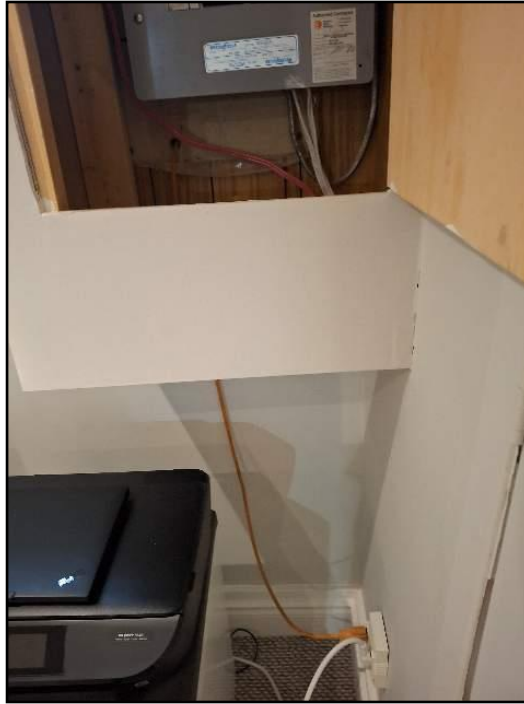
11.

**9. Condition:** • [Extension cord used as permanent wiring](#)

**Implication(s):** Electric shock | Fire hazard

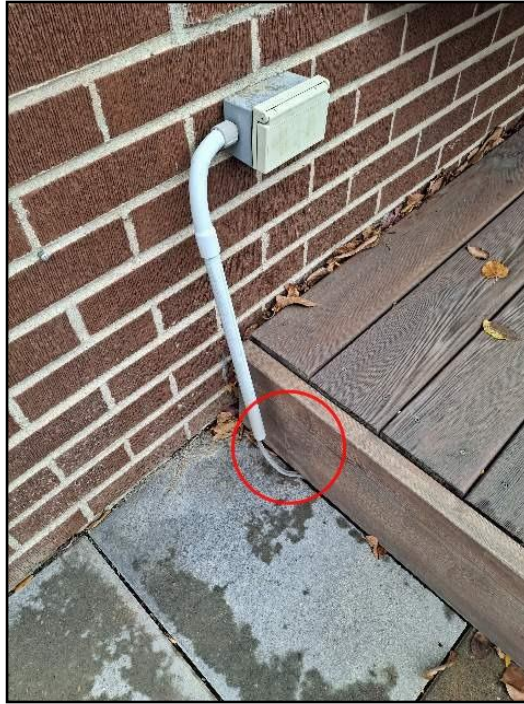
12.

**10. Condition:** • Protect exposed wiring with conduit.

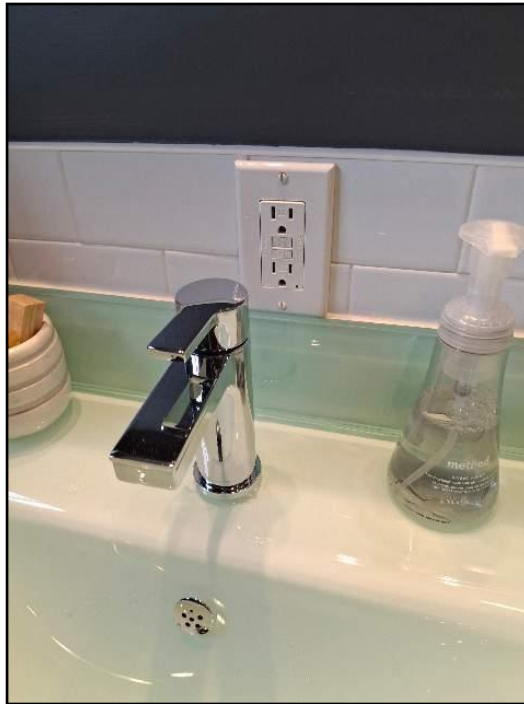
13.

**11. Condition:** • Poor location over sink.
