# Your Inspection Report

60 Grenadier Road  
Toronto, ON M6R 1R2

Wednesday, September 3, 2025

RE: Report No. 4325, v.2  
60 Grenadier Road  
Toronto, ON  
M6R 1R2

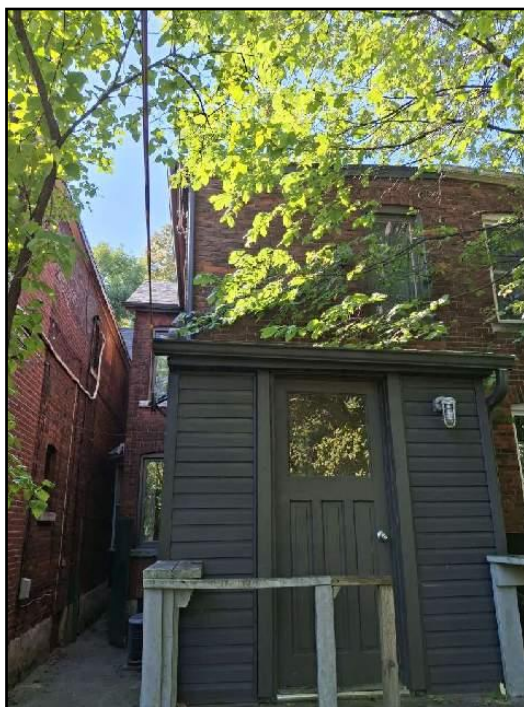
4.

**1. Condition:** • Cut branches back from roof.

**Location:** North Exterior

**Task:** Remove

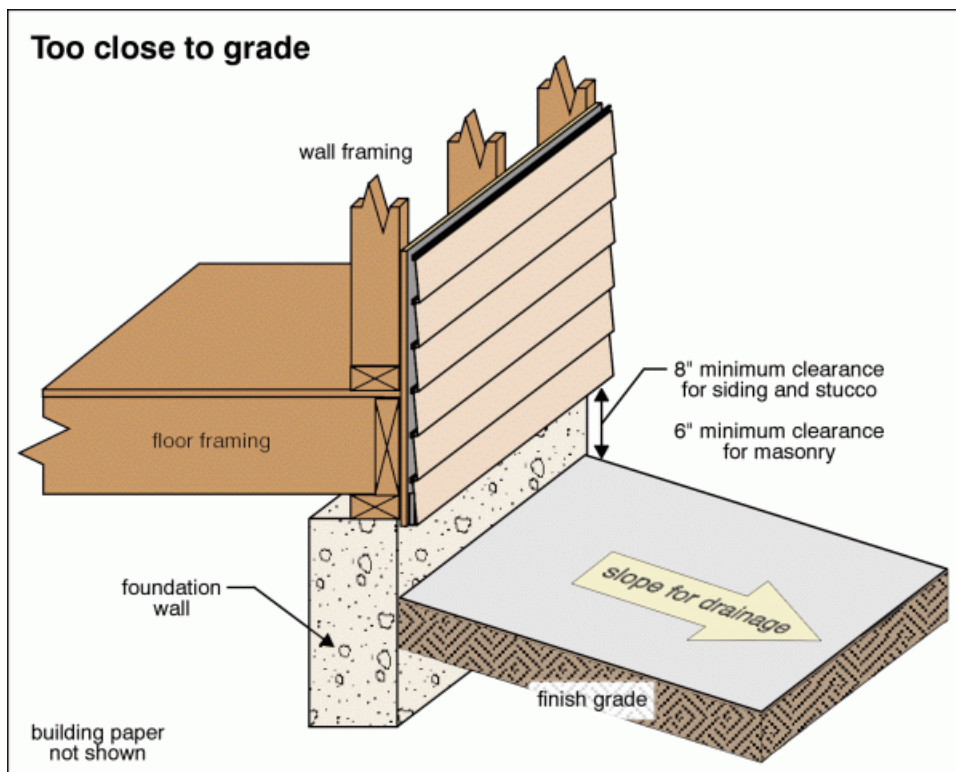
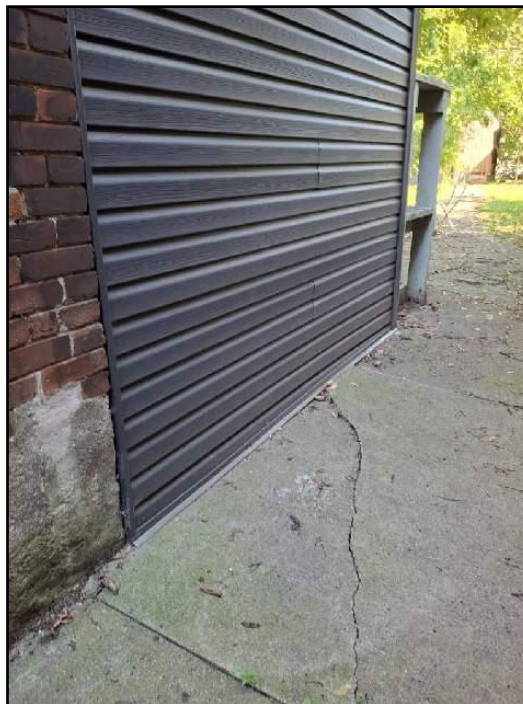
5.

4. Condition: • [Too close to grade](#)

Ideally siding and wood backing would terminate above grade.

Implication(s): Chance of water damage to structure, finishes and contents

Location: North Exterior

Task: Improve

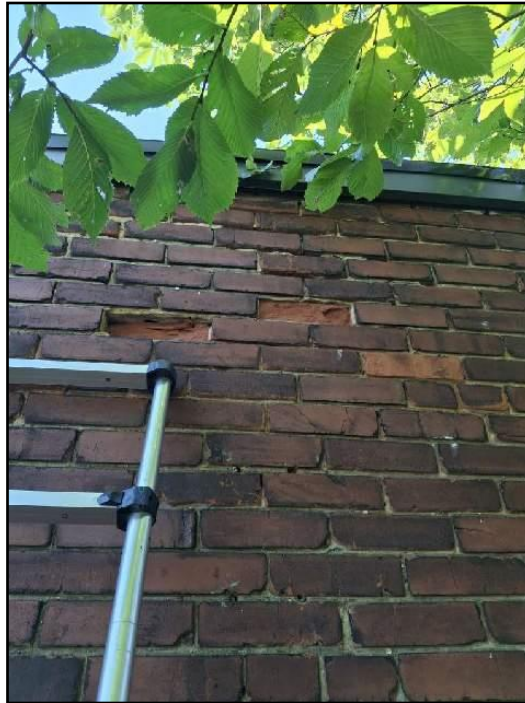
6.

5. Condition: • [Masonry deterioration](#)

Some tuckpointing and parging needed.

**Implication(s):** Weakened structure | Chance of structural movement

**Location:** Various Exterior Wall

**Task:** Repair

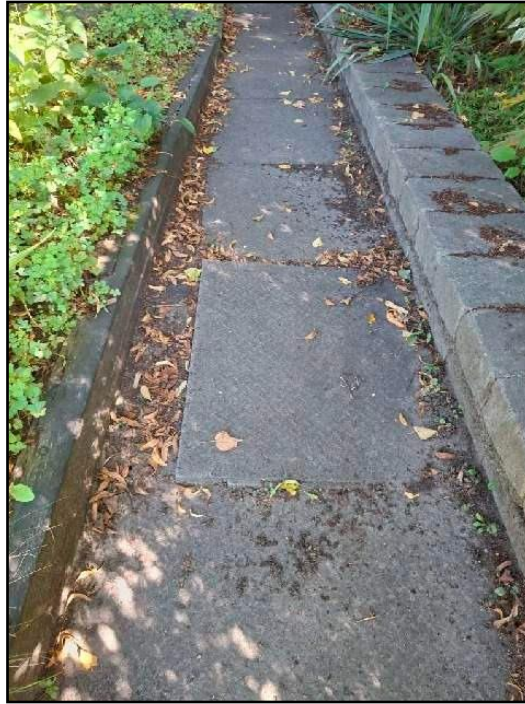
7.

**6. Condition:** • [Cracked or damaged surfaces](#)

Eliminate trip hazards and create drainage away from foundation.

**Implication(s):** Trip or fall hazard

**Location:** East Exterior

**Task:** Repair or replace

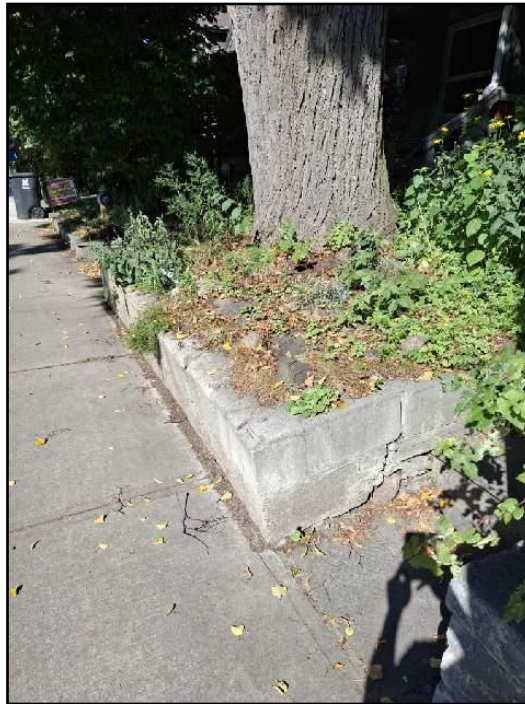
8.

7. Condition: • [Leaning](#)

Large tree moving garden wall.

**Implication(s):** Weakened structure | Chance of movement

**Location:** South Exterior

**Task:** Replace

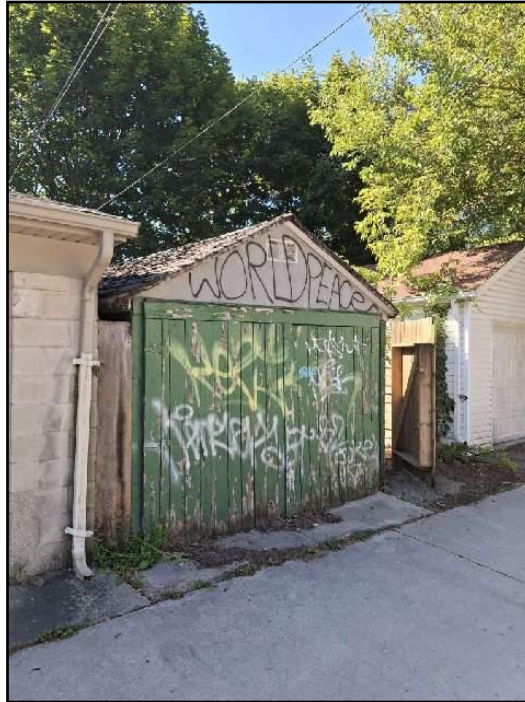
9.

**8. Condition:** • Typical low quality structure

**Implication(s):** Chance of water entering building | Chance of structural movement | Chance of pests entering building | Physical injury

**Location:** Garage

**Task:** Replace

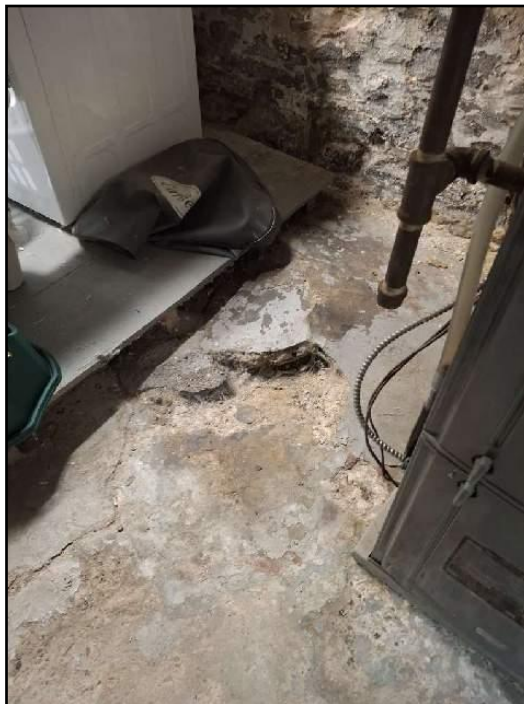
10.

**9. Condition:** • [Heaved](#)

Heaved concrete floor may be due to tree roots, recommend removing concrete to determine if roots are present and if foundation is vulnerable.

**Implication(s):** Chance of water damage to structure, finishes and contents | Loss of proper slope for drainage | Trip or fall hazard

**Location:** East Basement

**Task:** Further evaluation

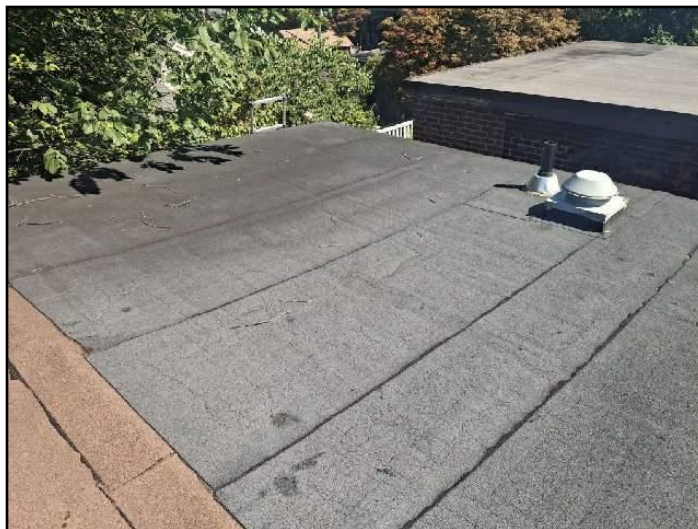
11.

Sheathing at flat roof is in poor condition (see STRUCTURE) likely shortening roof life expectancy. Inspect annually and budget for replacement.

**ROOF FRAMING \ Sheathing (roof/attic)****10. Condition:** • [Sagging](#)

Sheathing at flat roof in poor condition, soft sections likely indicate rot, this will likely shorten life expectancy. Replace sheathing when reroofing in future.

**Implication(s):** Weakened structure | Chance of structural movement

**Location:** Flat Roof

**Task:** Replace

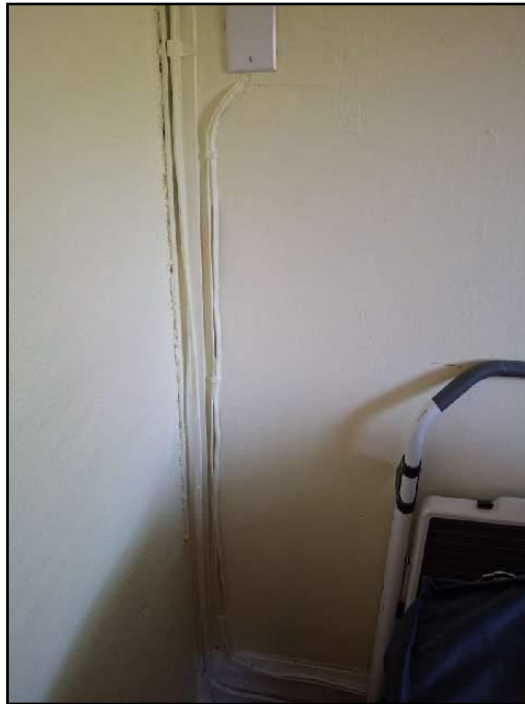
12.

**11. Condition:** • Cover exposed wiring with conduit.

**Location:** North First Floor

**Task:** Protect

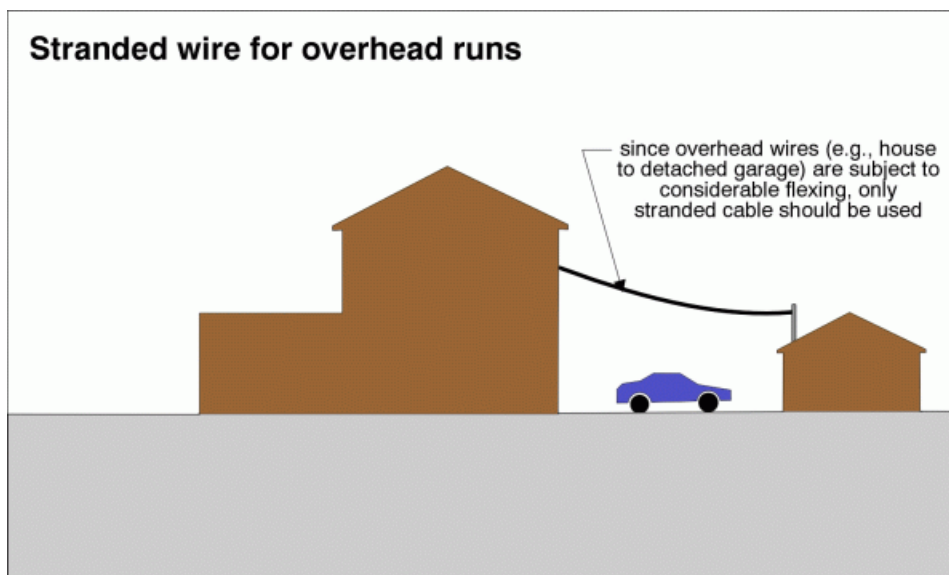
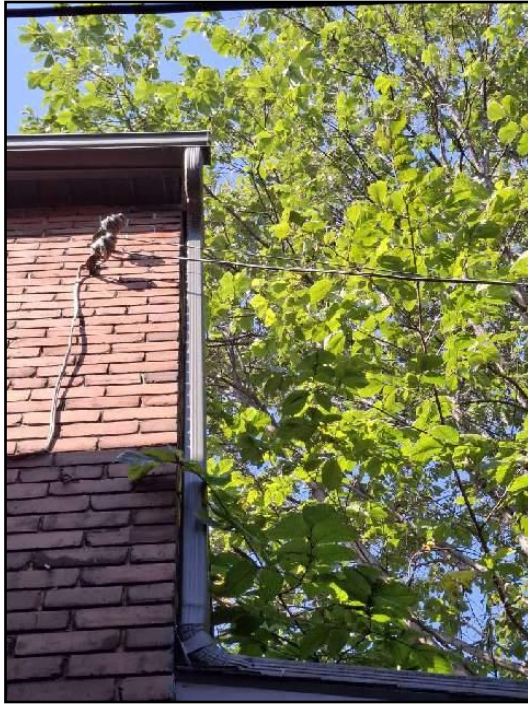
13.

**12. Condition:** • [Solid wire run overhead](#)

**Implication(s):** Shortened life expectancy of material | Electric shock

**Location:** North Exterior

**Task:** Replace

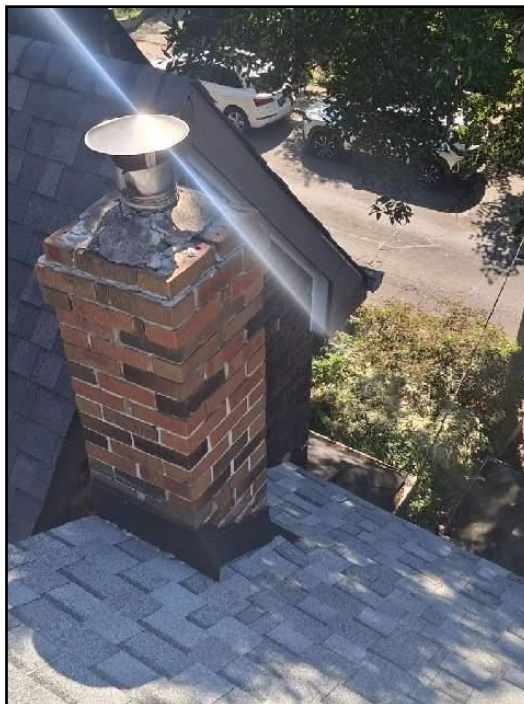
15.

• [Abandoned](#)

This chimney is no longer in use and can be removed.

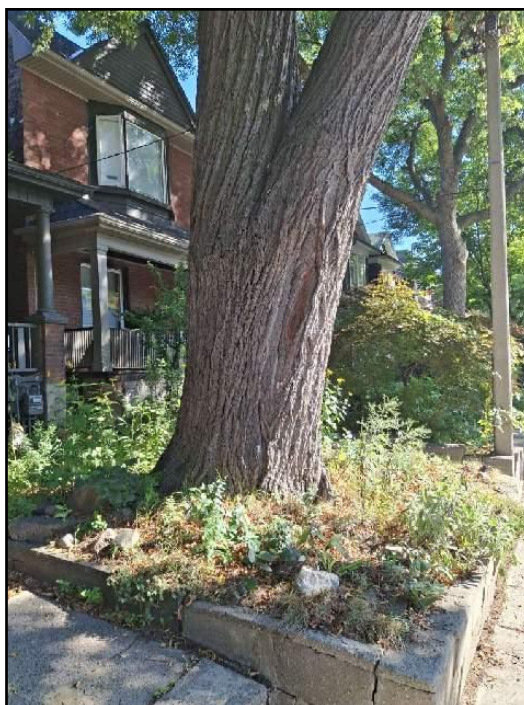
17.

**18. Condition:** • Recommend video inspection of main drains due to age and proximity of very large tree.

**Location:** South Exterior

**Task:** Further evaluation

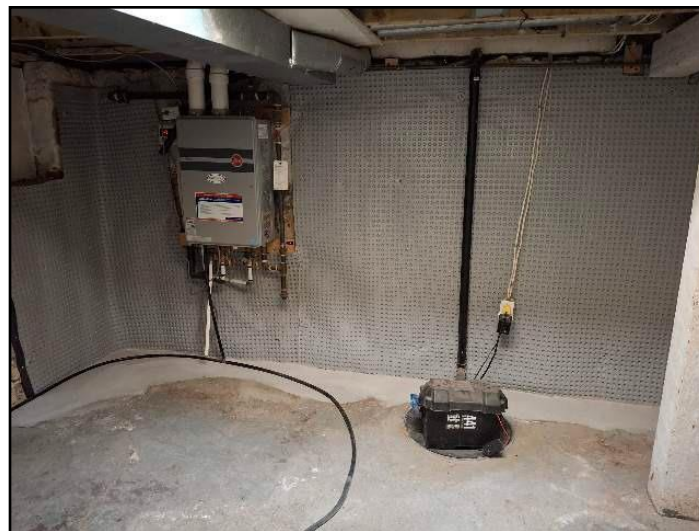
20.

### **22. Condition: • [Drainage membrane](#)**

Interior drainage system present at south basement. Recommend installation at balance of basement prior to finishing.
