# Your Inspection Report

172 Gladstone Avenue  
Toronto, ON M6J 3L4

RE: Report No. 4397, v.2  
172 Gladstone Avenue  
Toronto, ON  
M6J 3L4

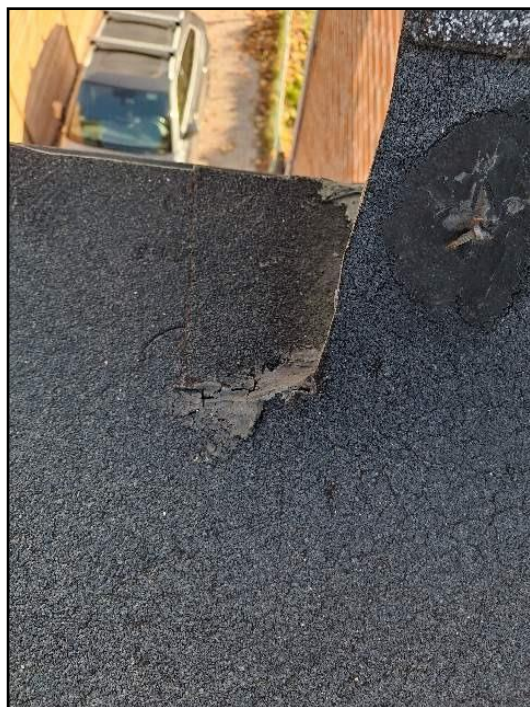
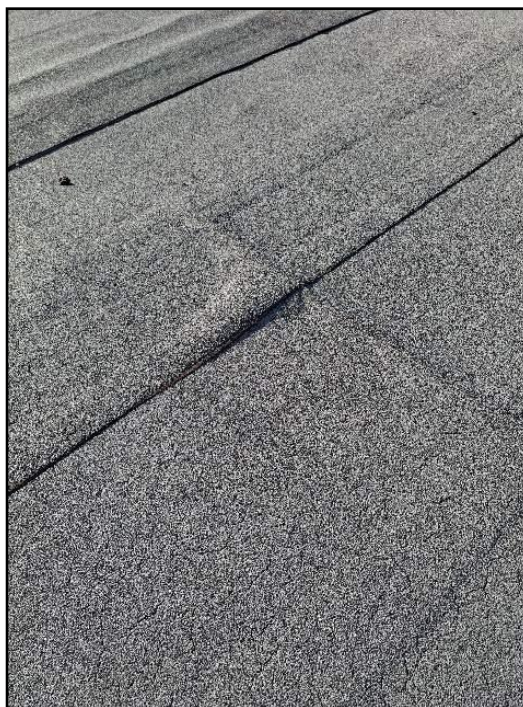
#### **1. Condition:** • [Openings at seams or flashings](#)

Reseal roof near meeting with slope, monitor existing blister.

**Location:** Northeast Flat Roof

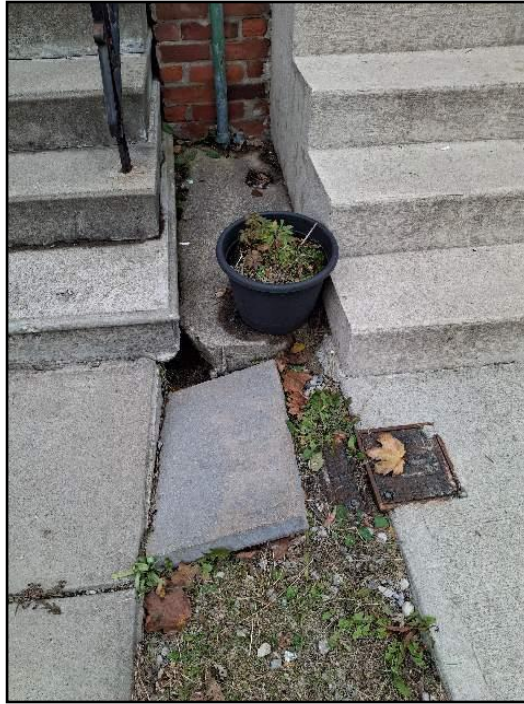
5.

2. Condition: • [Improper slope or drainage](#)

Repair sinkhole developing at adjoining front walks.

**Location:** Southeast Exterior

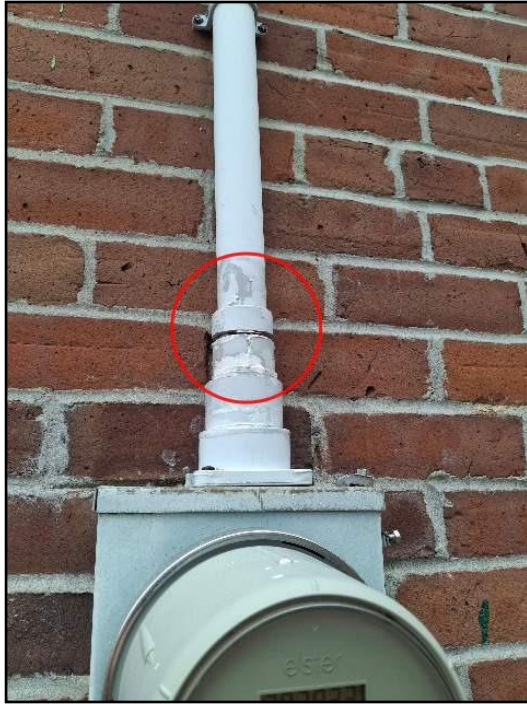
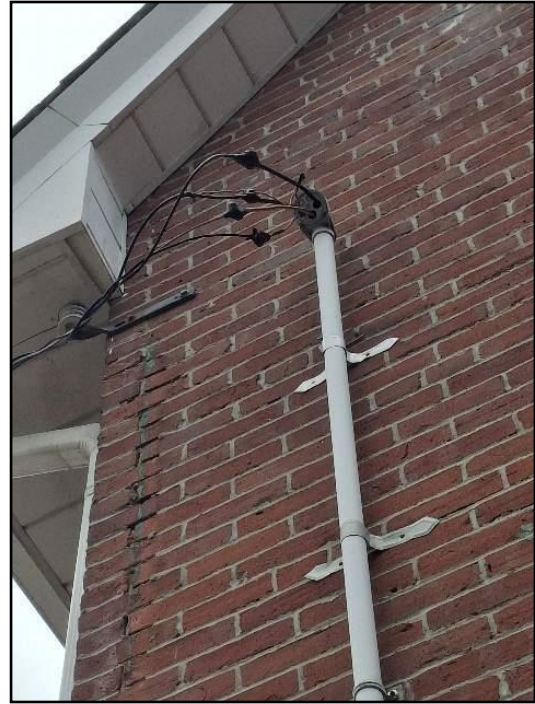
**5. Condition:** • [Conduit or cable damaged](#)

Replace damaged service conduit. Ensure service wires are securely fastened to wall, disconnect flat rate wires, install permanent connectors. Seller has quote for aprox. \$2500.

**Implication(s):** Electric shock | Interruption of electrical service

**Location:** Northeast Exterior

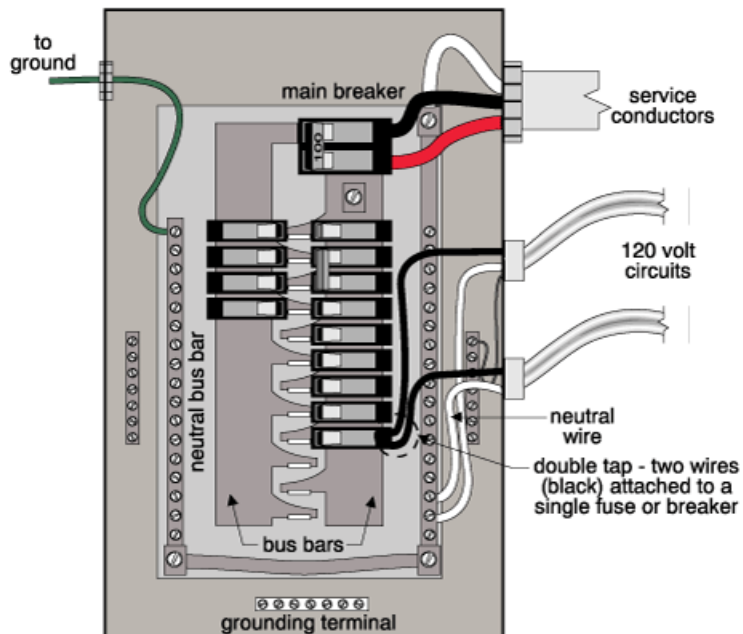
## Double tapping (double lugging)

### 6. Condition: • [Double taps](#)

**Location:** Basement Panel

Add breaker and split double tap if nuisance tripping occurs.

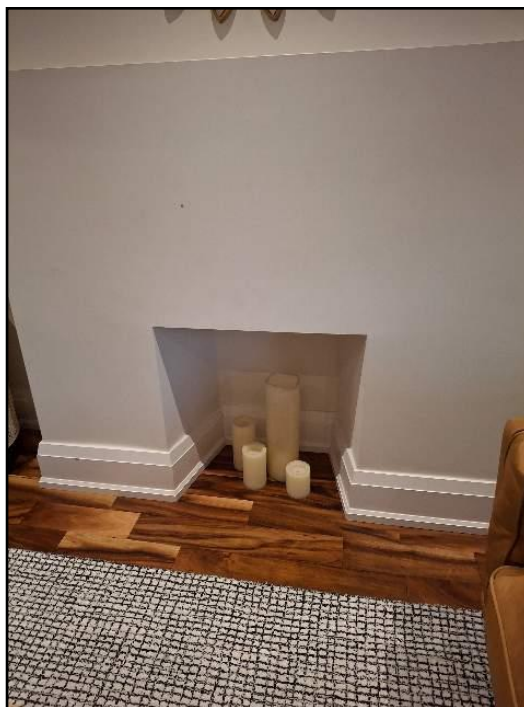
9. Do not use

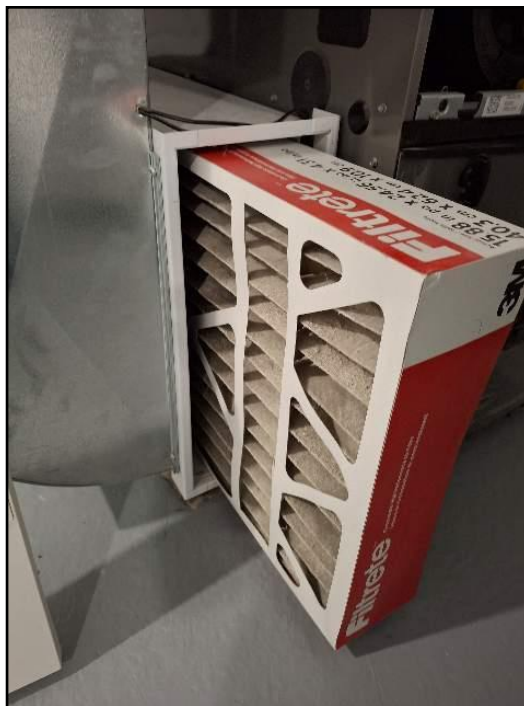
10.

**8. Condition:** • [Dirty](#)

**Implication(s):** Equipment ineffective | Increased heating costs | Reduced comfort | Increased maintenance costs

**Location:** Furnace Room

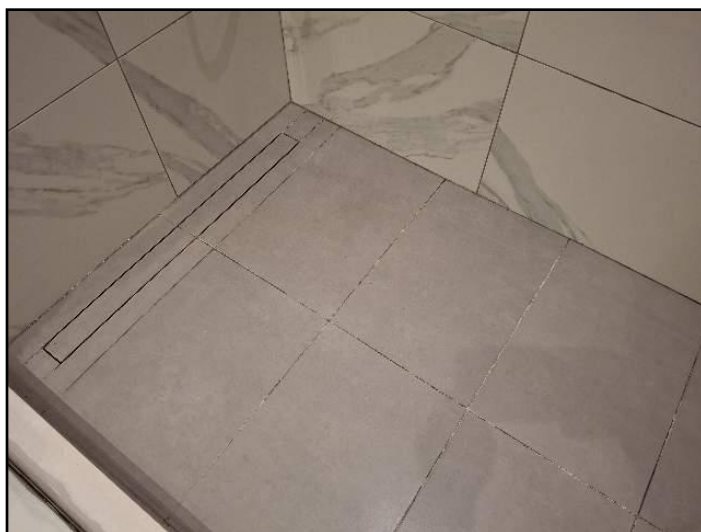
12.

**10. Condition:** • [Caulking loose, missing or deteriorated](#)

**Implication(s):** Chance of water damage to structure, finishes and contents

**Location:** Second Floor Bathroom

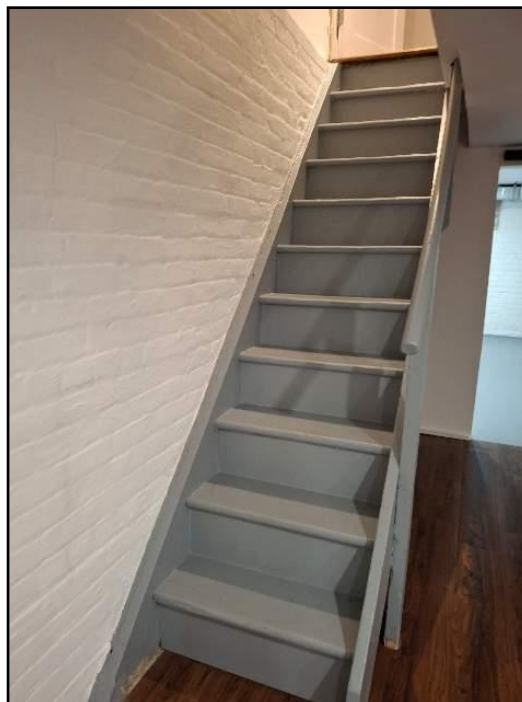
13.

12. Condition: • [Missing](#)

Implication(s): Fall hazard

Location: Basement Staircase
