# Your Inspection Report

2972 Oslo Crescent  
Mississauga, ON L5N 1Z9

RE: Report No. 4390, v.2  
2972 Oslo Crescent  
Mississauga, ON  
L5N 1Z9

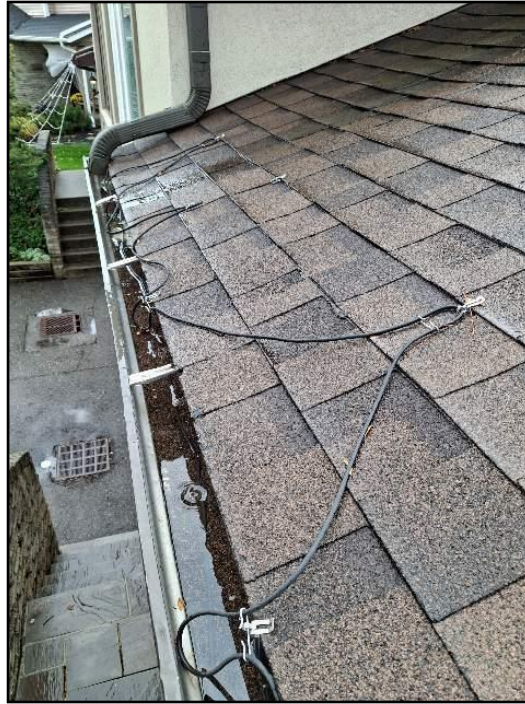
4.

#### 1. Condition: • [Vulnerable to ice damming](#)

**Implication(s):** Chance of water damage to structure, finishes and contents

Turn on heating cables at east eaves during winter to protect roof from ice damming.

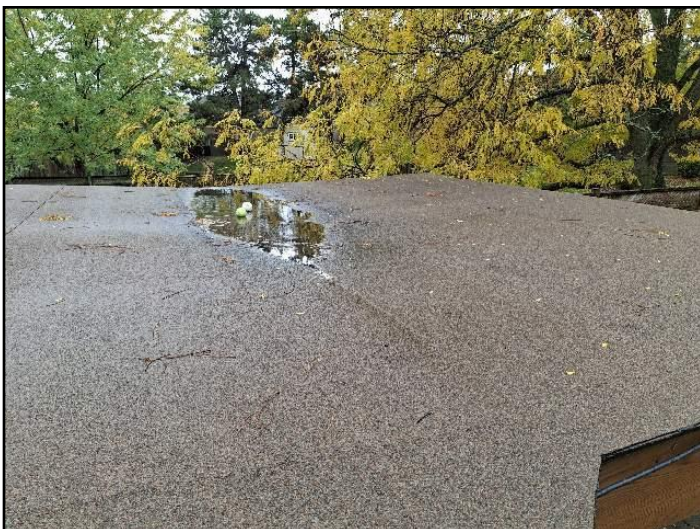
**2. Condition:** • Poorly built.

Patio roof does not drain well, edge of sheathing is exposed and vulnerable to rot.

5. Ponding

**Task:** Improve

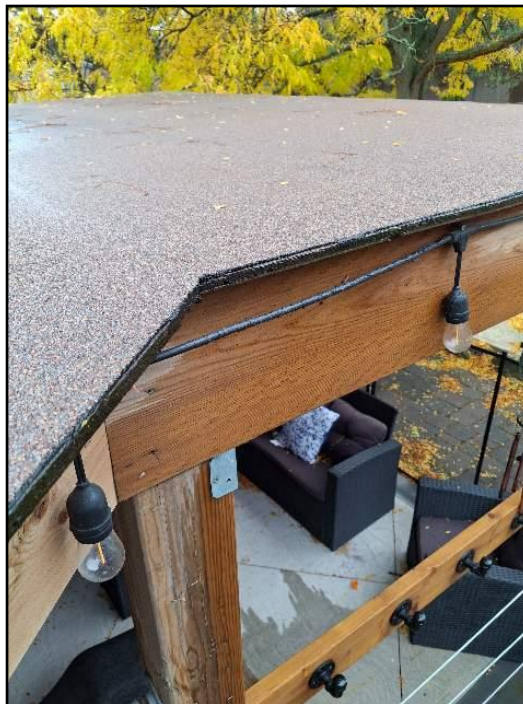
6. No drip egde

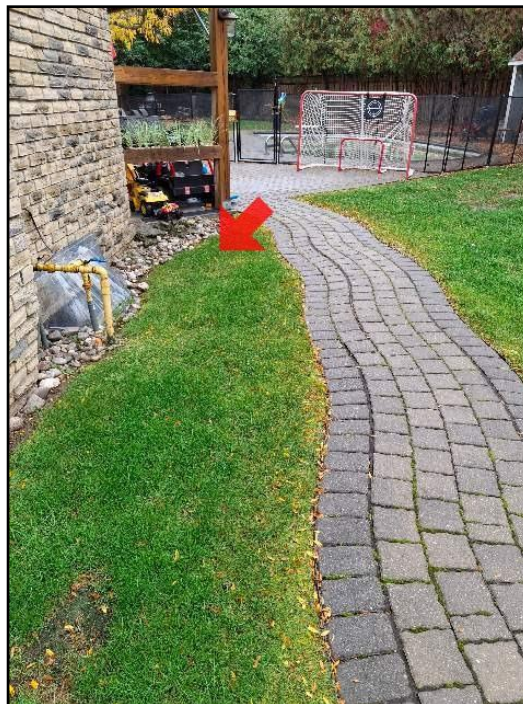
7.

### 3. Condition: • [Improper slope or drainage](#)

**Implication(s):** Chance of water damage to structure, finishes and contents

Create drainage slope away from foundation.

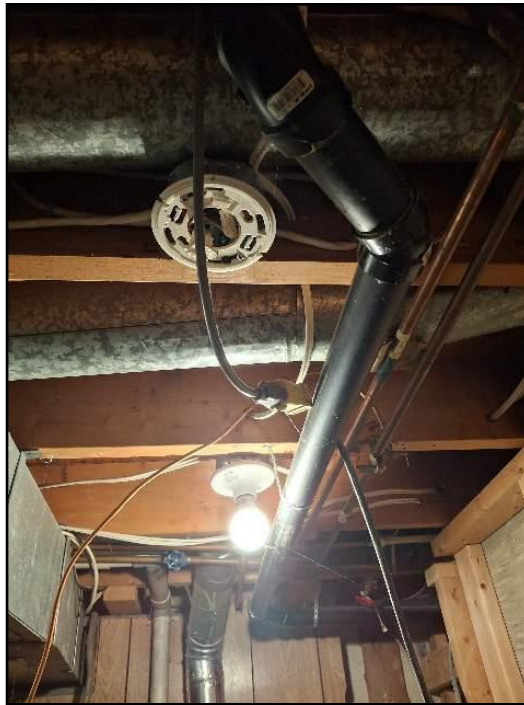
8.

**7. Condition:** • [Extension cord used as permanent wiring](#)

**Implication(s):** Electric shock | Fire hazard

**Location:** Basement Furnace Room

Replace extension cord with outlet in kitchen above. This may require a designated circuit.

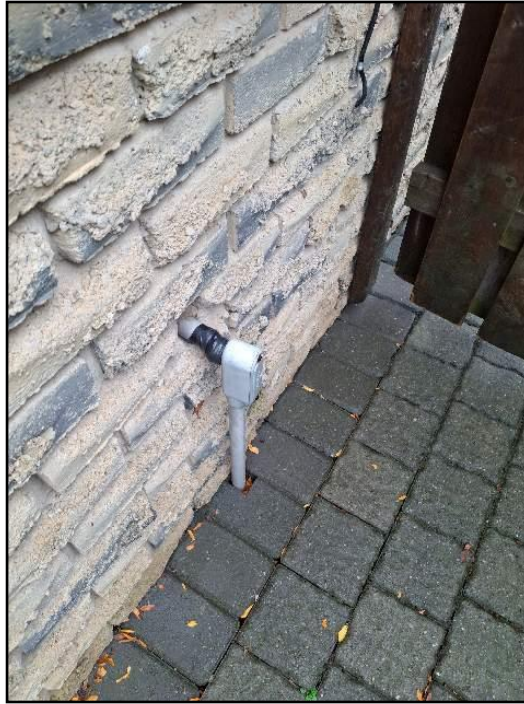
9.

**8. Condition:** • Conduit damaged at exterior wall.

**Location:** Northeast Exterior Wall

**Task:** Repair or replace

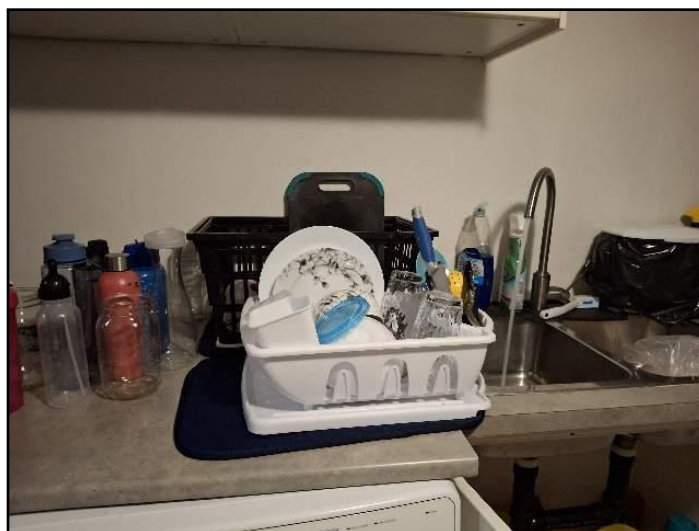
10.

**DISTRIBUTION SYSTEM \ Outlets (receptacles)****9. Condition:** • [GFCI/GFI needed \(Ground Fault Circuit Interrupter\)](#)

**Implication(s):** Electric shock**Location:** Various**Task:** Replace**Time:** Immediate**Cost:** Minor

Recommend gfcı protection at all wet locations.

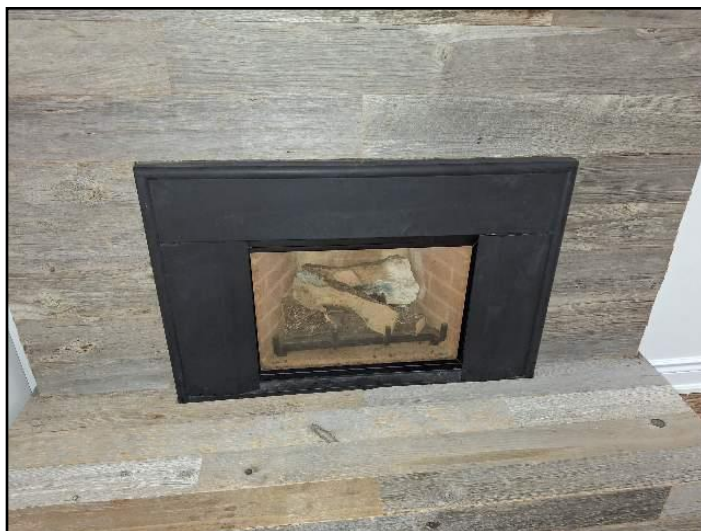
• Non-functional

11. Do not use

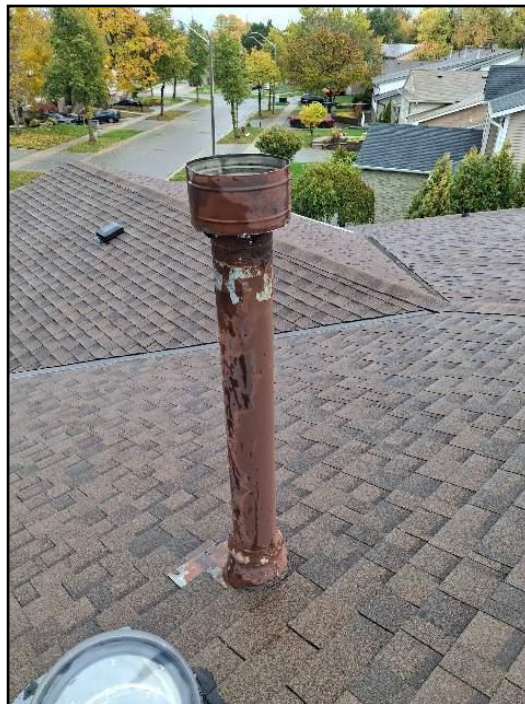
13. *Not in use*

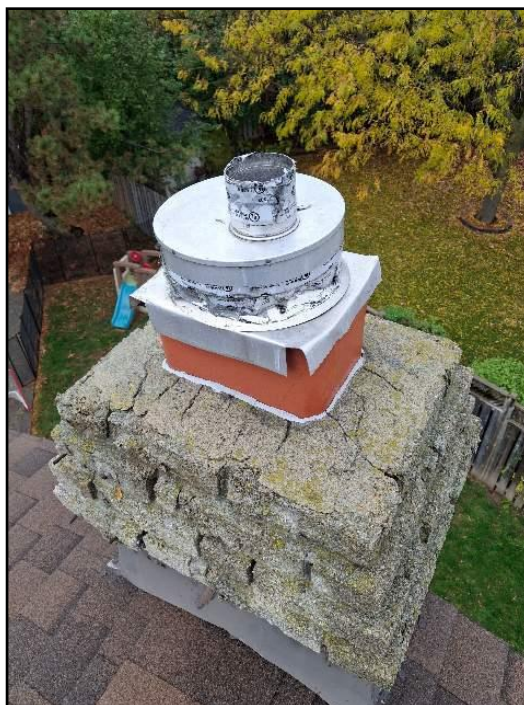
14.

**10. Condition:** • [Inoperative](#)

Gas fireplace off, top of liner damaged. Have inspected and repaired by qualified gas technician before use.

**Implication(s):** No heat for building

**Task:** Further Evaluate/Repair

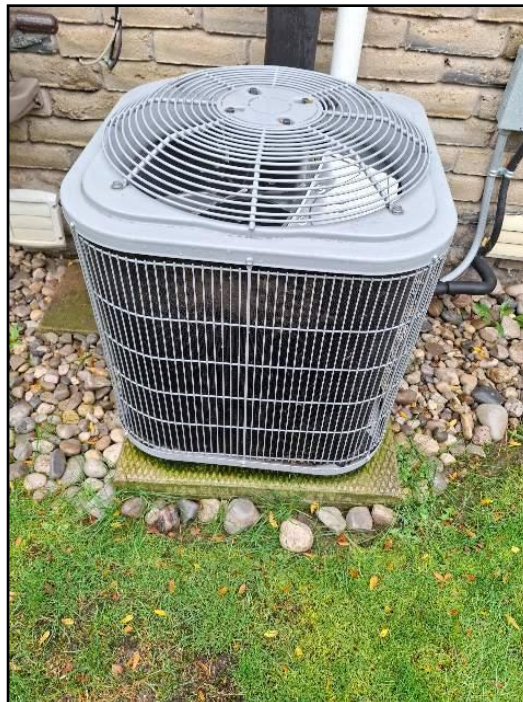
15.

**11. Condition:** • [Dirty](#)

**Implication(s):** Reduced system life expectancy | Increased cooling costs | Reduced comfort

**Task:** Clean
