# Your Inspection Report

91 Indian Road  
Toronto, ON M6R 2V5

Monday, November 17, 2025

RE: Report No. 4398, v.4  
91 Indian Road  
Toronto, ON  
M6R 2V5

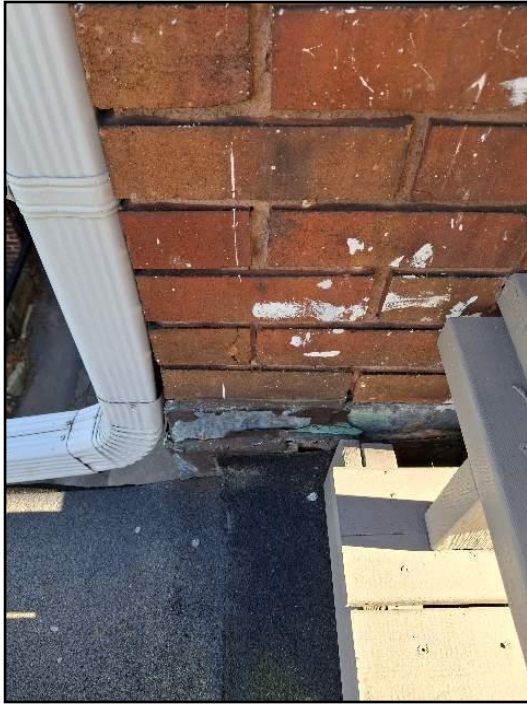
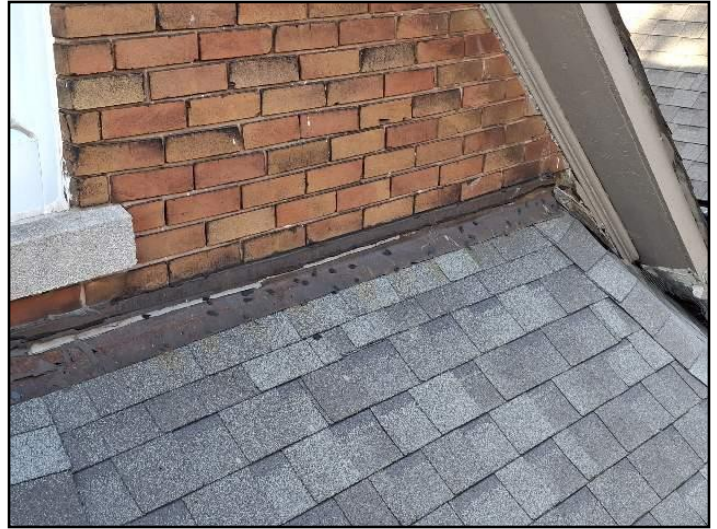
**1. Condition:** • Some poor flashings need repair.

**Location:** Various

**Task:** Repair or replace

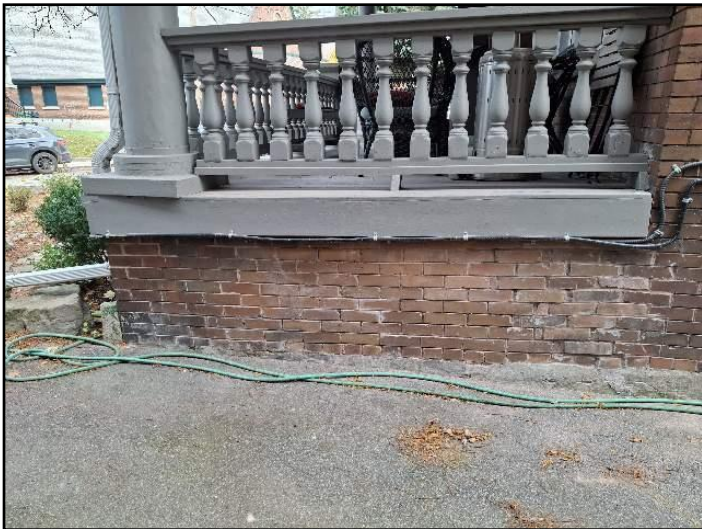
8.

**2. Condition:** • Significant settlement evident at front porch, south column is in poor condition. While sound at time of inspection, porch will require eventual rebuild.

**Location:** West Porch

**Task:** Monitor

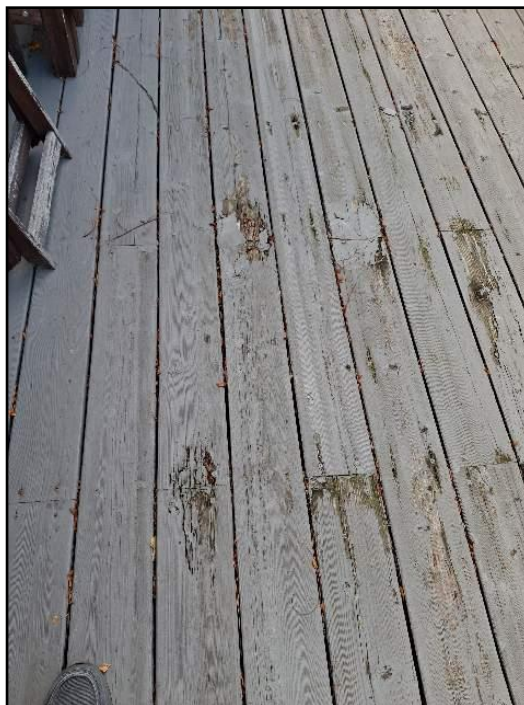
11.

3. Condition: • [Rot](#)

West balcony due for rebuild.

**Implication(s):** Weakened structure | Chance of movement | Material deterioration

**Location:** West Balcony

**Task:** Repair or replace

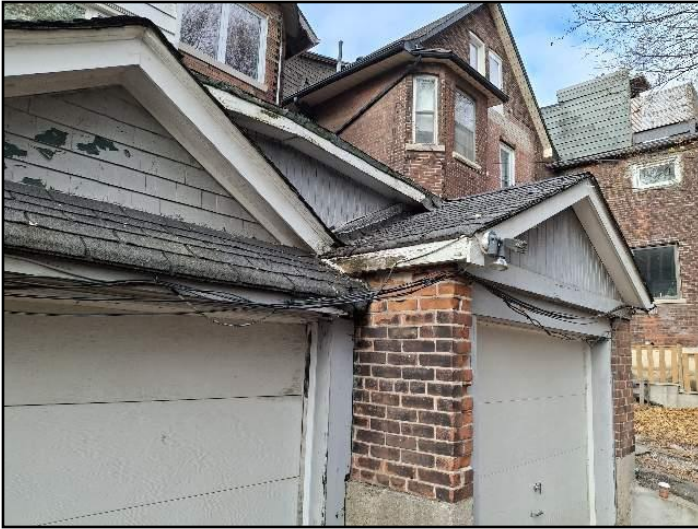
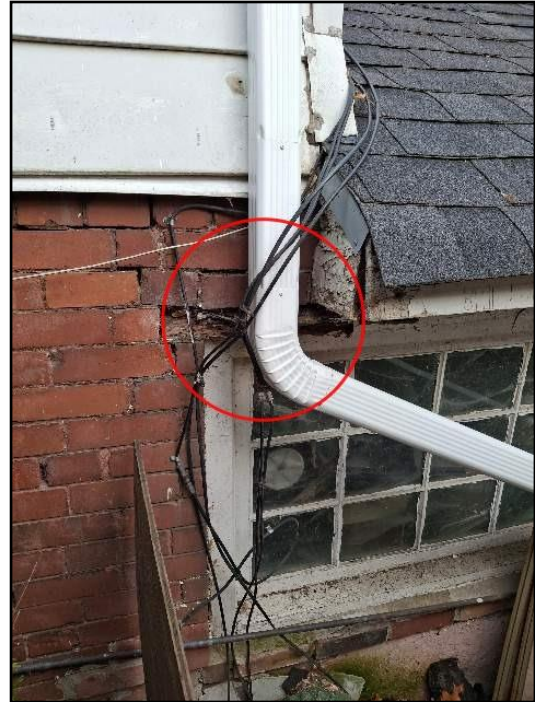
Some wood, roofing and masonry repairs needed at garage.

**Location:** East Exterior

**Task:** Repair

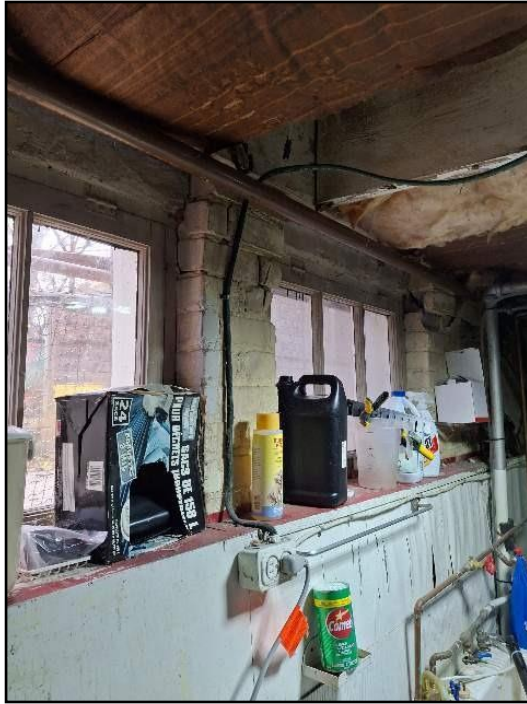
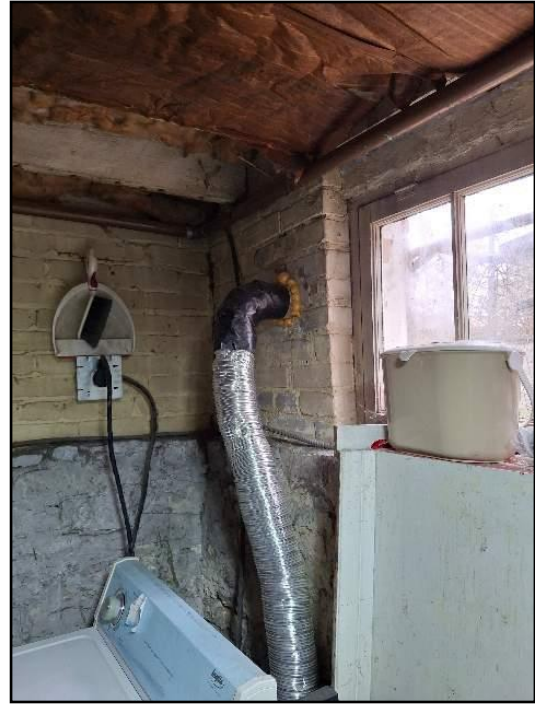
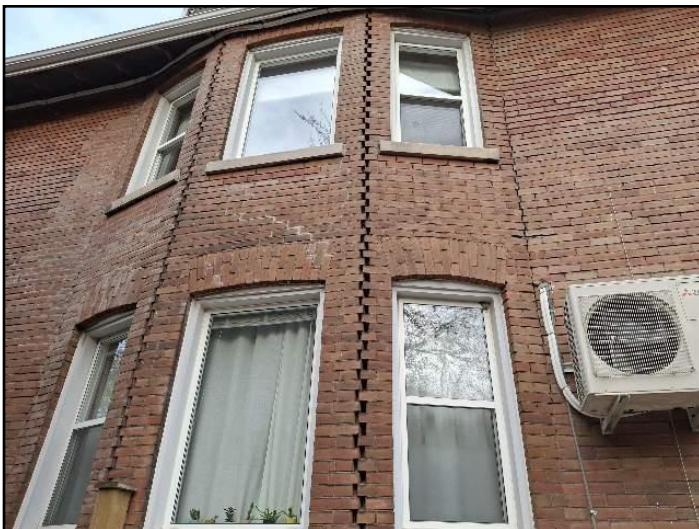
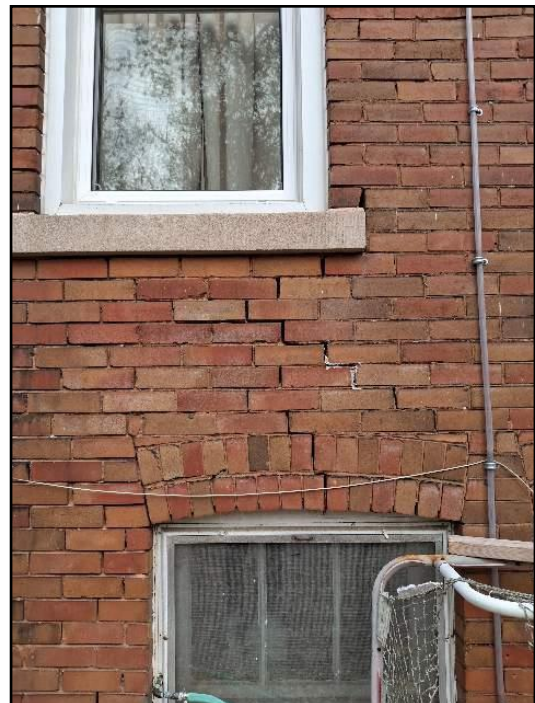
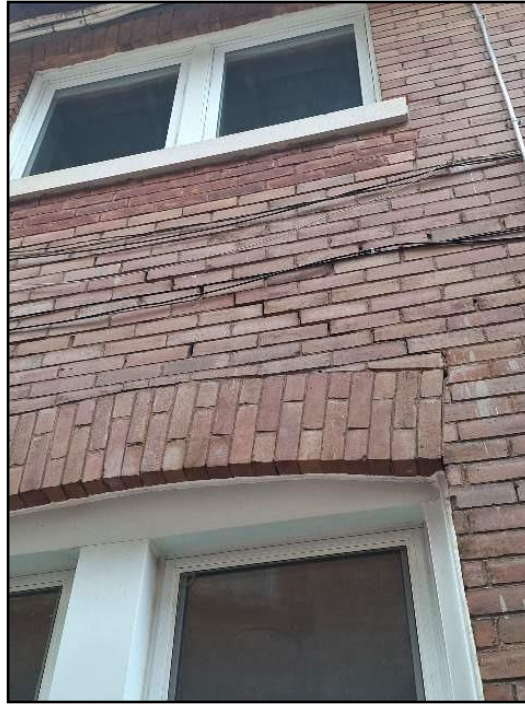
Typical of this area some masonry damage due to settlement is evident. Some areas can be repaired with tuckpointing. Recommend replacement of s/e arches with steel lintels and repair of supporting masonry when replacing basement windows.

**Implication(s):** Weakened structure

**Location:** Various Exterior Wall

**Task:** Repair

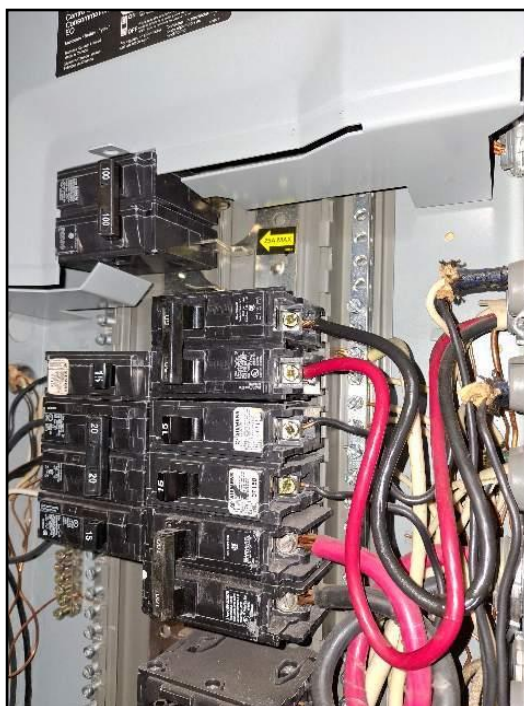
20.

**6. Condition:** • Oversized breaker (breaker too big).

**Location:** Basement Panel

**Task:** Correct

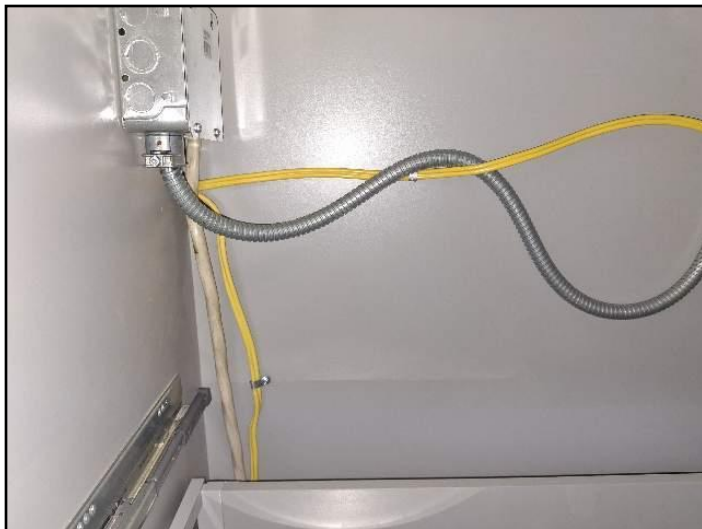
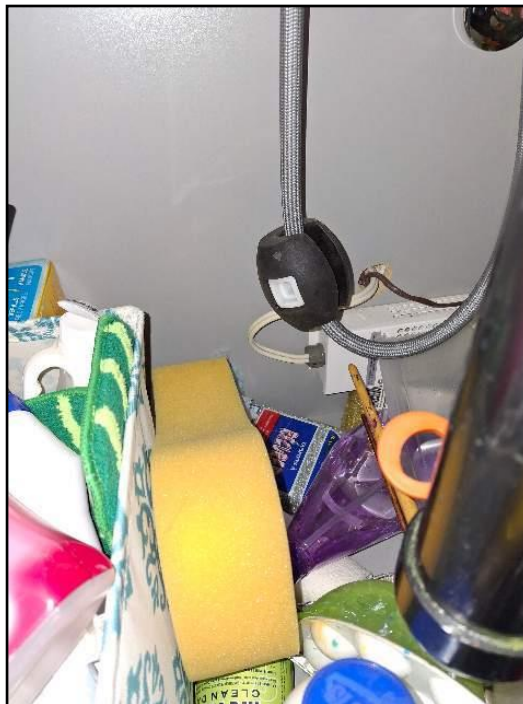
**7. Condition:** • Cover exposed wiring with conduit.

**Location:** Various

**Task:** Protect

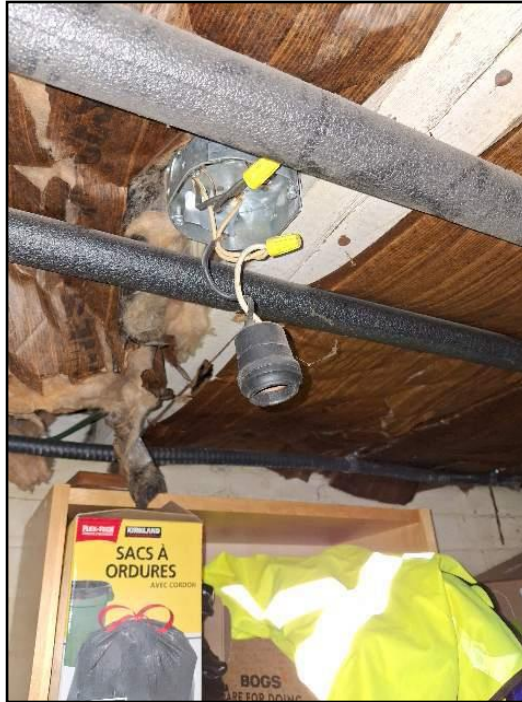
23.

**8. Condition:** • Exposed wires.

**Location:** Basement Laundry Area

**Task:** Improve

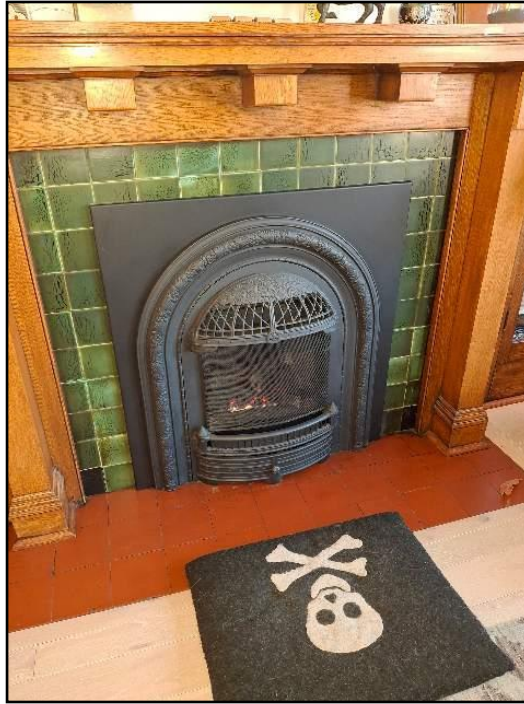
25. Gas fireplace

- Non-functional

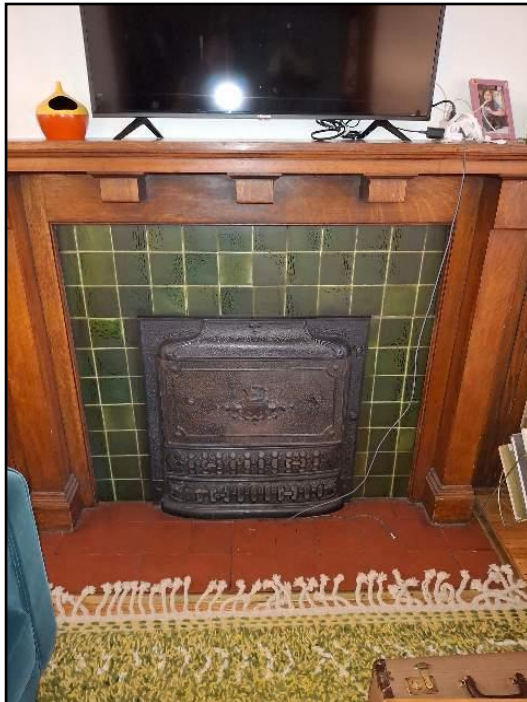
26. Do not use

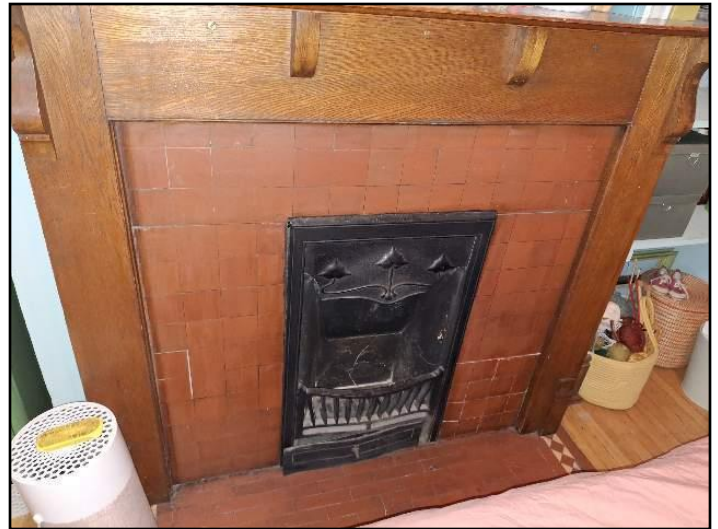
27. Do not use

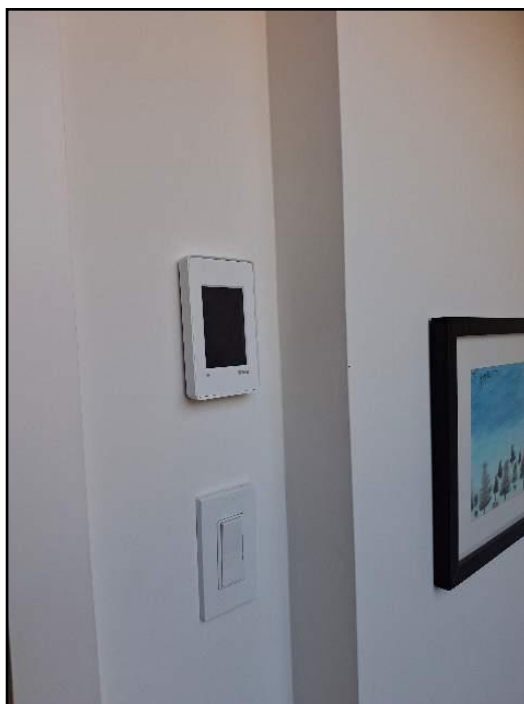
28.

**10. Condition:** • Electric radiant floor heat inoperative.

**Location:** North Third Floor

**Task:** Replace

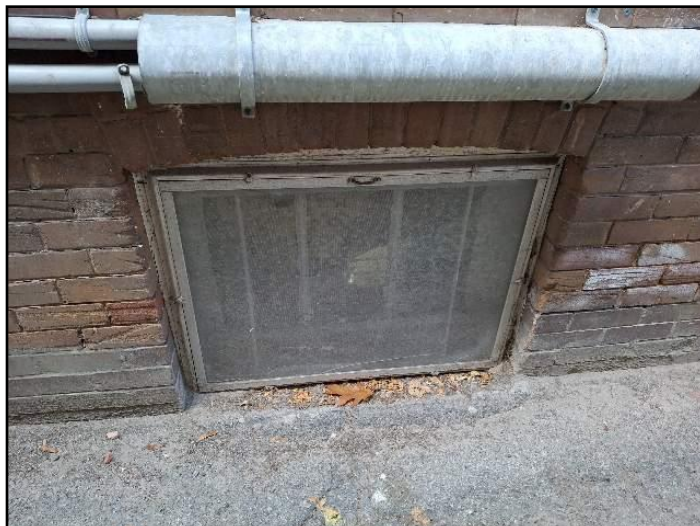
32.

15. Condition: • [Original lower quality units](#)

Task: Replace

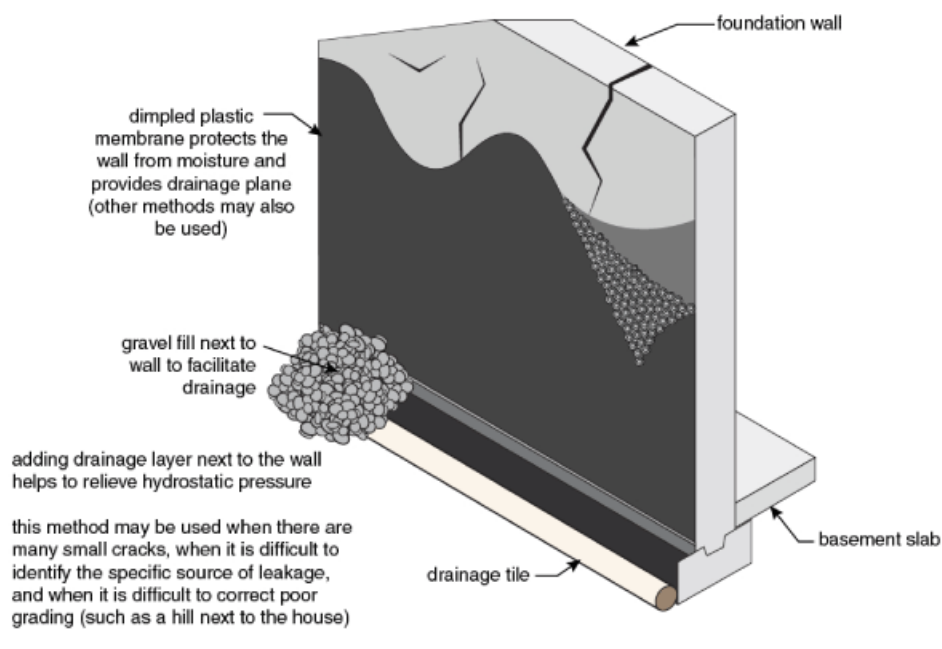
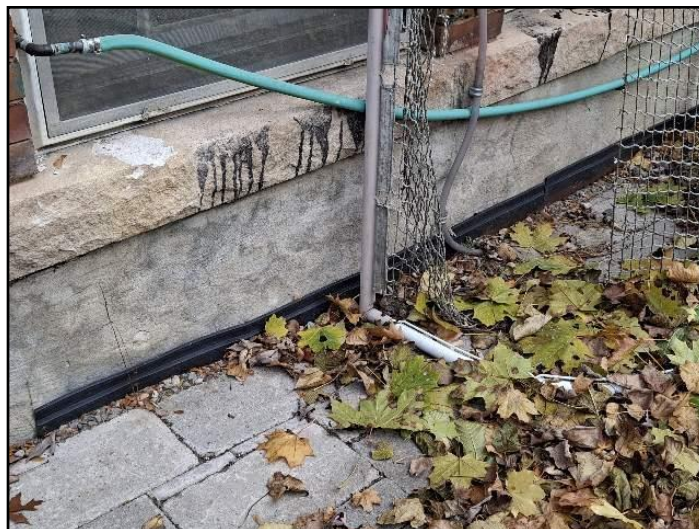
33.

**17. Condition:** • [Drainage membrane](#)

Exterior foundation membrane present at s/e exterior only. Recommend installing at interior of balance of basement when renovating..
