Your Inspection Report

91 Indian Road
Toronto, ON M6R 2V5

Monday, November 17, 2025

RE: Report No. 4398, v.3
91 Indian Road
Toronto, ON
M6R 2V5

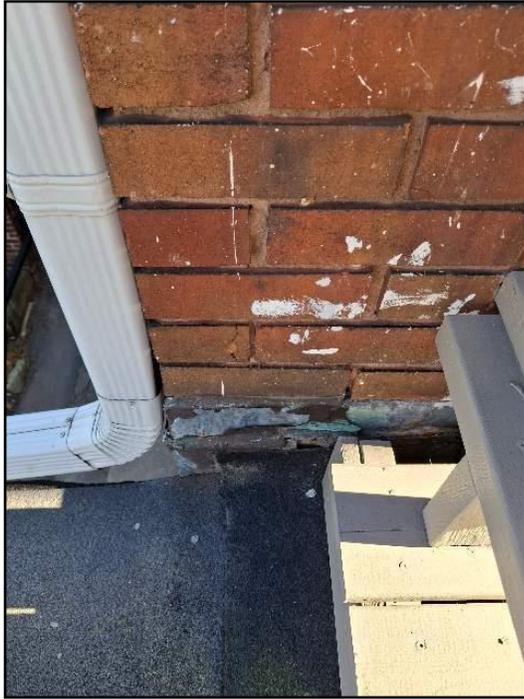
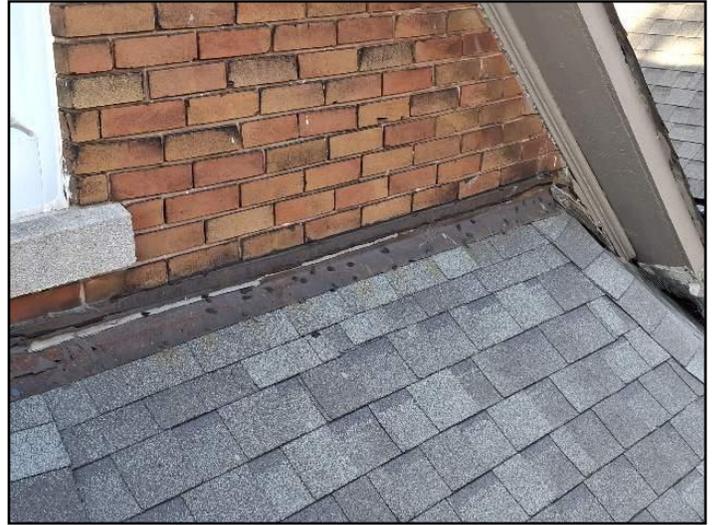
1. Condition: • Some poor flashings need repair.

Task: Repair or replace

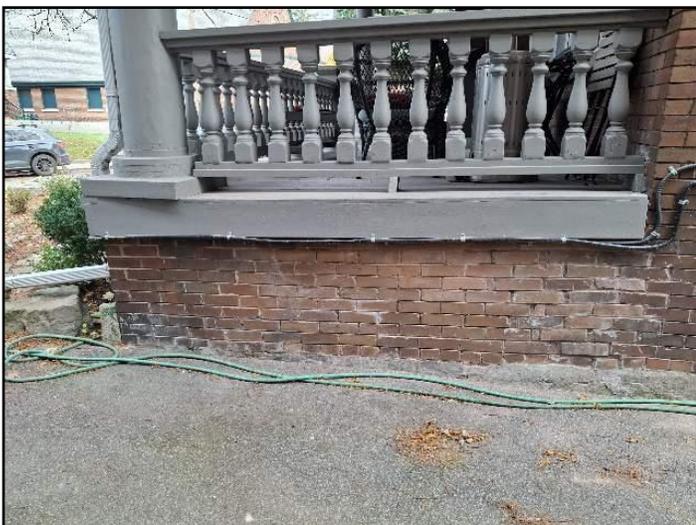
8.

2. Condition: • Significant settlement evident at front porch, south column is in poor condition. While sound at time of inspection, porch will require eventual rebuild.

Task: Monitor

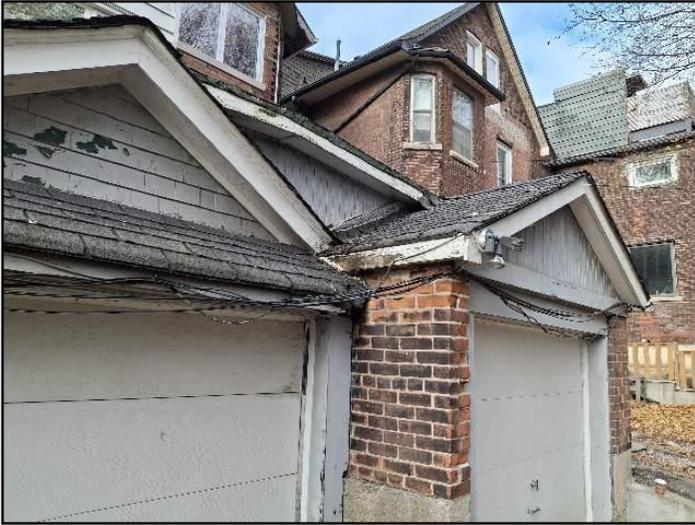
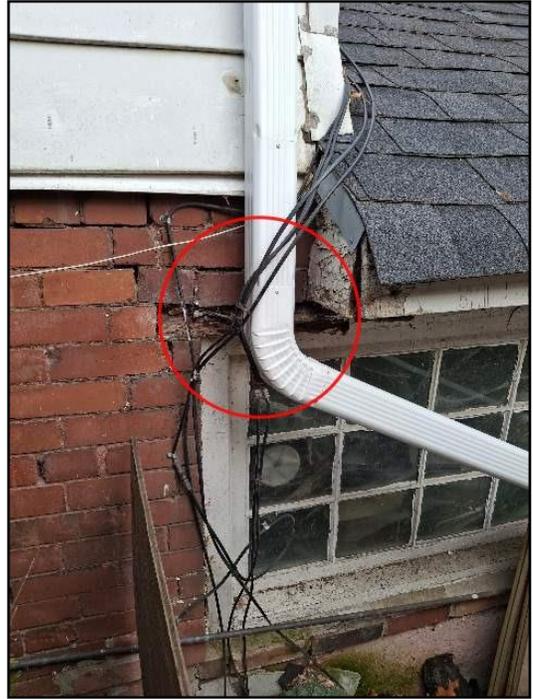
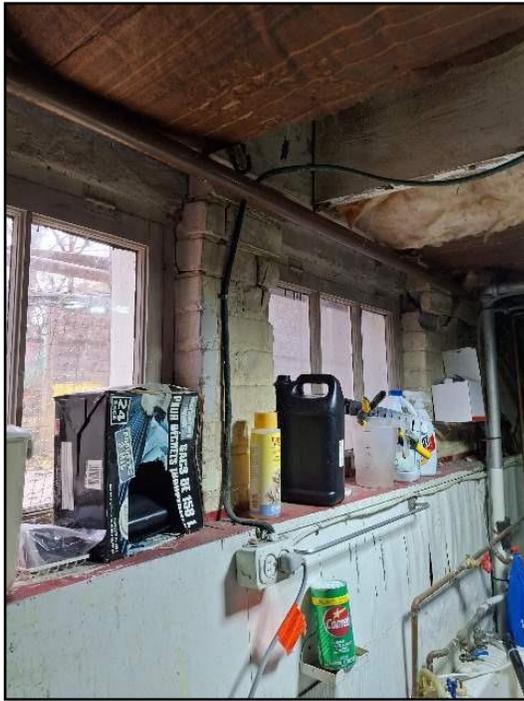
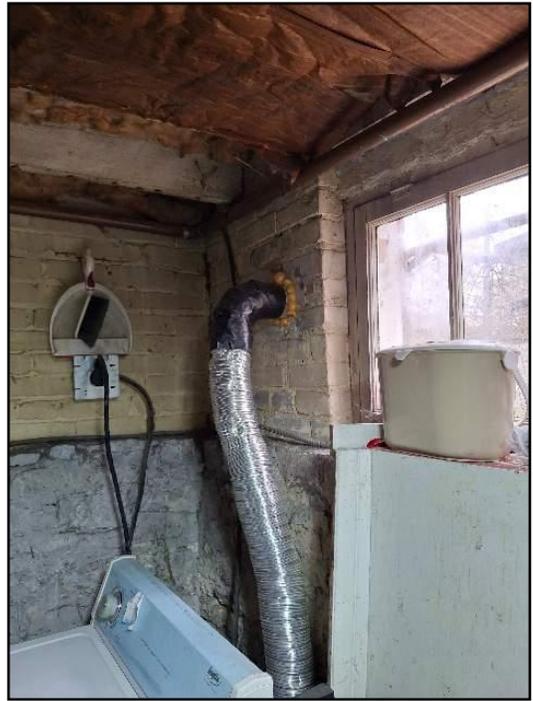
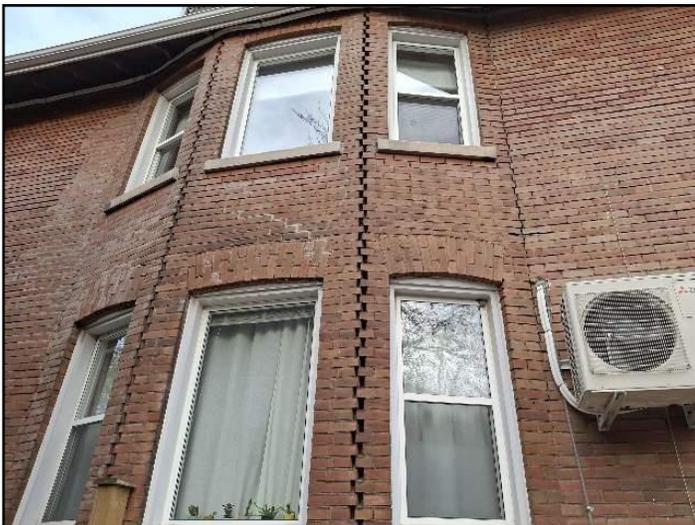
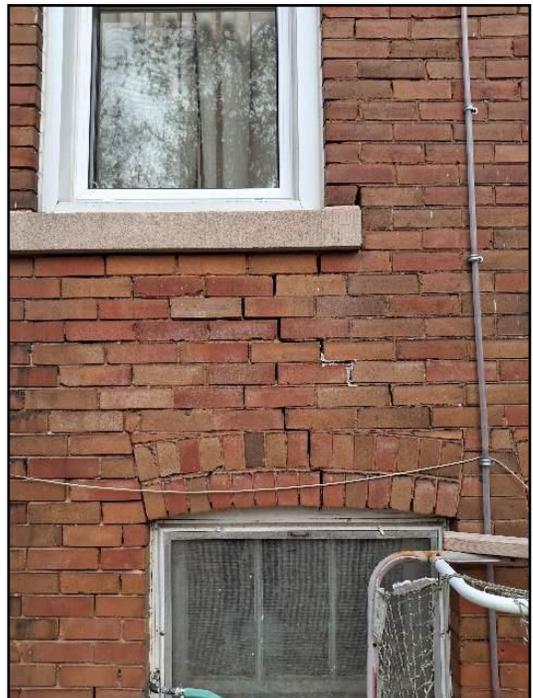
5. Condition: • [Cracked](#)

Typical of this area some masonry damage due to settlement is evident. Some areas can be repaired with tuckpointing. Recommend replacement of s/e arches with steel lintels and repair of supporting masonry when replacing basement windows.

Implication(s): Weakened structure

Task: Repair

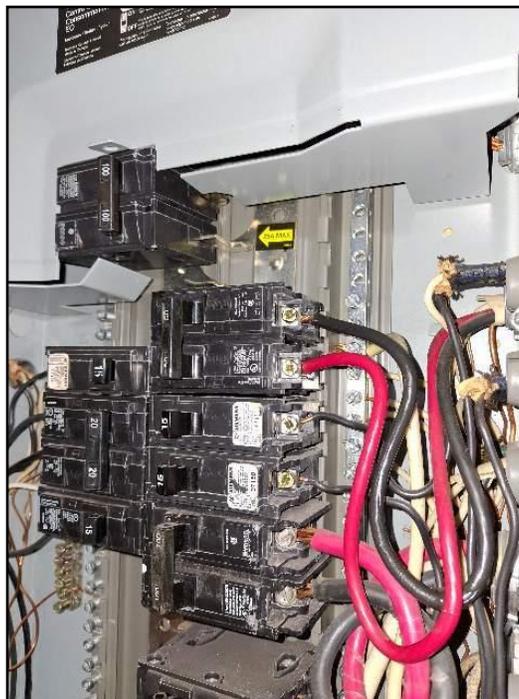
20.

6. Condition: • Oversized breaker (breaker too big).

Task: Correct

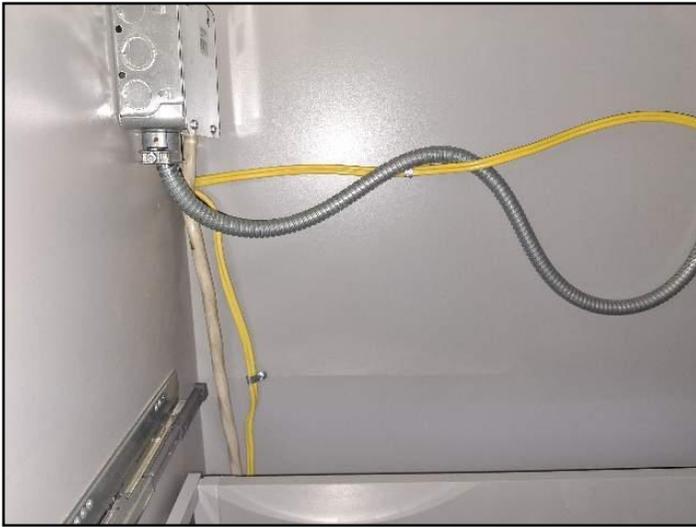
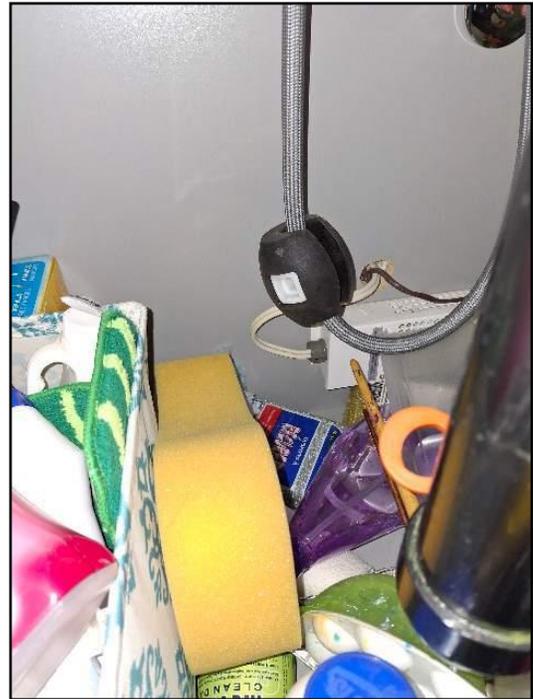
7. Condition: • Cover exposed wiring with conduit.

Task: Protect

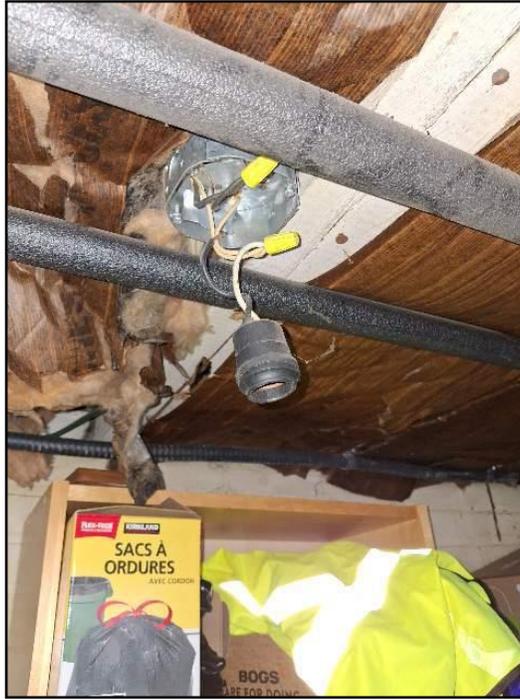
23.

8. Condition: • Exposed wires.
Location: Basement Laundry Area
Task: Improve
Time: Immediate
Cost: Minor

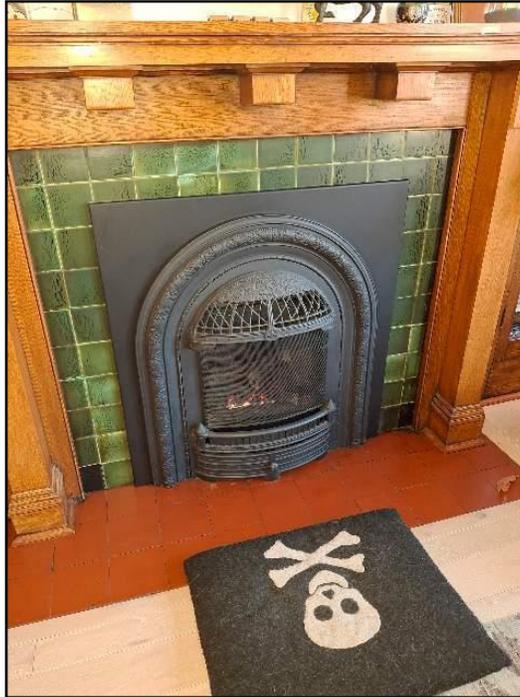
25. Gas fireplace

- Non-functional

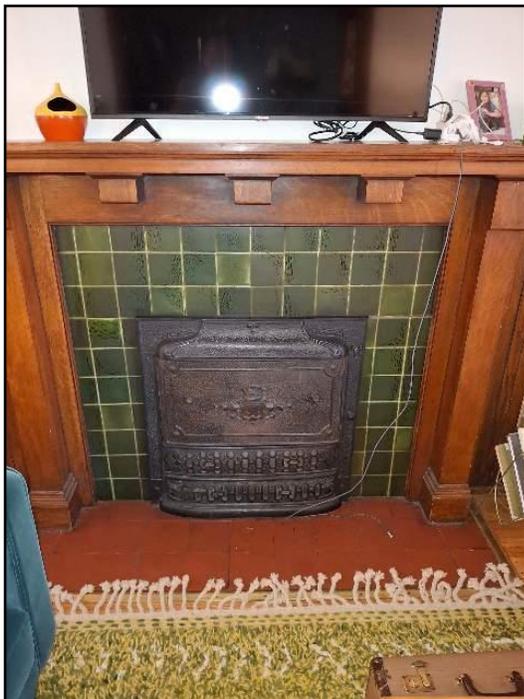
26. Do not use

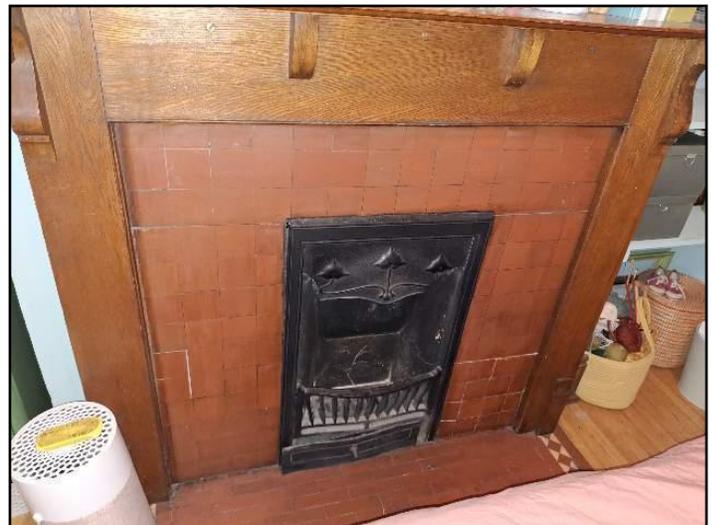
27. Do not use

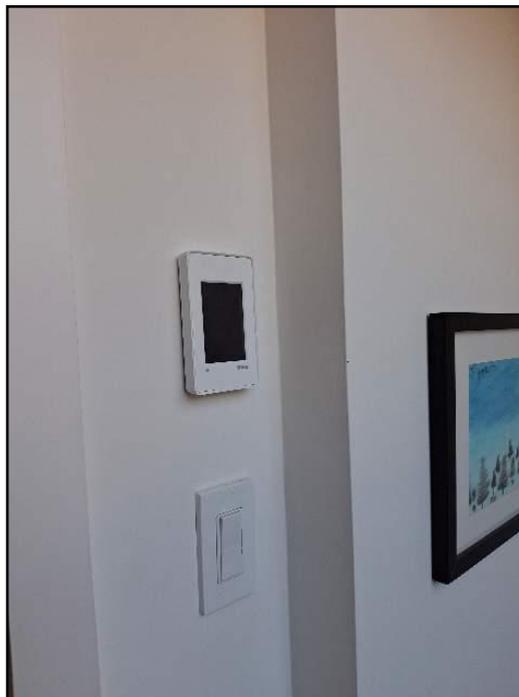
28.

10. Condition: • Electric radiant floor heat inoperative.

Task: Replace

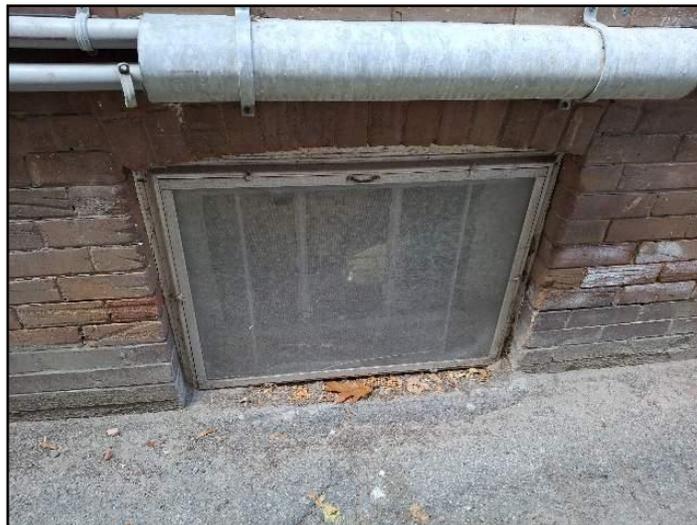
32.

15. Condition: • [Original lower quality units](#)

Some original windows remain in use.

Implication(s): Increased heating costs | Increased maintenance costs

Task: Replace

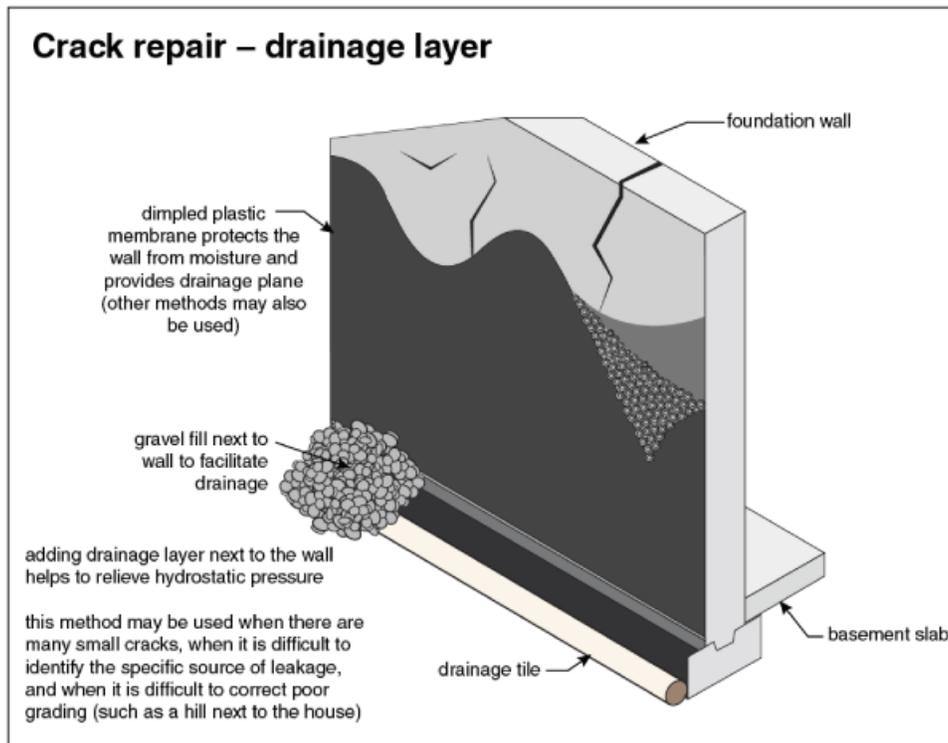
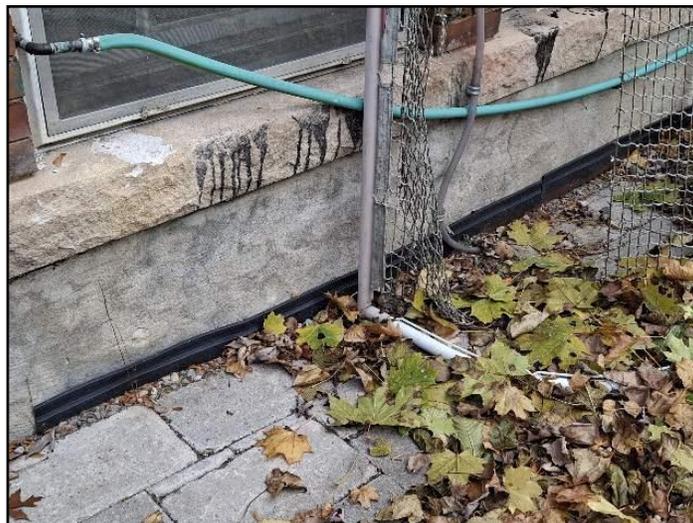
33.

17. Condition: • [Drainage membrane](#)

Exterior foundation membrane present at s/e exterior only. Recommend installing at interior of balance of basement when renovating..
