Your Inspection Report

725 Manning Avenue
Toronto, ON M6G 2W5

Tuesday, March 24, 2026

RE: Report No. 4437
725 Manning Avenue
Toronto, ON
M6G 2W5

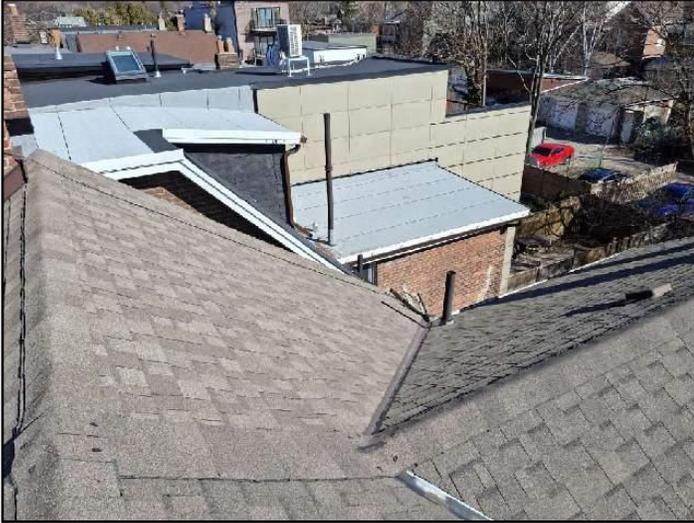
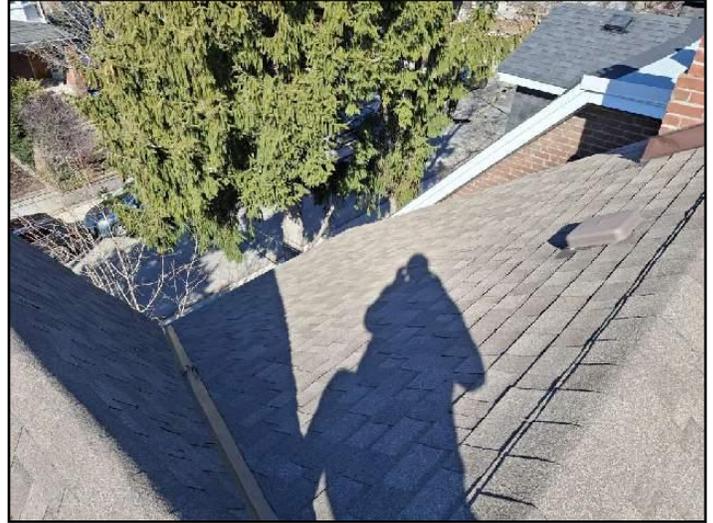
1. **Condition:** • No roofing recommendations are offered as a result of this inspection.
2. **Condition:** • Roof in good condition.

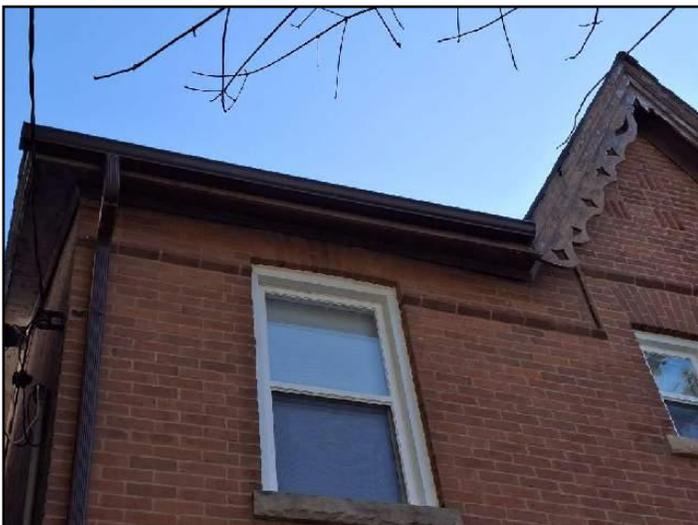
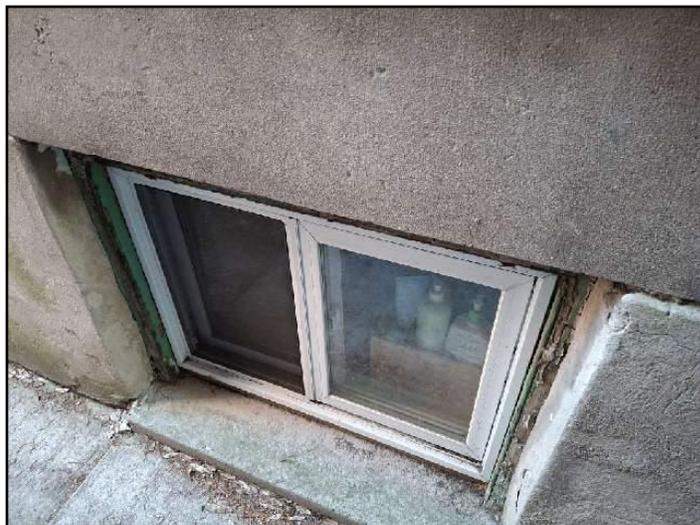
3. Condition: • Paint maintenance needed.
Maintenance needed at wood trim.
Location: Various Exterior
Task: Improve
Time: Regular maintenance
Cost: Consult Contractor For Cost

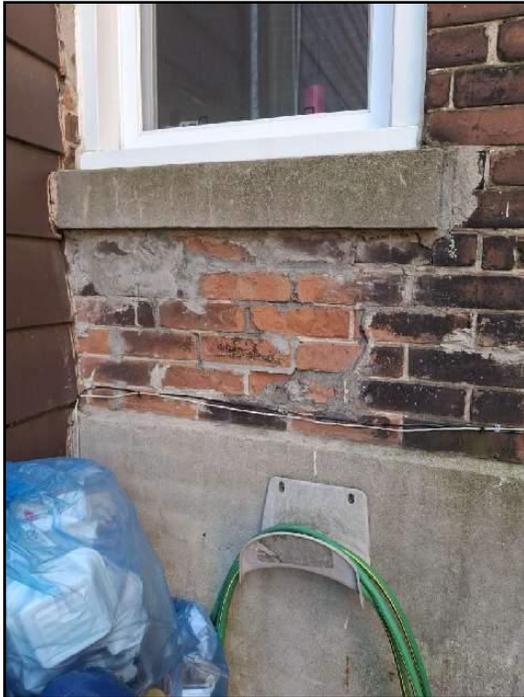
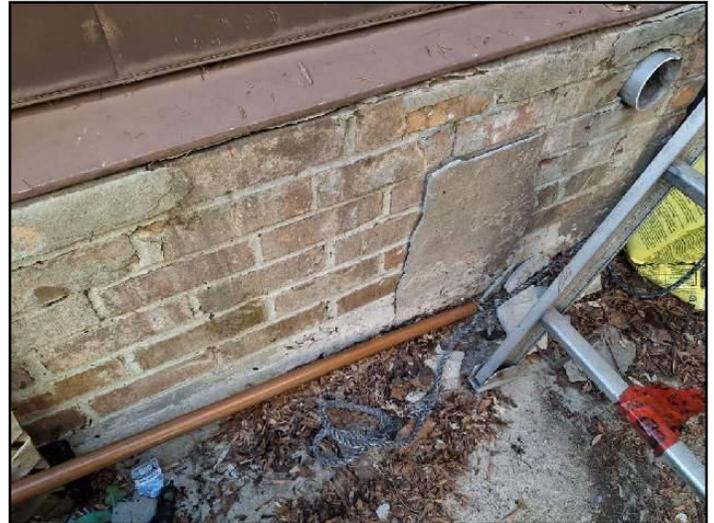
WALLS \ Masonry (brick, stone) and concrete**4. Condition:** • [Masonry deterioration](#)

Some parging repair needed. Replace missing dryer vent cover.

Implication(s): Weakened structure | Chance of structural movement**Location:** Various Exterior**Task:** Repair**Time:** Regular maintenance**Cost:** Minor

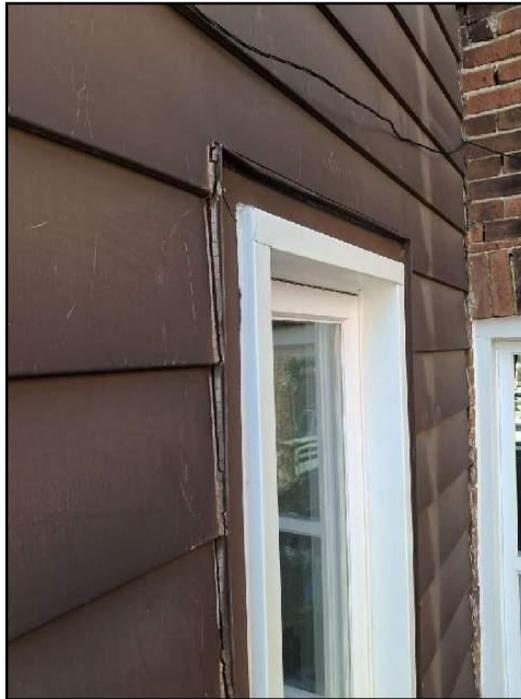
EXTERIOR GLASS/WINDOWS \ Exterior trim**5. Condition:** • [Caulking loose, missing or deteriorated](#)**Implication(s):** Chance of water damage to structure, finishes and contents | Increased heating and cooling costs**Location:** East Exterior**Task:** Repair**Time:** Regular maintenance**Cost:** Minor

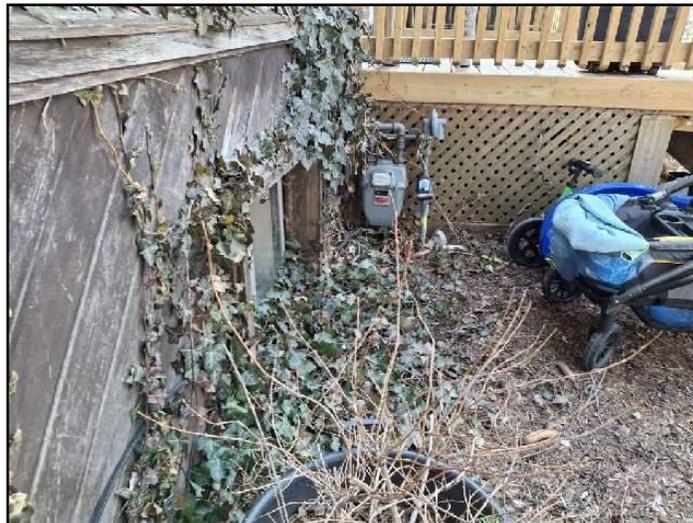
6. Condition: • [Wood/soil contact](#)

This area is known for termites, eliminate wood soil contact with all future improvements.

Implication(s): Rot | Insect damage

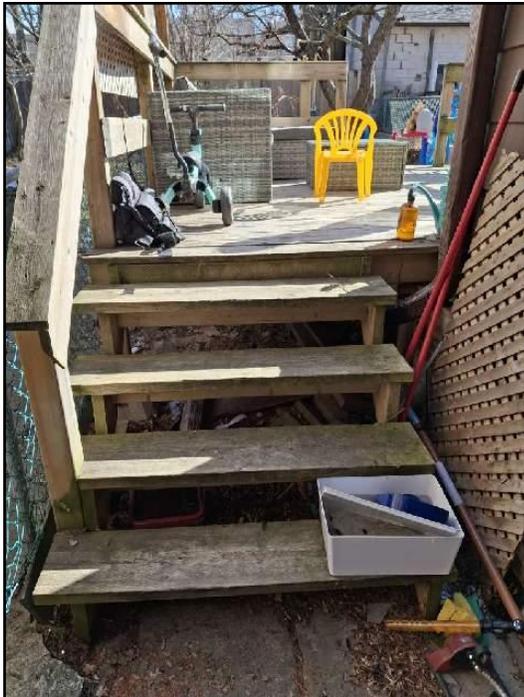
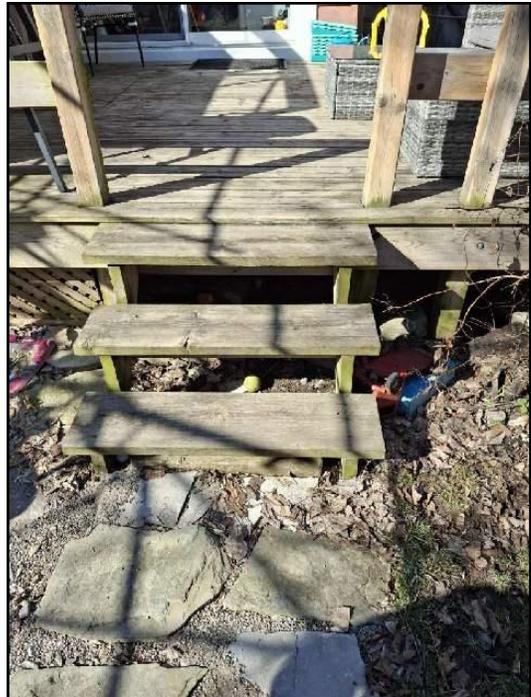
7. Condition: • Uneven rise at steps creates trip hazard.

Rebuild steps with uniform rise.

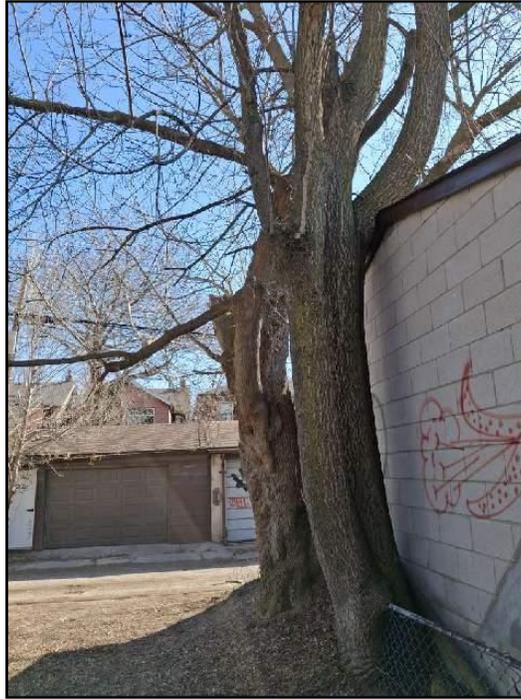
8. Condition: • Two large trees at driveway (ownership not determined) appear to be in poor condition.

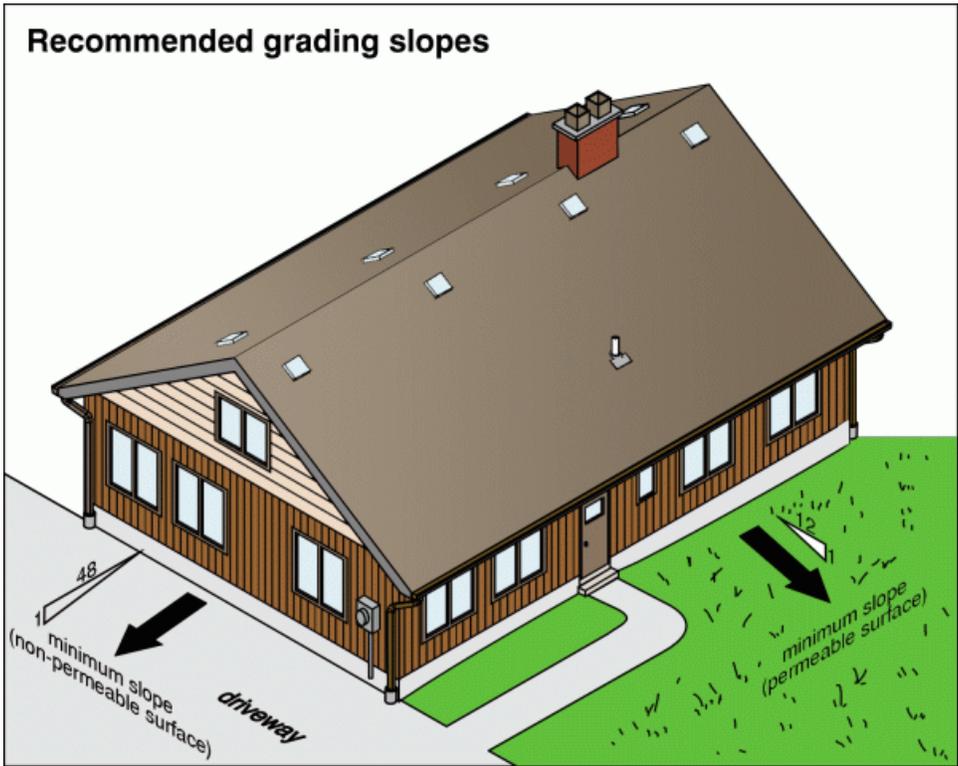
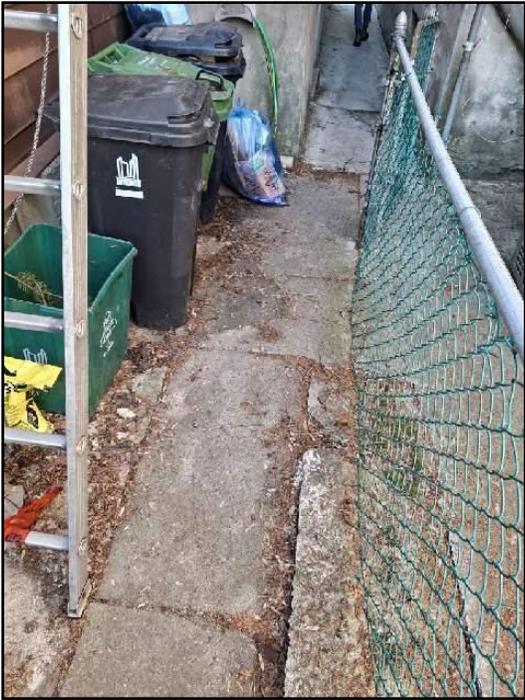
9. Condition: • [Improper slope or drainage](#)

Implication(s): Chance of water damage to structure, finishes and contents

Create drainage slope away from foundation.

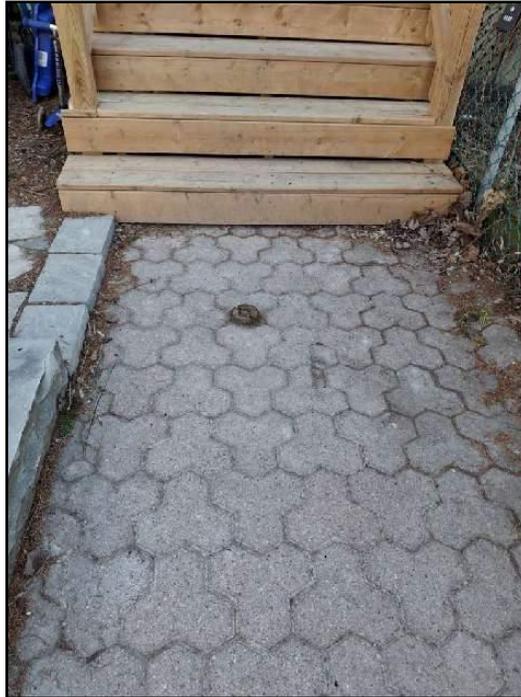
10. Condition: • [Uneven \(trip hazard\)](#)
Raise interlocking flush with water access cover.

Implication(s): Physical injury

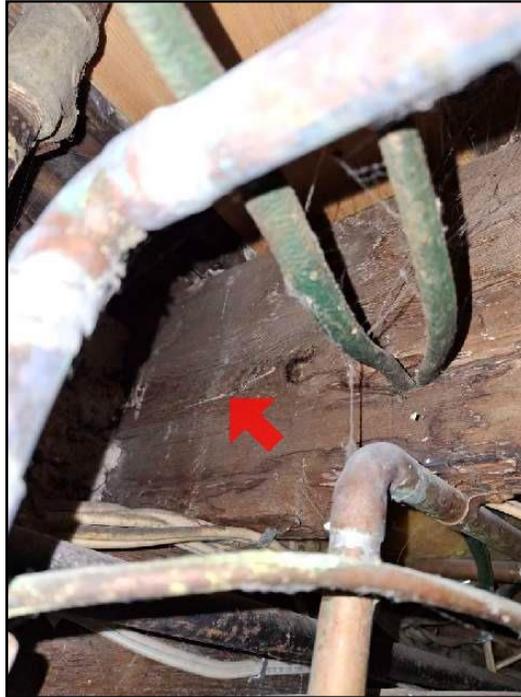
11. Condition: • Evidence of termite activity, recommend further evaluation by qualified pest control company and treatment if necessary.

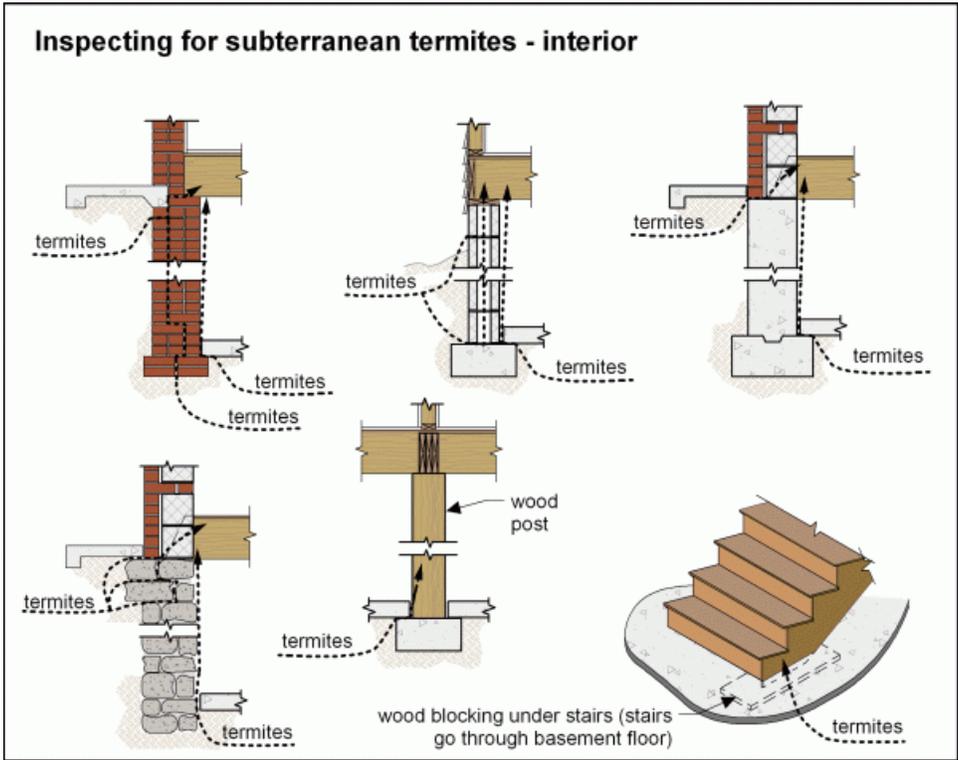
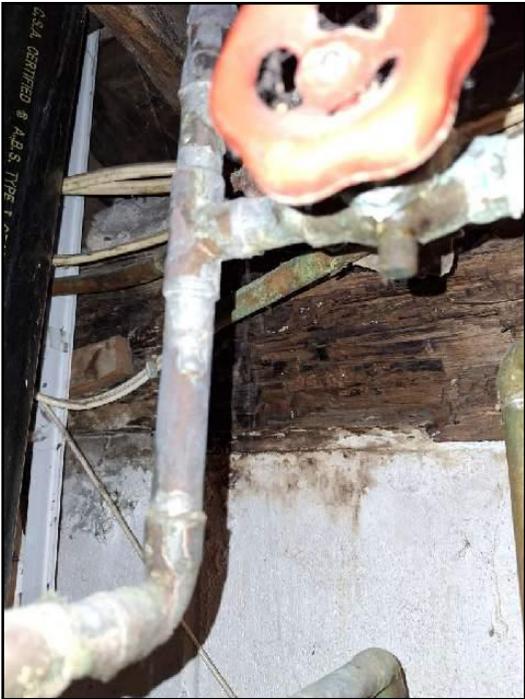
12. Condition: • [Rot or insect damage](#)

Some rot at sill beam, replace section if finishing area.

Implication(s): Weakened structure

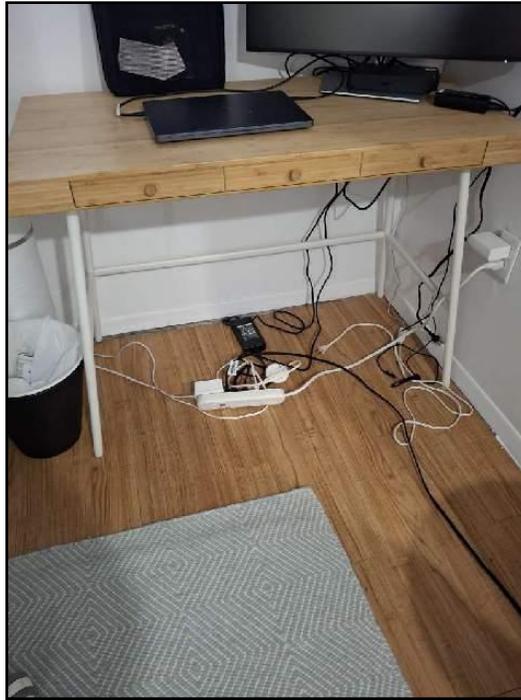
- 13. Condition: • [Too few outlets](#)
Recommend additional outlets (on additional circuits). Install gfci outlets in wet locations.
- Implication(s): Nuisance
- Location: Various
- Task: Improve

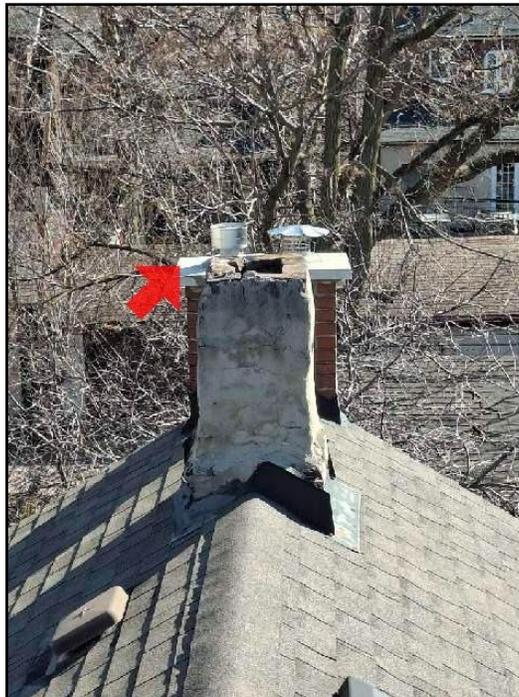
• [Masonry](#)

For water heater only.

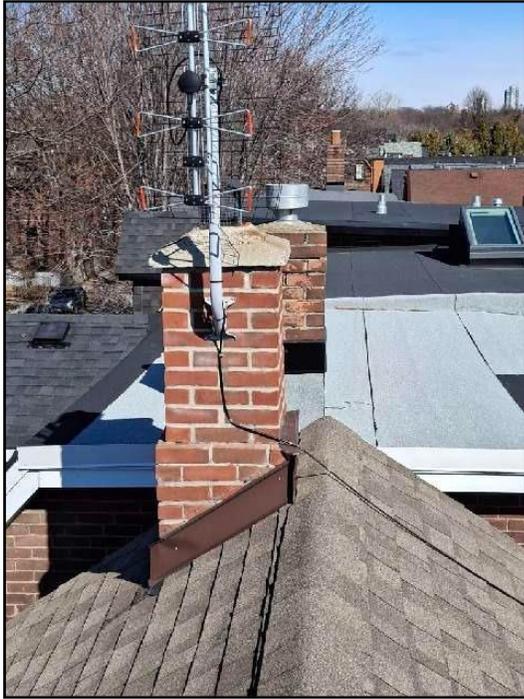
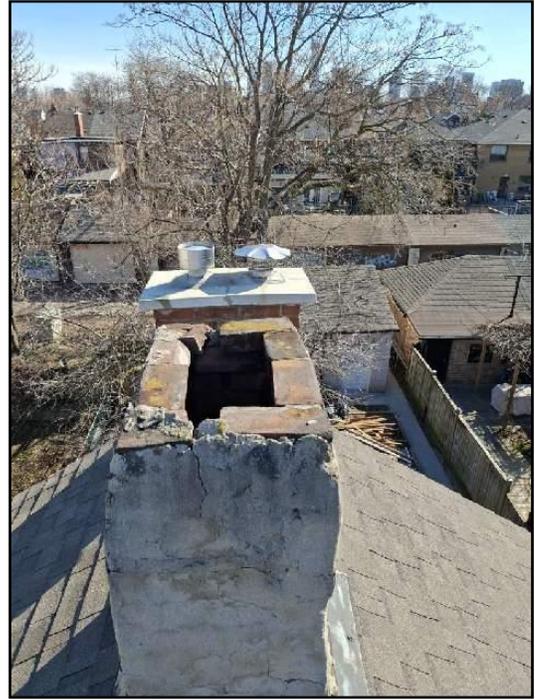
• [Abandoned](#)

These two chimneys are not in use and can be removed when reshingling in future. Cap unused east chimney against pest and water entry in interim.

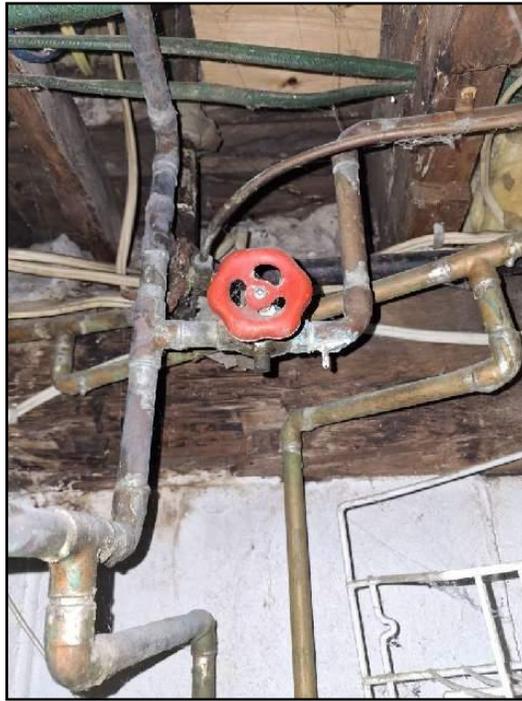
19. Condition: • [Leak or drip](#)

Implication(s): Chance of water damage to structure, finishes and contents

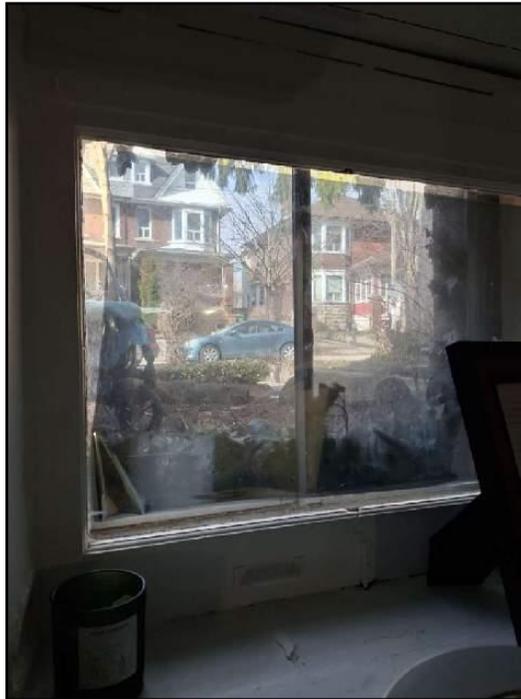
21. Condition: • Some older windows remain in use.

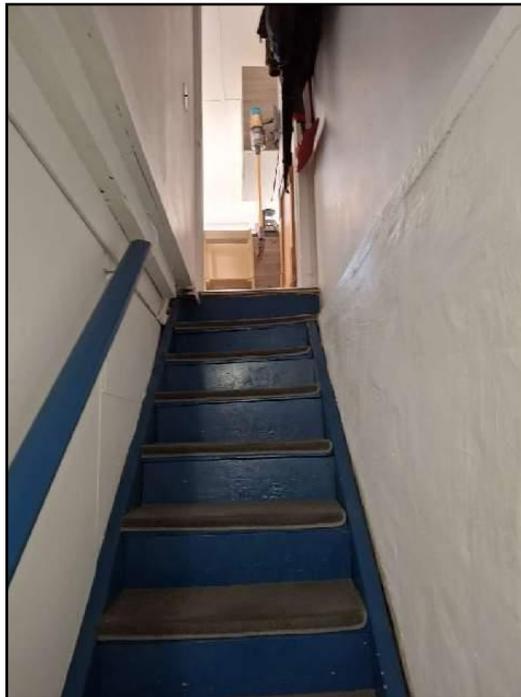
22. Condition: • Basement stairs narrow, add continuous handrail, reconfigure if renovating.
