# Your Inspection Report

183 Gladstone Avenue  
Toronto, ON M6J 3L3

RE: Report No. 4471  
183 Gladstone Avenue  
Toronto, ON  
M6J 3L3

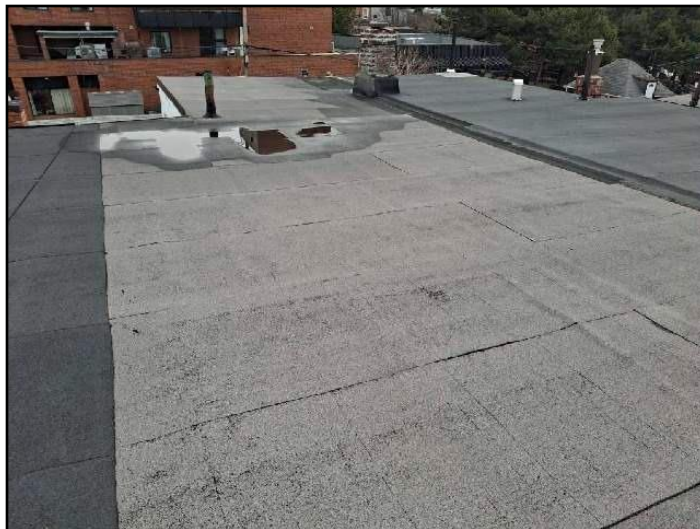
3.

Flat roof has leaked previously around unused chimney. Recommend removing chimney flush with roof and resurfacing area with new membrane.

Flat roof is aging, some ponding and blistering, inspect annually after repair.

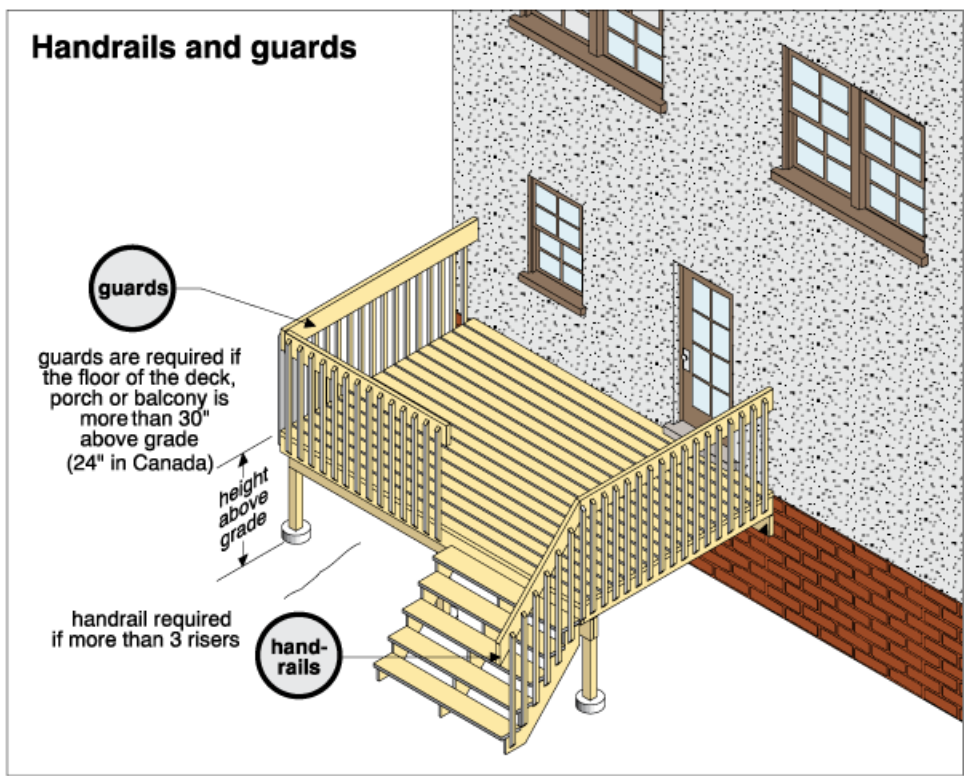
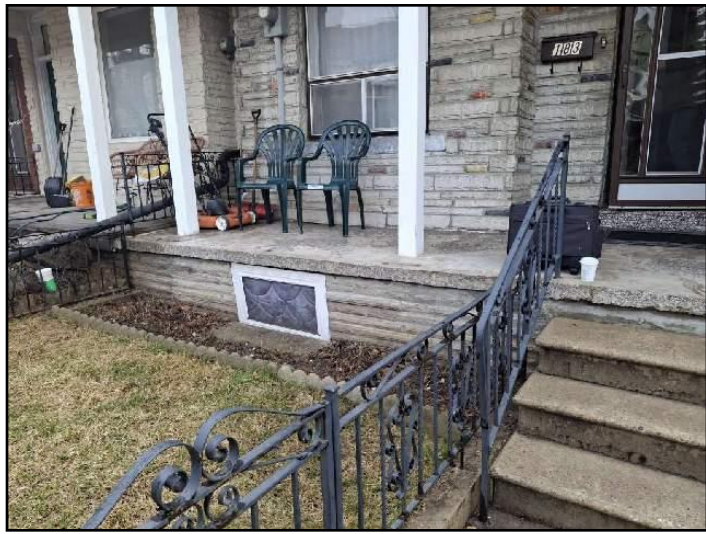
5.

**PORCHES, DECKS, STAIRS, PATIOS AND BALCONIES \ Handrails and guards**  
**2. Condition:** • [Missing](#)  
Add railing at front porch.  
**Implication(s):** Fall hazard  
**Location:** West Exterior  
**Task:** Install  
**Time:** Immediate  
**Cost:** Depends on approach

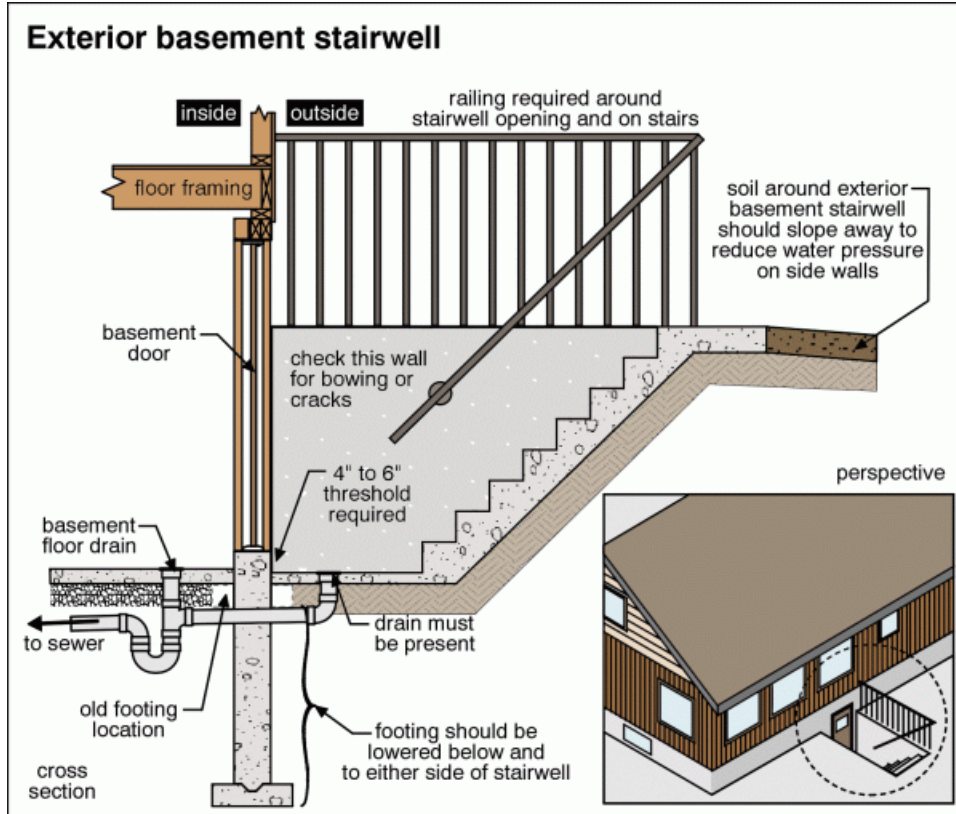
**3. Condition:** • [Step and landing problems](#)

Ideally walkout would have a step up into basement and a larger landing.. Keep drain clear. Monitor for need to alter landing to create step up into basement.

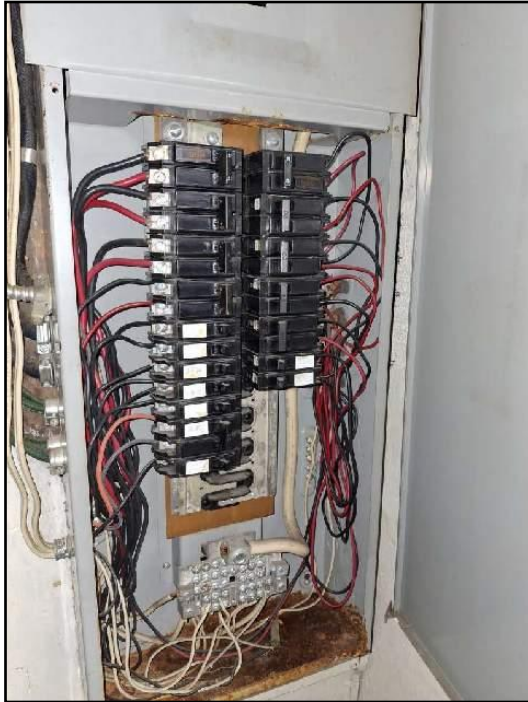
**5. Condition:** • Property due for complete rewire upon possession.  
Rewiring needed due to presence of knob and tube, aluminum, and very poor wiring installation.

7. Rusted panel

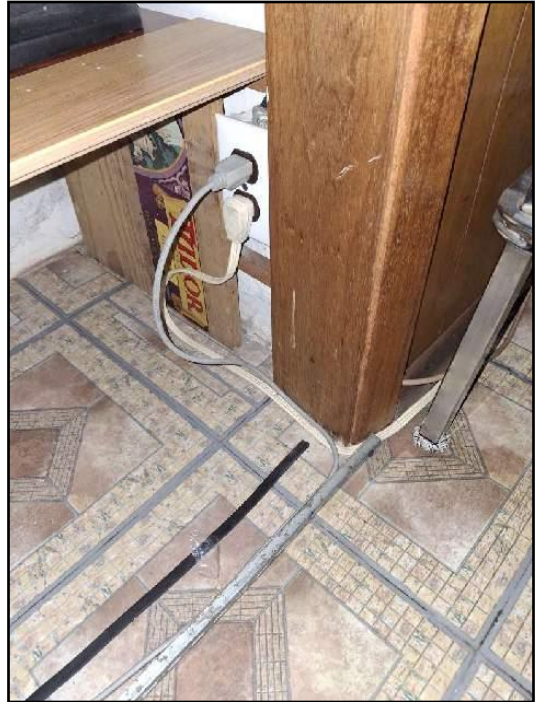
8. Surface wiring

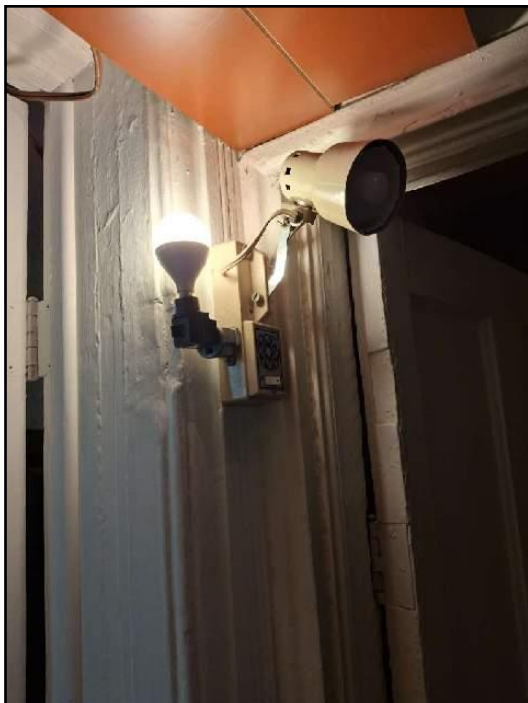
9. Unsafe switches

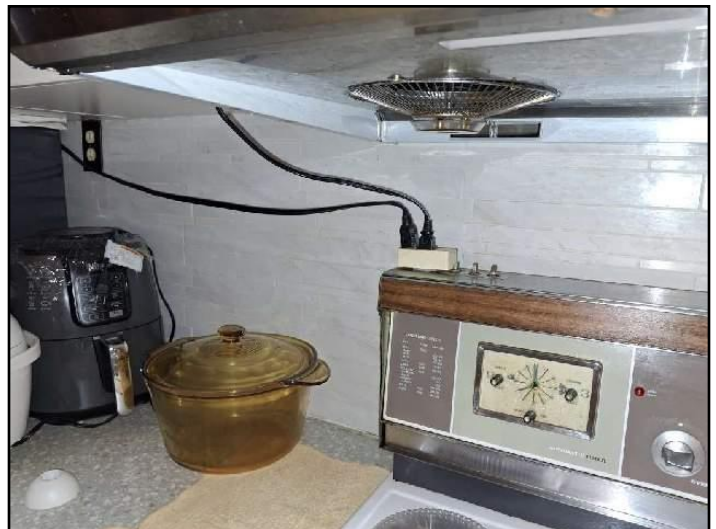
10. Too few outlets

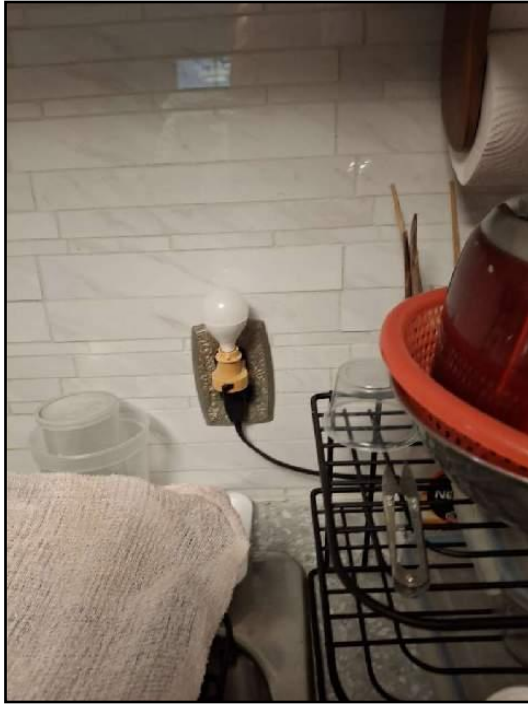
11. Missing gfcis

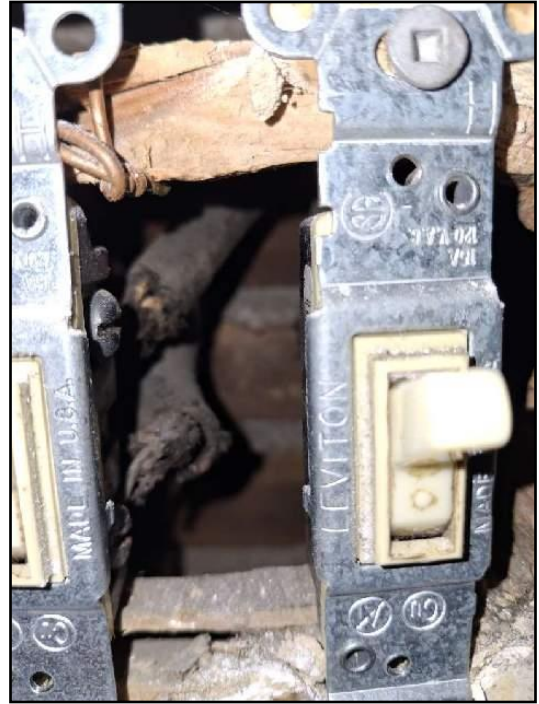
12. Knob and tube

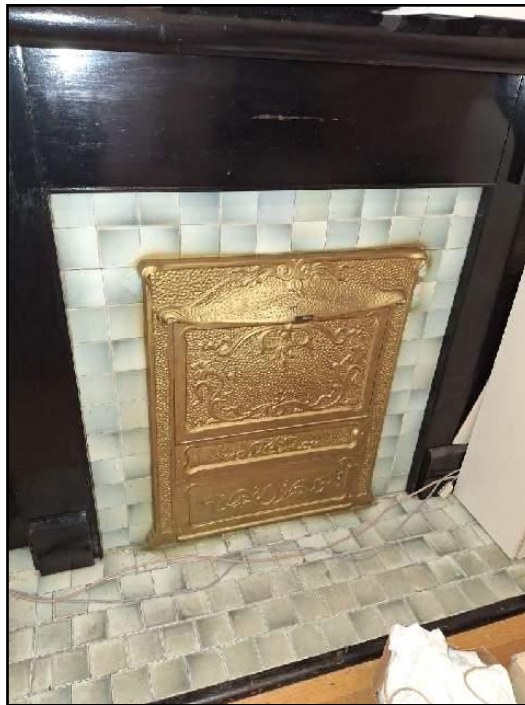
13. Do not use

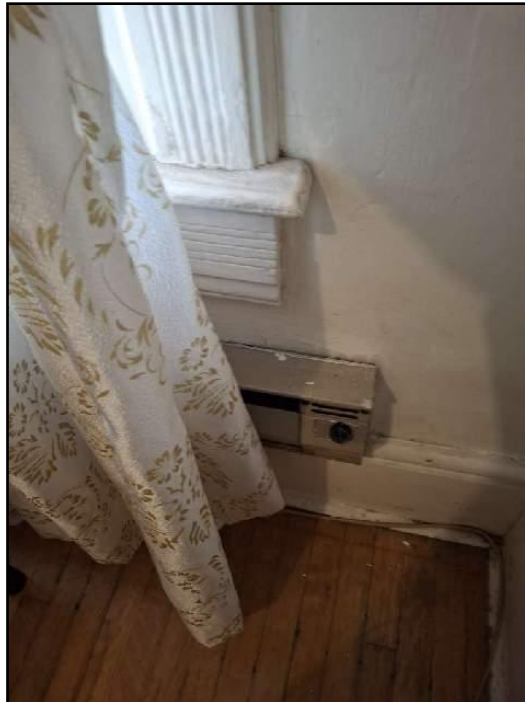
14.

**6. Condition:** • Inadequate combustible clearance.

Ensure proper clearances are present around all heaters.

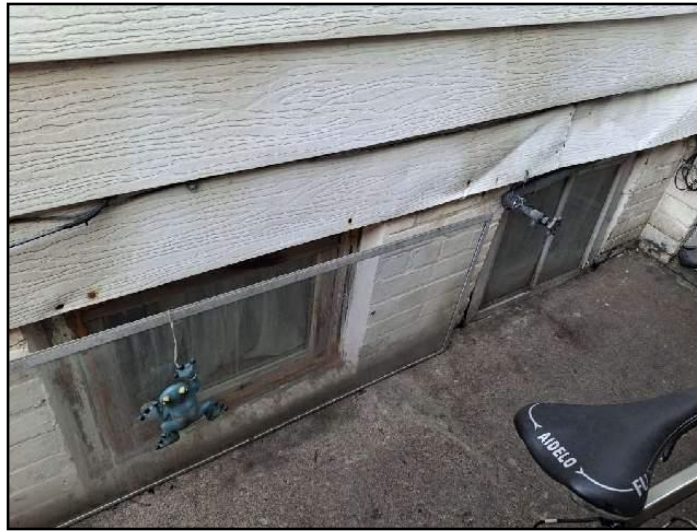
16.

**12. Condition:** • [Original lower quality units](#)

Especially poor windows at basement.

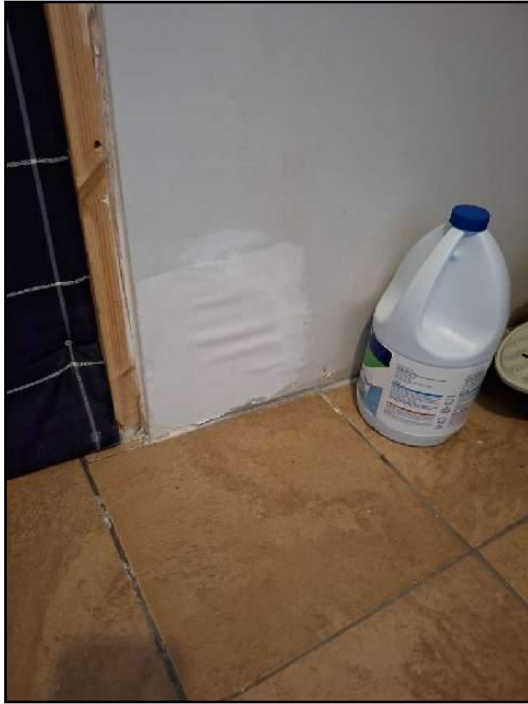
17.

14. Condition: • [Dampness on floor or walls](#)

Some dampness evident at basement entrance. Recommend interior foundation membrane system throughout when renovating.
